**FLORIDA DEPARTMENT OF TRANSPORTATION
BRIDGE MANAGEMENT SYSTEM
Inspection/CIDR/Bridge Profile Report
Inspection**

Structure ID: 884039

INSPECTION DATE: 10/29/2019 MYLK

BY: TranSystems Corporation Consultants	STRUCTURE NAME: Not recorded
OWNER: 2 County Hwy Agency	YEAR BUILT: 1961
MAINTAINED BY: 2 County Hwy Agency	SECTION NO.: 88 000 002
STRUCTURE TYPE: 1 Reinforced Concrete - 01 Slab	MP: 1.988
LOCATION: CR-615 (66TH AVE.)	ROUTE: 00508
SERV. TYPE ON: 1 Highway	FACILITY CARRIED: CR-508 (69TH ST.)
SERV. TYPE UNDER: 5 Waterway	FEATURE INTERSECTED: LATERAL A CANAL

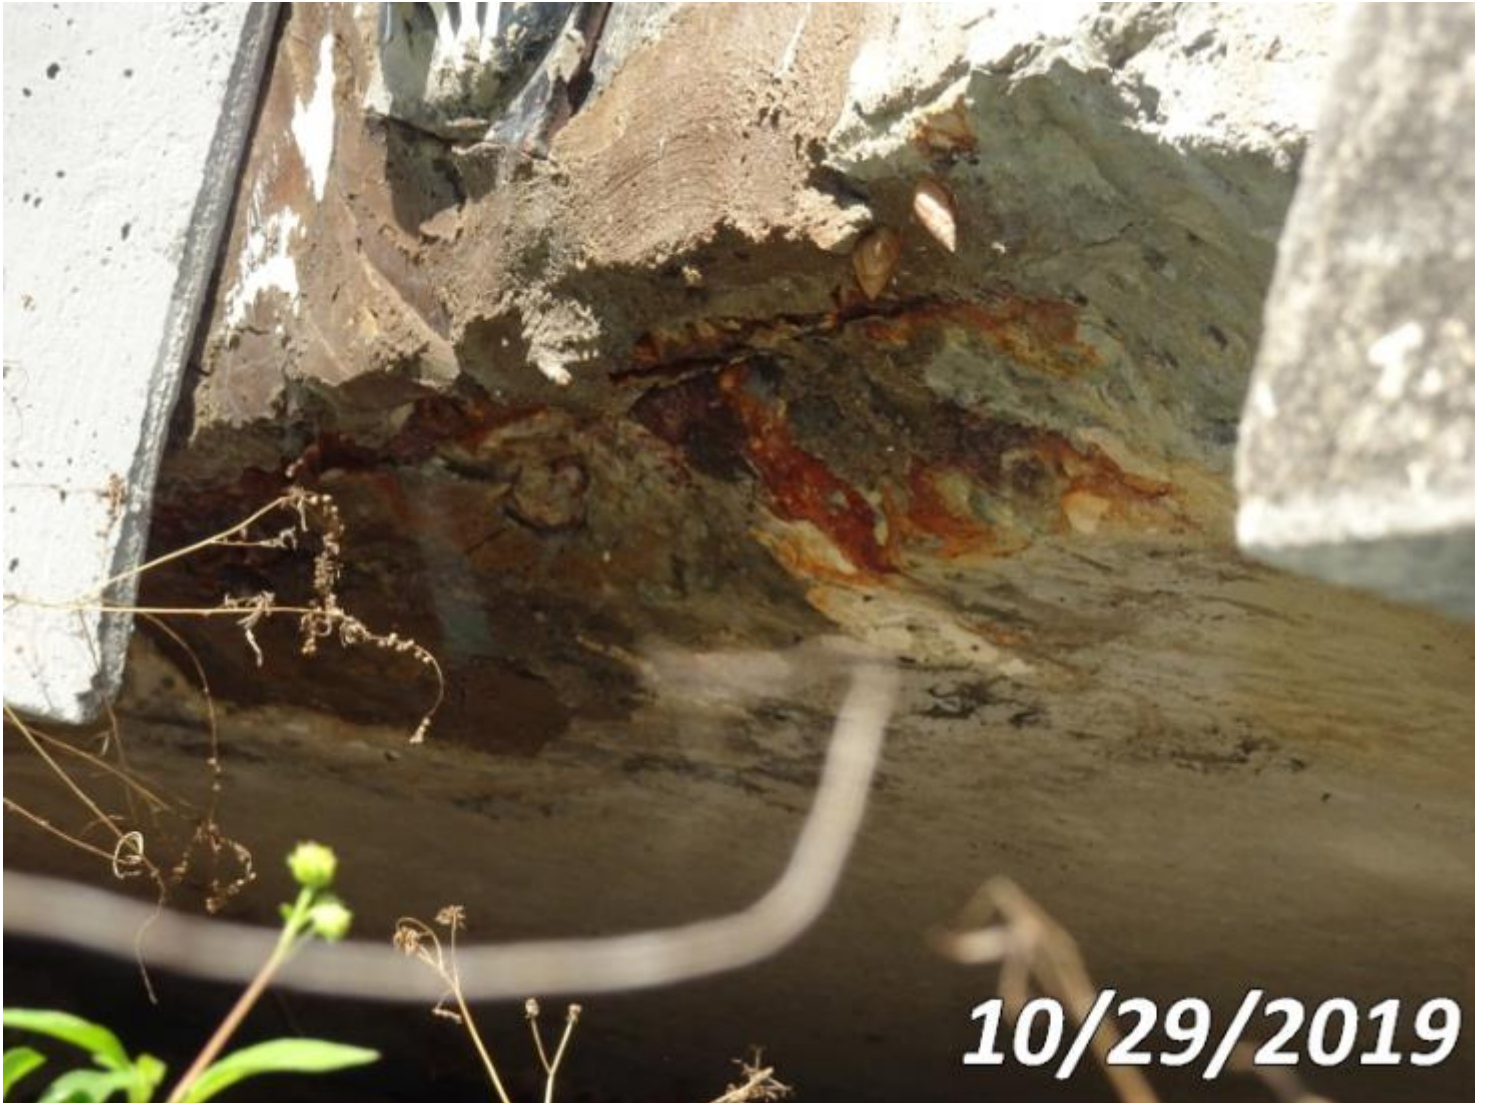
Photo 38-S01 (Unit 0: Re Concrete Slab)

- CS3:
- 1) Slab Unit 1-6 south edge has a spall 3ft. L x 7in. W x 2in. D with exposed corroded rebar with up to 7/8in. remaining section, adjacent to Post 1-2 and near the cap at Bent 2 (total 3sf). NO CHANGE. See Photo 38-S01.

Spall with exposed corroded rebar with section loss in the south edge of Slab Unit 1-6, adjacent to Post 1-2 and near the cap at Bent 2.

Repair spalls and delaminations in Slab Units 1-6 2-1 2-2 2-3 3-1 and 3-2.

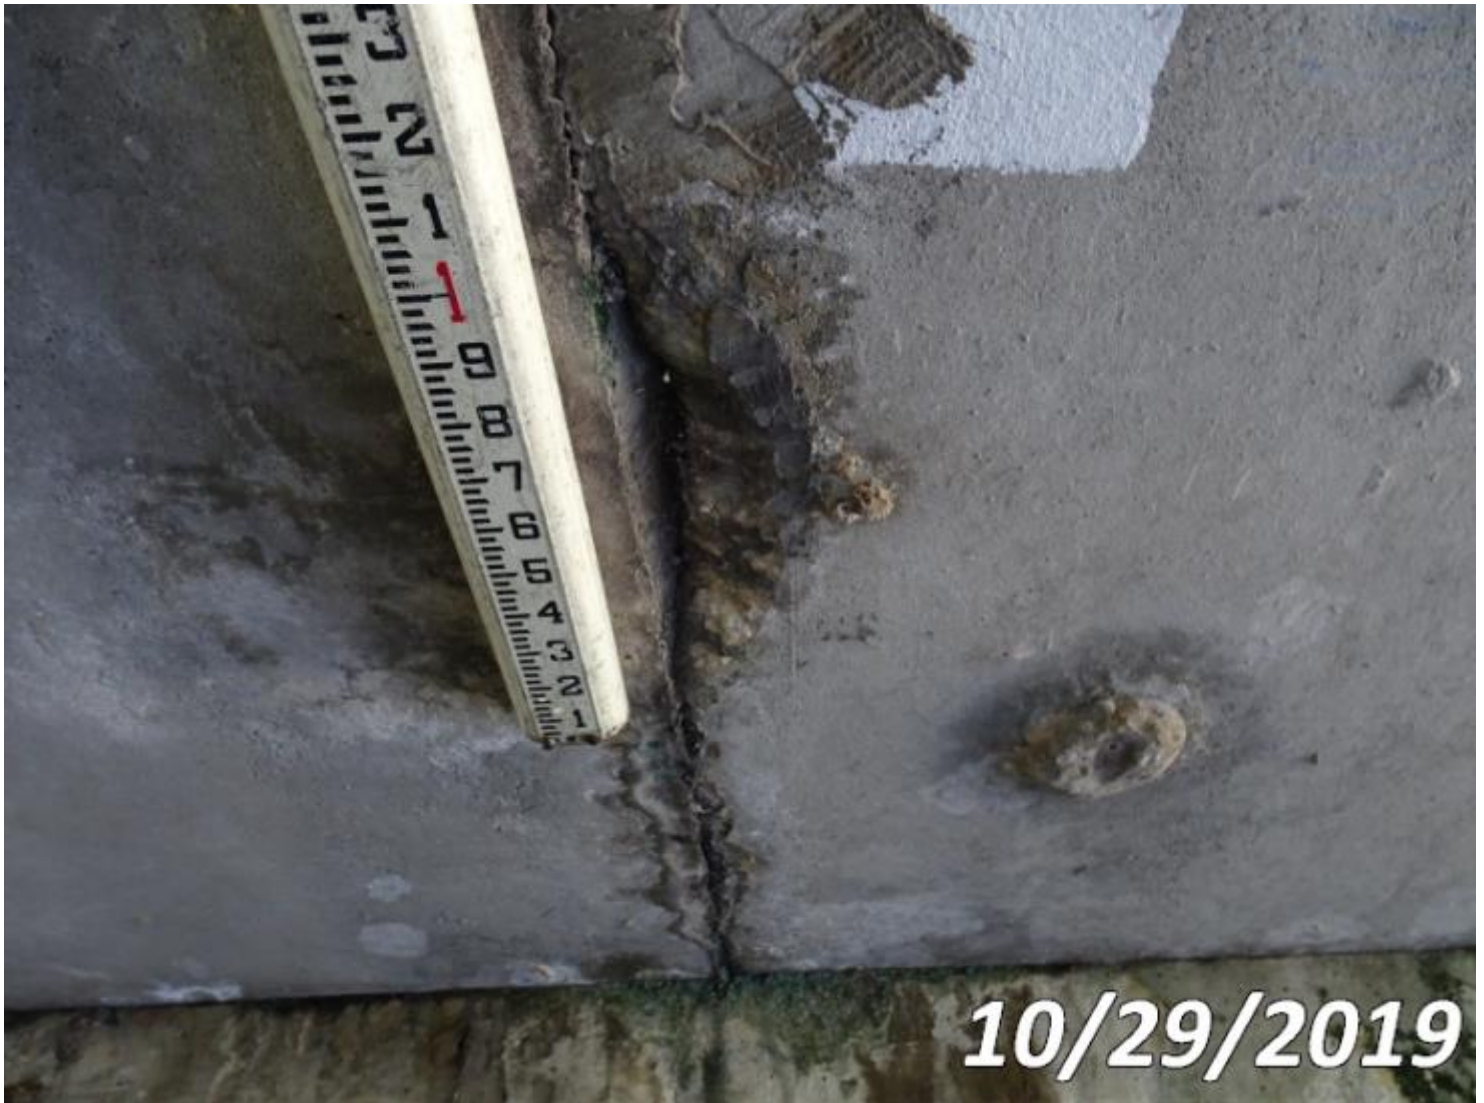
Photo 38-S02 (Unit 0: Re Concrete Slab)

- 2) Slab Unit 2-1 exhibits a spall 1ft. L x 4in. W x 2in. D with no exposed steel, 2ft. from Bent 2 (total 1sf). NEW. See Photo 38-S02.
 - 3) Slab Unit 3-1 north edge has a spall 20in. L x 10in. H x 4in. D with exposed corroded rebar, at Post 3-2 left (total 2sf). NEW. See Photo 38-S03.

Spall with no exposed steel in Slab Unit 2-1, 2ft. from Bent 2.

Repair spalls and delaminations in Slab Units 1-6 2-1 2-2 2-3 3-1 and 3-2.

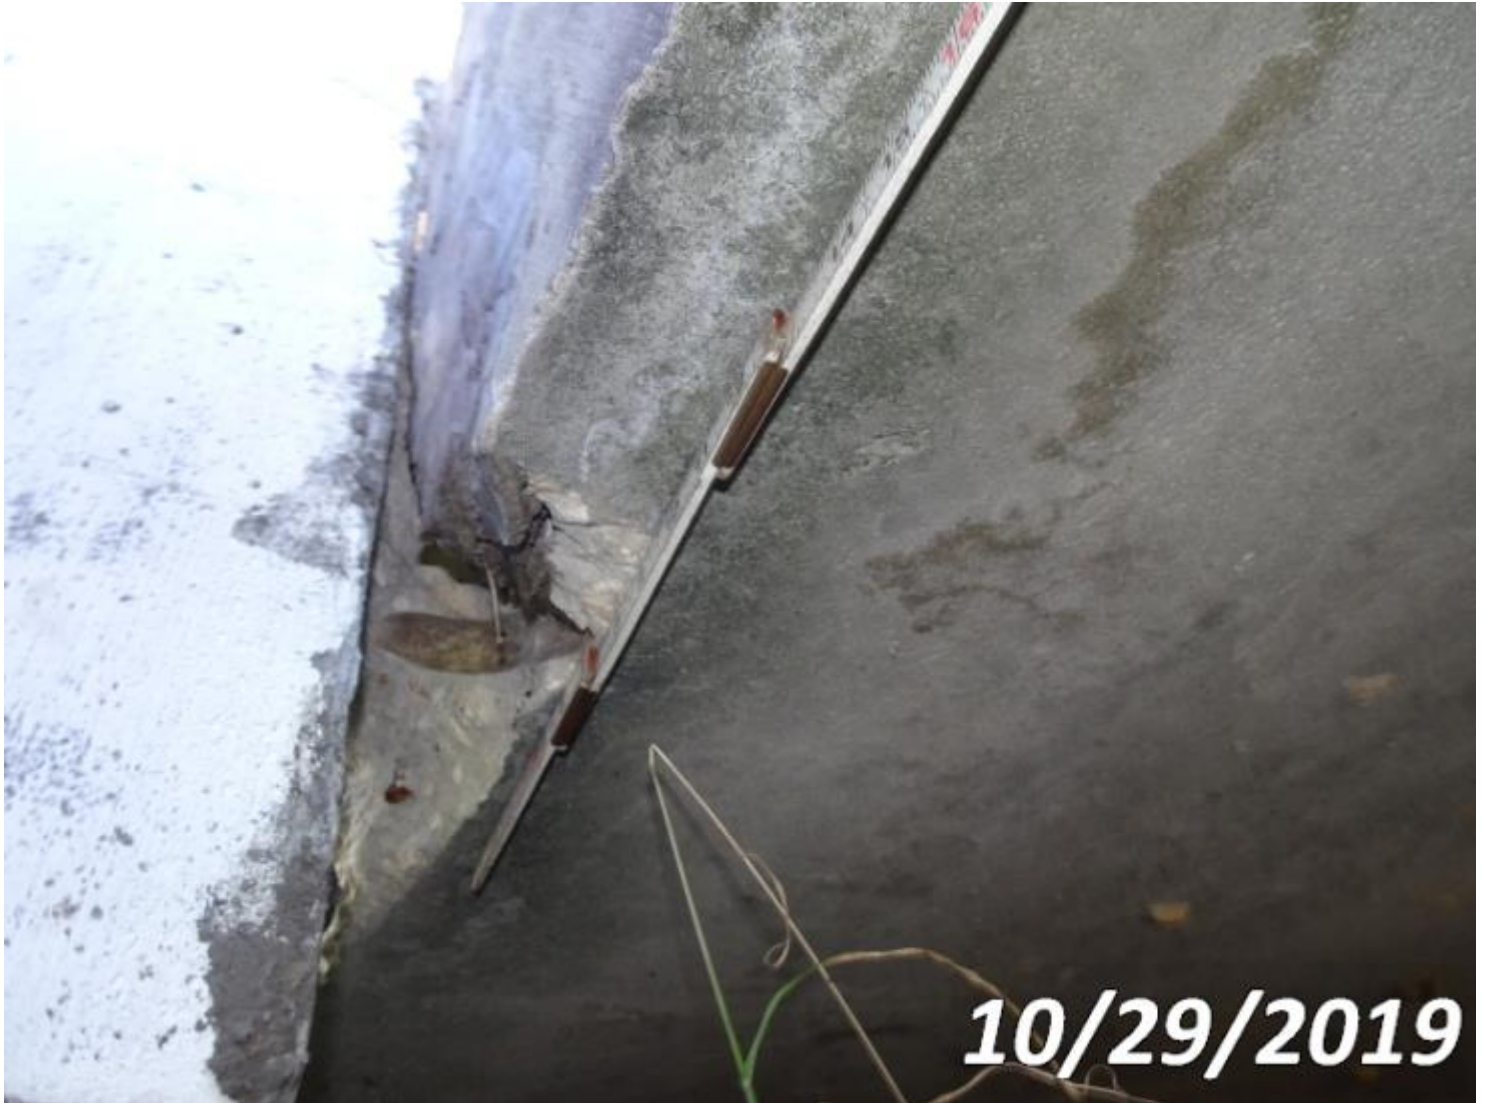
Photo 38-S03 (Unit 0: Re Concrete Slab)

Spall with exposed corroded rebar in the north edge of Slab Unit 3-1 at Post 3-2 left.

Repair spalls and delaminations in Slab Units 1-6 2-1 2-2 2-3 3-1 and 3-2.

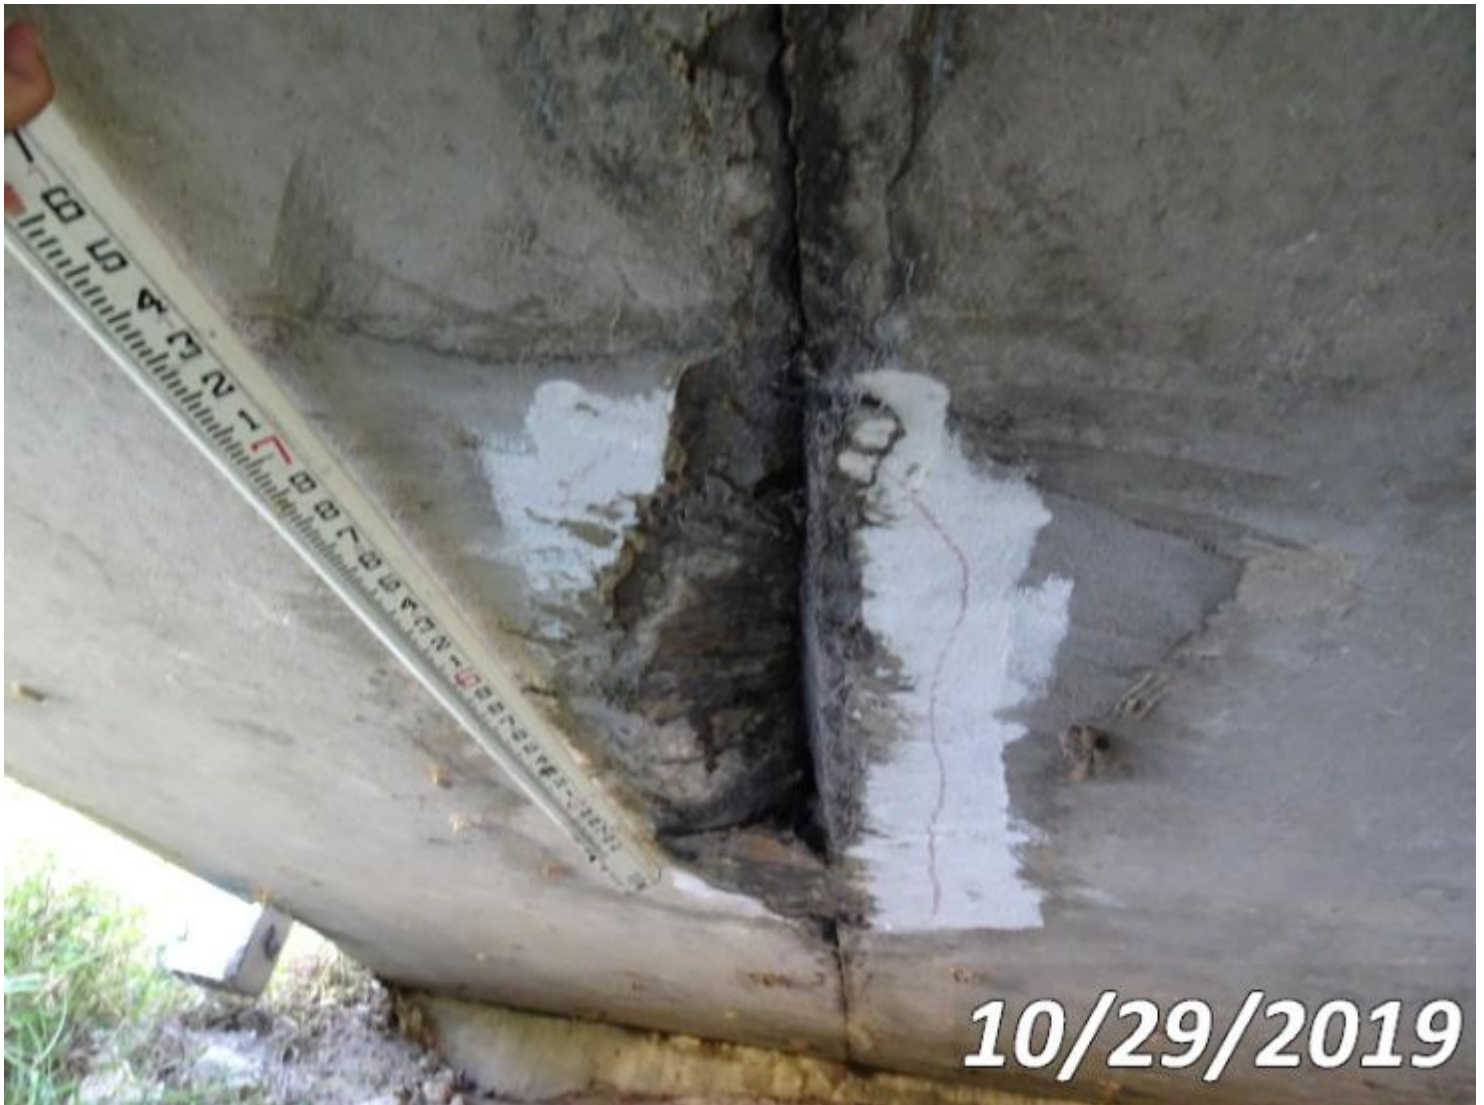
Photo 38-S04 (Unit 0: Re Concrete Slab)

- 4) Slab Unit 3-1 south edge has a spall/delamination 4ft. L x 1ft. W x 4in. D with exposed corroded steel, at midspan (total 4sf). NO CHANGE. See Photo 38-S04.

- 5) Slab Unit 3-2 north edge has a delaminated patch 4ft. L x 6in. W at midspan (total 4sf). Previously noted as a delamination only. INCREASE. See Photo 38-S04.

Spall/delamination with exposed corroded steel in the south edge of Slab Unit 3-1 at midspan. Note delaminated patch in the north edge of Slab Unit 3-2.

Repair spalls and delaminations in Slab Units 1-6 2-1 2-2 2-3 3-1 and 3-2.

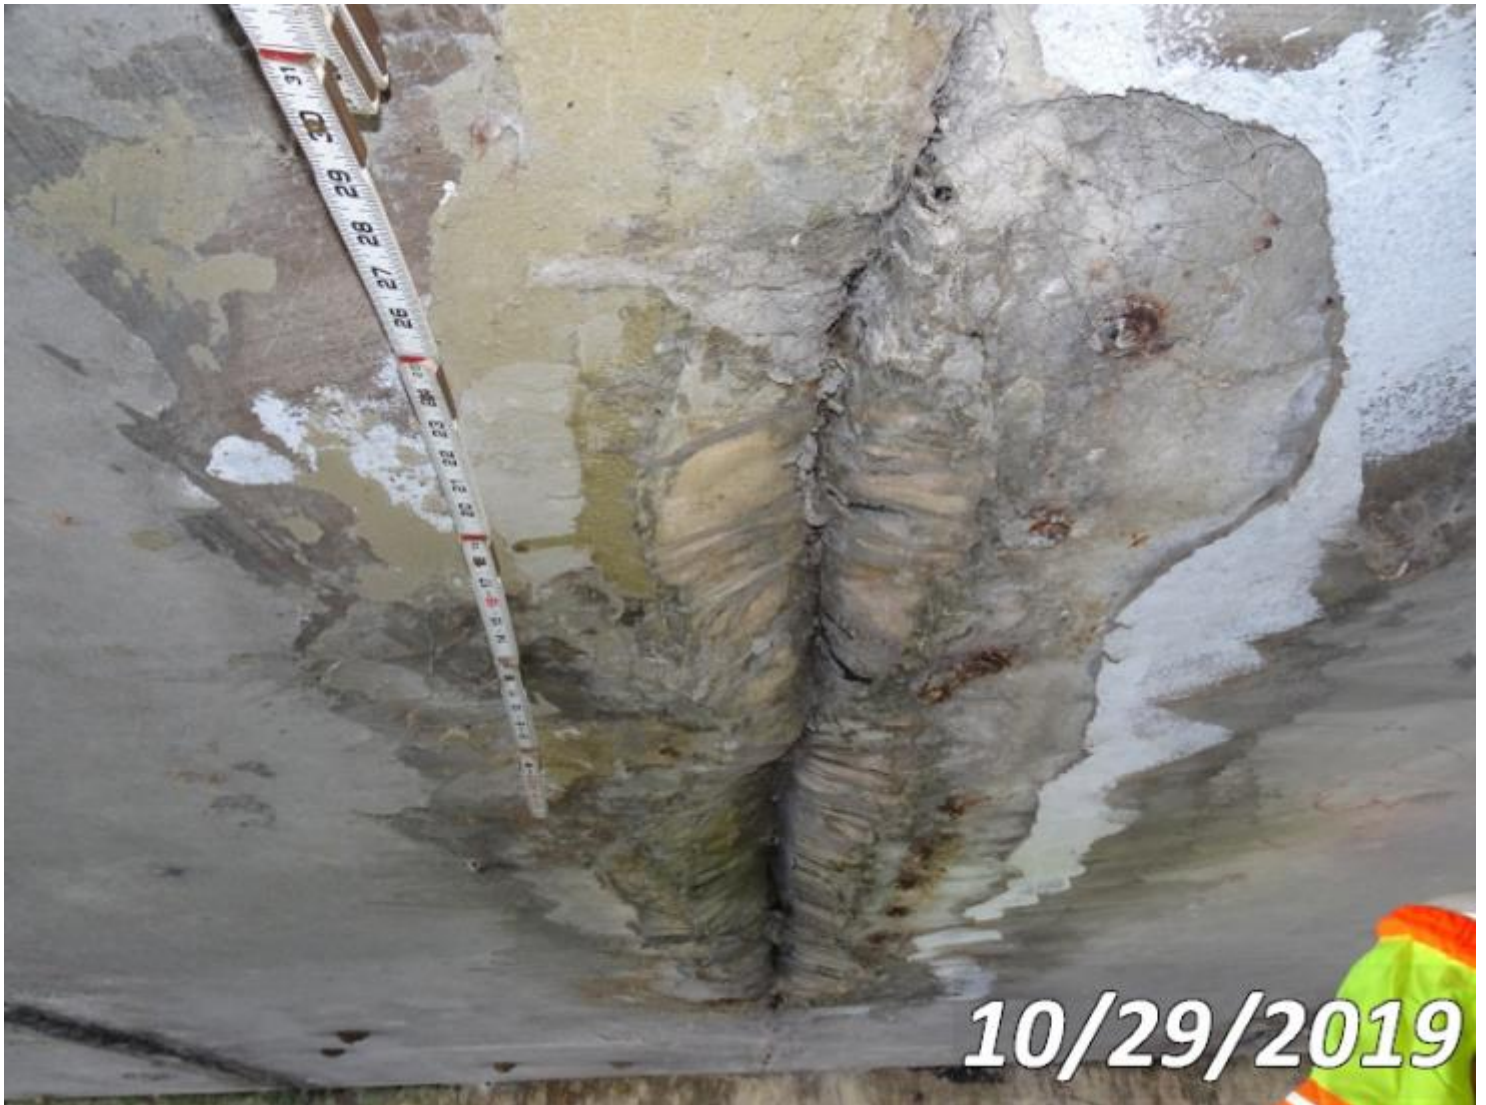
Photo 38-S05 (Unit 0: Re Concrete Slab)

- CS2:
- 6) Slab Unit 2-1 south edge has a sound patch 3ft. 4in. L x 7in. W at midspan (total 3sf). Previously noted as a spall. DECREASE.
 - 7) Slab Units 2-2 and 2-3 has a sound patch 6ft. L x 9ft. W, at midspan (total 54sf). Previously noted as spalls. DECREASE. See Photo 38-S05.

Sound patch in Slab Units 2-2 and 2-3 at midspan.

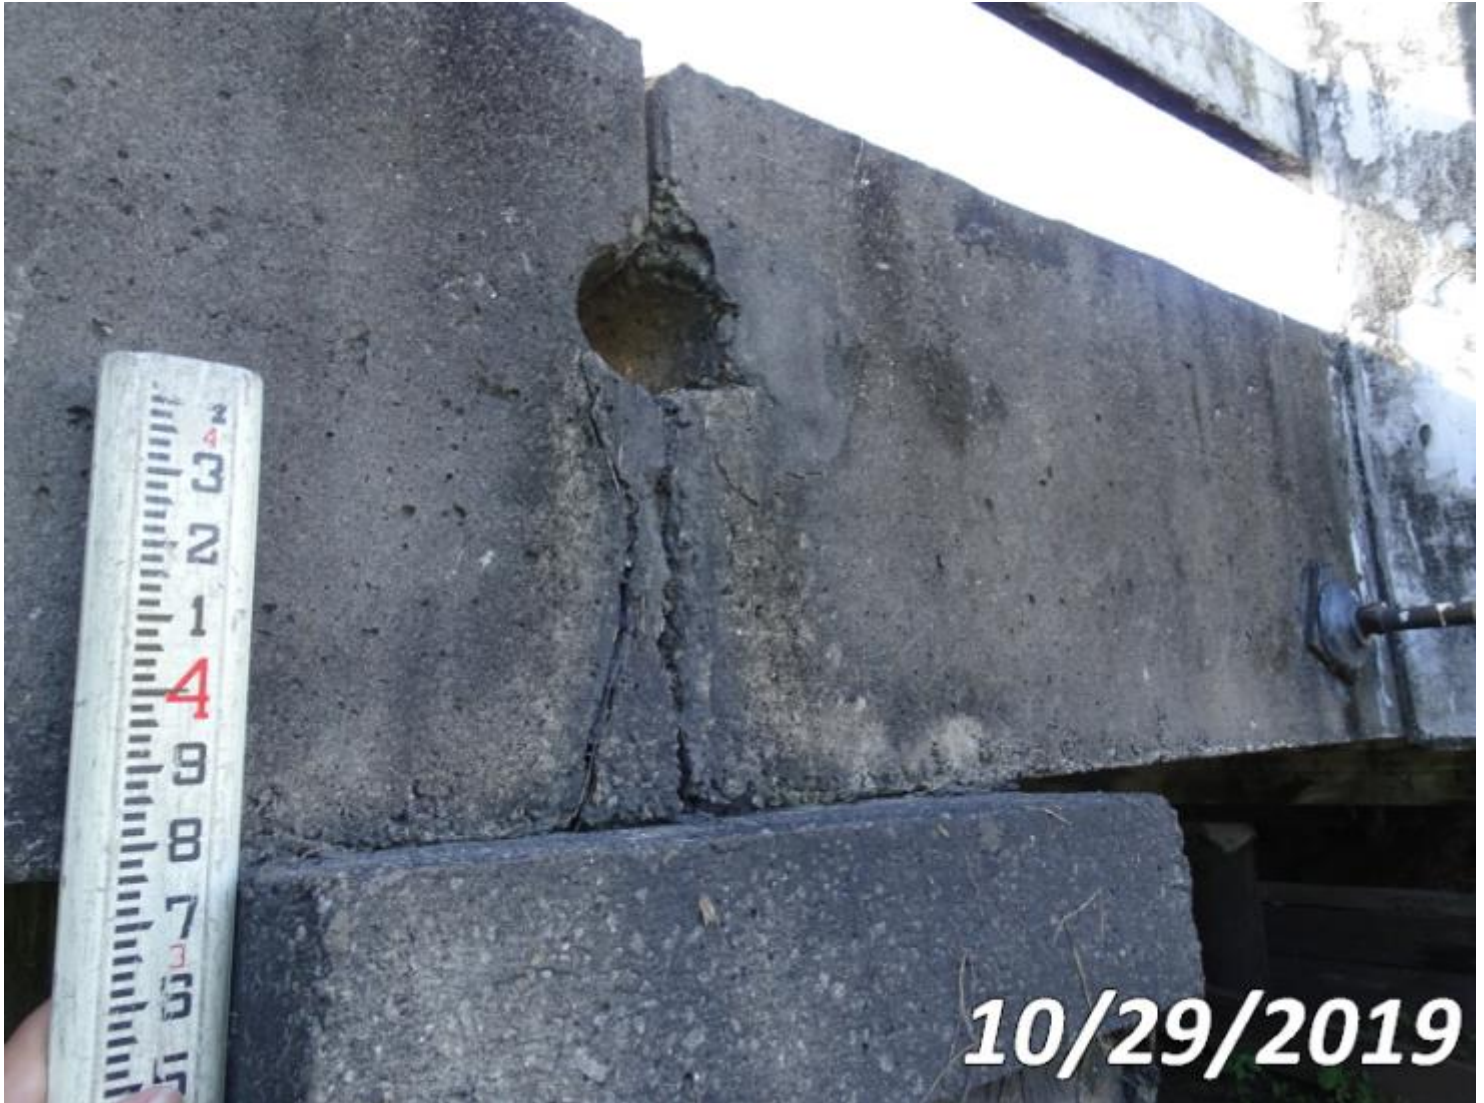
Photo 38-S06 (Unit 0: Re Concrete Slab)

- 8) Slab Unit 2-3 adjacent to Bent 3 cap has a sound patch 2ft. L x 7ft. L (total 2sf). Previously noted as a spall. DECREASE.
 - 9) Slab Unit 3-1 north face has a delamination 1ft. 2in. L x 2in. W at Bent 3 (total 1sf). NO CHANGE. See Photo 38-S06.

Delamination in the north face of Slab Unit 3-1 at Bent 3.

Repair spalls and delaminations in Slab Units 1-6 2-1 2-2 2-3 3-1 and 3-2.

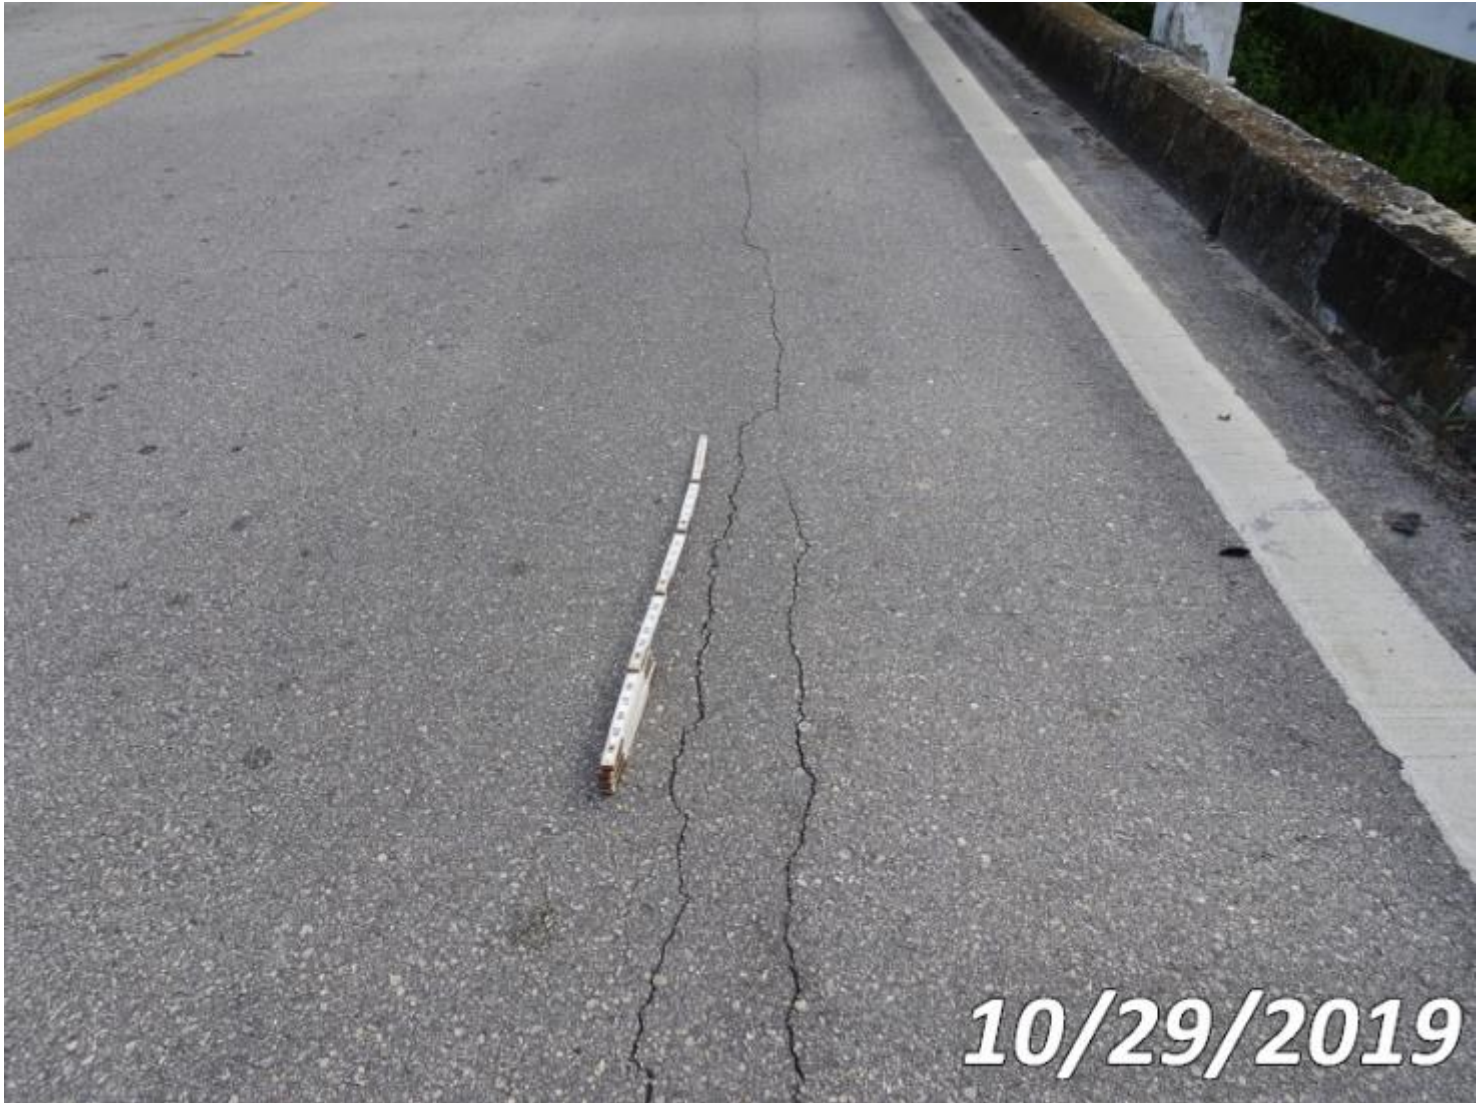
Photo 38-S07 (Unit 0: Re Concrete Slab)

- 10) The asphalt overlay exhibits transverse and longitudinal cracks up to 15ft. L x 1/32in. W (total 150sf). NO CHANGE. See Photo 38-S07.

Longitudinal crack in the asphalt overlay eastbound lane in Span 1.

Repair transverse and longitudinal cracks in the asphalt overlay throughout the bridge.

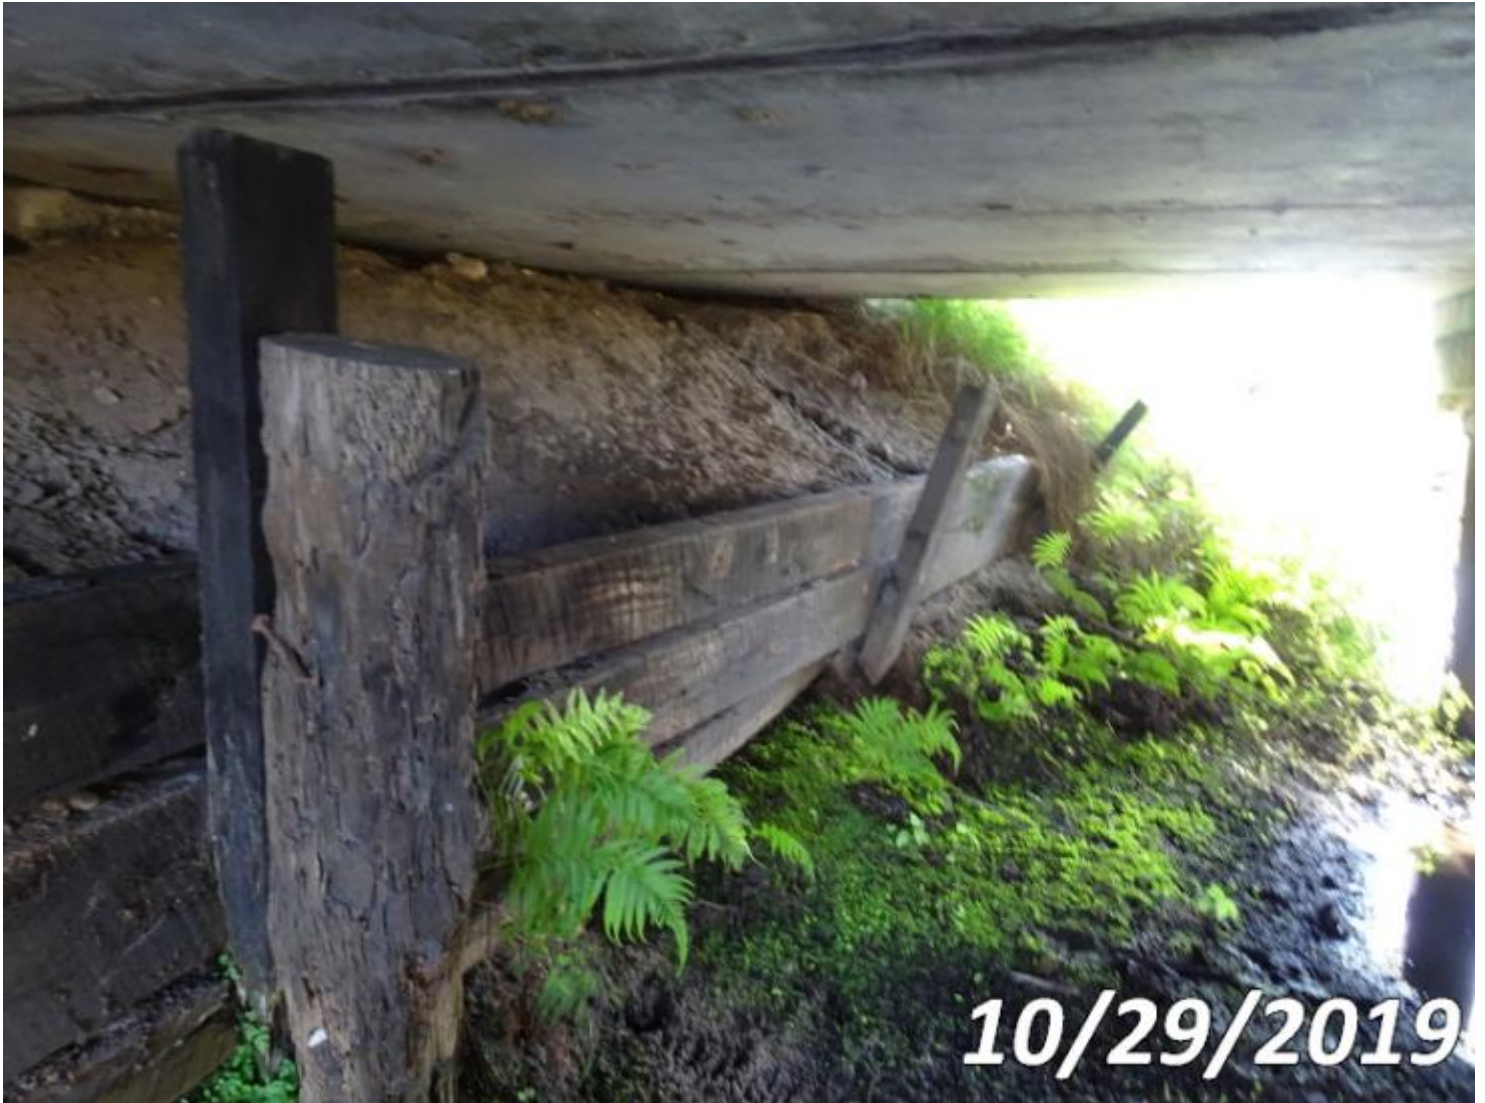
Photo 8290-S01 (Unit 0: Channel)

8290/3 CS2:
1) The dirt slopes at End Bents 1 and 4 are not protected and have erosion up to 10ft. L x 6ft. W x 4ft. under the joints between Slab Units 3 and 4. NO CHANGE. See Photo 8290-S01.

Erosion with timber wall installed at End Bent 4.

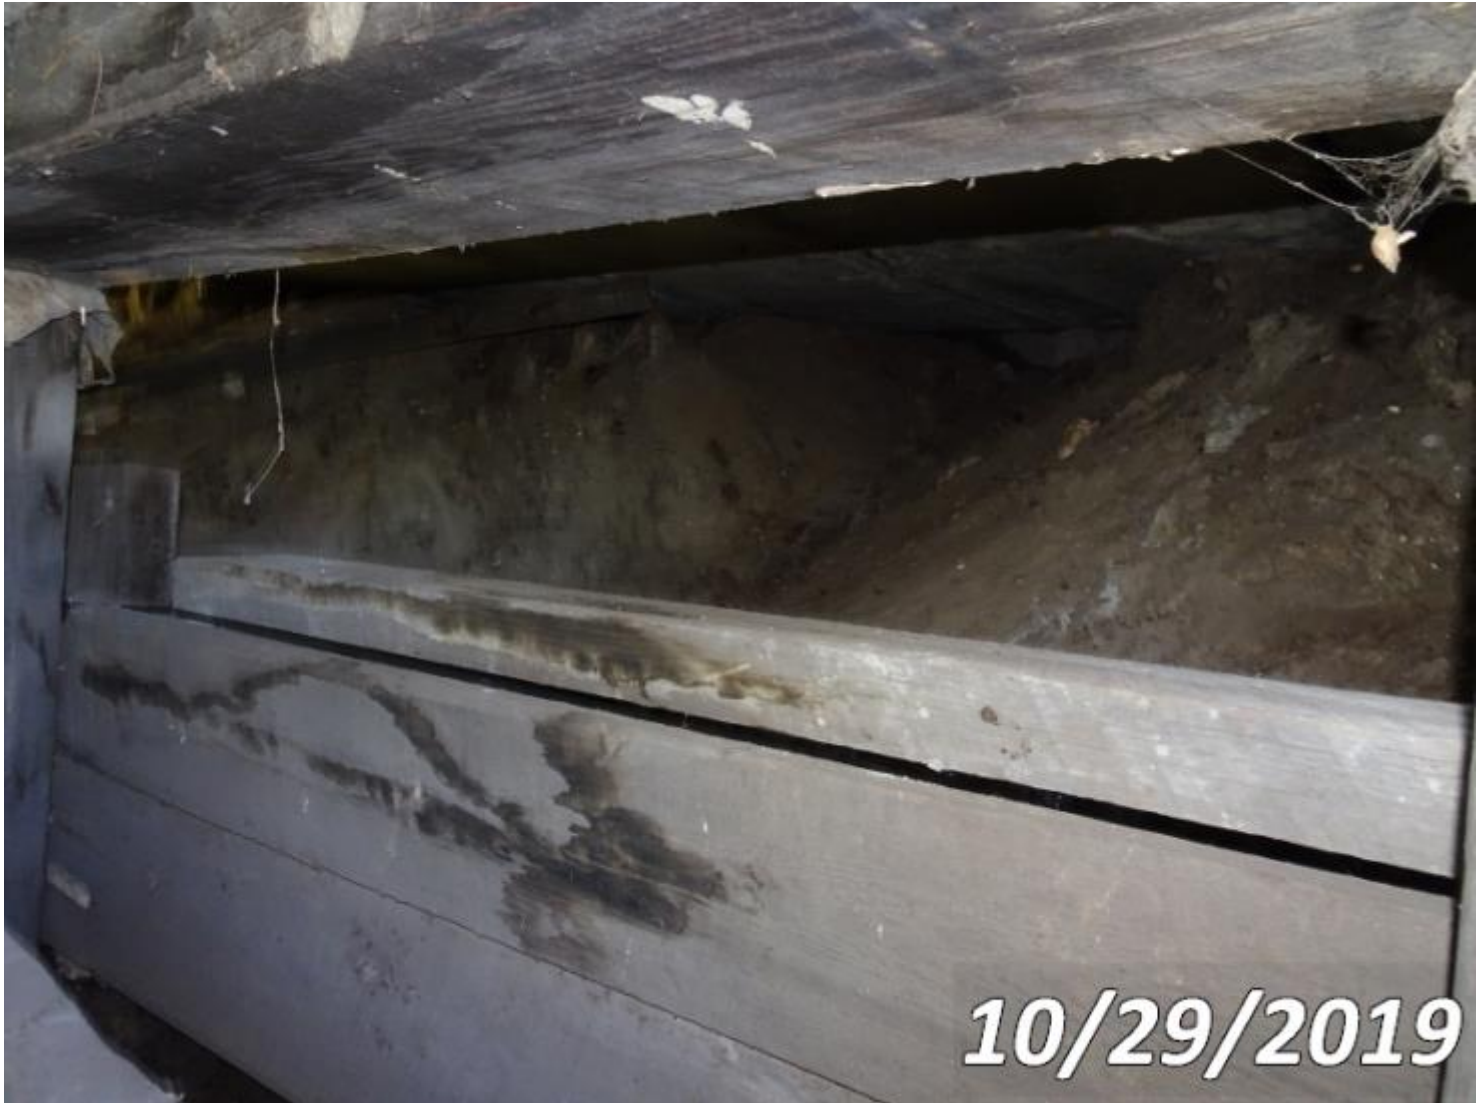
Photo 8476-S01 (Unit 0: Timber Walls)

8476/3 CS2:
1) The south end of the timber wall between Piles 2-3 and 2-5 at Bent 2 is displaced and separated up to 8ft. L x 2ft. H (total 8ft). NEW. See Photo 8476-S01.

Displaced and separated timber wall at the south end between Piles 2-3 and 2-5 at Bent 2.

Repair displaced and separated timber wall at the south end between Piles 2-3 and 2-5 at Bent 2.

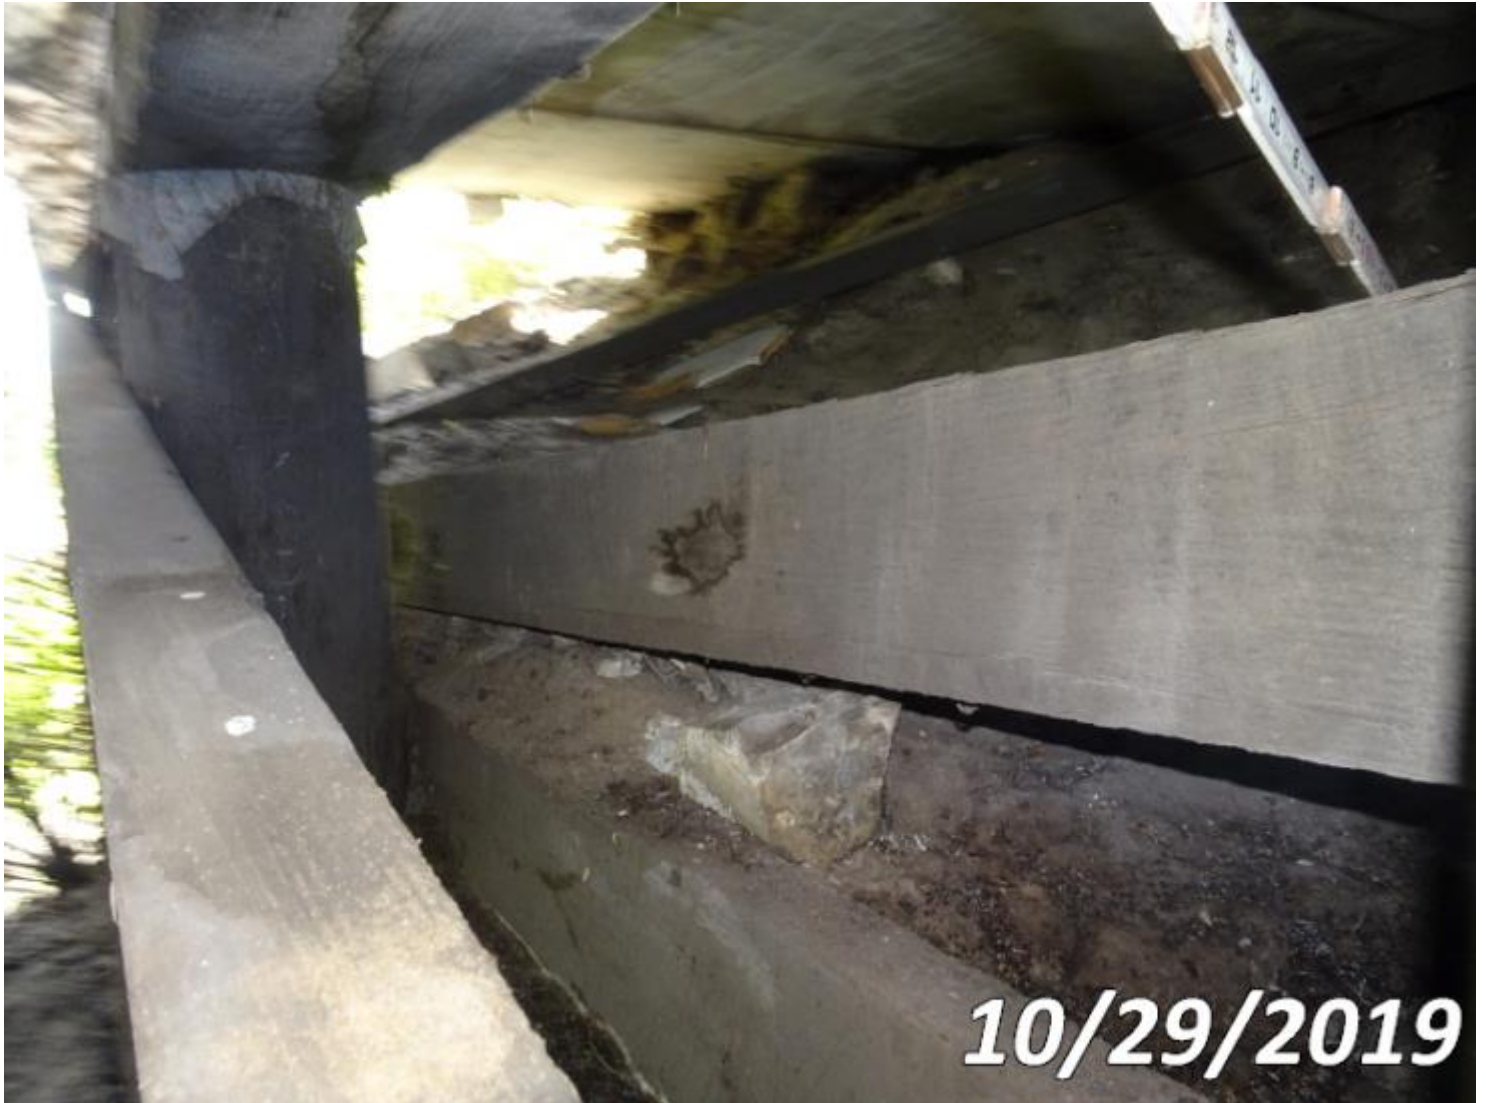
Photo 8476-S02 (Unit 0: Timber Walls)

4) The timber wall below Span 3 is leaning towards the channel at the north and south ends. Previously noted at the north end only. INCREASE. See Photo 8476-S02.

Leaning timber wall towards the channel below Span 3.

Repair deteriorated and leaning timber wall below Span 3.

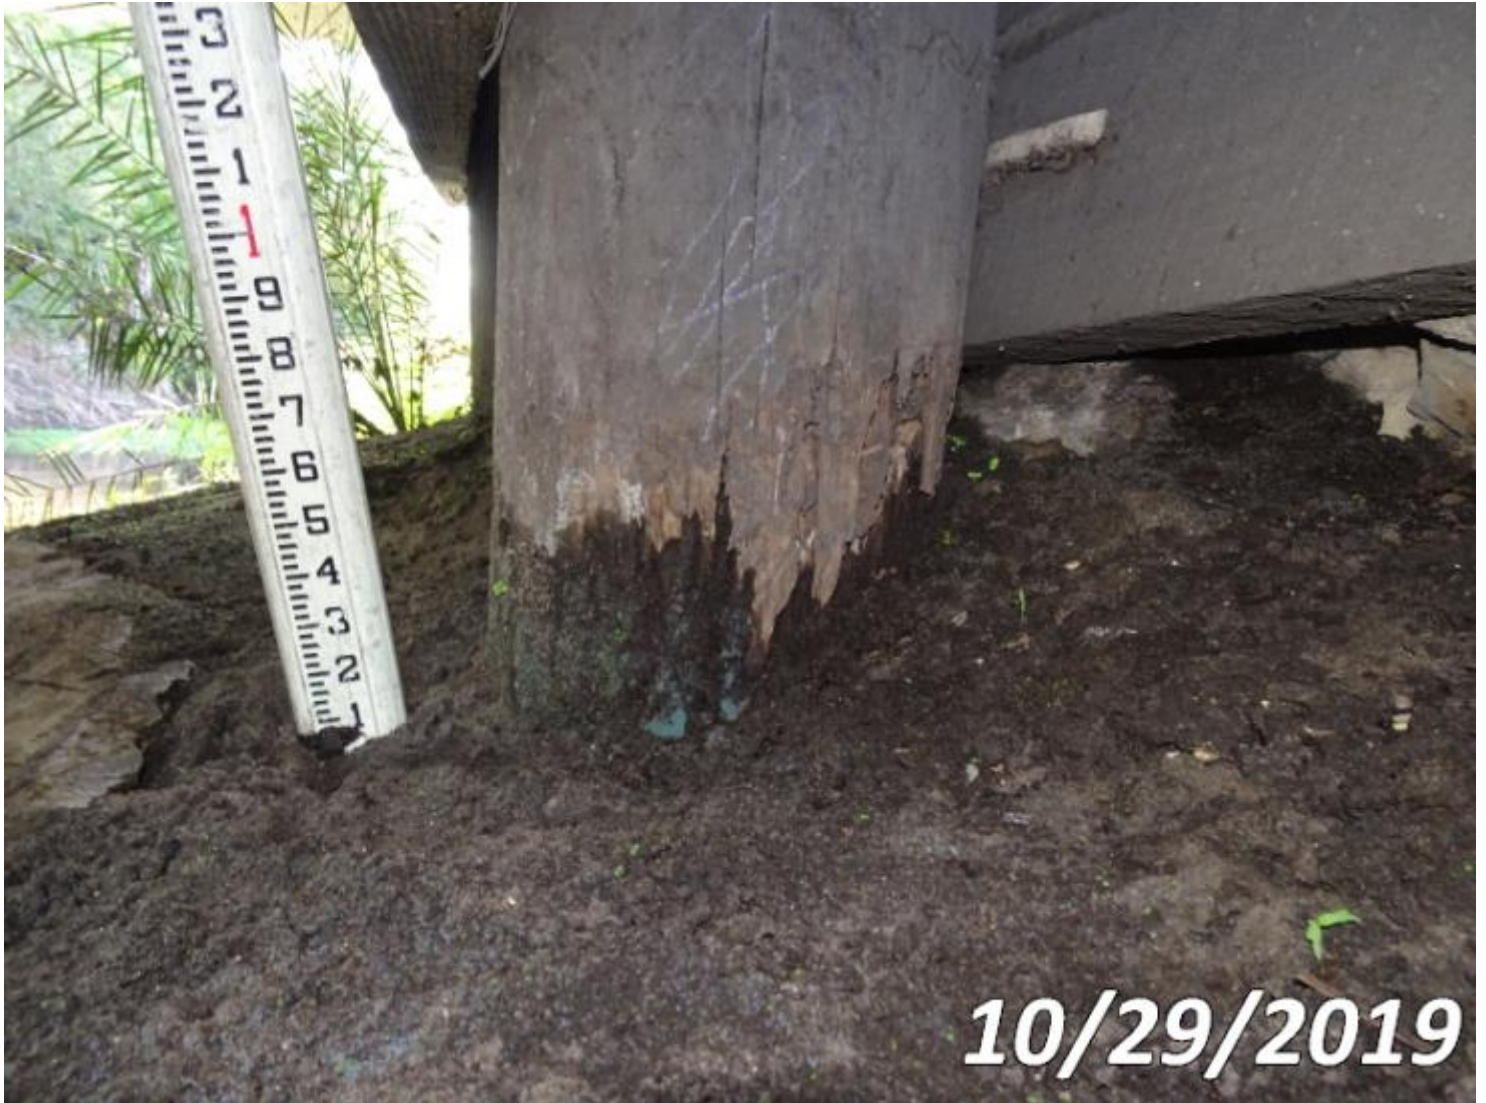
Photo 228-S01 (Unit 0: Timber Pile)

2) Pile 2-3 at the north quadrant has an area of decay 6in. L x 1ft. W x 2in. D at the groundline (total 1 ea). NO CHANGE. See Photo 228-S01.

Decaying area in the north quadrant at Pile 2-3 at the groundline.

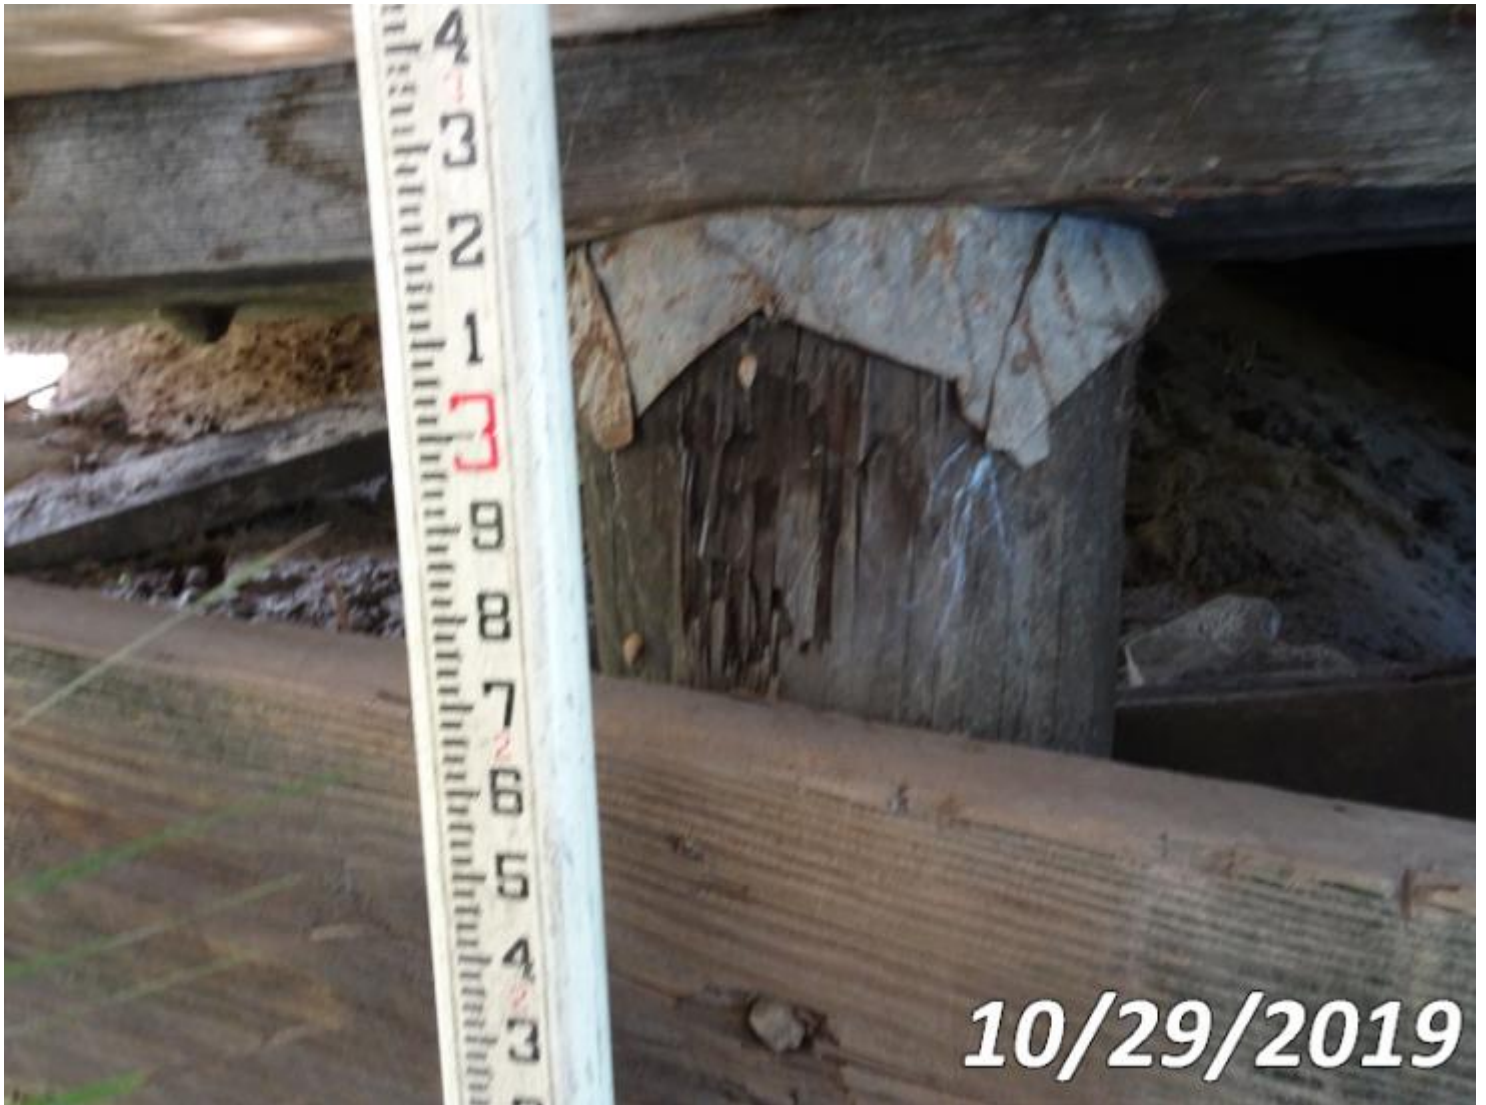
Photo 228-S02 (Unit 0: Timber Pile)

3) Pile 2-4 at the east quadrant at the cap has a splintered area 6in. L x 6in. W x 2in. D (total 1 ea). NO CHANGE. See Photo 228-S02.

Splintered area in the east quadrant at Pile 2-4 at the cap.

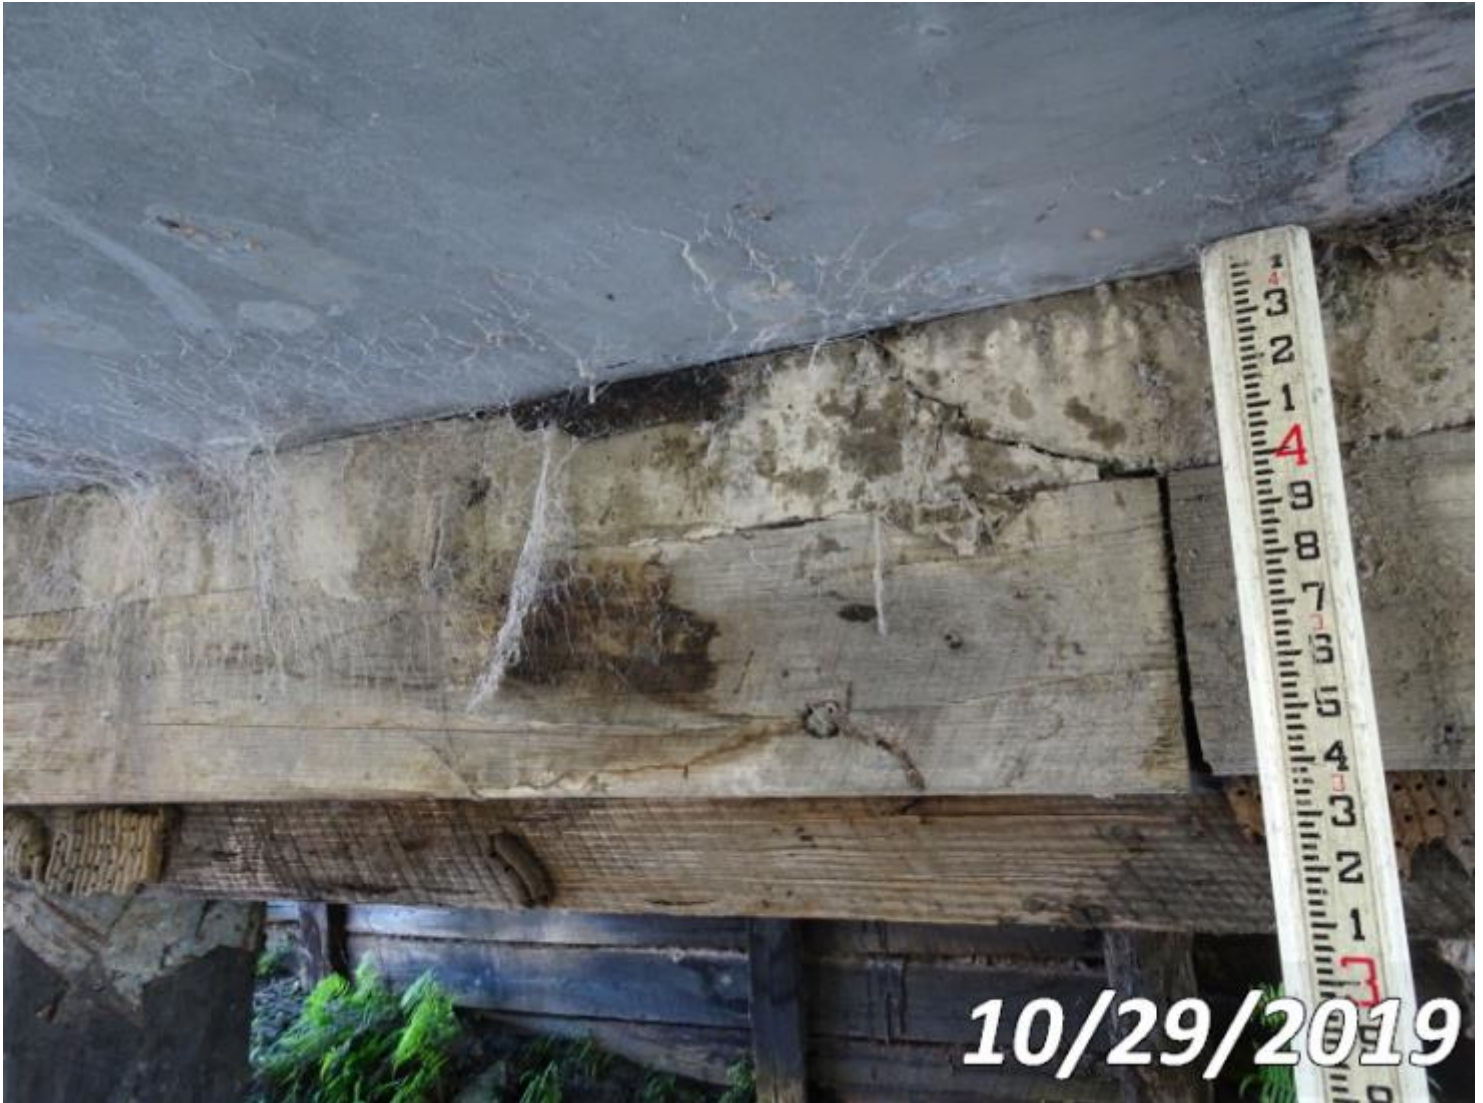
Photo 234-S01 (Unit 0: Re Conc Pier Cap)

1) The cap at Bent 3 on the west face has a delamination 2ft. L x 6in. H adjacent to Pile 3-3. NEW. See Photo 234-S01.

Delamination in the west face of the cap at Bent 3 adjacent to Pile 3-3.
