**FLORIDA DEPARTMENT OF TRANSPORTATION
BRIDGE MANAGEMENT SYSTEM
Inspection/CIDR/Bridge Profile Report
Inspection**

Structure ID: 884039

INSPECTION DATE: 10/29/2019 MYLK

BY: TranSystems Corporation Consultants	STRUCTURE NAME: Not recorded
OWNER: 2 County Hwy Agency	YEAR BUILT: 1961
MAINTAINED BY: 2 County Hwy Agency	SECTION NO.: 88 000 002
STRUCTURE TYPE: 1 Reinforced Concrete - 01 Slab	MP: 1.988
LOCATION: CR-615 (66TH AVE.)	ROUTE: 00508
SERV. TYPE ON: 1 Highway	FACILITY CARRIED: CR-508 (69TH ST.)
SERV. TYPE UNDER: 5 Waterway	FEATURE INTERSECTED: LATERAL A CANAL

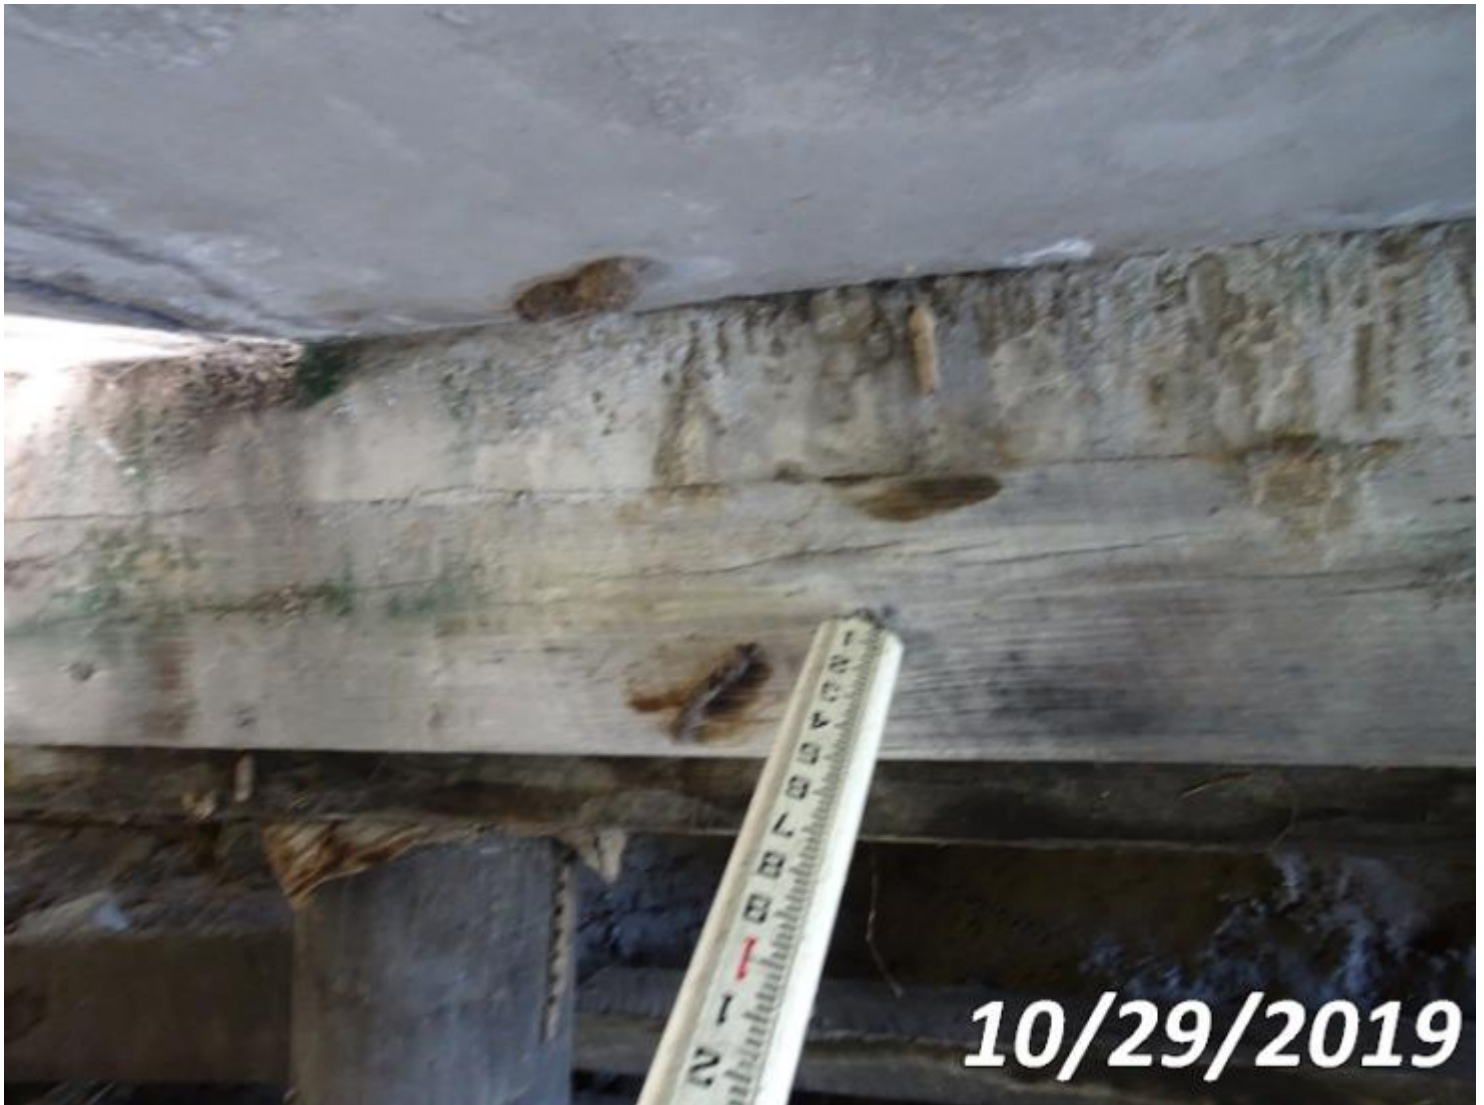
Photo 235-S01 (Unit 0: Timber Pier Cap)

Weathering splits in the timber extension board at the cap at Bent 2 at Pile 2-3.

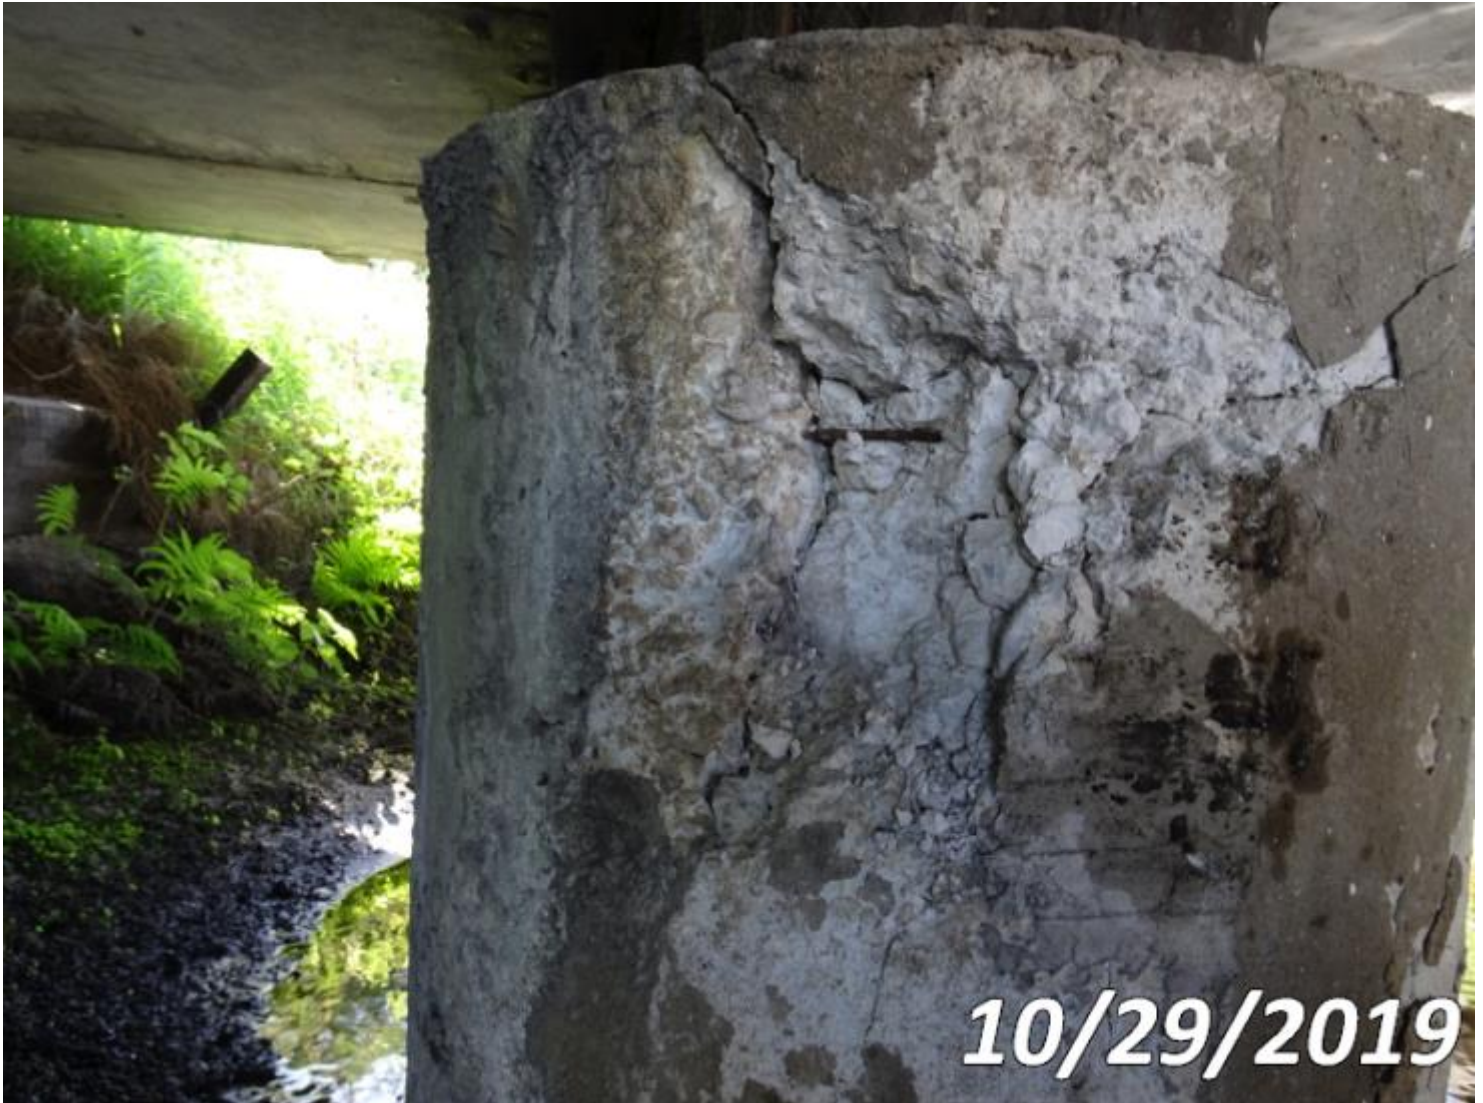
Photo 8298-S01 (Unit 0: Pile Jacket Bare)

1) Pile Jacket 3-3 in the north quadrant has a spall and delamination 2ft. H x 20in. W x 3in. D with exposed corroded steel (total 1 ea). NO CHANGE. See Photo 8298-S01.

Spall and delamination with exposed corroded steel in the north quadrant at Pile Jacket 3-3.

CONDITION STATE		PRIORITY
1, 2, 3	MMS Quantity: 1 mh Element Estimated Quantity: 1 (EA)	3
WORK ORDER RECOMMENDATION: Repair spall and delamination in the north quadrant at Pile Jacket 3-3.

Repair spall and delamination in the north quadrant at Pile Jacket 3-3.

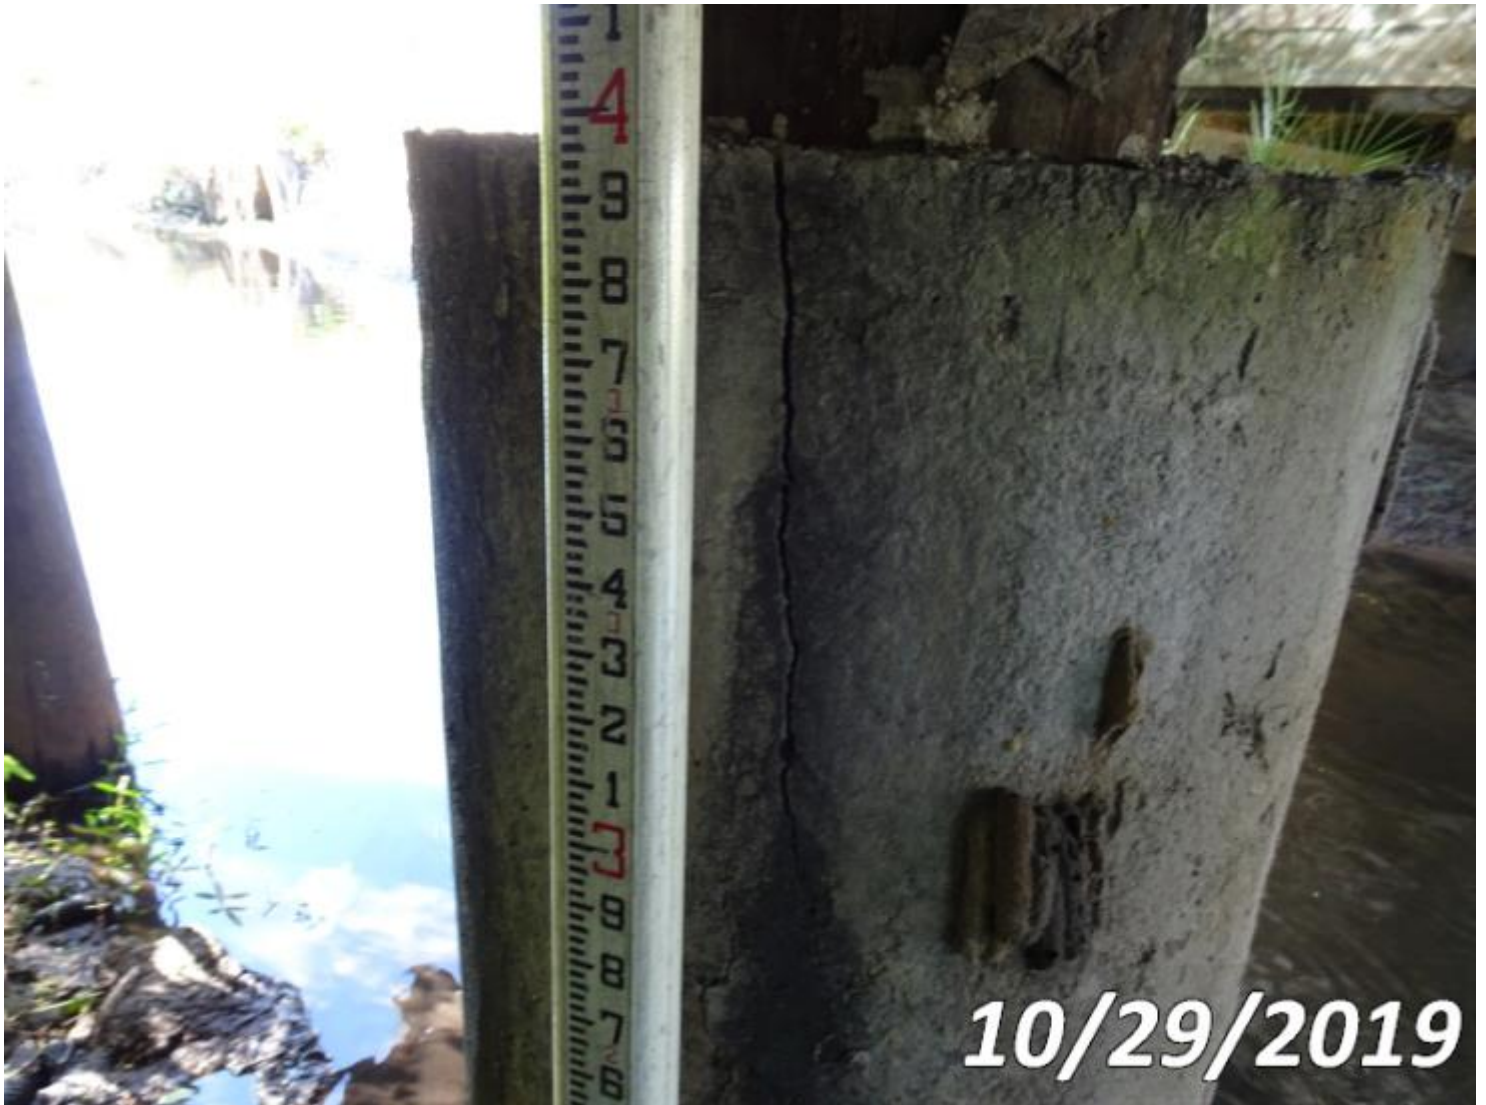
Photo 8298-S02 (Unit 0: Pile Jacket Bare)

2) Pile Jacket 3-4 has vertical cracks up to 3ft. L x 1/8in. W at random locations (total 1 ea). NO CHANGE. See Photo 8298-S02.

Vertical crack in the east quadrant of Pile Jacket 3-4.

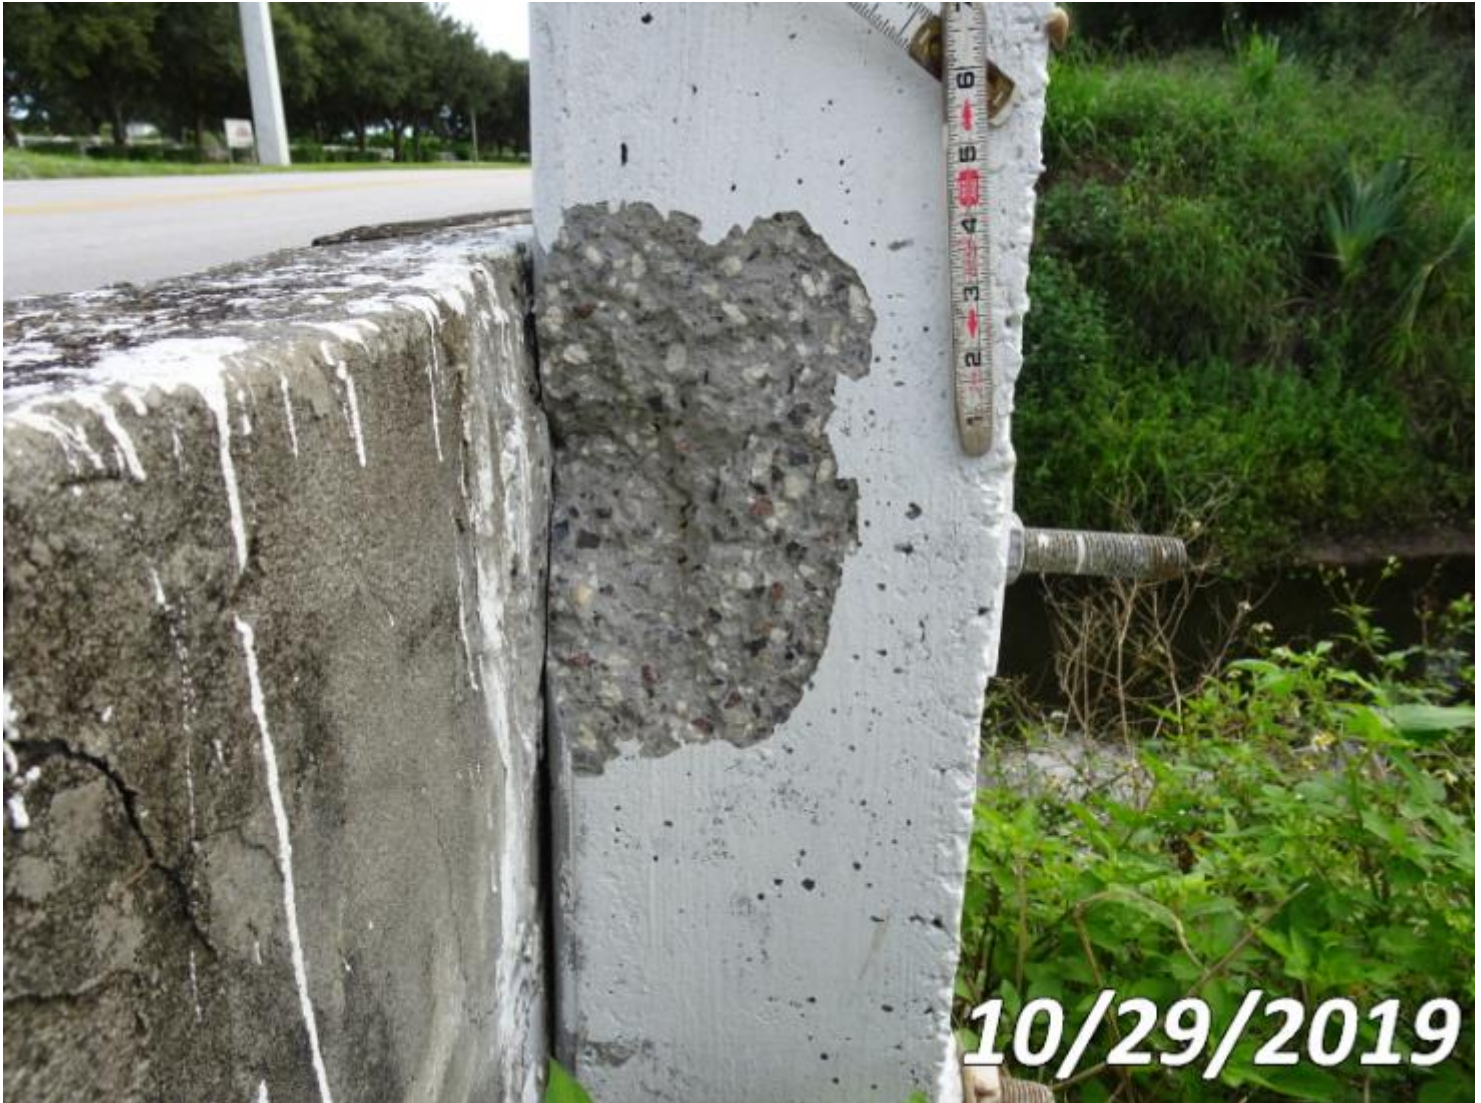
Photo 333-S01 (Unit 0: Other Bridge Railing)

1) Posts 1-2, 2-1 and 3-1 right has spalls up to 10in. H x 6in. W x 3in. D with some exposing the anchor bolts (total 3ft). NEW. See Photo 333-S01.

Spall in the west face of Post 1-2 right.

Repair spalls in Posts 1-2 2-1 and 3-1 right.

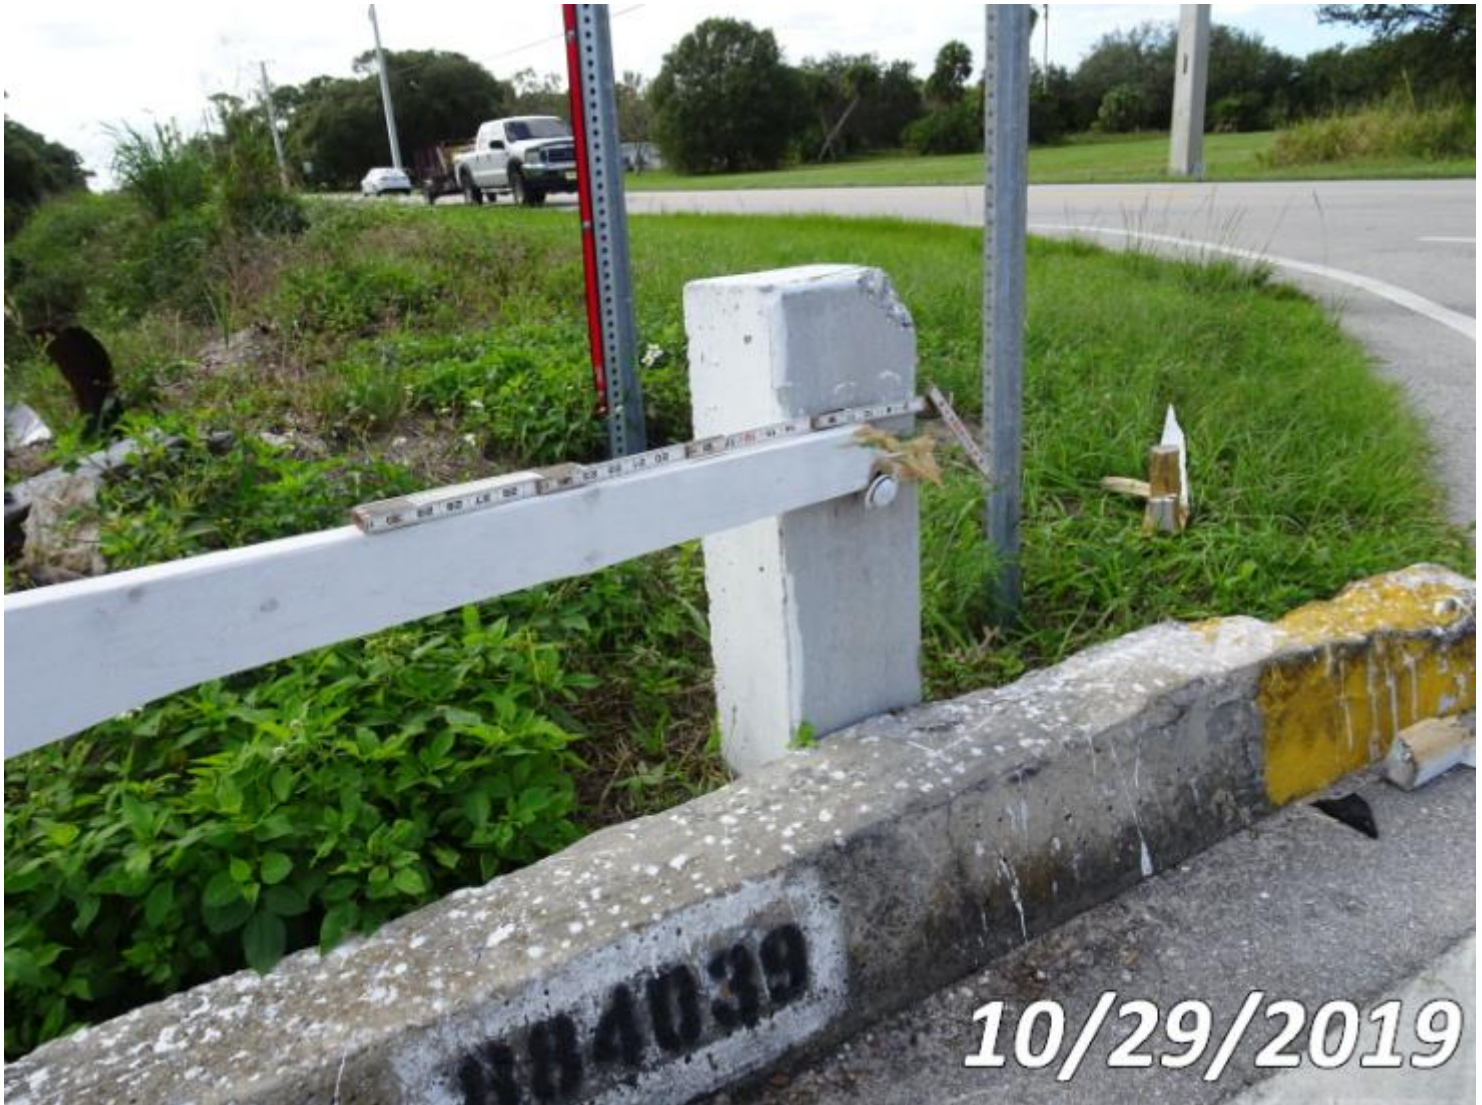
Photo 333-S02 (Unit 0: Other Bridge Railing)

2) The timber railing between Post 1-1 and 1-2 right have a fractured area 4ft. L x 6in. H (total 4ft). NEW. See Photo 333-S02.

Fractured area at the timber railing between Post 1-1 and 1-2 right.

<u>UNIT: 0</u>	<u>SUPERSTRUCTURE</u>		
<u>ELEMENT/ENV: 333 / 3</u>	<u>Other Bridge Railing</u>	<u>ELEM CATEGORY: Superstructure</u>	
CONDITION STATE			PRIORITY
1 , 2 , 3	MMS Quantity: 1 lf Element Estimated Quantity: 1 ft		3
WORK ORDER RECOMMENDATION: Install approach guardrails at all four corners pf the bridge.			
1 , 2 , 3	MMS Quantity: 1 lf Element Estimated Quantity: 1 ft		3
WORK ORDER RECOMMENDATION: Repair spalls in Posts 1-2 2-1 and 3-1 right.			
1 , 2 , 3	MMS Quantity: 1 lf Element Estimated Quantity: 4 ft		3
WORK ORDER RECOMMENDATION: Repair fractured area at the timber railing between Posts 1-1 and 1-2 right.

Repair fractured area at the timber railing between Posts 1-1 and 1-2 right.

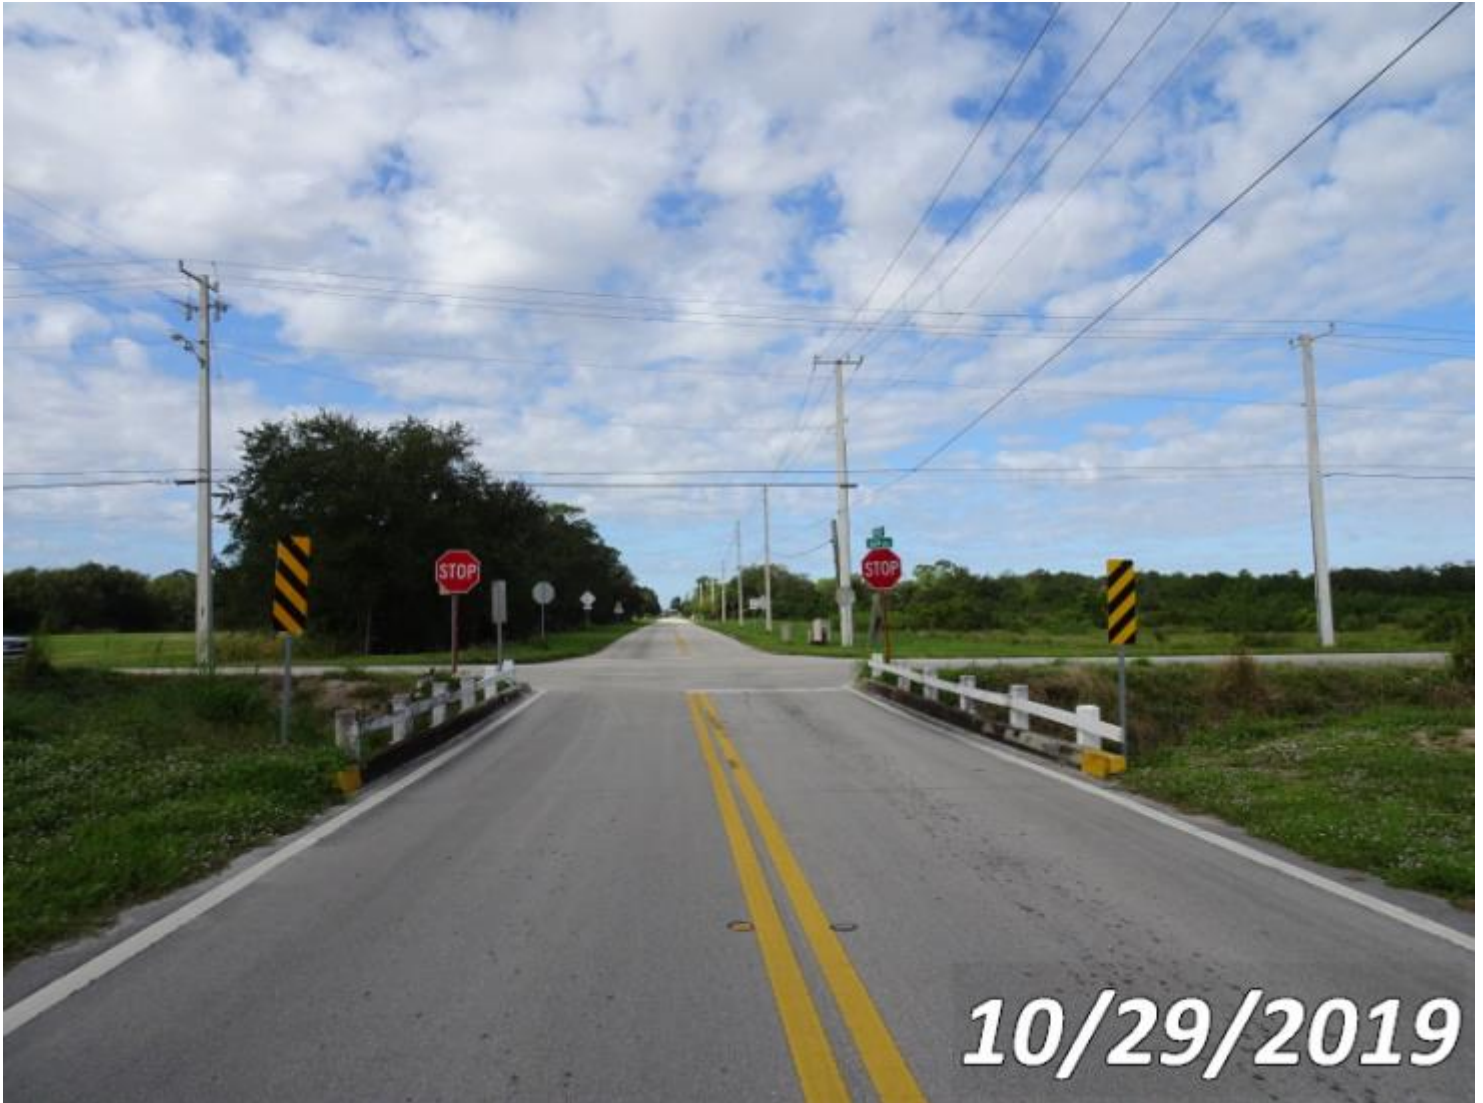
Photo 333-S03 (Unit 0: Other Bridge Railing)

No guardrail system provided at south approach.
