**FLORIDA DEPARTMENT OF TRANSPORTATION  
BRIDGE MANAGEMENT SYSTEM  
Inspection/CIDR/Bridge Profile Report  
Inspection**

Structure ID: 884093

INSPECTION DATE: 8/19/2019 TTTR

BY: TranSystems Corporation Consultants	STRUCTURE NAME: Not recorded
OWNER: 2 County Hwy Agency	YEAR BUILT: 2011
MAINTAINED BY: 2 County Hwy Agency	SECTION NO.: 88 000 005
STRUCTURE TYPE: 5 Prestressed Concrete - 01 Slab	MP: 0.011
LOCATION: At CR-615 (66th Ave.)	ROUTE: 00000
SERV. TYPE ON: 5 Highway-pedestrian	FACILITY CARRIED: 57th Street
SERV. TYPE UNDER: 5 Waterway	FEATURE INTERSECTED: Lateral A Canal

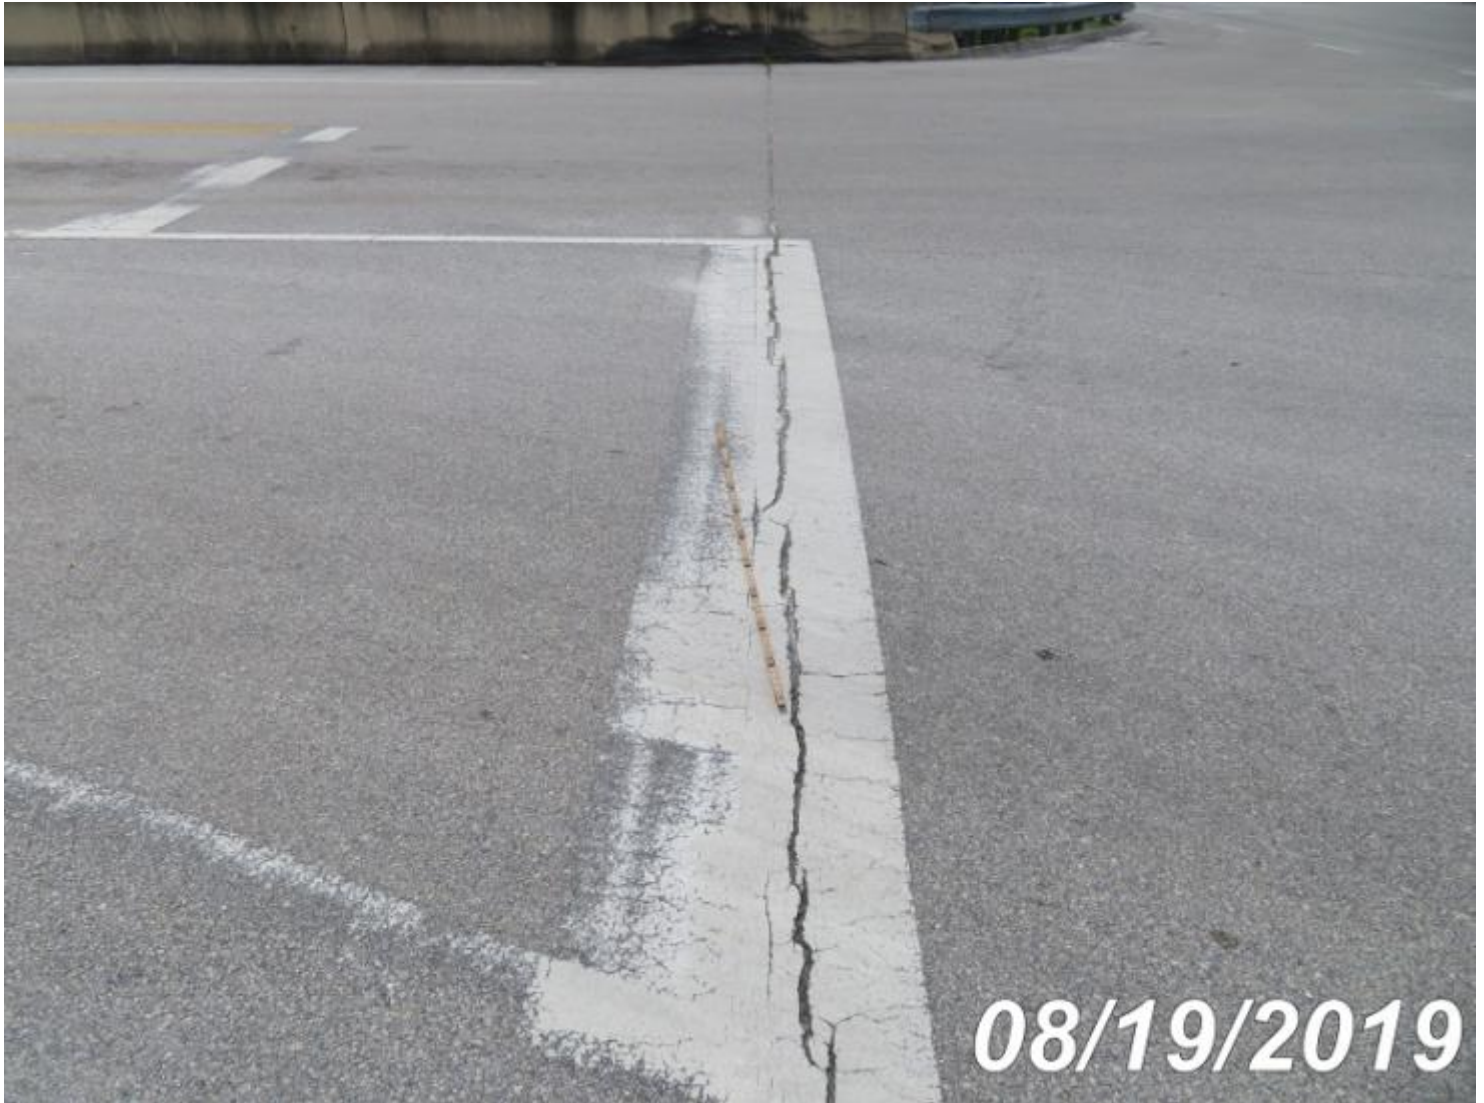
**Photo 8099-S01 (Unit 0: PS Conc Slab (Sonovoid))**

510/3 CS3:  
1) The asphalt overlay over End Bent 1 exhibits a transverse crack 48ft. L x 1/4in. W which is filled with dirt (total 48sf.). NO CHANGE. See Photo 8099-S01.

Transverse crack in the asphalt overlay over End Bent 1.

Clean and seal transverse crack over End Bent 1.

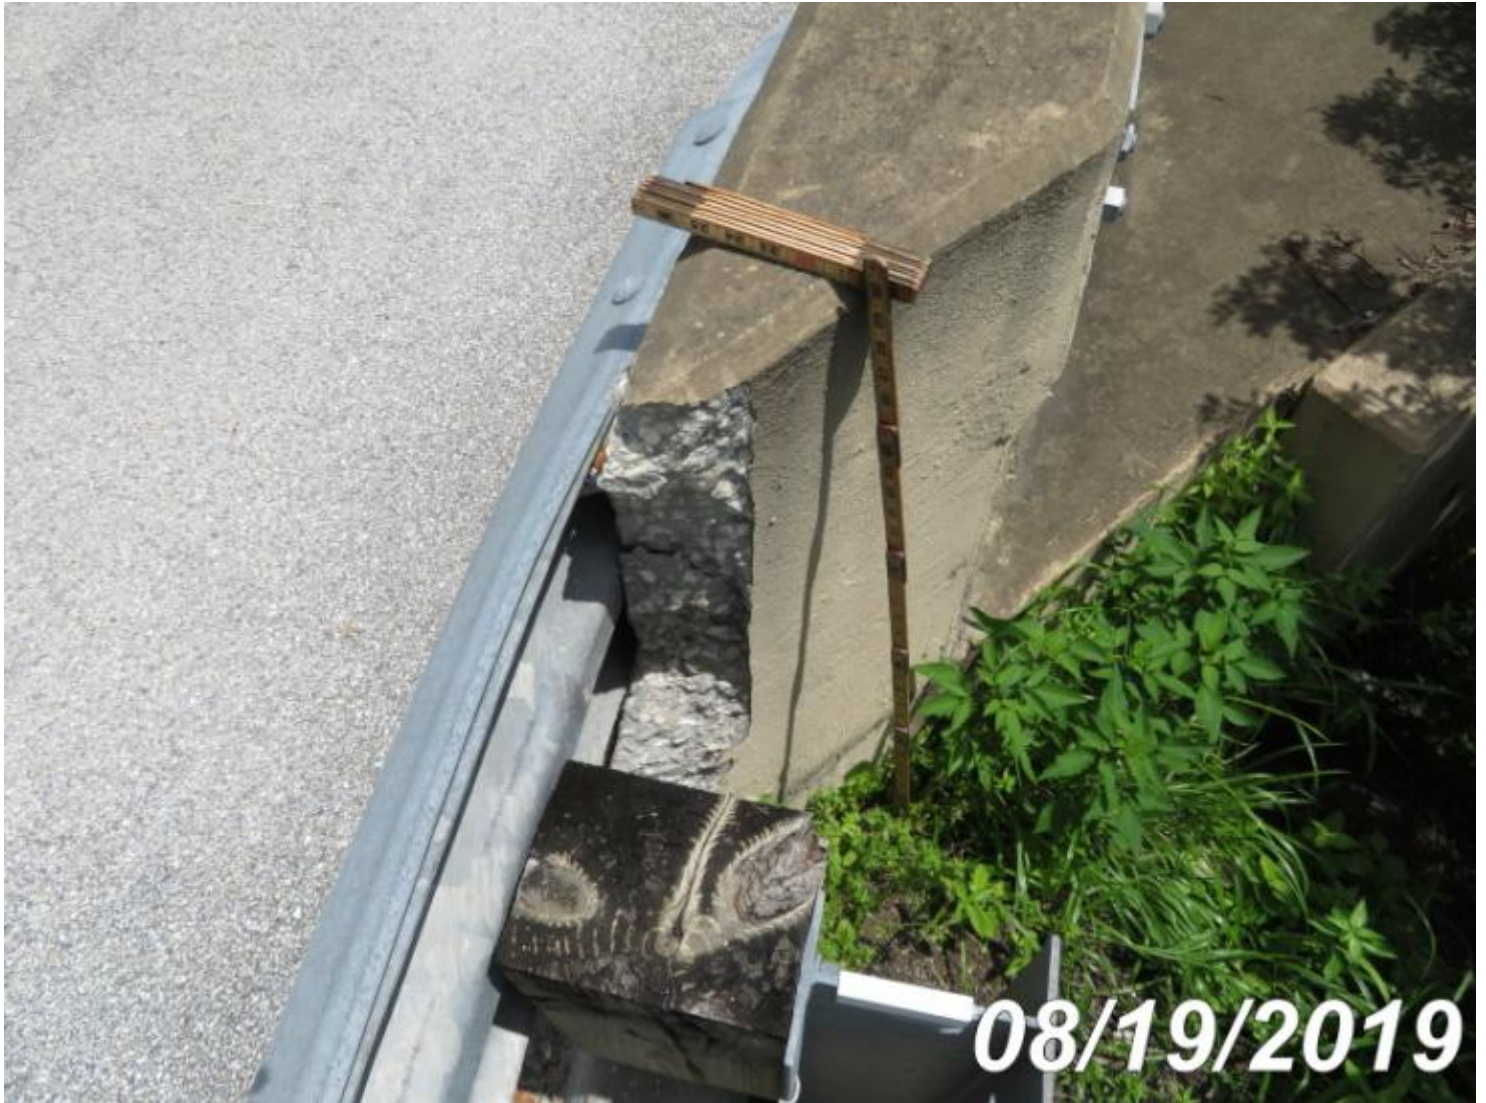
**Photo 321-S01 (Unit 0: Re Conc Approach Slab)**

4) The southwest approach barrier exhibits a spall 30in. H x 8in. W x 3in. D with no exposed steel at the west end. NEW. See Photo 321-S01.

Spall in the west end of the southwest approach barrier.

Patch spall in the west end of the southwest approach barrier.

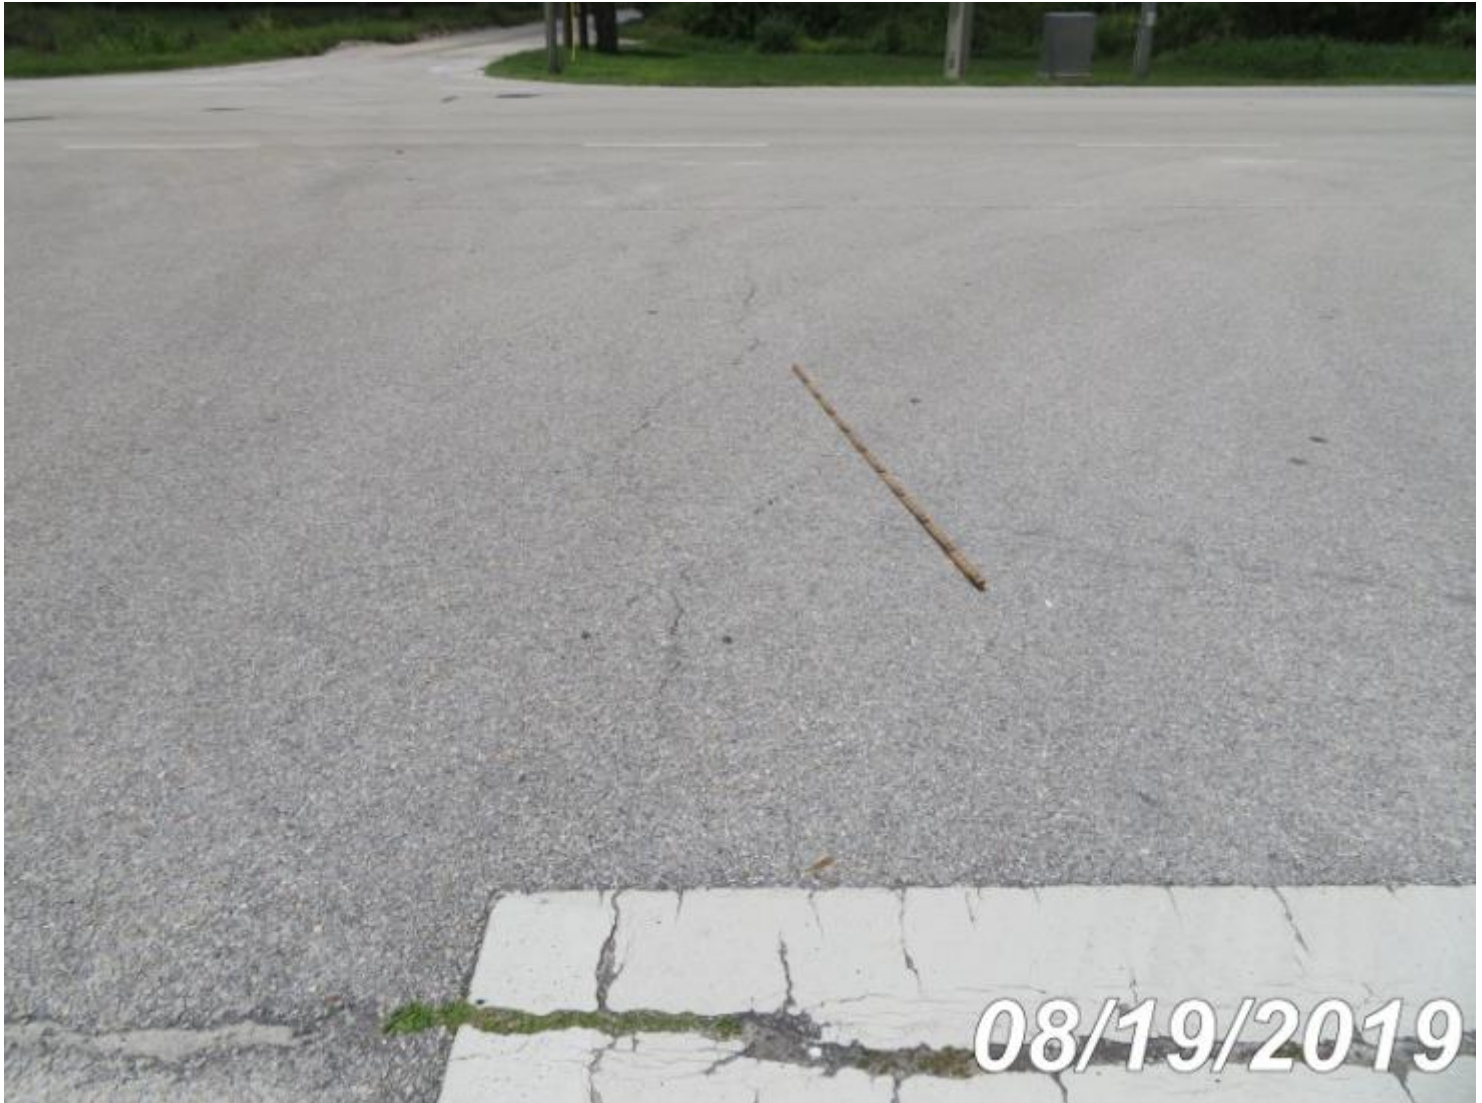
**Photo 321-S02 (Unit 0: Re Conc Approach Slab)**

5) The west approach slab asphalt exhibits longitudinal cracks up to 10ft. L x 1/32in. W in the westbound lanes (Total 30sf) NEW. See Photo 321-S02.

Longitudinal crack in the asphalt overlay at the west approach slab.

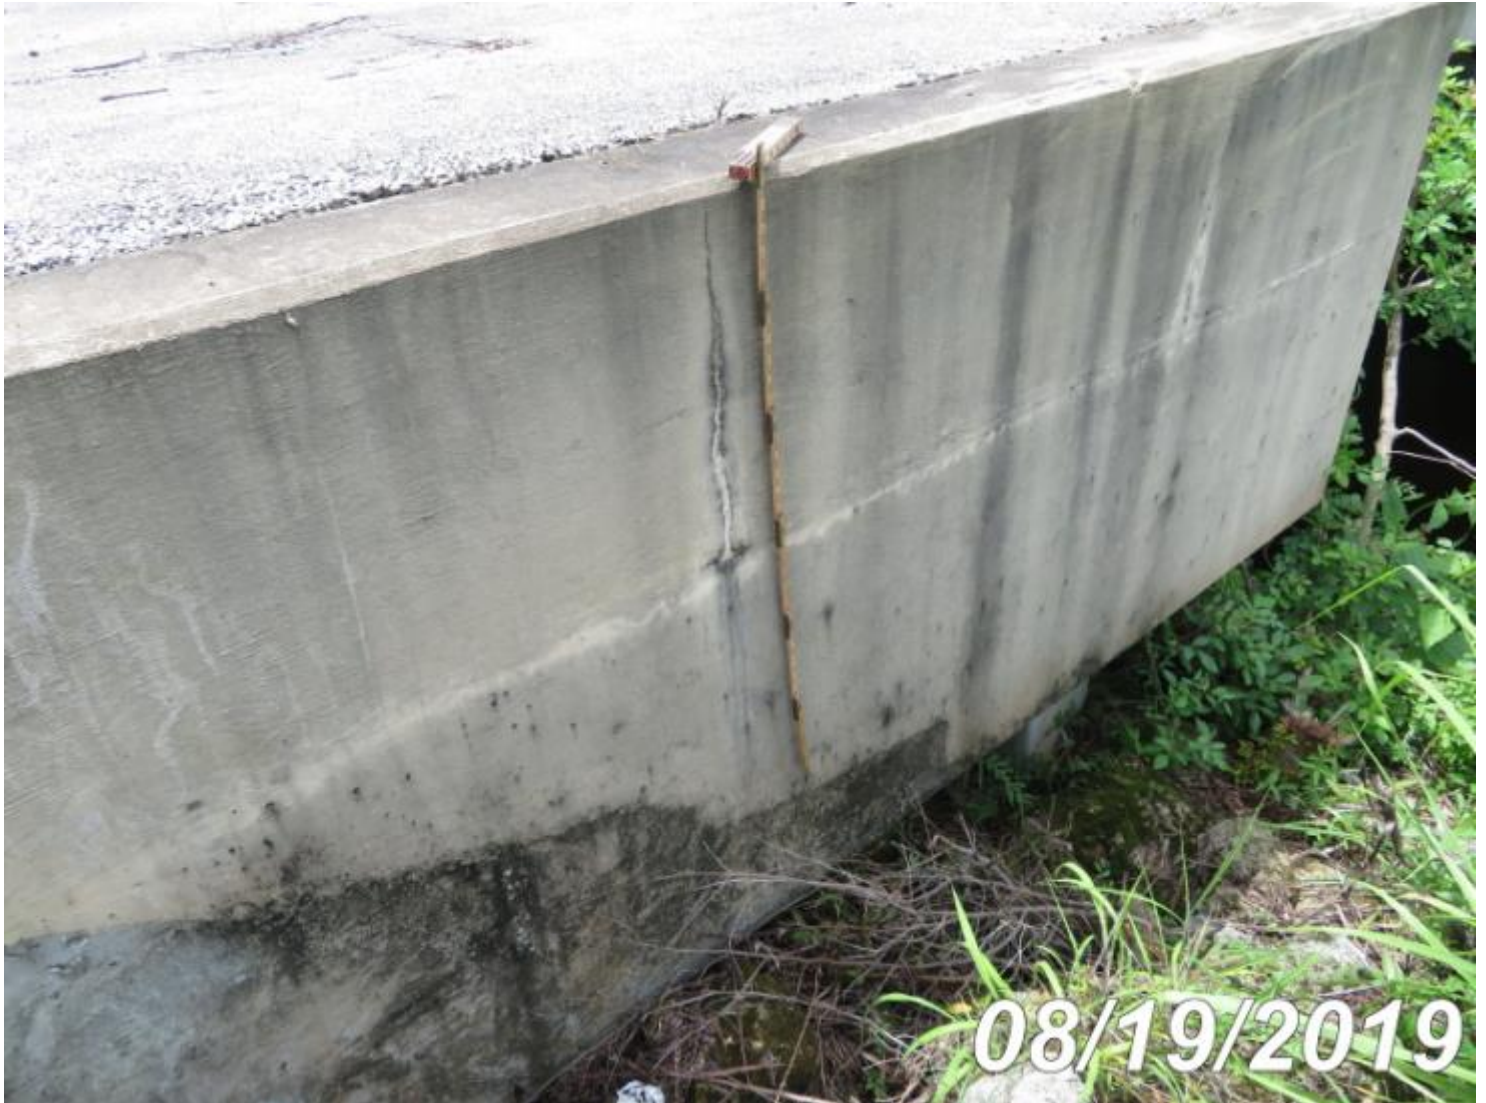
**Photo 8475-S01 (Unit 0: R/Conc Walls)**

1) The northwest and northeast retaining walls exhibits vertical cracks up to 3ft. H x 1/32in. W with efflorescence at random locations. (Total 4ft). NEW. See Photo 8475-S01.

Vertical crack in the northeast retaining wall.

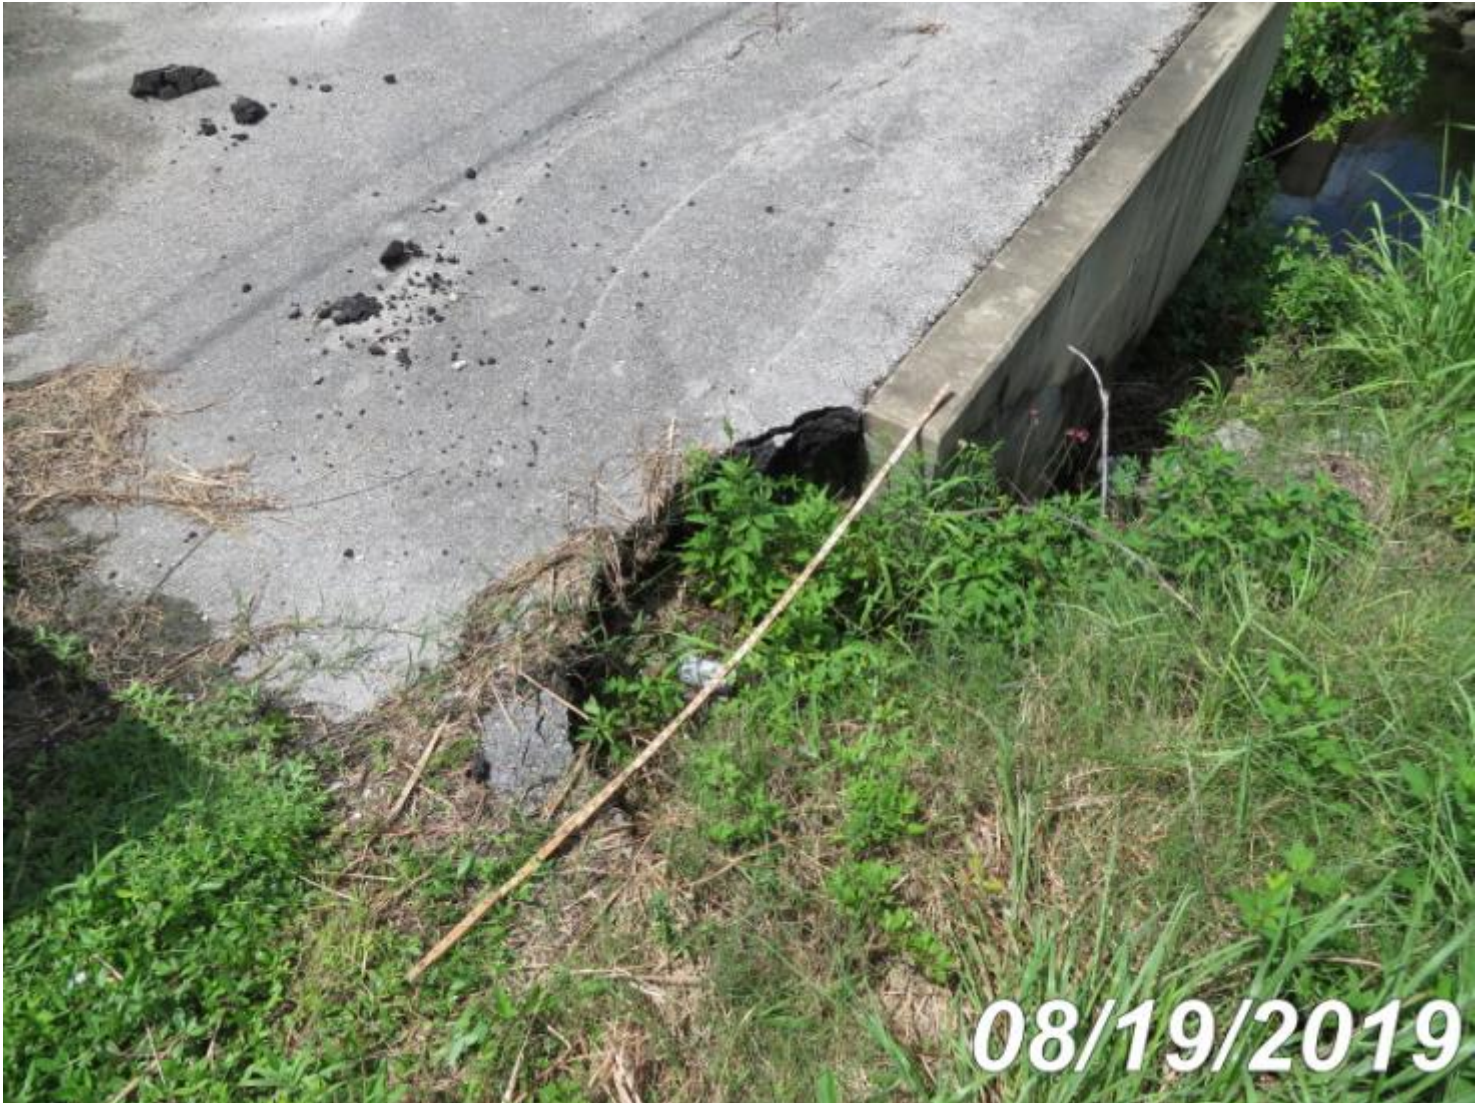
Photo 8475-S02 (Unit 0: R/Conc Walls)

2) The east end of the northeast retaining wall exhibits an area of erosion 30in. L x 20in. W x 14in. D with the asphalt at this location that has settled. NEW. See Photo 8475-S02.

Erosion at the northeast retaining wall.

Backfill and stabilize erosion at the northeast retaining wall.

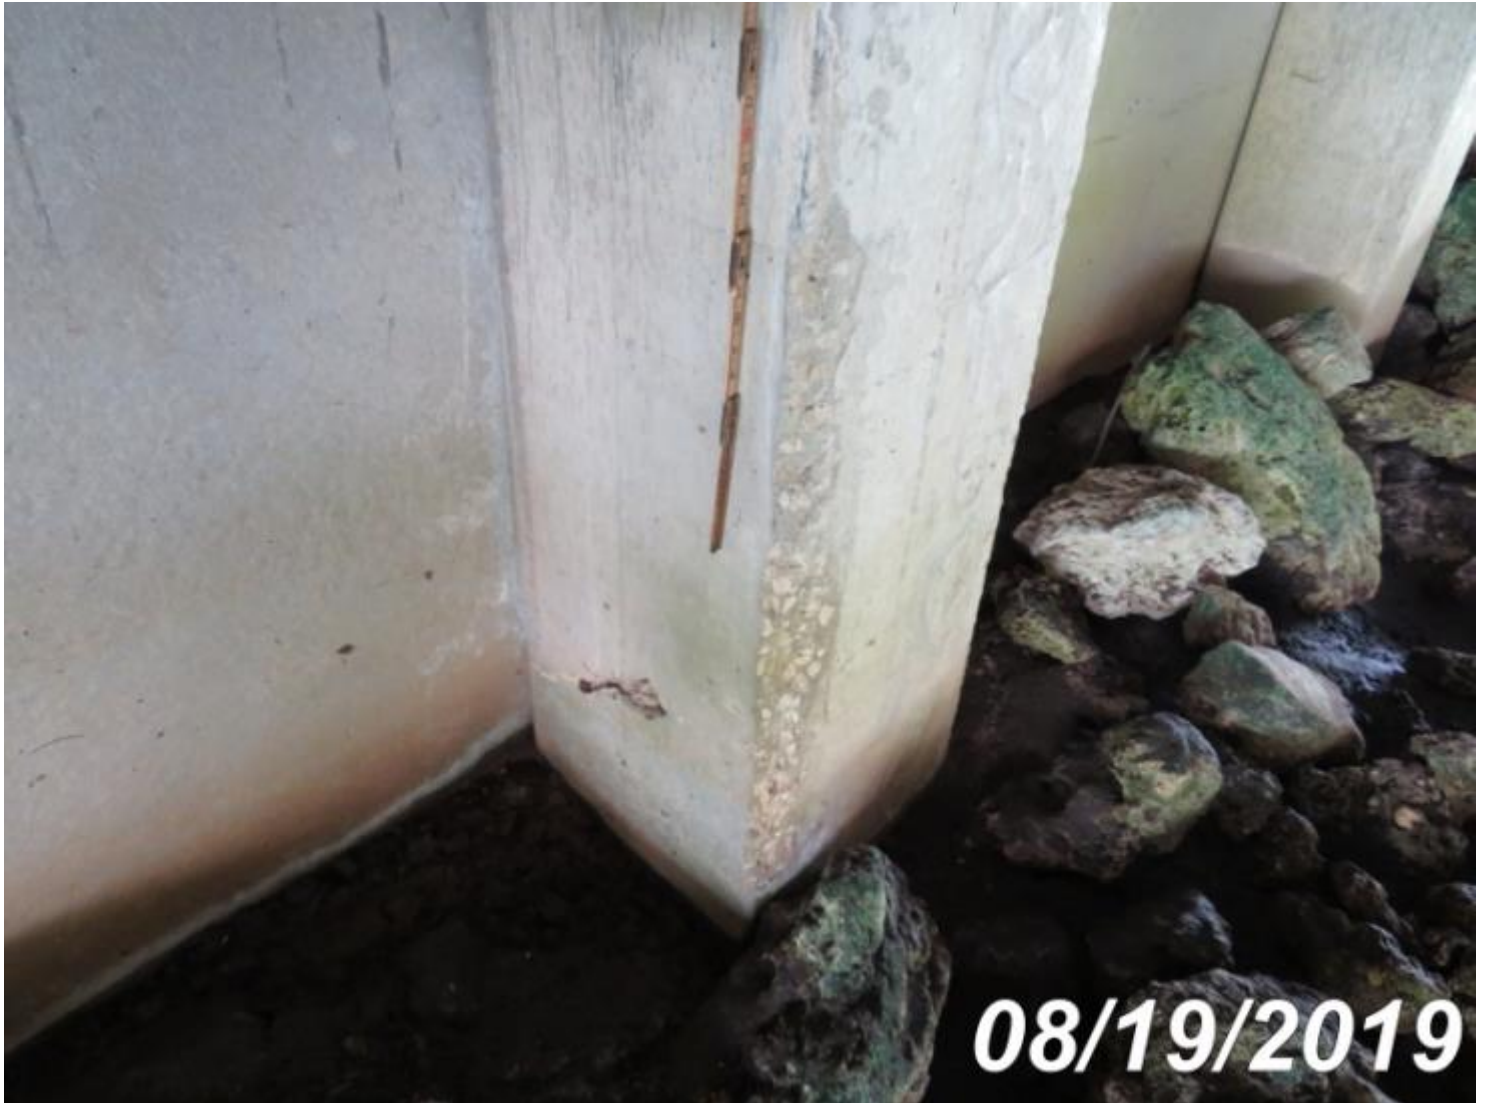
Photo 226-S01 (Unit 0: Pre Conc Pile)

- 226/3 CS3:  
1) Pile 1-2, northwest and southeast corners within 2.5ft. of the cap, has two spalls up to 19in. H x 4in. W x 1in D (total 1ea.). NO CHANGE.  
2) Pile 1-3, northwest corner 3ft. below the cap has a 9in. H x 9in. W x 3/4in. D spall (total 1ea.). NO CHANGE.  
3) Piles 1-4, 1-5, 1-6, 1-8, 1-9, 1-10 and 1-11 have edge spalls up to 6in. H x 4in. W x 3/4in. D (total 7ea.). NO CHANGE.  
4) Pile 1-7, southeast corner 1ft. below the cap has a 3ft. H x 4in. W x 3/4in. D spall (total 1ea.). NO CHANGE. See Photo 226-S01.

Spall in Pile 1-7 southeast corner.

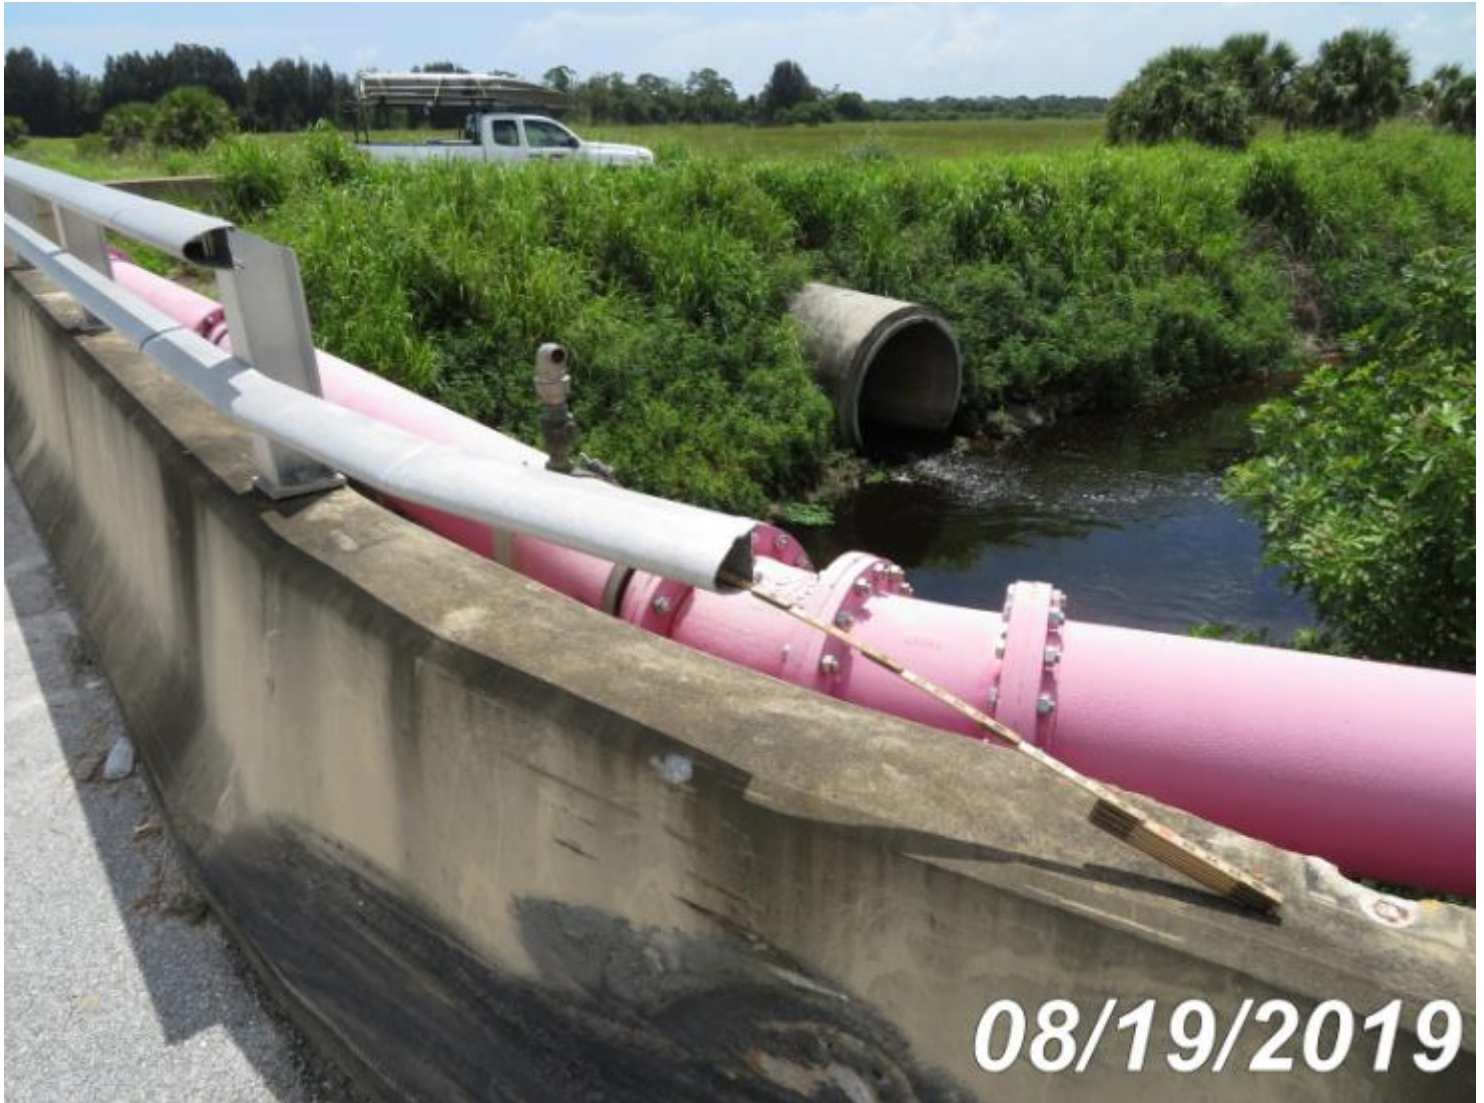
**Photo 333-S01 (Unit 0: Other Bridge Railing)**

1) The south face of the right barrier adjacent to End Bent 1 exhibits a spall 36in. L x 12in. H x 4in. D with exposed steel and anchor rods for the handrail, also at this location 6' of the handrail is missing/broken (total 3ft.). NEW. See Photos 331-S01 and 331-S02.

missing/broken hand railing section of the right barrier at End Bent 1.

Patch spall in south face of right barrier and replace missing hand railing at this location near End Bent 1.

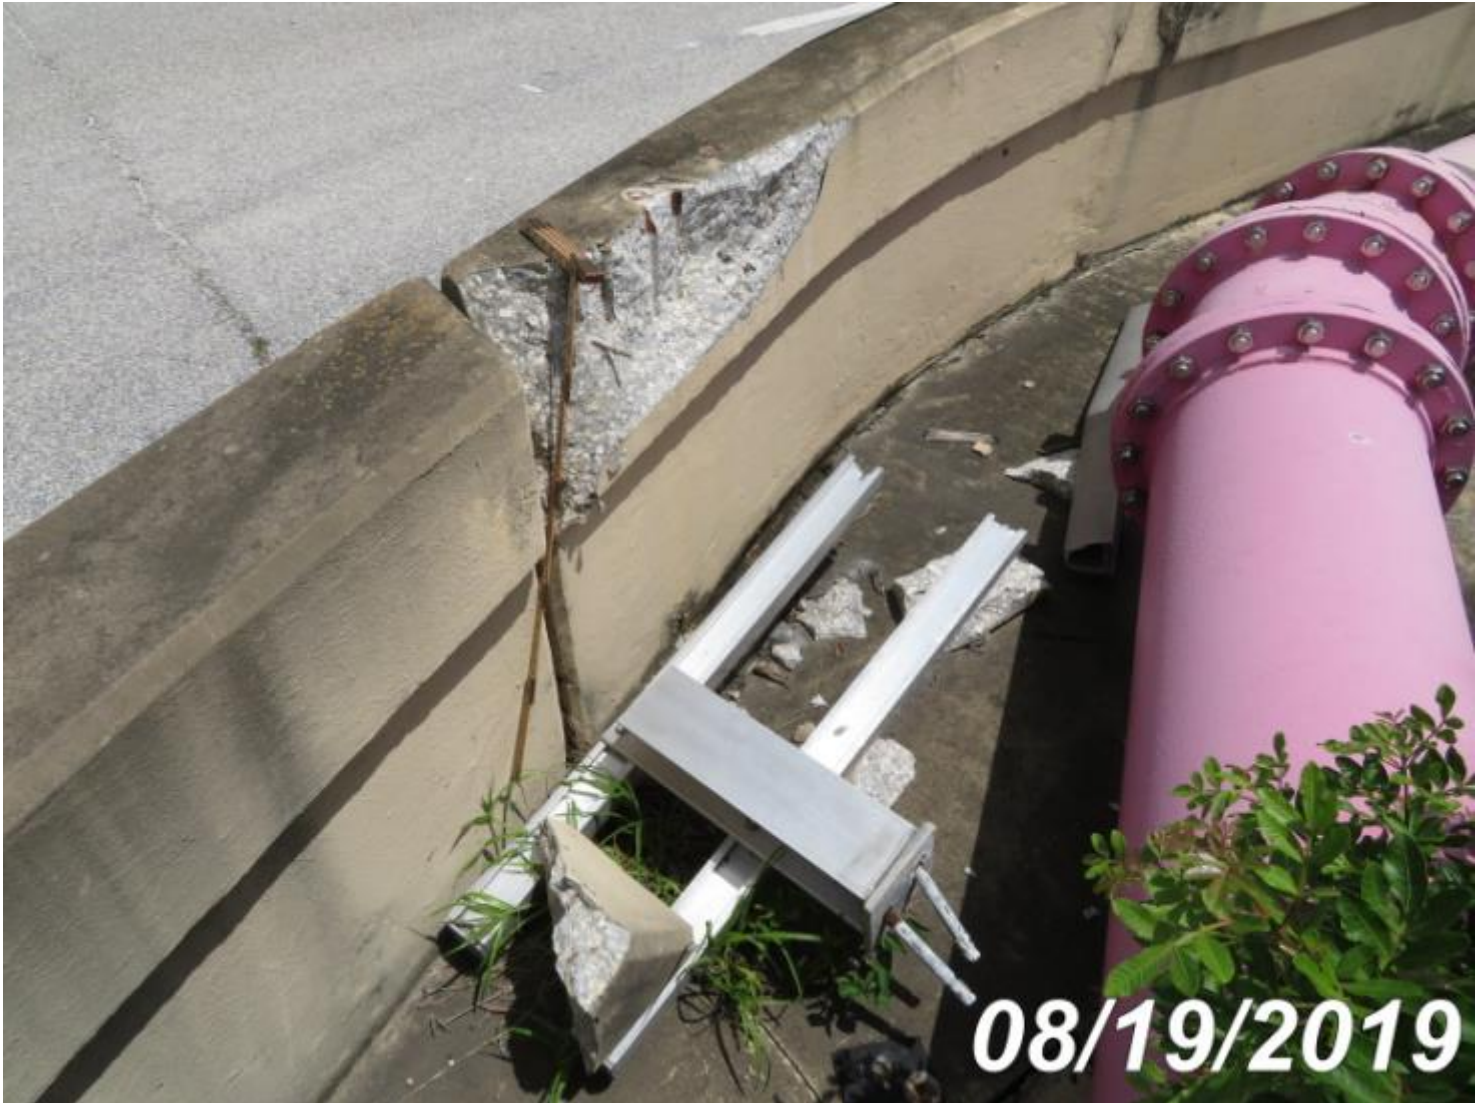
**Photo 333-S02 (Unit 0: Other Bridge Railing)**

Spall in the right barrier outside face over End Bent 1.

Patch spall in south face of right barrier and replace missing hand railing at this location near End Bent 1.

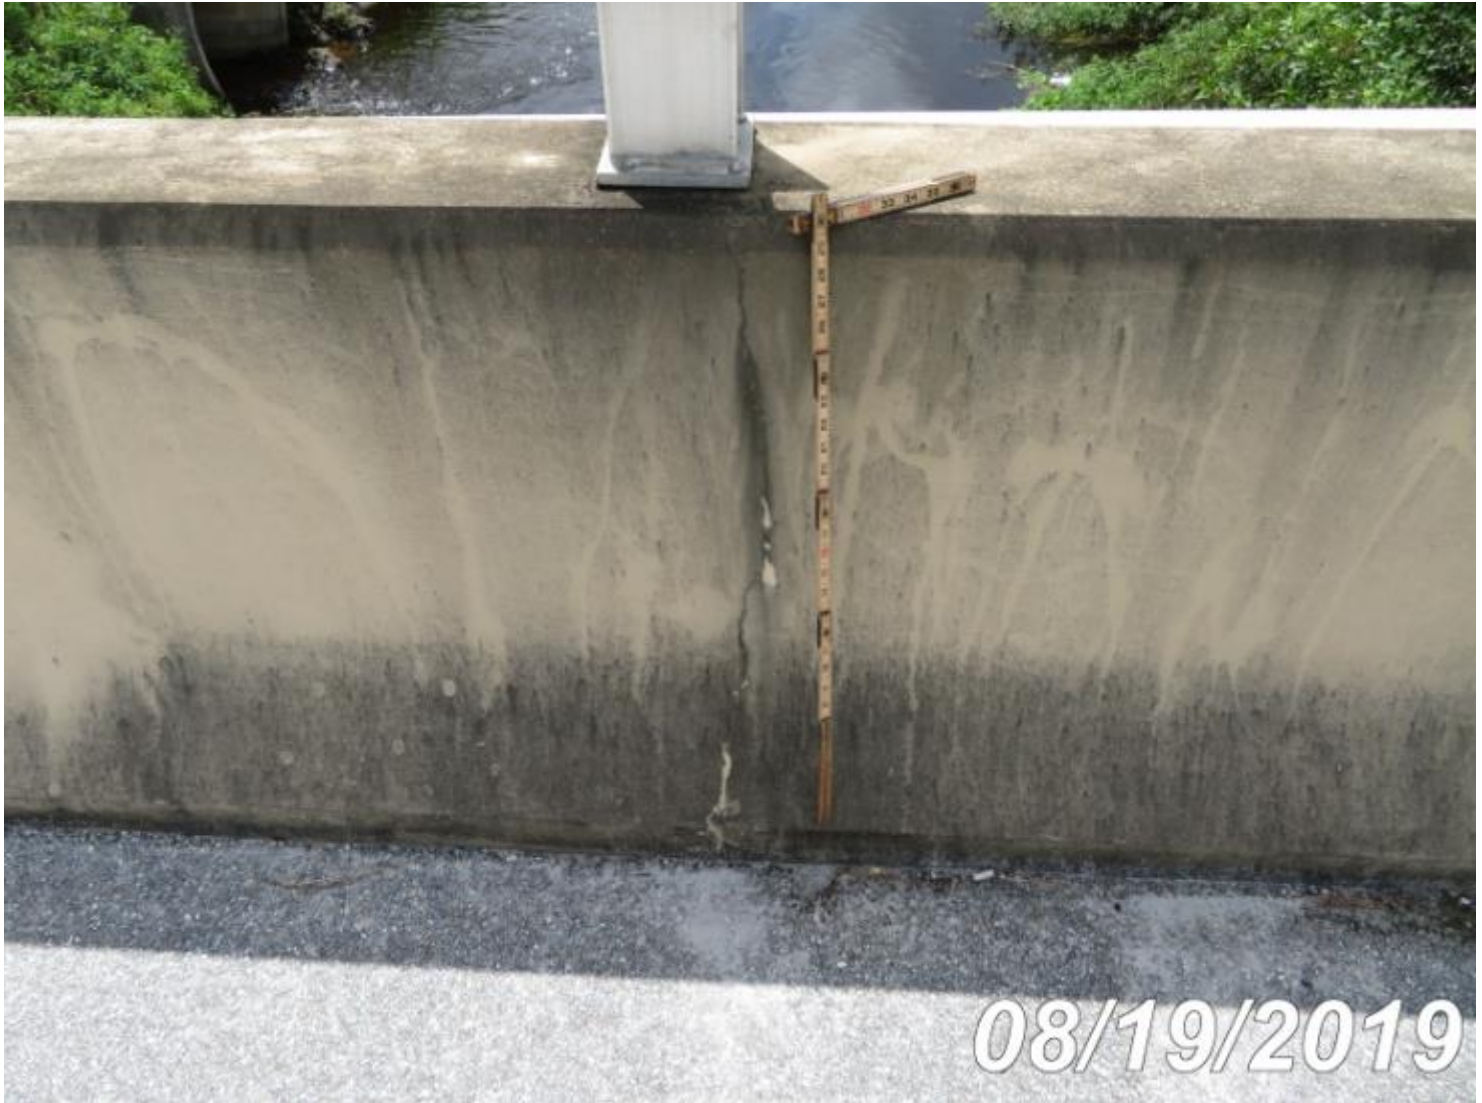
**Photo 333-S03 (Unit 0: Other Bridge Railing)**

4) The barriers exhibits vertical cracks up to 3ft. H x 1/32in. W. in random locations (Total 15ft.) NEW. See Photo 331-S03.

Vertical crack in the right barrier, near End Bent 1.

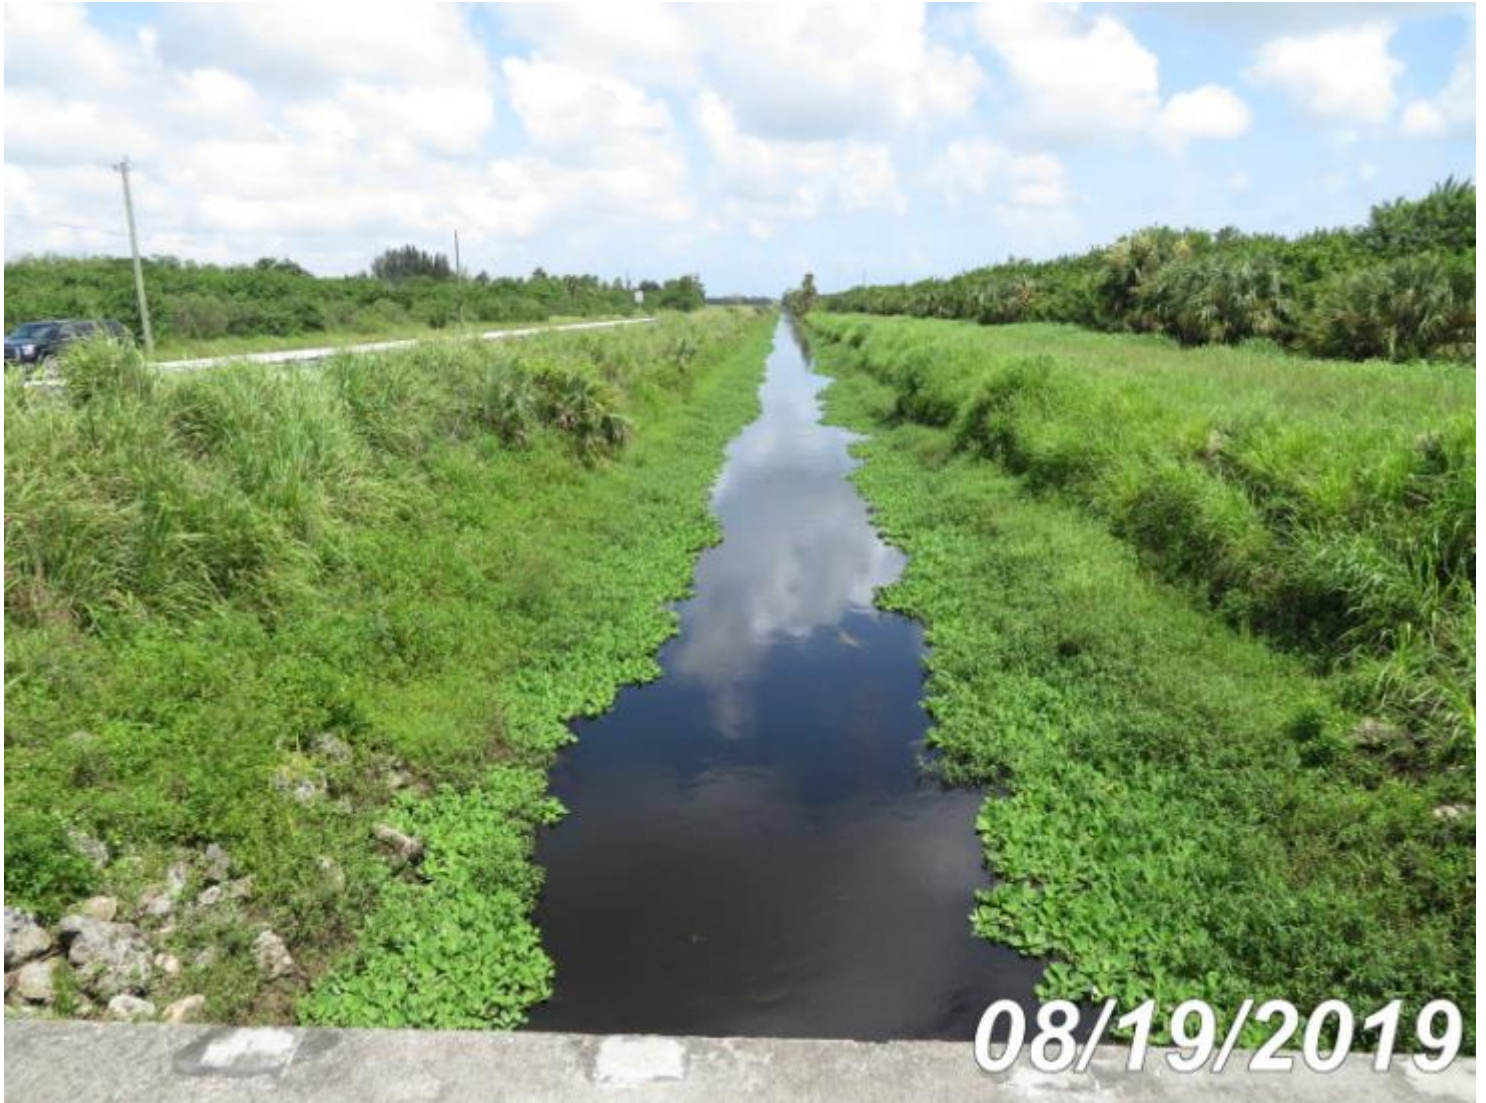
**NORTH CHANNEL**

8290/3 CS1:  
1) There is floating aquatic vegetation on both sides of the structure which does not affect the flow. NO CHANGE.
