LEAD-BASED PAINT INSPECTION REPORT

**442 Breeze Street
Spartanburg, South Carolina**

REPORT DATE: June 23, 2020

**Crossroads Environmental, LLC
1258 Boiling Springs Road
Spartanburg, South Carolina 29303
(864) 541-8736
CRE Project # 19085-IL**

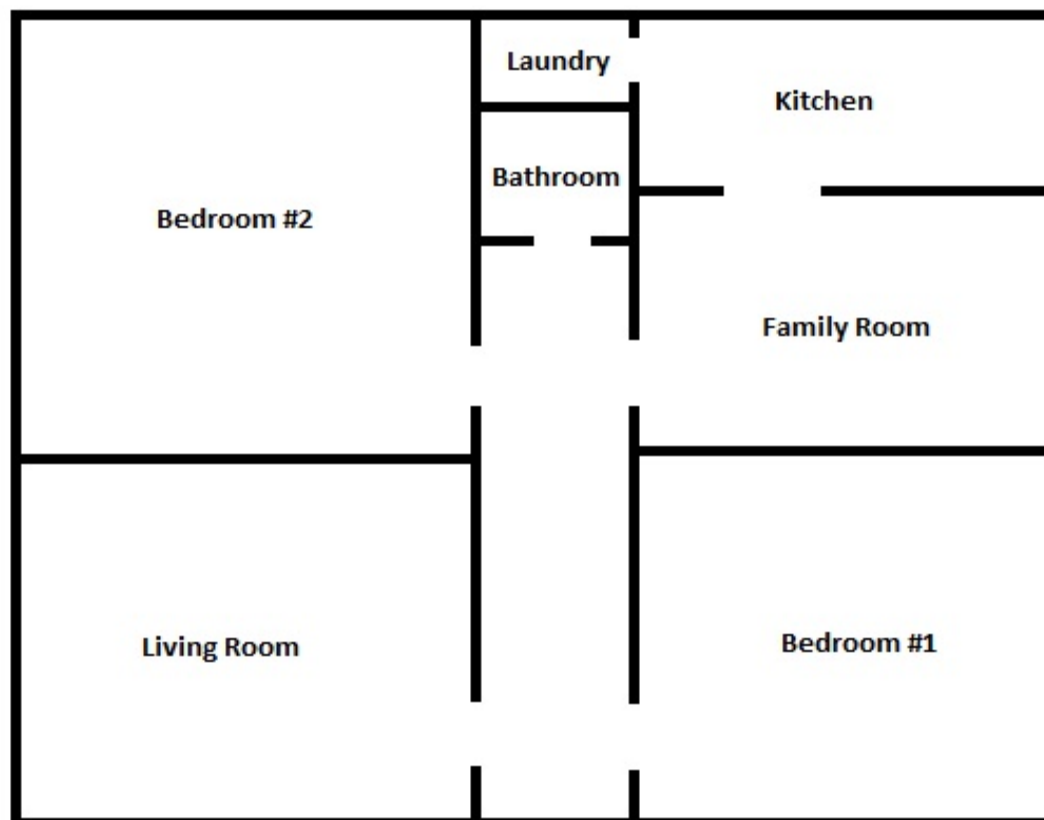
Sketch #: 001

Sample ID	Description	Mass (g)	Concentration (ppm)	Concentration (% by weight)
Lab Sample ID	Lab Notes			
127	Drip line soil	1.5384	3500	0.35%
71944549PBS_1

- 2) Removal of a minimum of two inches of soil at dripline, and addition of mulch over areas where soil is removed.
- 3) Paint stabilization of all wooden components that cannot be feasibly wrapped (roof overhang, supports, columns, rails, etc.).
