**ADDENDUM SIX
MULTIPLE BALLFIELD AND FACILITY IMPROVEMENTS
CONTRACT NO. R-19-006-201
CITY OF CHATTANOOGA, TENNESSEE**

NESHAP REPORT

**John A. Patten Recreation Center- 2nd Floor
3202 Kelley's Ferry Road
Chattanooga, Tennessee 37402
AAI – 5251
March 5, 2019**

**TARGETED LEAD INSPECTION
REPORT**

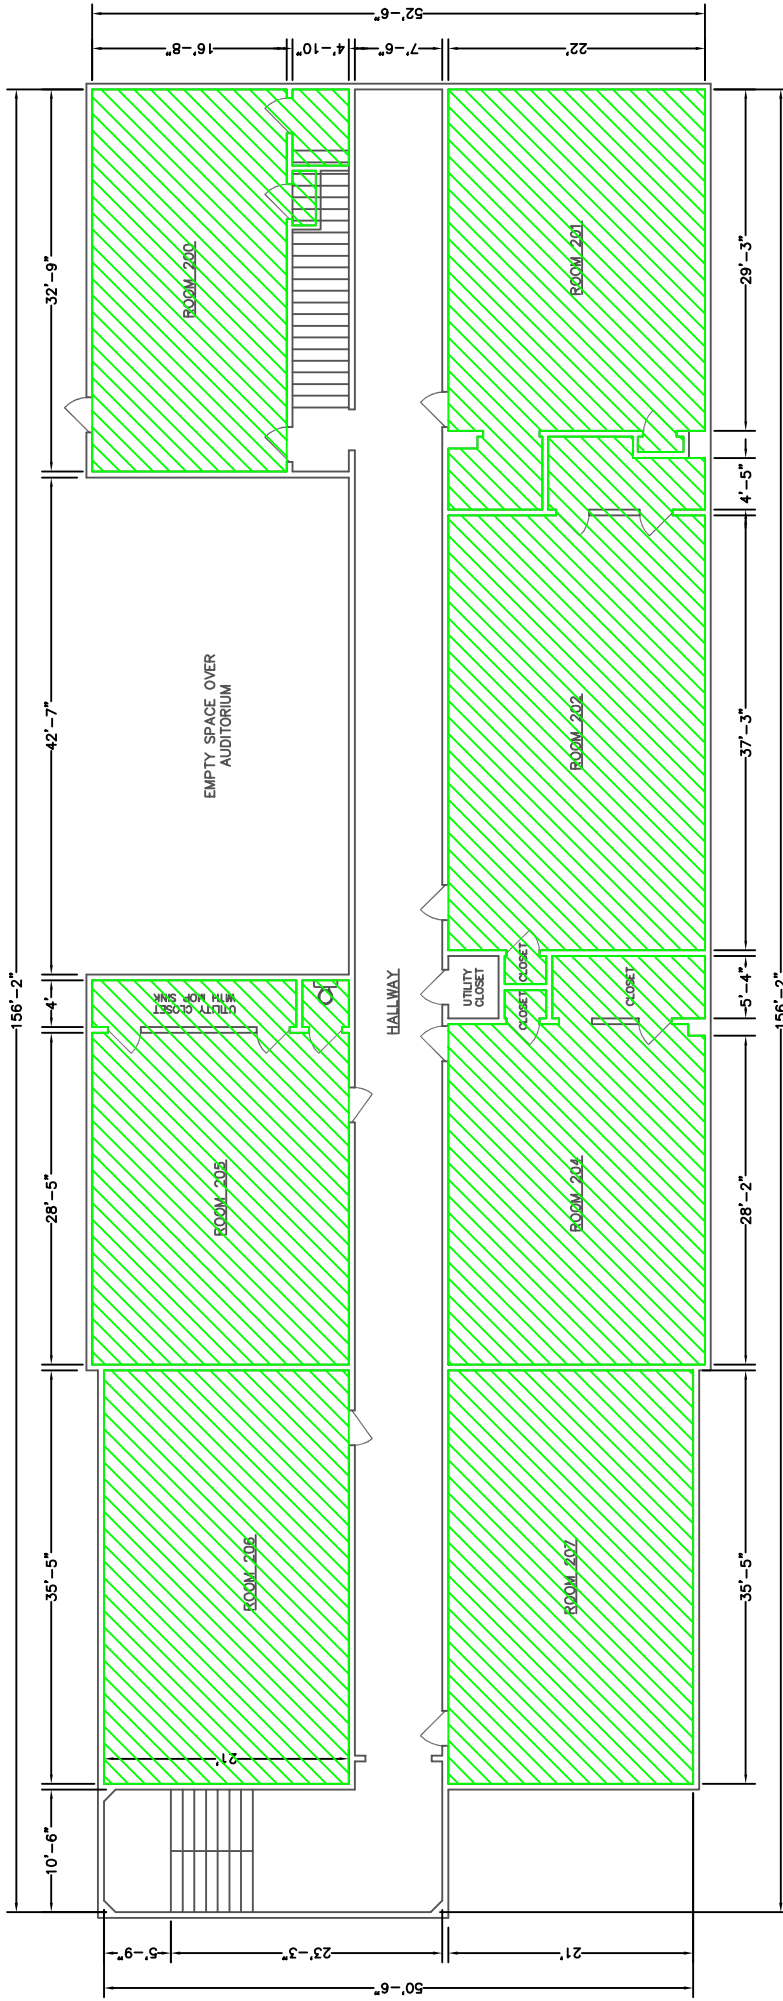
Asbestos Locations
 John A. Patten Recreation Center-- 2nd Floor
 3202 Kelly's Ferry Road
 Chattanooga, Tennessee 37419

- 9" x 9" Green Floor Tile RM 200, RM 201, RM 202, RM 204,
RM 205, RM 206, RM 207

Asbestos Floor Tile

Asbestos Floor Tile/Adhesives - Asbestos floor tile and mastic adhesives are considered to be a Category I, non-friable, asbestos containing building material by Federal NESHAP Regulations. Adhesives, found in good condition, have the option of being left in place and maintained, covered by another type of flooring or removed.

If removed, the asbestos floor tile and mastic adhesive should be removed by an asbestos contractor with accredited supervision and workers. All material and debris must be properly disposed of at an approved asbestos landfill. While EPA looks upon this material as non-friable, OSHA Regulations require special training and other requirements for anyone disturbing any asbestos material. OSHA also has procedural requirements pertaining to asbestos removal and handling. Contractor must comply with State of Tennessee Asbestos Program requirements and TOSHA.
