Contract #15-047, Detention Center Building Condition Assessment

Final Assessment

GEORGETOWN COUNTY DETENTION CENTER

EXECUTIVE SUMMARY

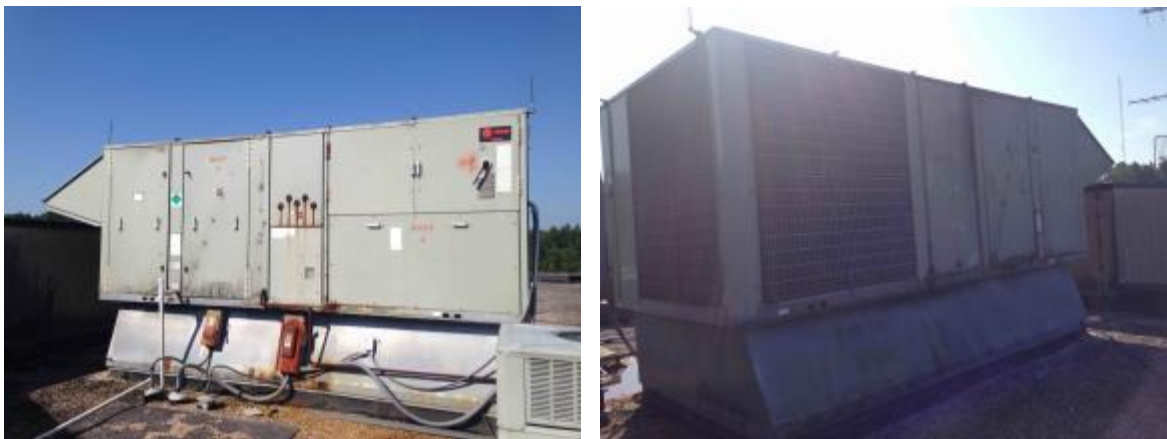
The unit is 9 years old and in poor condition. There is rust and microbial growth visible on the exterior of the unit. Condensation within the unit has allowed the unit to corrode in a short amount of time, and has caused the insulation inside the unit to delaminate. Where the insulation is damaged, more condensation will occur, resulting in more rust. Areas with delaminated or saturated insulation have visible microbial growth. Temperature readings from the FLIR show the rooftop unit's surface temperature is above dew point.

RTU-1 has rust and microbial growth.

Temperature readings were recorded using the FLIR. The temperature readings on the exterior of the unit vary by about 40°F due to sunlight in addition to insulation delamination. The temperature of the unit should be uniform on the exterior and above the dew point. The moisture, microbial growth, and rust are occurring at the coldest parts of the unit.

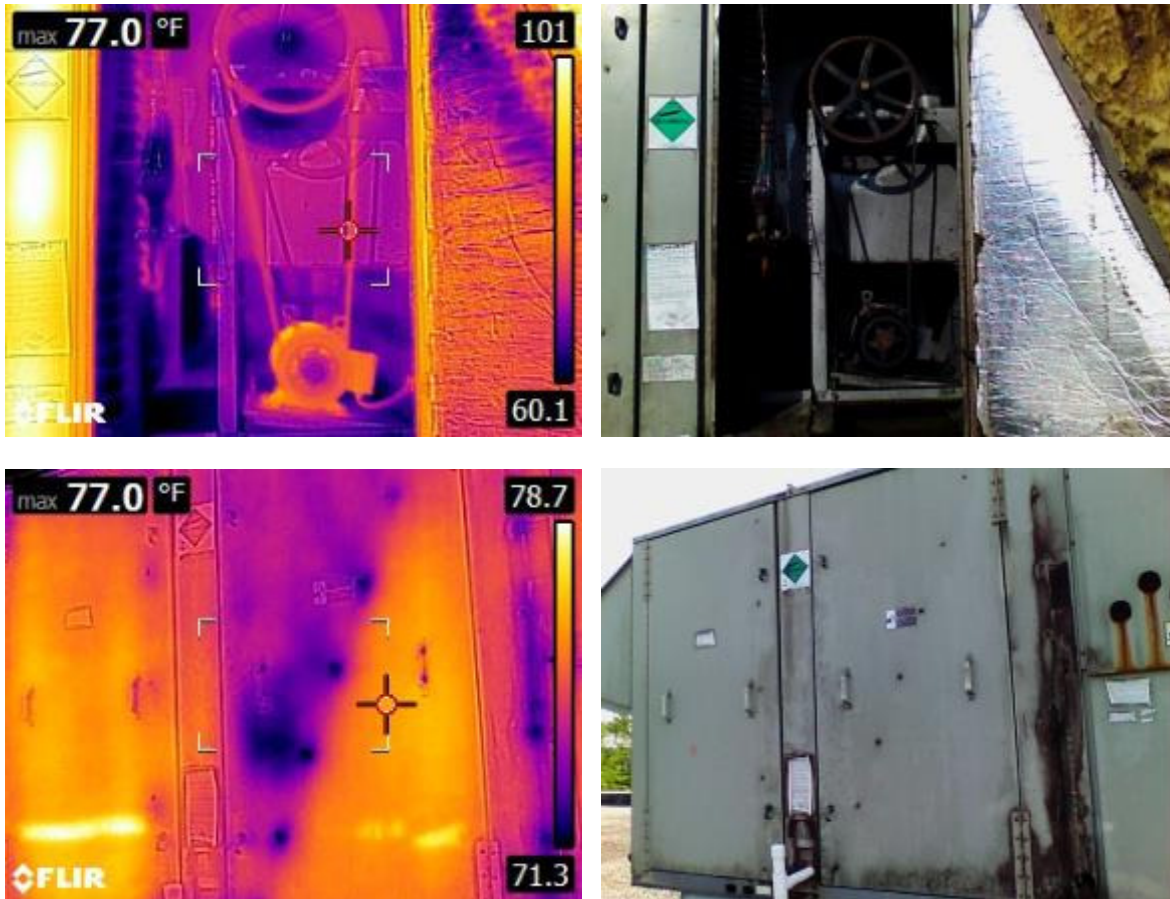
The insulation jacket is missing on half of the unit's access door. Microbial growth is occurring where the jacket is missing.

Above are side by side comparisons of the unit.

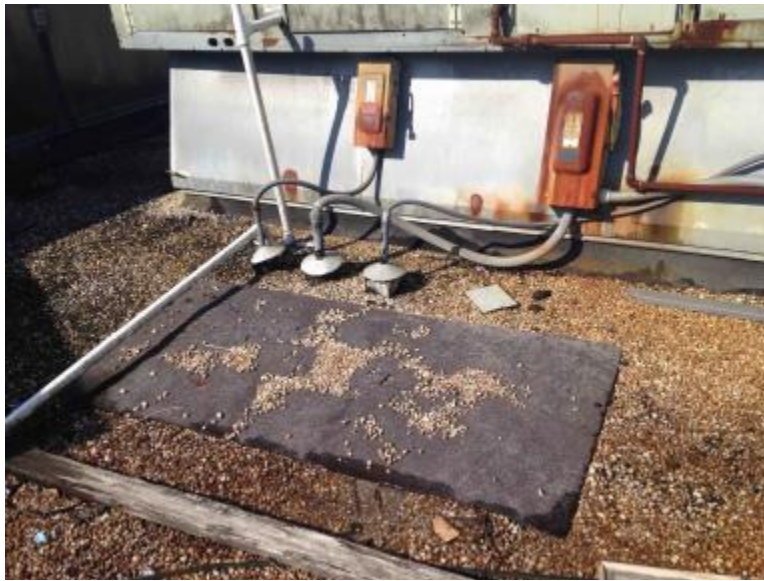
The roof curb adaptor is sized appropriately for the unit, but it is rusted. Rusted electrical disconnects are attached to the roof curb. The gas piping penetrations enter the building by pitch pockets.

There is visible rust on the RTU-1 roof curb.

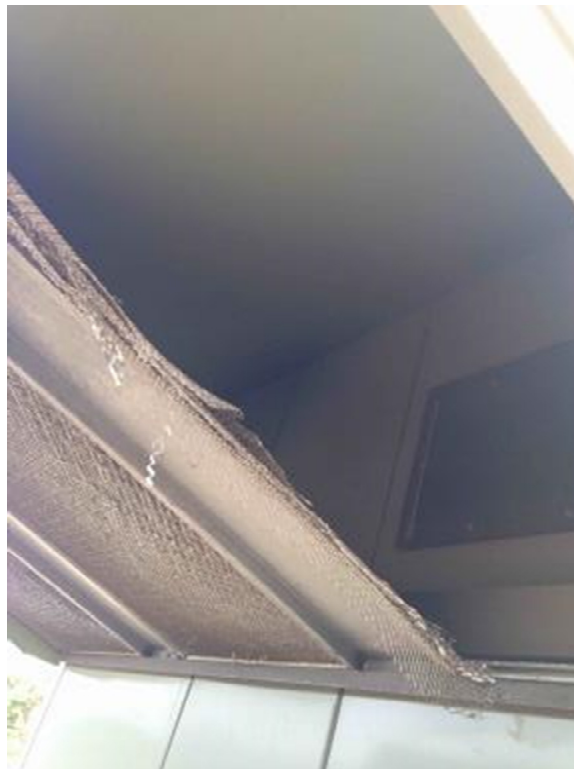
The bird screen is torn on the intake side of the unit.

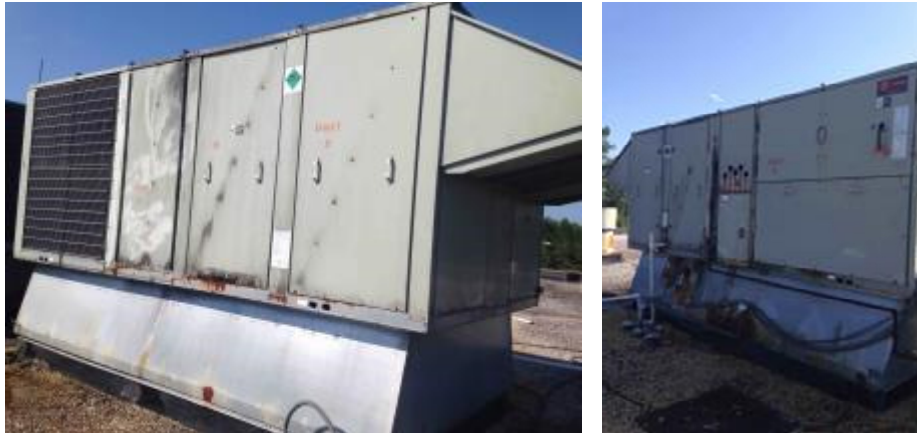
The unit is 10 years old and in poor condition. There is rust and microbial growth visible on the exterior of the unit. Condensation within the unit has allowed the unit to corrode in a short amount of time, and has caused the insulation inside the unit to delaminate. The condensation has caused the insulation to delaminate. Where the insulation is damaged, more condensation can occur, resulting in more rust. Areas with delaminated or saturated insulation have visible microbial growth.

RTU-2 has rust and microbial growth.

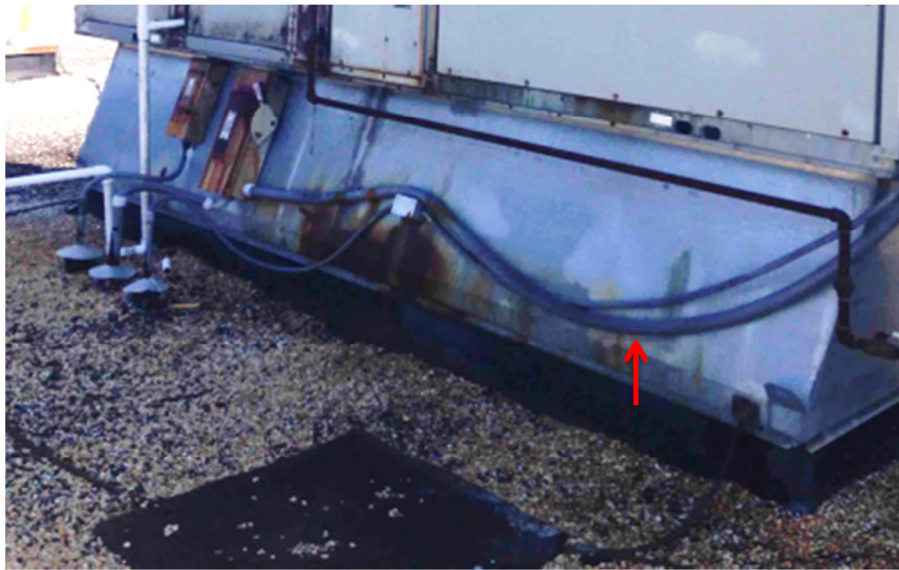
The roof adaptor curb is sized appropriately for the unit, but is rusted. Rusted electrical disconnects are attached to the roof curb. The gas piping penetrations enter the building by pitch pockets.

There is visible rust on the RTU-2 roof curb and conduit is not properly supported.

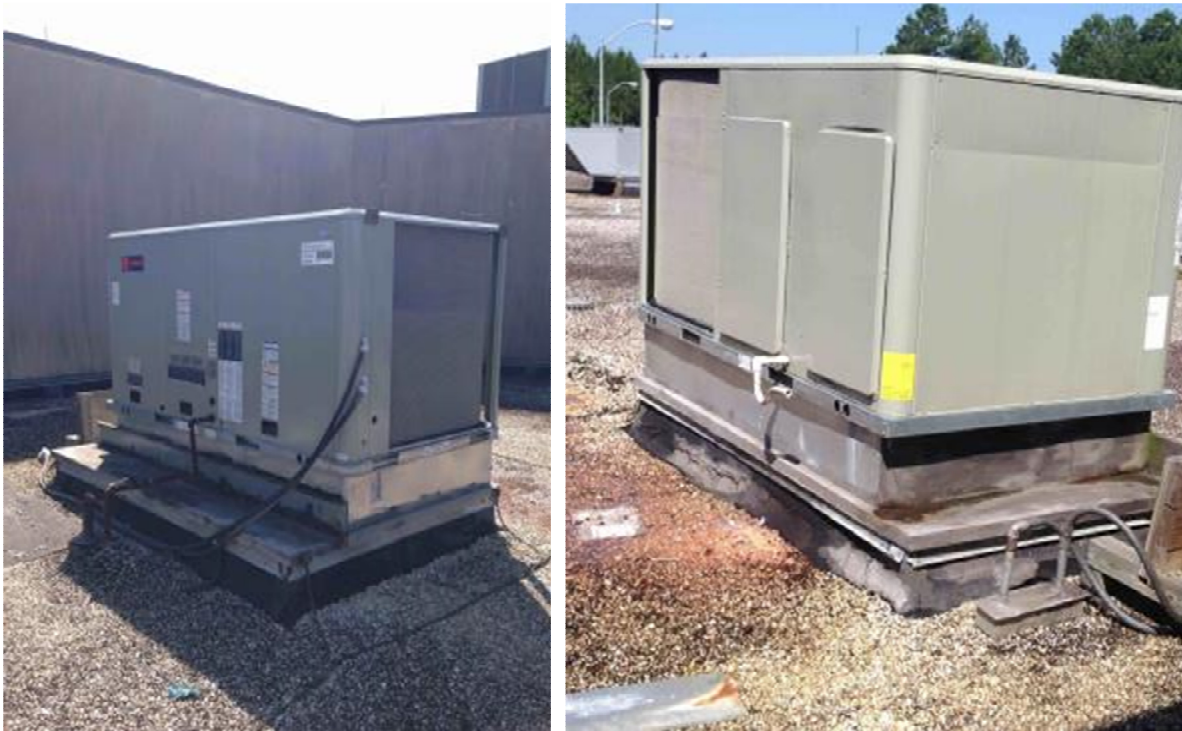
The unit was installed on June 8, 2015. The new unit was placed on the existing roof curb, which is oversized and corroded. The roof curb is likely not seismically braced/restrained.

RTU-3 was placed on the existing roof curb.

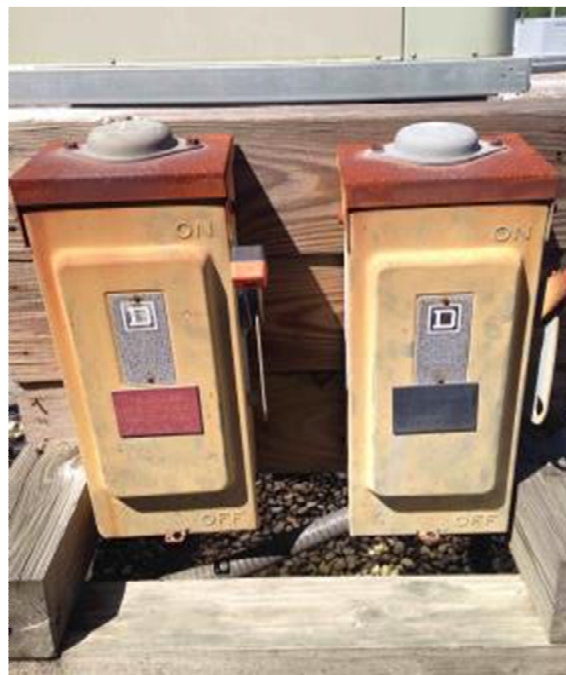
The original, rusted electrical disconnects are being reused and are mounted on wood next to the unit.

The corroded disconnects are mounted to wood.

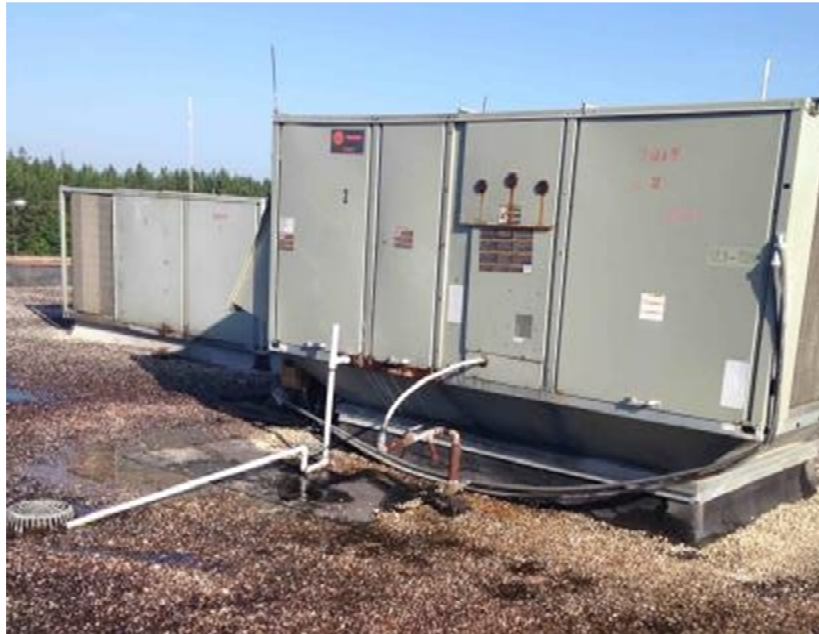
The unit is 6 years old and in poor condition. There is rust and microbial growth visible on the exterior of the unit. The rooftop equipment has been installed on the existing roof curb, which is rotting. Condensation within the unit has allowed the unit to corrode in a short amount of time, and has caused the insulation inside the unit to delaminate. The condensation has caused the insulation to delaminate. Where the insulation is damaged, more condensation can occur, resulting in more rust. Areas with delaminated or saturated insulation have microbial growth.

RTU-5 has rust and microbial growth.

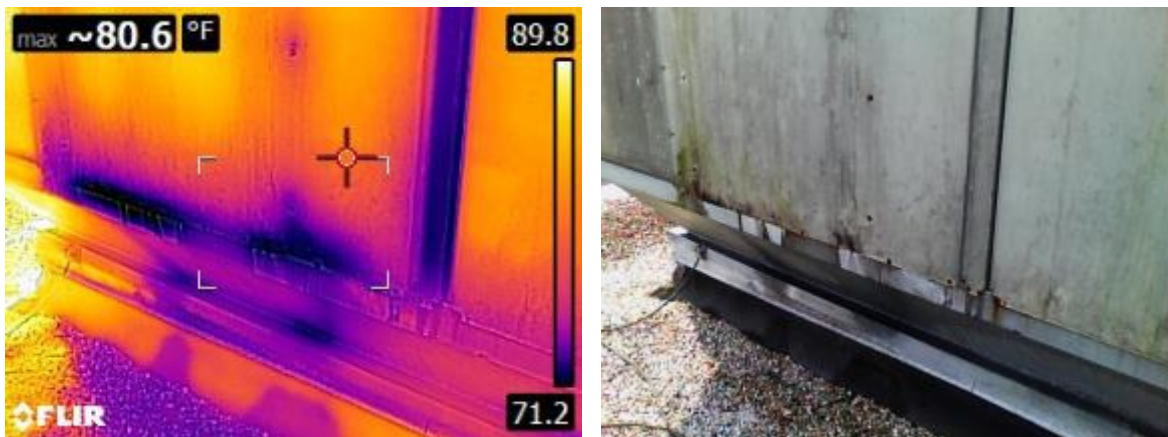
Temperature readings were recorded using the FLIR. The temperature readings on the exterior of the unit vary by about 20°F due to sunlight in addition to insulation delamination. The temperature of the unit should be uniform on the exterior and below dew point. Temperature readings from the FLIR show the rooftop unit's surface temperature is above dew point. The moisture, microbial growth, and rust are occurring at the coldest parts of the unit.

Above is a side by side comparison of the unit.

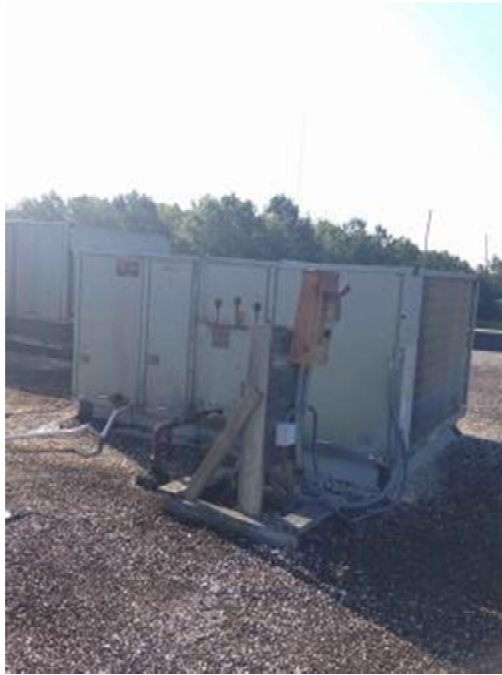
The unit is 10 years old and in poor condition. There is rust and microbial growth visible on the exterior of the unit. Condensation within the unit has allowed the unit to corrode in a short amount of time, and has caused the insulation inside to delaminate. Where the insulation is damaged, more condensation can occur, resulting in more rust. Areas with delaminated or saturated insulation have visible microbial growth.

RTU-6 has rust and microbial growth.

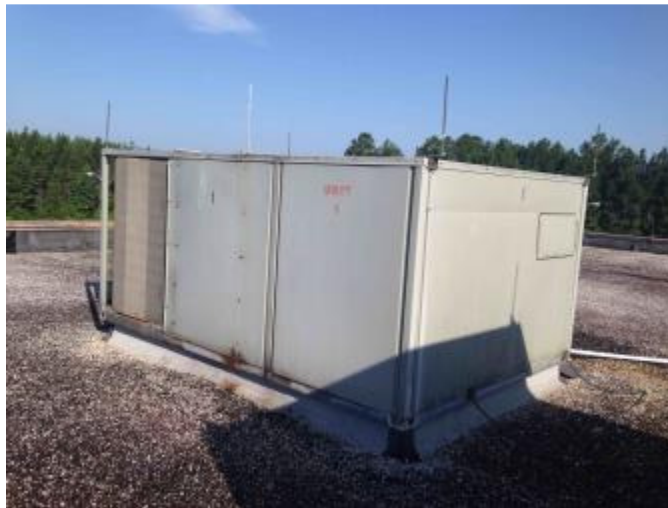
The roof curb is sized appropriately for the unit, but is rusted.

There is visible rust on the RTU-6 roof curb.

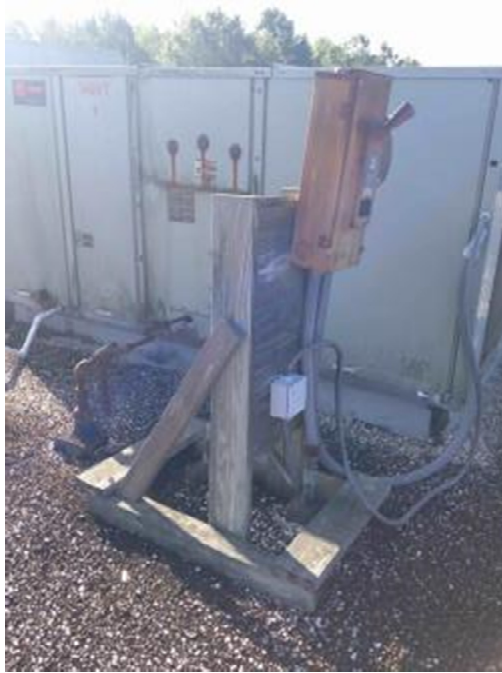
The rusted electrical disconnect is mounted on wood next to the unit.

The corroded disconnect is mounted to wood.

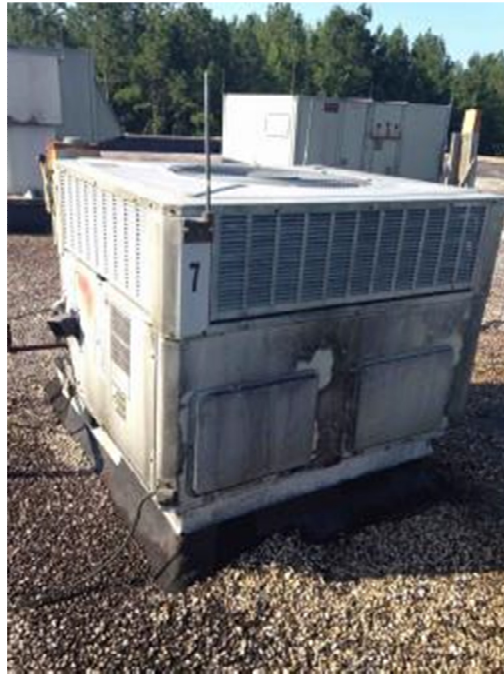
The unit is 8 years old and in poor condition. There is rust and microbial growth visible on the exterior of the unit. Condensation within the unit has allowed the unit to corrode in a short amount of time, and has cause the insulation inside the unit to delaminate. The condensation has caused microbial growth.

RTU-7 has rust and microbial growth.

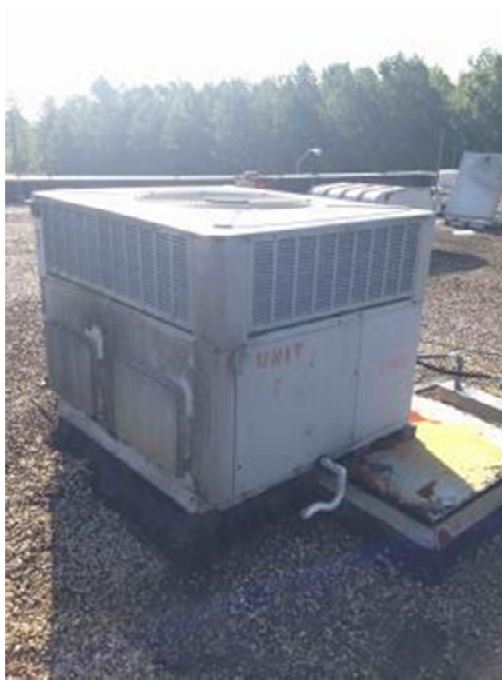
The rooftop unit has been installed on the original roof curb without proper modifications and a roof adaptor curb. When the new equipment was installed, the supply and return air ductwork connections did not align with the existing curb. In lieu of a roof curb, wood blocks are currently being used under the unit. This does not meet code requirements. Wood is never considered a proper support.

RTU-7 was placed on the existing roof curb.

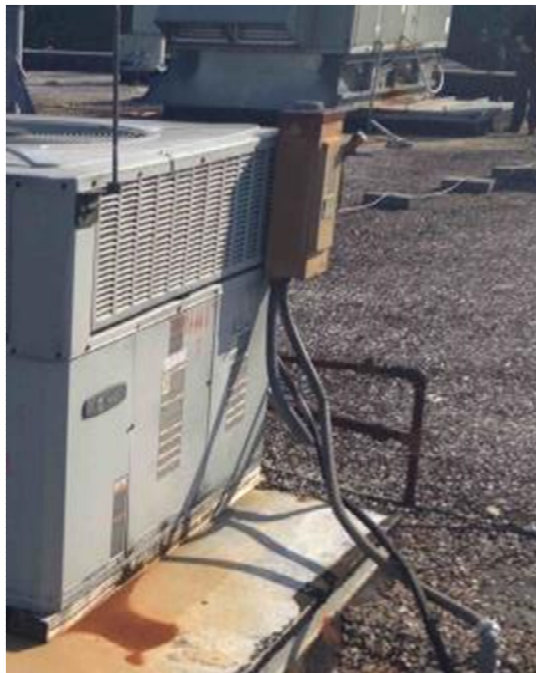
A rusted electrical disconnect is attached to the unit.

The corroded disconnect is attached to the rooftop unit.

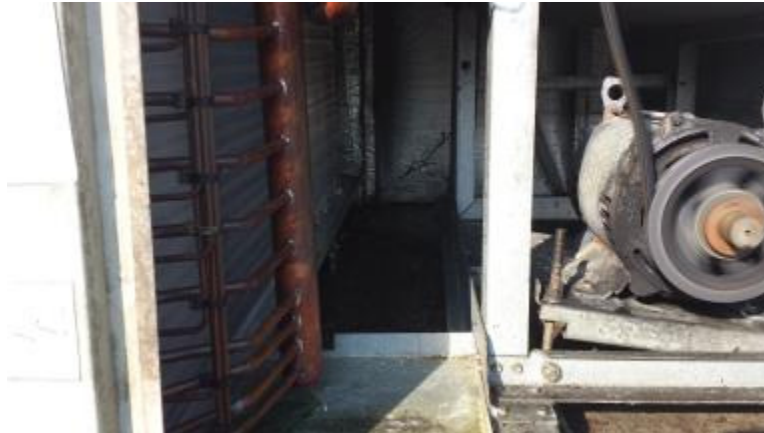
It appears the inside of the rooftop units have never been cleaned. There is visible microbial growth on the air handler and rust. The units are poorly insulated. Condensation is occurring which has allowed microbial growth to happen.

This is the interior condition of a rooftop unit.

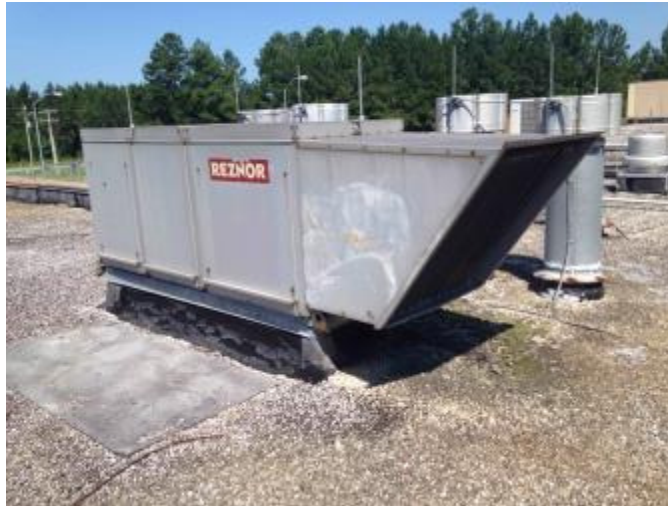
The unit is 21 years old and is rusting on the exterior. The existing roof curb is rotting. The total CFM for MAU-1 is scheduled as 3,600 CFM. At this time 2 UniMac commercial dryers are installed in the laundry room and rough-in connections exist for up to 2 more dryers. The existing makeup air unit is appropriately sized for up to 4 UniMac 55 pound clothes dryers exhausting 700 CFM apiece.

MAU-1 has rust on the exterior of the unit.

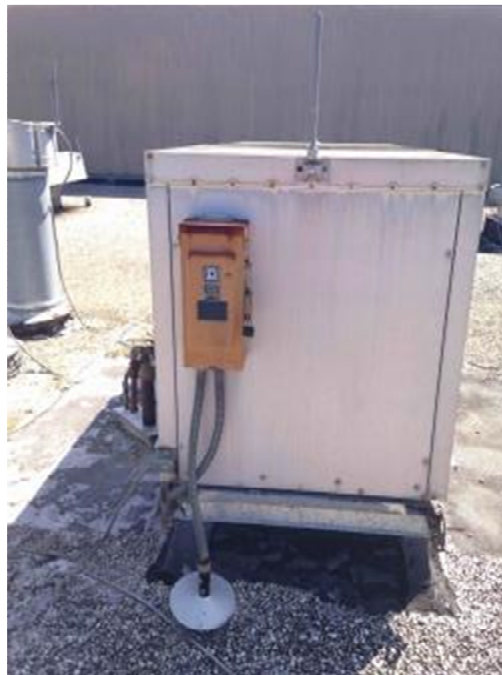
A rusted electrical disconnect is attached to the unit. Conduit has been routed through lifting lugs, which is an incorrect installation.

The corroded disconnect is attached to the makeup air unit.

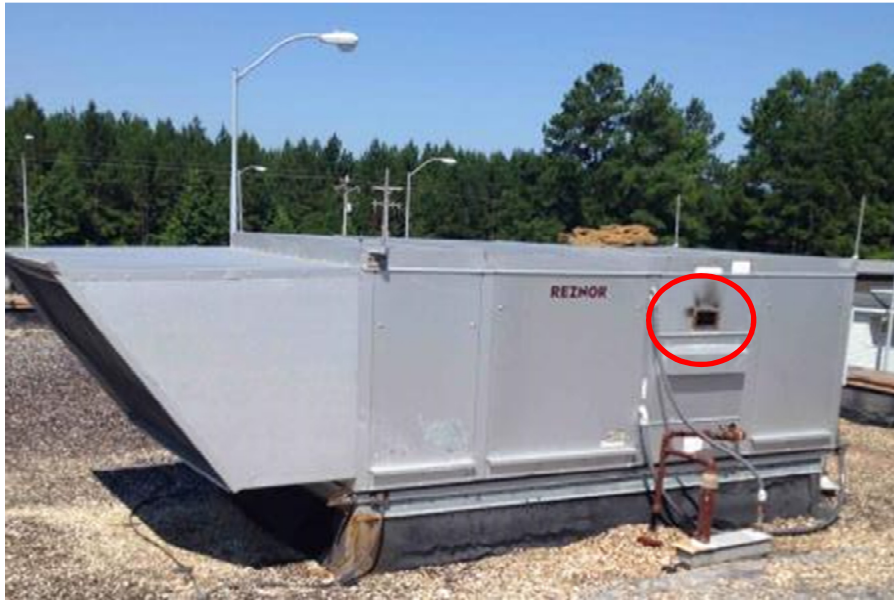
The roof curb is sized appropriately for the unit, but is rusted. The gas piping penetration is not protected by a pitch pocket. The gas vent to MAU-2 is very sooty which indicates combustion issues.

The gas vent to MAU-2 has visible soot.

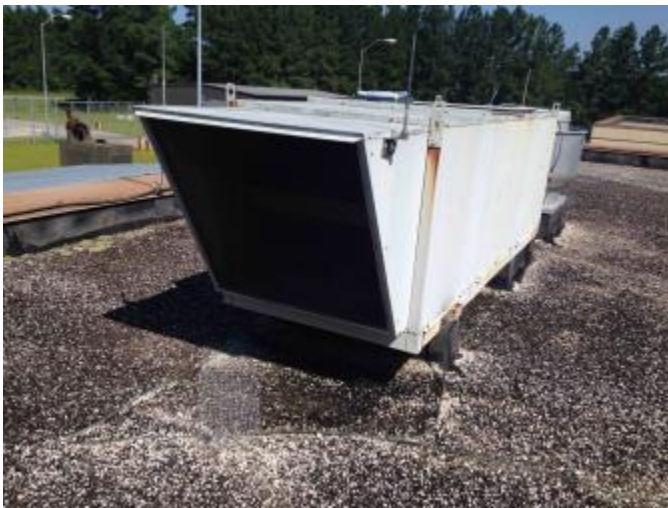
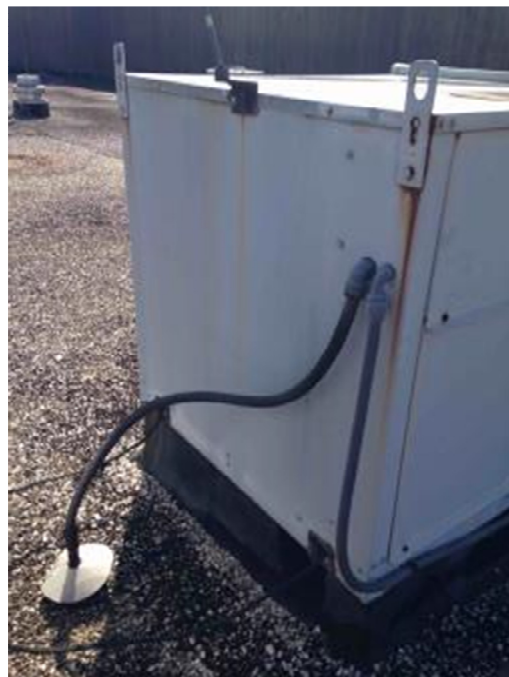
The unit is 21 years old and is rusting on the exterior. The total CFM for MAU-3 is scheduled as 5,670 CFM. The area of the hood is approximately 180 square feet. The exhaust fan used with the kitchen hood, EF-16, exhausts 8100 CFM. Additional air is pulled from MAU-2, which serves the kitchen.

MAU-3 has rust on the exterior of the unit.

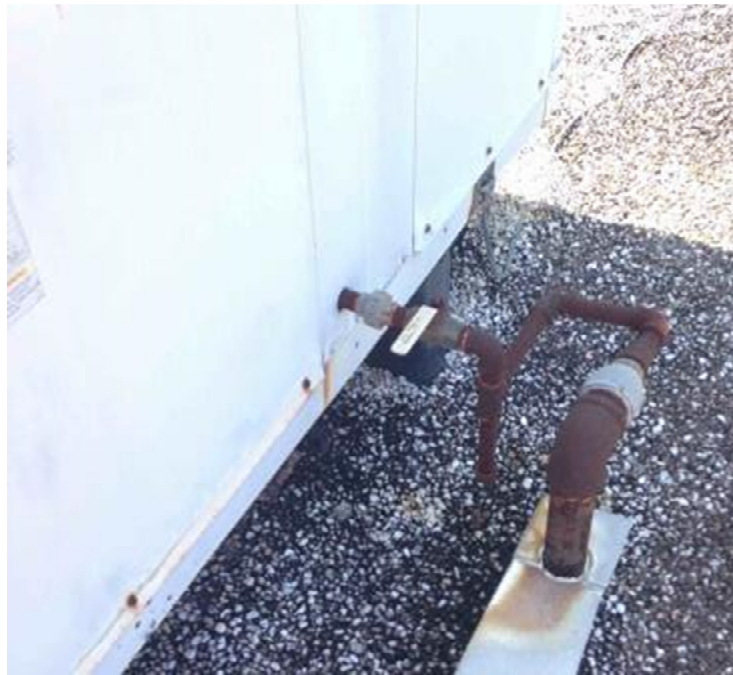
The gas piping penetration is not protected by a pitch pocket. The gas has been turned off to MAU-3.

The gas valve serving MAU-3 is in the off position.

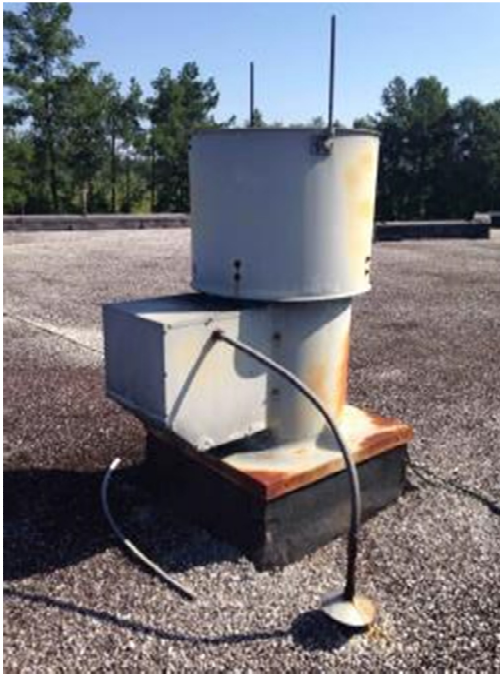
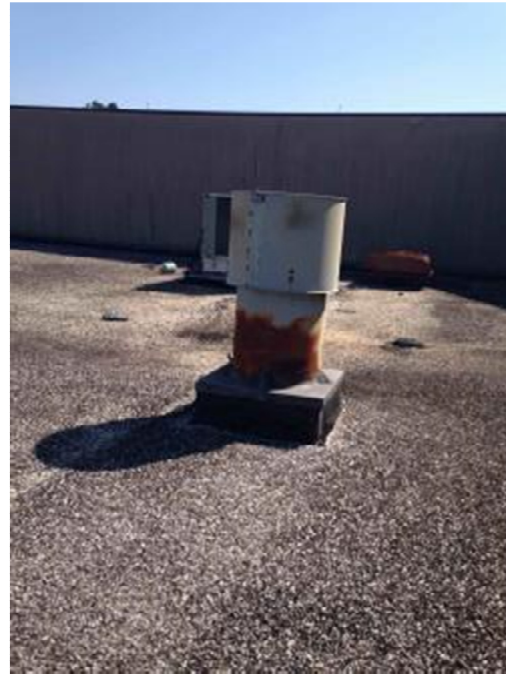
The roof mounted Greenheck exhaust fans are worn and corroded.

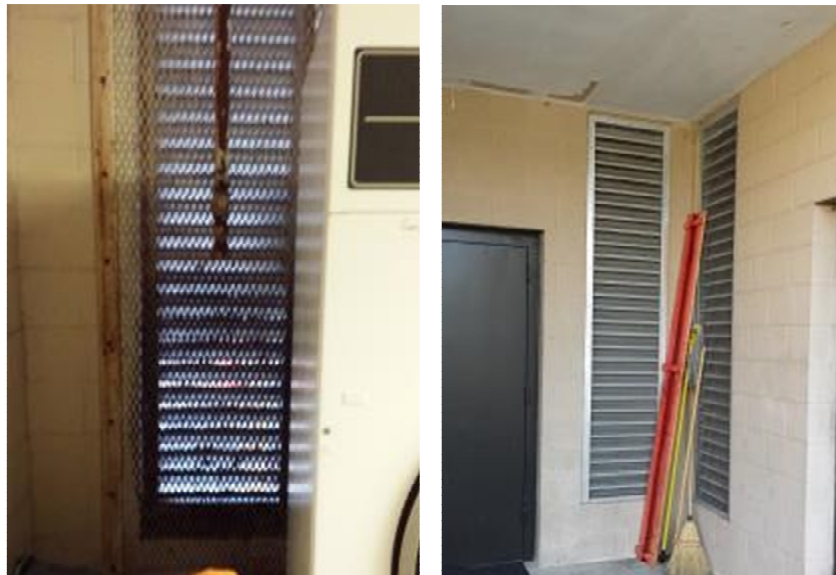
There are large, uninsulated, louvers in the housing blocks allowing uncontrolled infiltration. Unconditioned, humid air enters through the louvers frequently when the exhaust system is running. These large outdoor air louvers are used frequently to pull in raw outside air when the general exhaust system is operating to remove odors from the space.

There is uncontrolled infiltration through the louver in the laundry room.

- Provide a new HVAC system for the facility that properly introduces code required ventilation air.
- Replace the louvers that are allowing for uncontrolled infiltration.

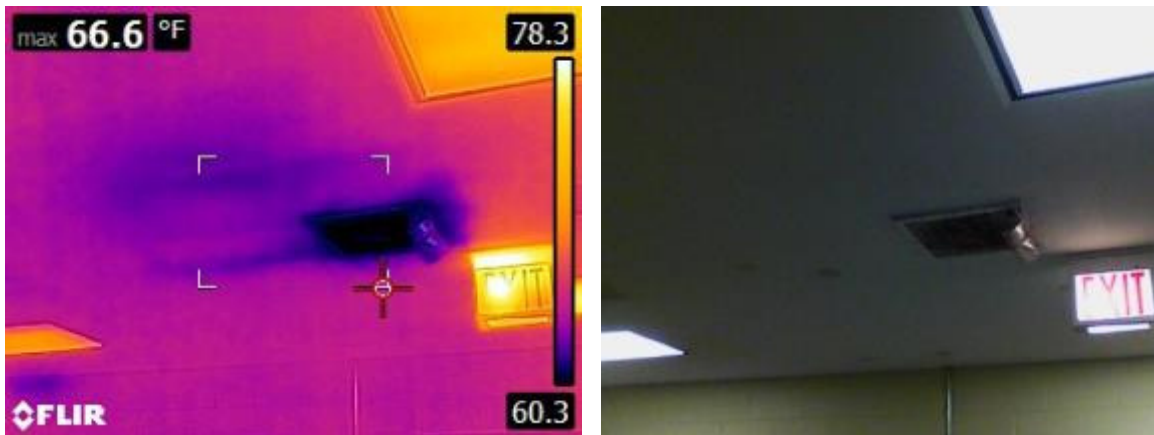
There is wet drywall (the shaded blue area) under the ductwork leading to the air device located in Intake 103 due to condensation on the ductwork above the ceiling.

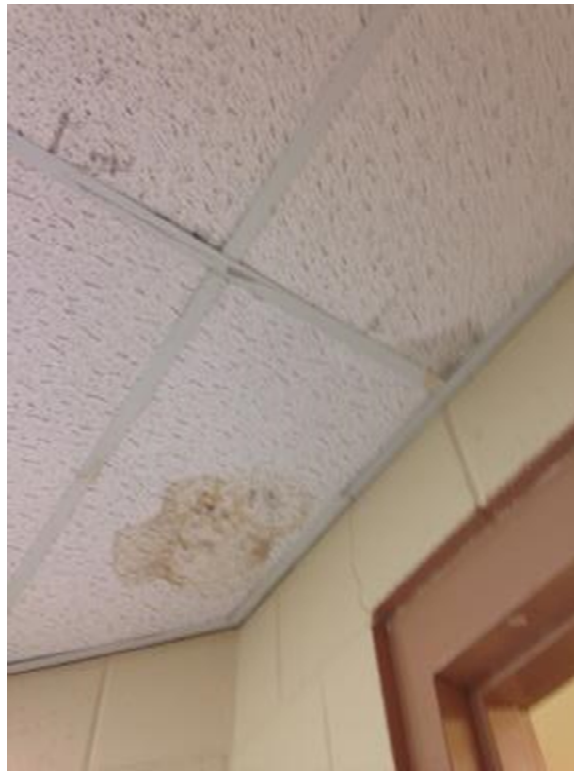
There is visible damage in the ceiling of Nurse 164.

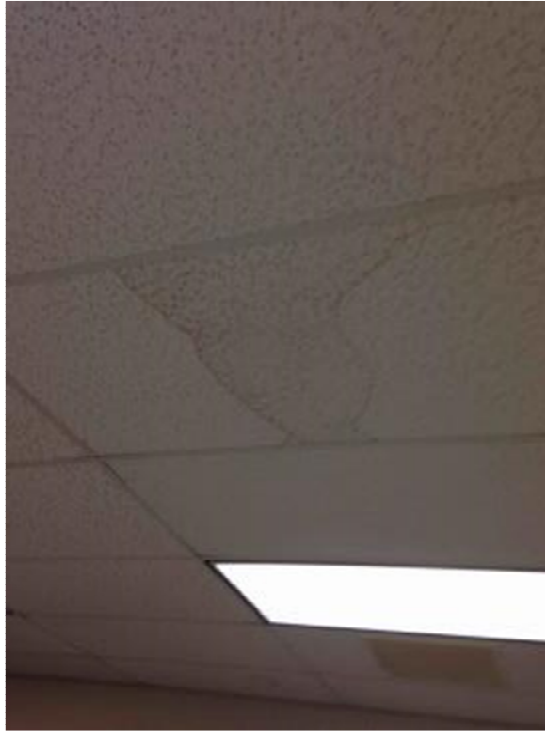
There is visible damage in the ceiling of Waiting/Visitor Area 201.

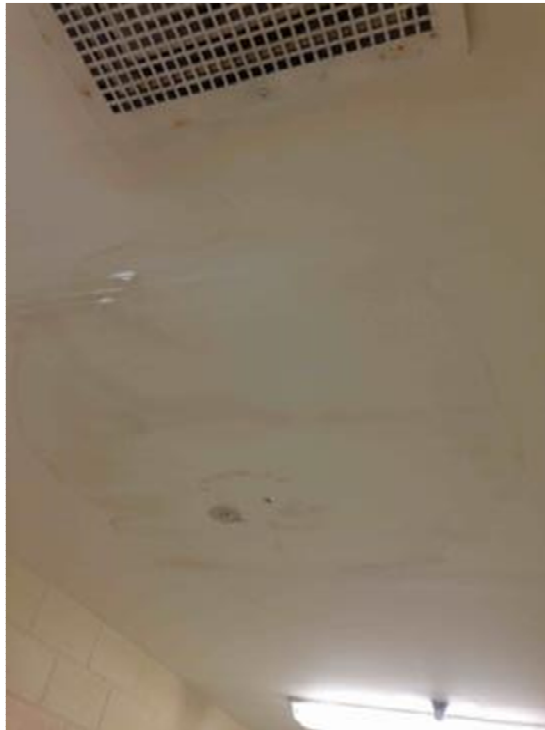
There is visible damage in the ceiling of Corridor 250.

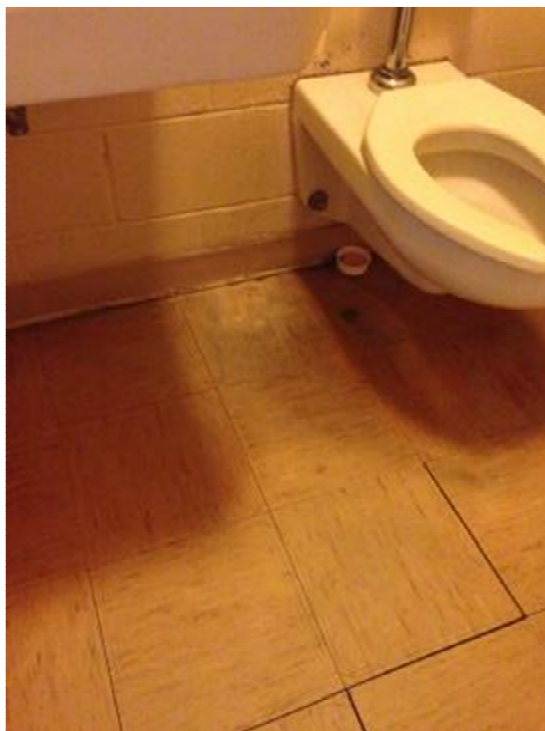
There is water damage to the floor below the water closet used by staff in Room 113 in the booking area.

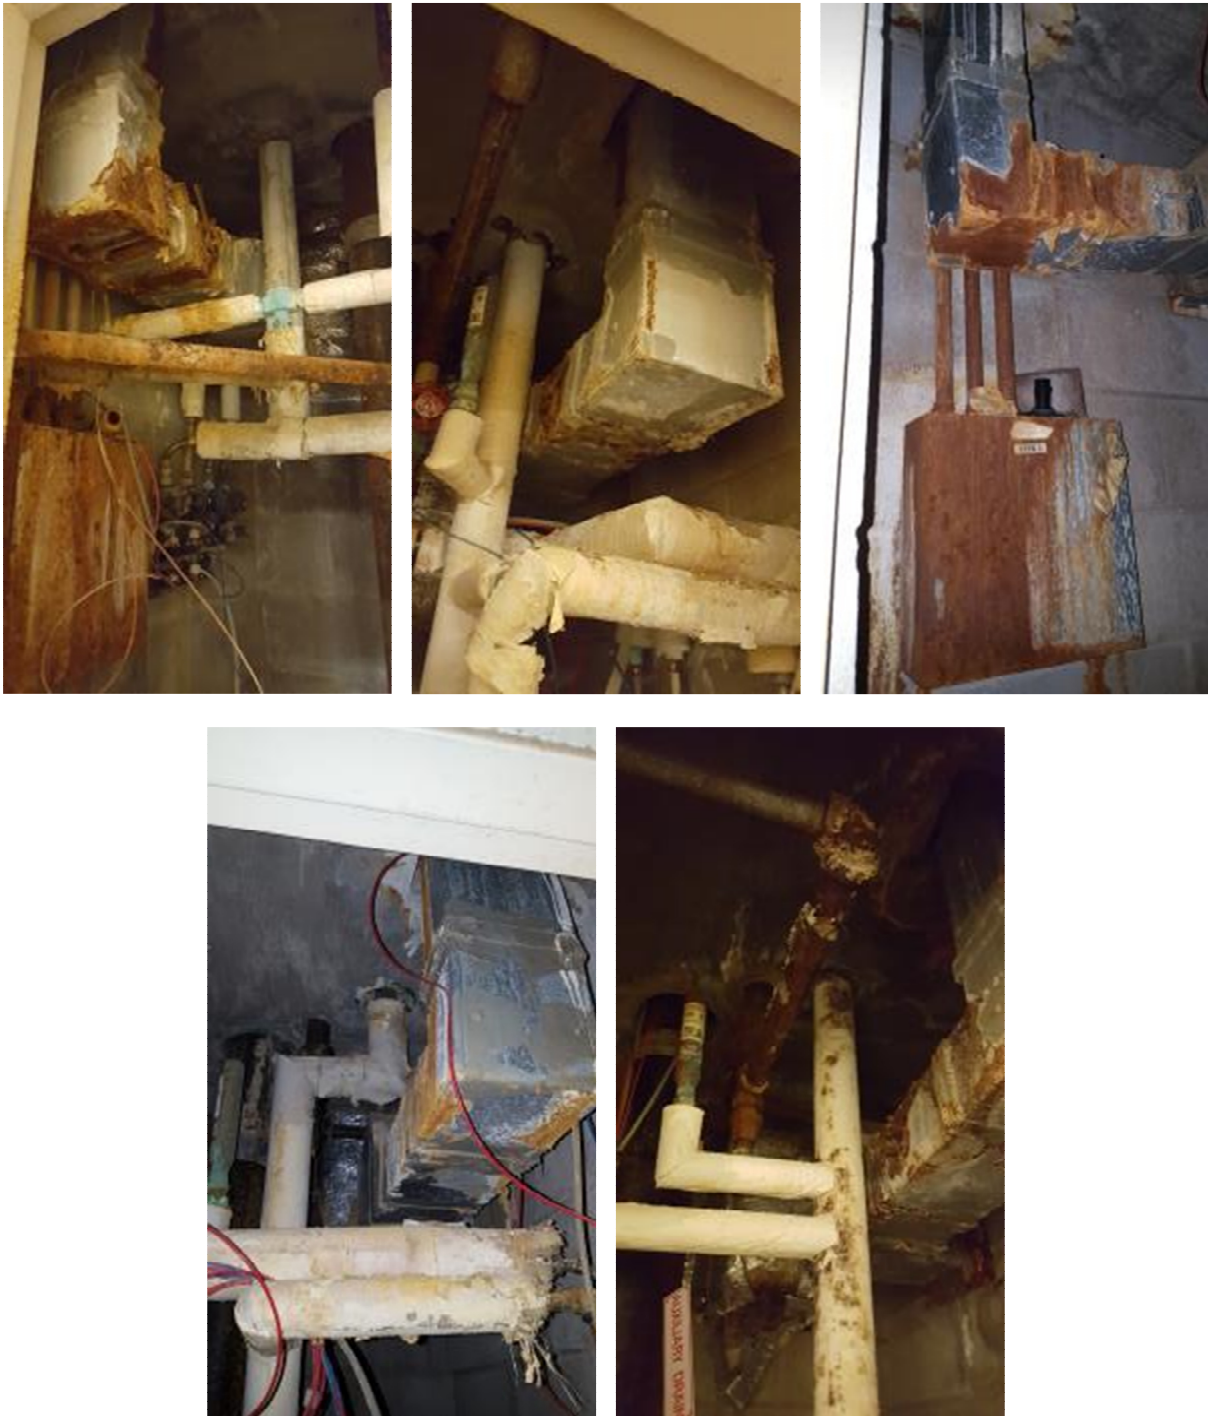
There is excessive corrosion on the ductwork in the housing unit chases.

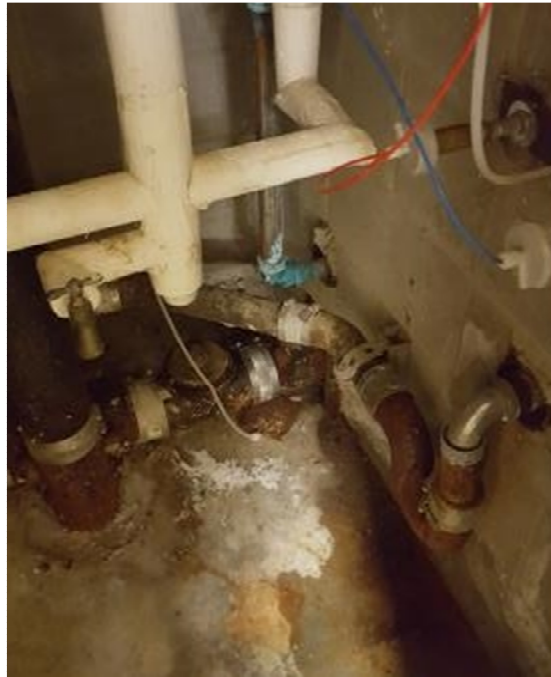
There is surface rust on cast iron piping in the housing unit chases.

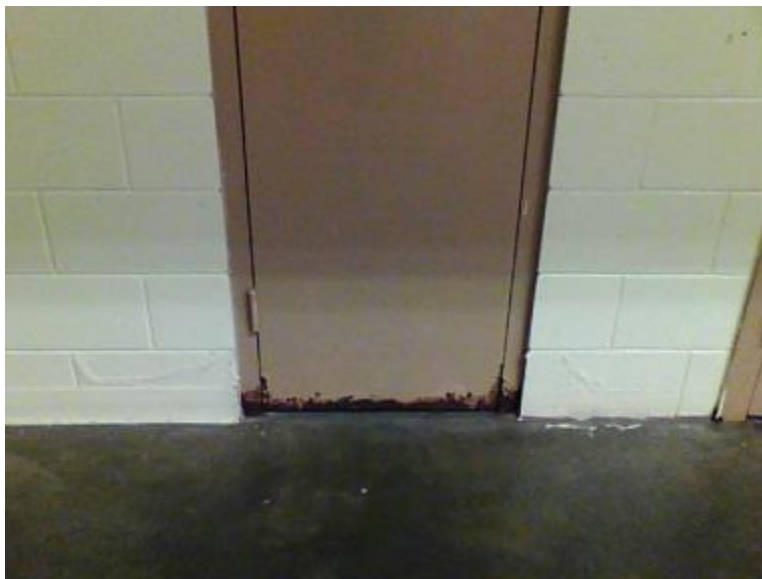
There is rust on the doors in the housing units.

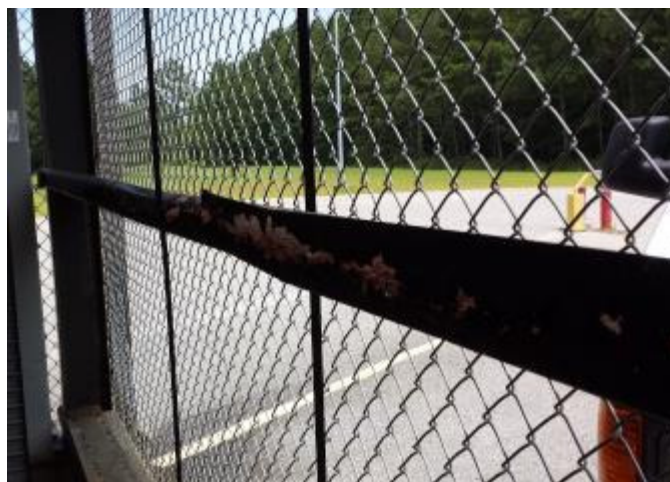
There is corrosion on the gates outside of the booking area.

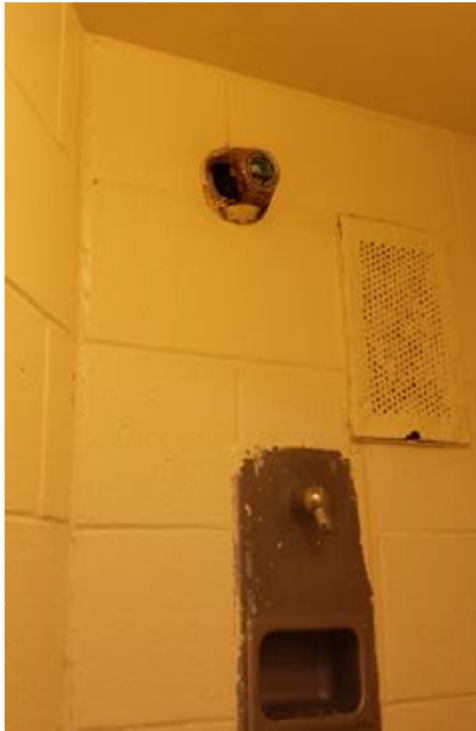
There is a corroded sprinkler head in the shower.

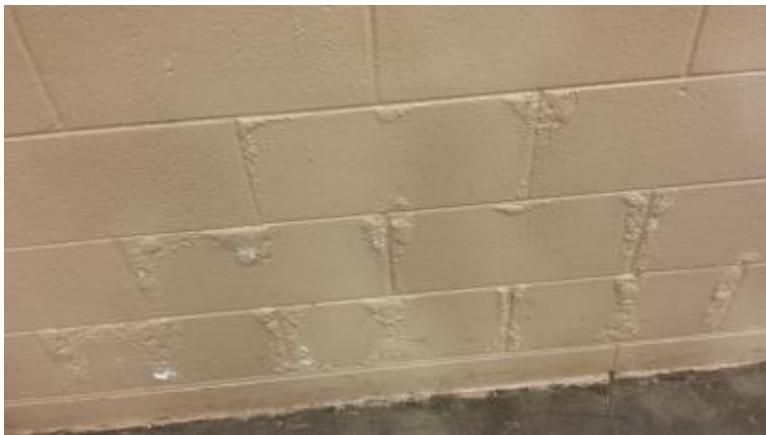
The paint is delaminating due to apparent migration moisture from the CMU block.

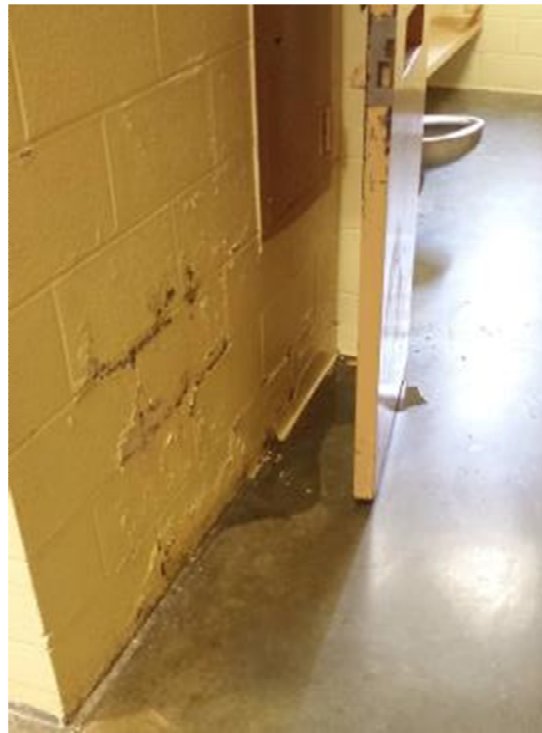
The paint is delaminating and there is standing water below.

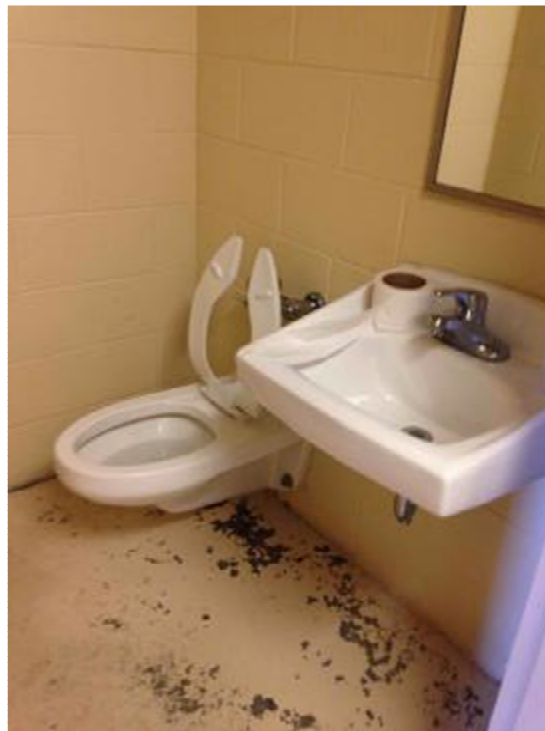
Several of the current restrooms do not meet ADA requirements – Rooms 106, 113, 172, and J101. ADA compliant grab bars, fixtures, fixture heights, pipe insulation, clearances, and faucets are required.

The staff toilet next to the juvenile holding room does not have ADA compliant fixtures or ADA compliant insulation on the piping below the lavatory.

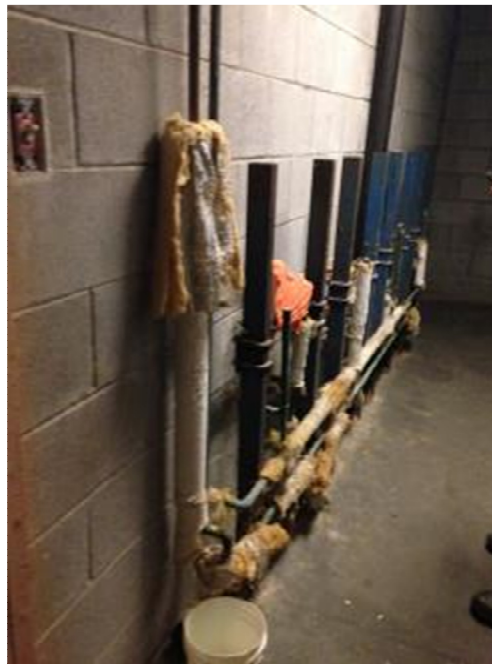
Piping insulation is in poor condition in plumbing chases. The existing insulation is torn and/or missing on piping. Additionally, there is a leak and a bucket has been placed below it as a temporary provision.

This is torn and damaged insulation on the piping serving the group restroom lavatories with a bucket placed below a leak.

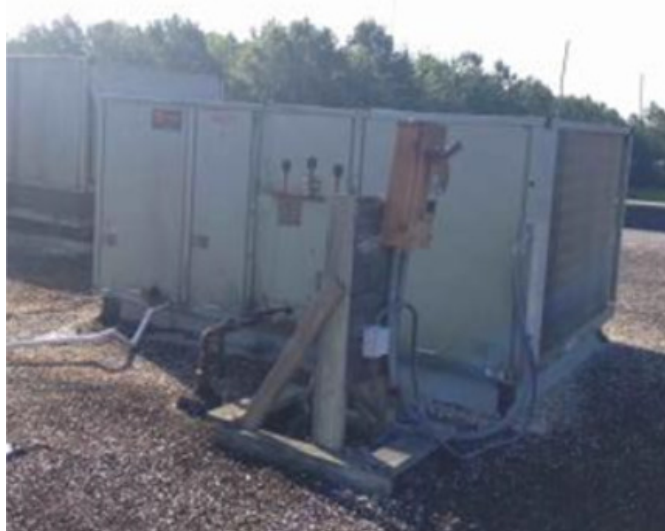
Rooftop equipment local safety switches have excessive rust damage and are mounted on wood stands. The support structures are not seismically anchored as a permanent structure to the building.

This rooftop unit has a rusted safety switch that is mounted on wood.

- Replace the safety switches and raceways for the mechanical equipment on the roof. There is a significant amount of rust corrosion and failing conduits and connectors that contribute to an unsafe work environment for maintenance.

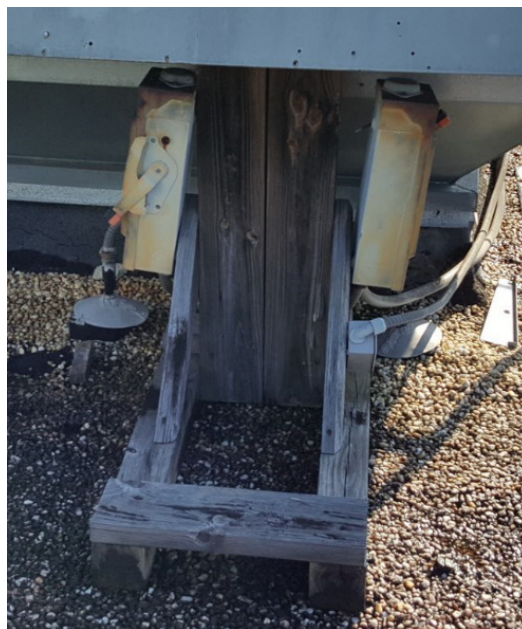
This rooftop unit supply fan safety switch is in the OFF position.

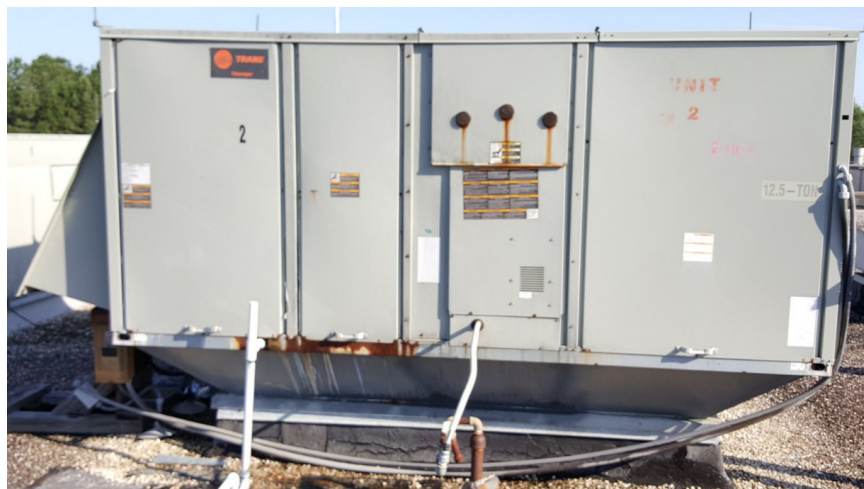
This flexible conduit is not supported from the rooftop unit to the safety switch. Condition is typical for all of the rooftop units.

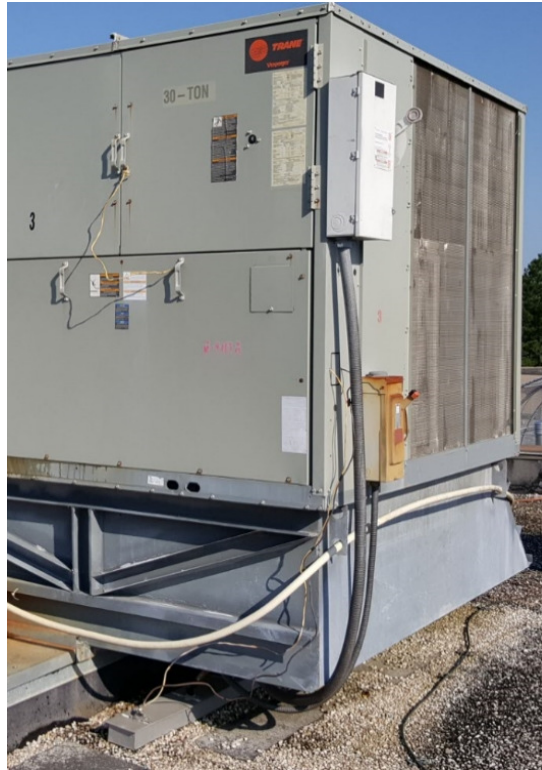
This safety switch handle is mounted at 84” above finished roof.

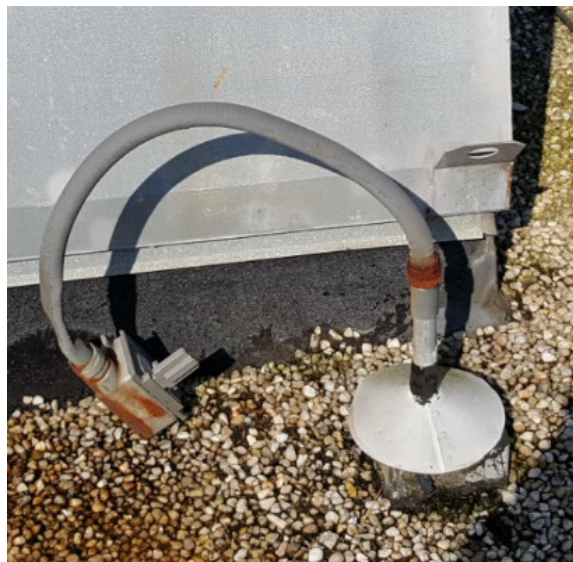
Code required mechanical equipment receptacles are in poor condition.

This receptacle is not properly supported, latch on weatherproof cover appears broken and electrical conduit is crushed.
