Contract #15-047, Detention Center Building Condition Assessment

Final Assessment

GEORGETOWN COUNTY DETENTION CENTER

EXECUTIVE SUMMARY

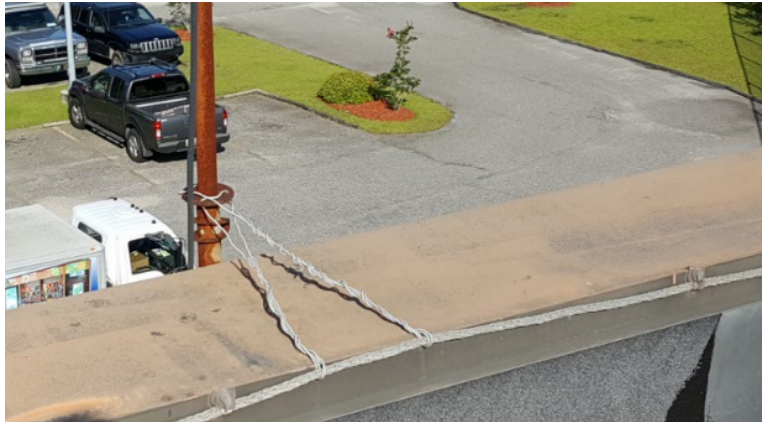
This is an improper connection to the lightning protection system or it is being used for support.

- Replace the lightning protection system. The current system does not appear to be functioning. Coastal South Carolina has a high density of lightning strikes per year. It is critical that this building not be crippled by such a strike.

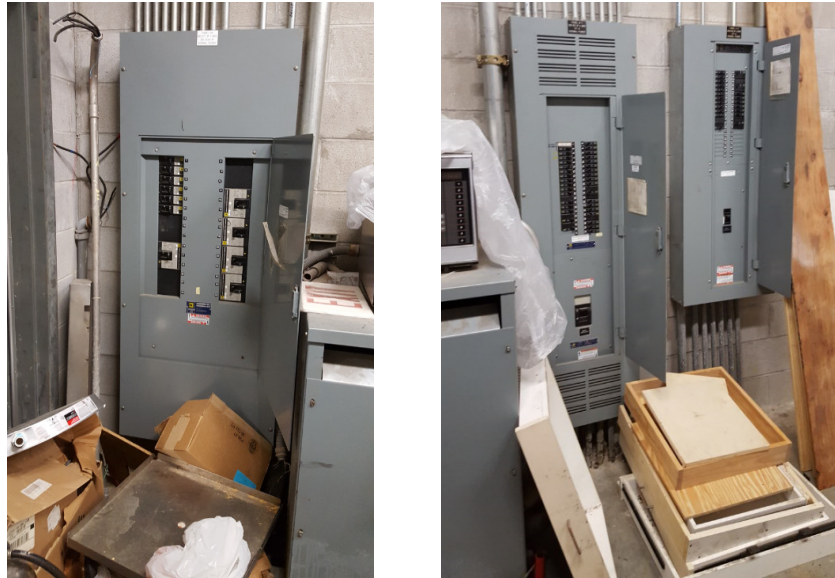
Main Electrical Room. Condition occurs in several of the other electrical rooms.

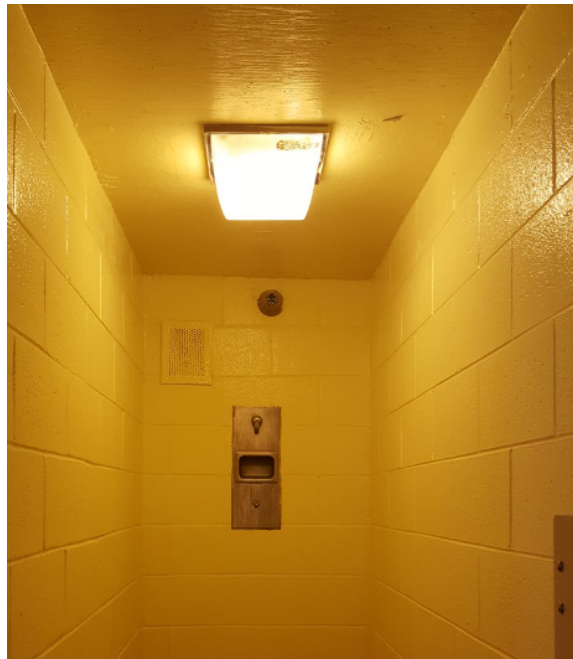
This is in A Block.

Light fixtures located within shower facilities show a significant amount of moisture damage.

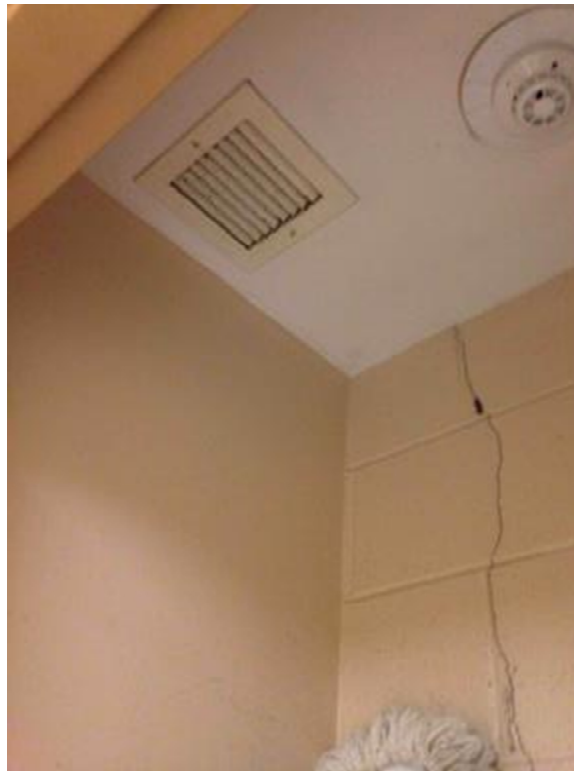
There is a crack in Janitor Room 233 in the administrative area.

While not part of the scope of the project, RMF noted many instances of visible cracks throughout the building. RMF recommends further investigation of these visible issues by a qualified structural engineer.

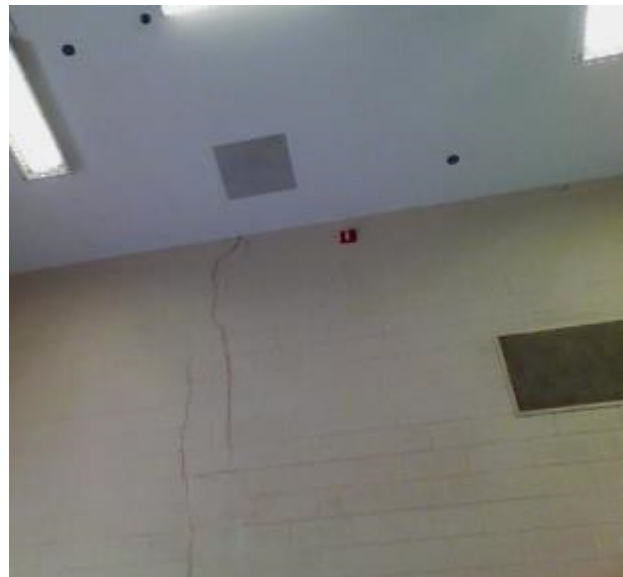
There is a crack in Multipurpose Room A100.

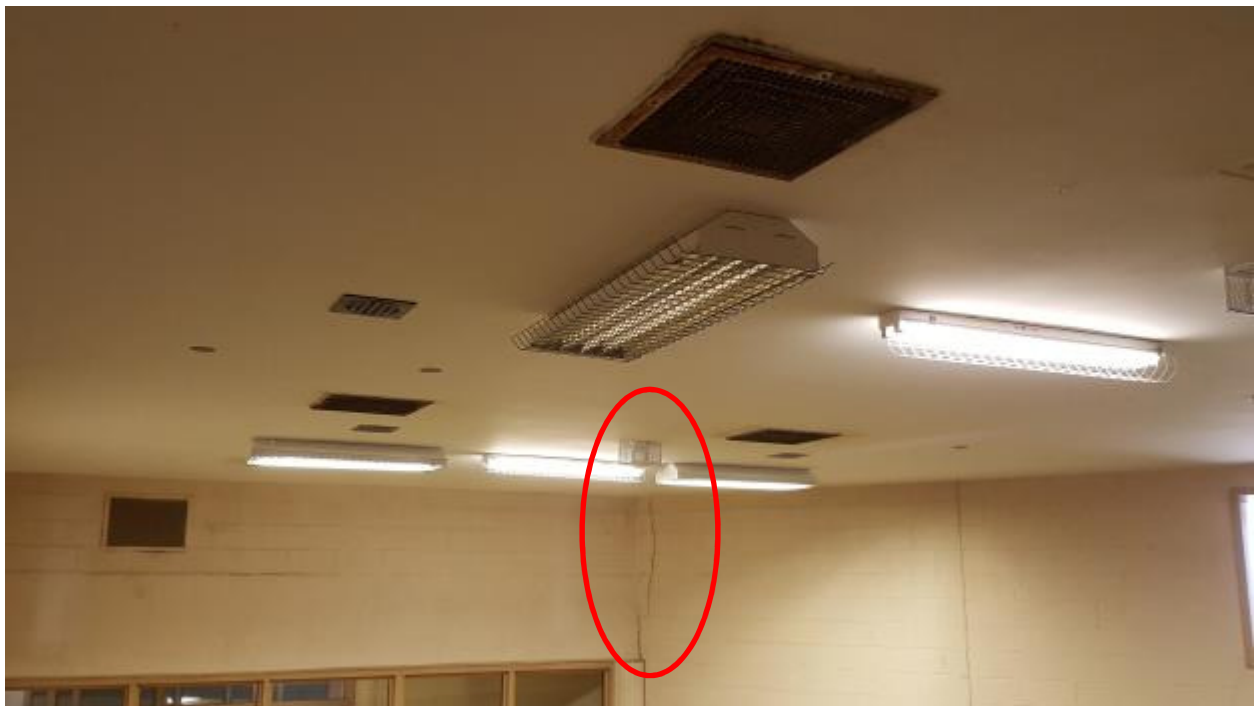
There is a crack in A-Block Female Presentenced Dayroom B100.

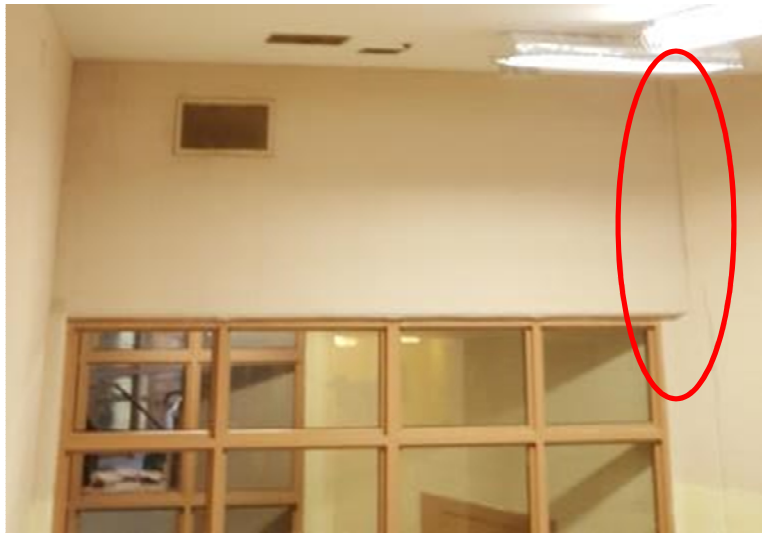
There is a crack in C-block Initial Housing Dayroom D100.

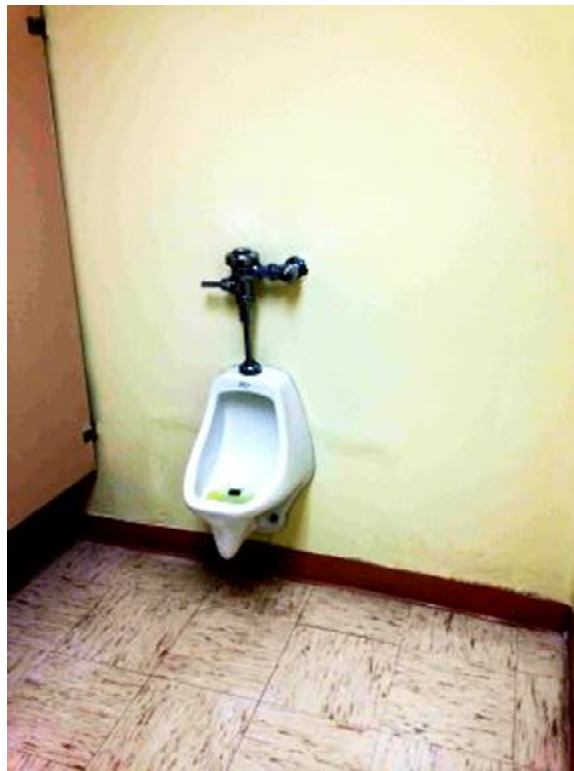
Walls have been partially repaired behind plumbing fixtures.

The wall behind the urinal in Men's Toilet 231 needs repair.

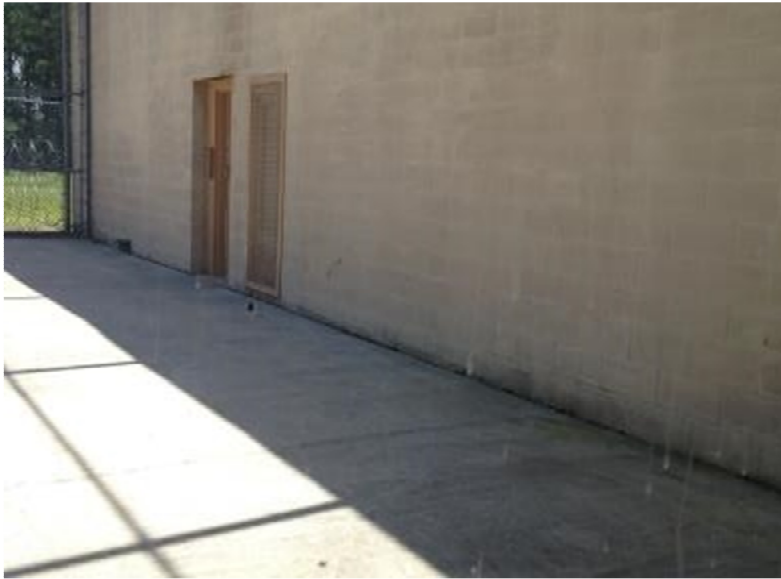
There is a gap forming between the concrete slab and wall.

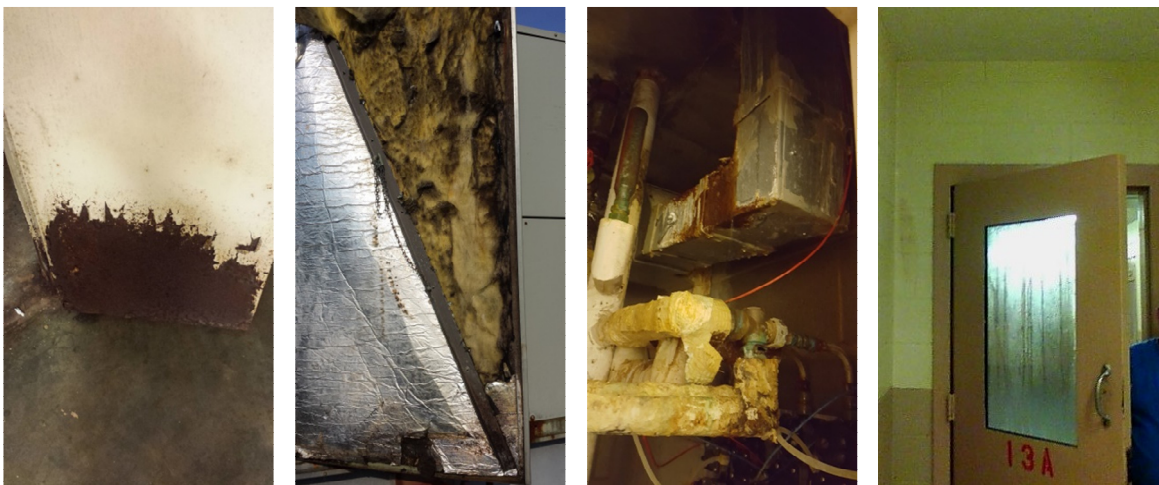
Above are primary examples of moisture concerns throughout the building.

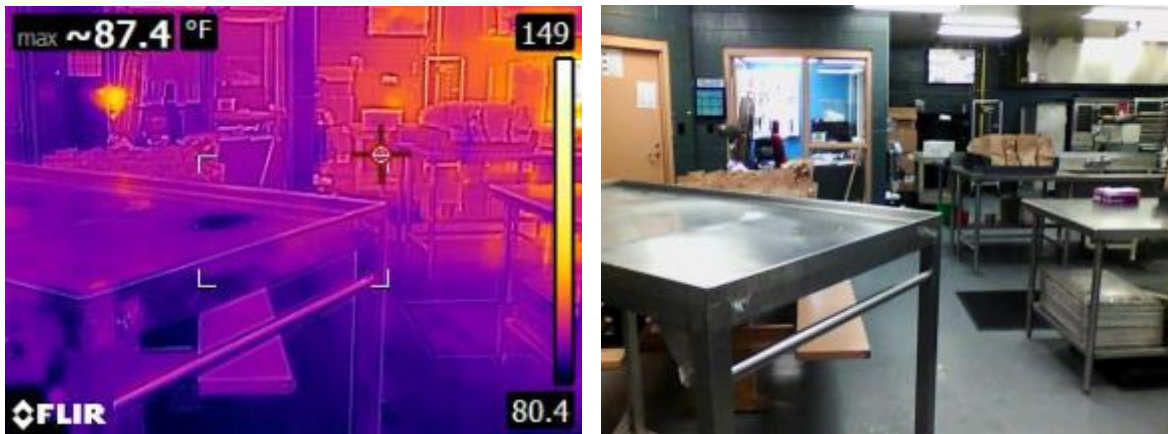
High temperatures exist in the uncooled kitchen.

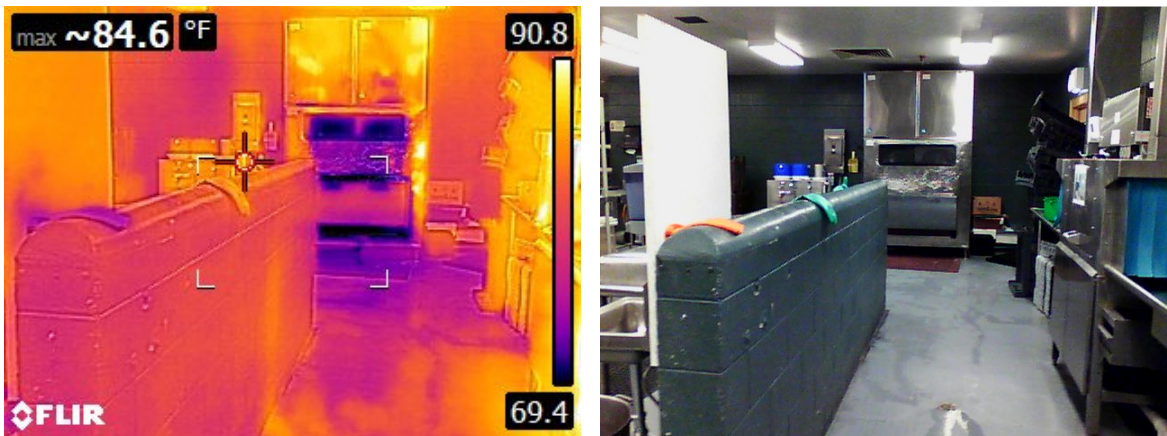
There is a drastic difference in temperature by the ice machine.

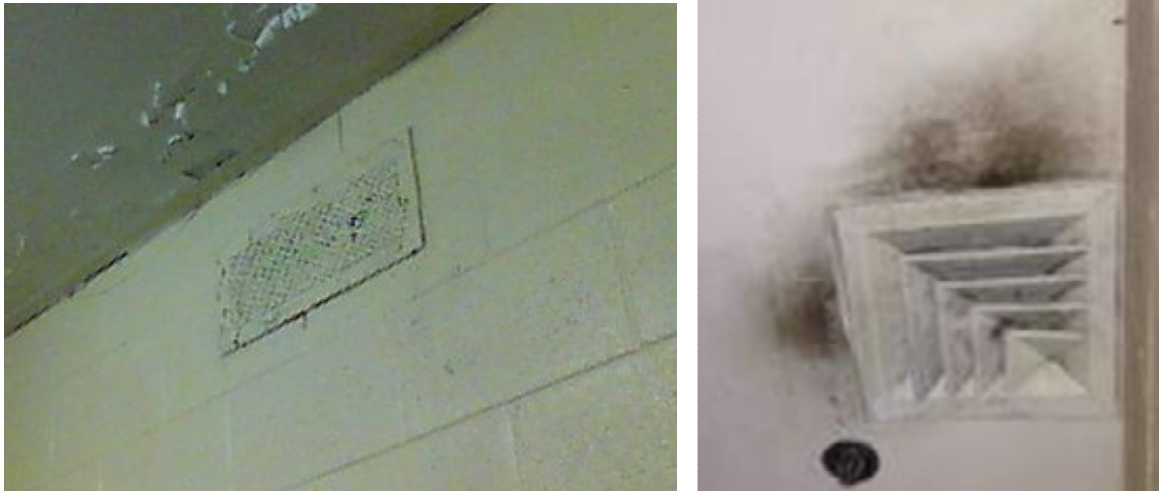
There are many instances of dirty and damaged air devices throughout the building.

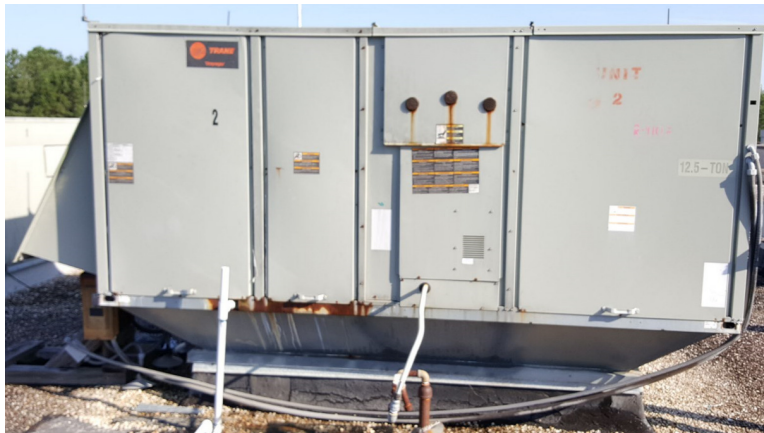
Electrical conduit not supported (RTU-5)

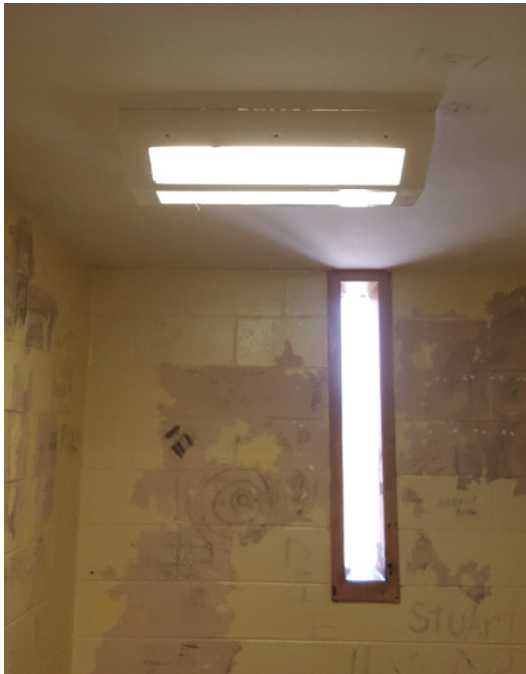
Light Fixtures in Cell Block D & H not flush with ceiling. Note gap where light is leaking out from behind the fixture.
