Asbestos & Lead Based Paint Assessment

City of Spartanburg
581 South Center Street
Spartanburg, South Carolina

Project Number: 0815-163

January 12, 2017

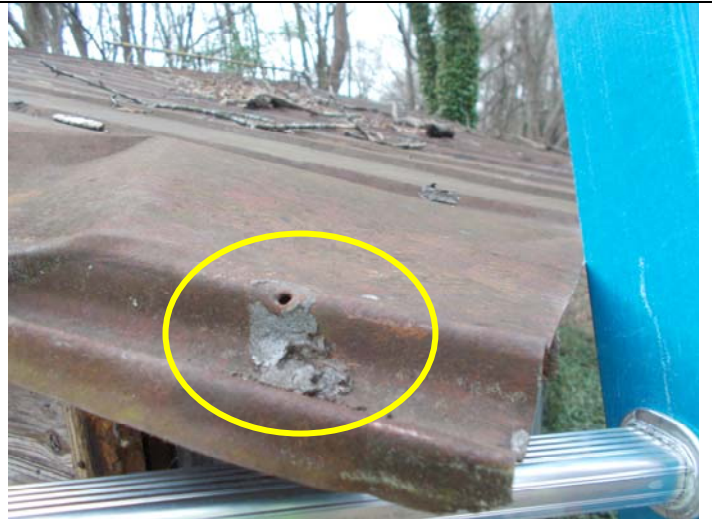
Photo 2 – Roof sealant on shed roof.

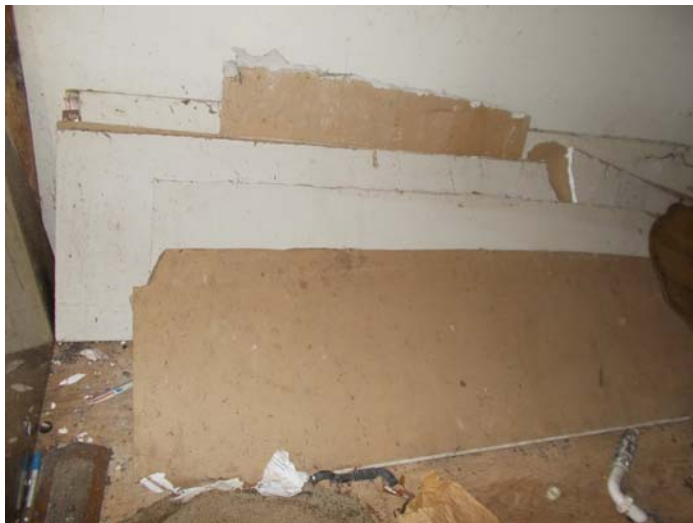
Photo 3 – Unfinished drywall inside the shed.

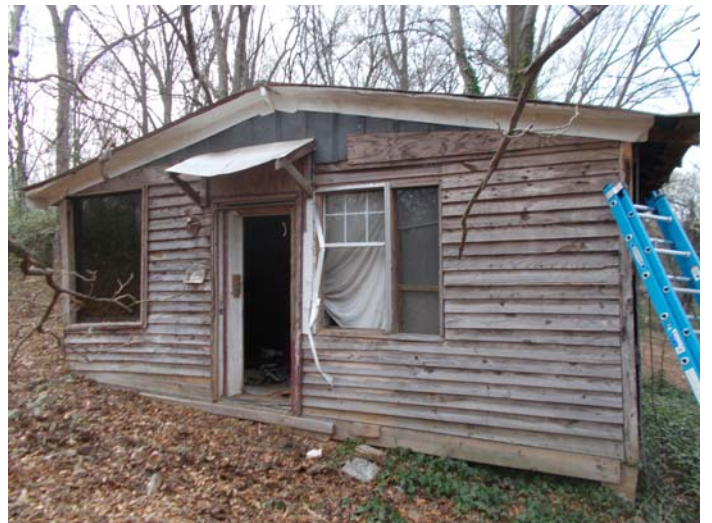
Photo 4 – Exterior rear shed.

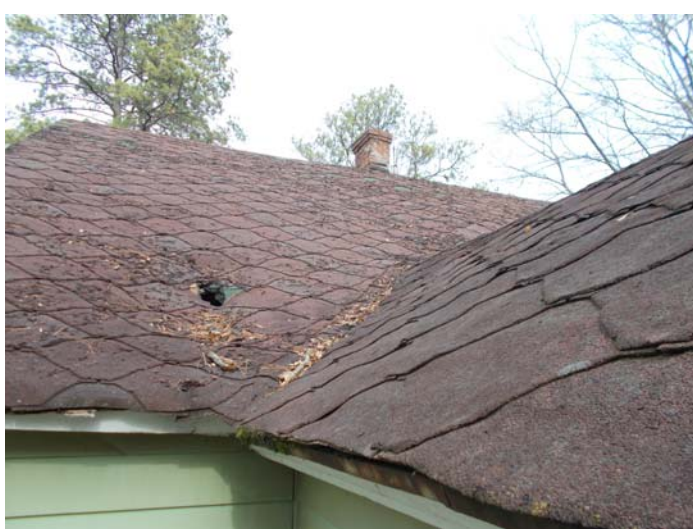
Photo 5 – Six layers of roof shingles and no felt (red diamond shaped shingles).

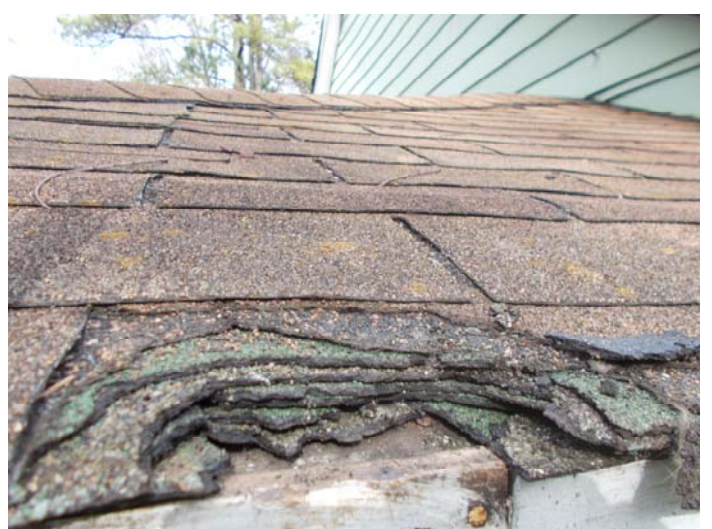
Photo 6 – Eight layers of roof shingles and no felt (brown rectangular shaped shingles).

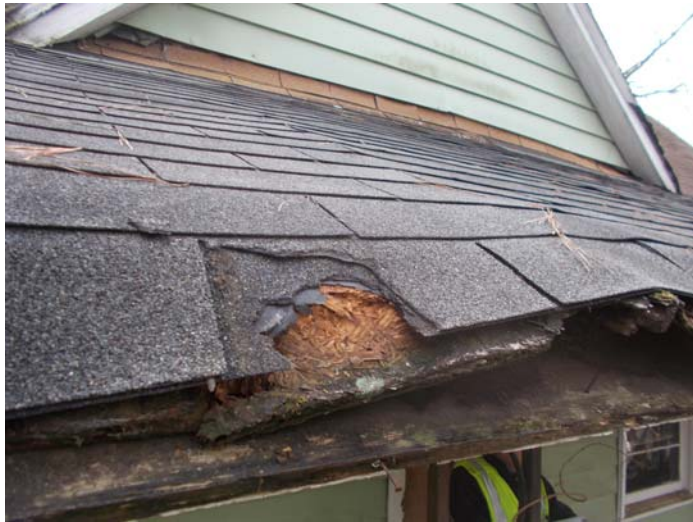
Photo 7 – Two layers of roof shingles and one layer of felt on front porch roof.

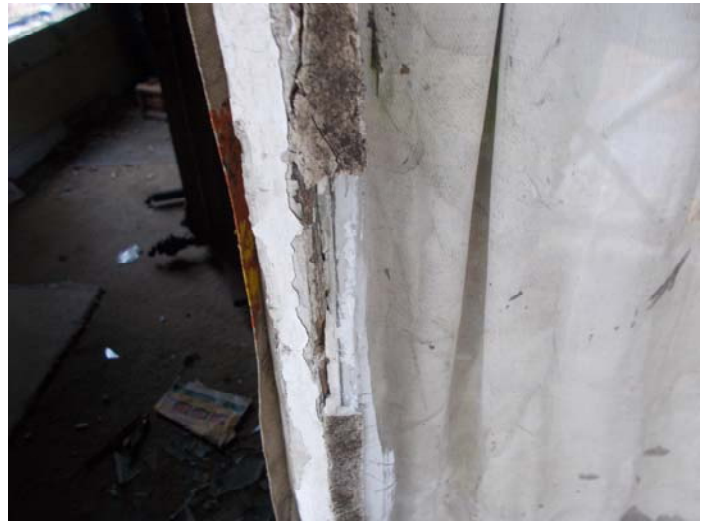
Photo 8 – Window glazing on wooden windows.

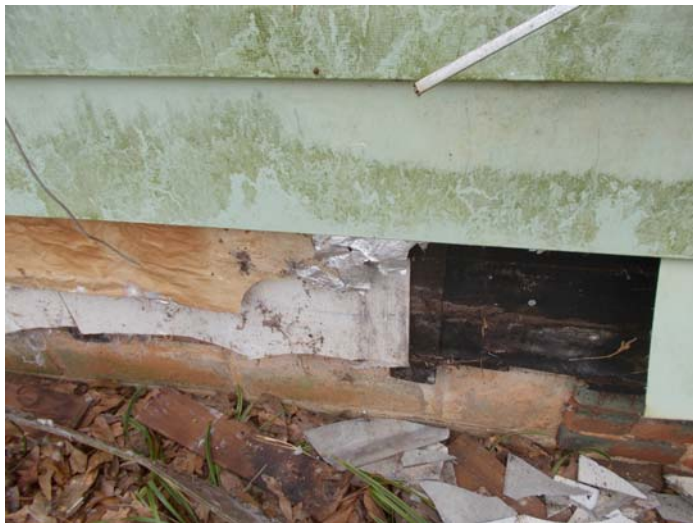
Photo 9 – Black felt paper beneath cement board siding. Brown siding paper under metal siding.

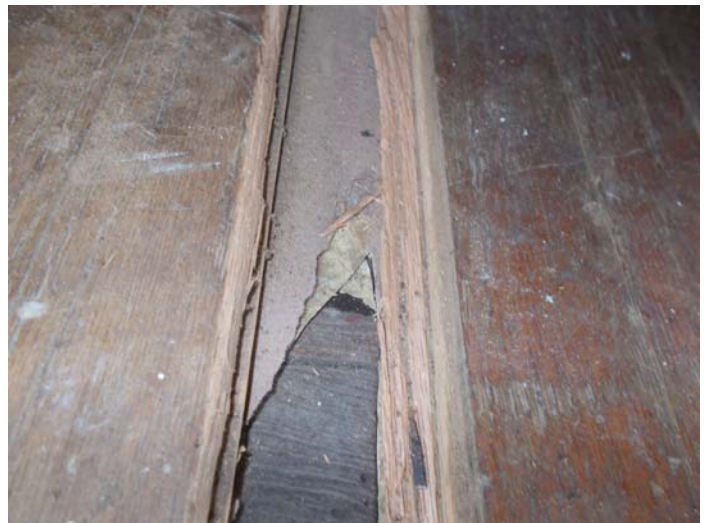
Photo 10 – Tan pattern vinyl flooring with brown paper and no mastic under wood in the living room.

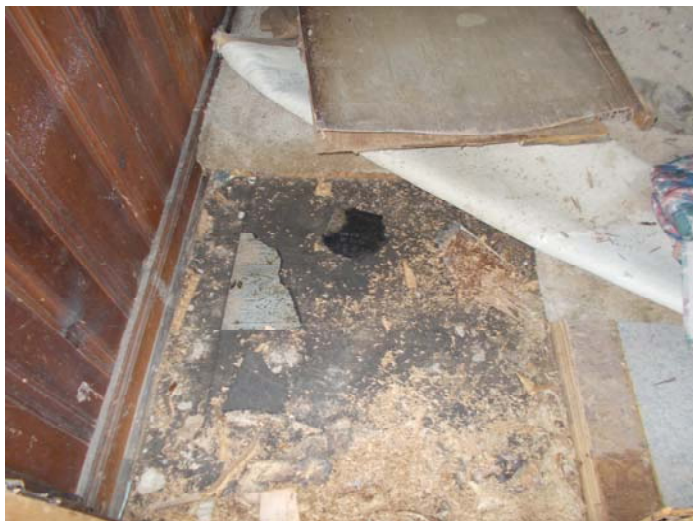
Photo 11 – Flooring felt in front right room.

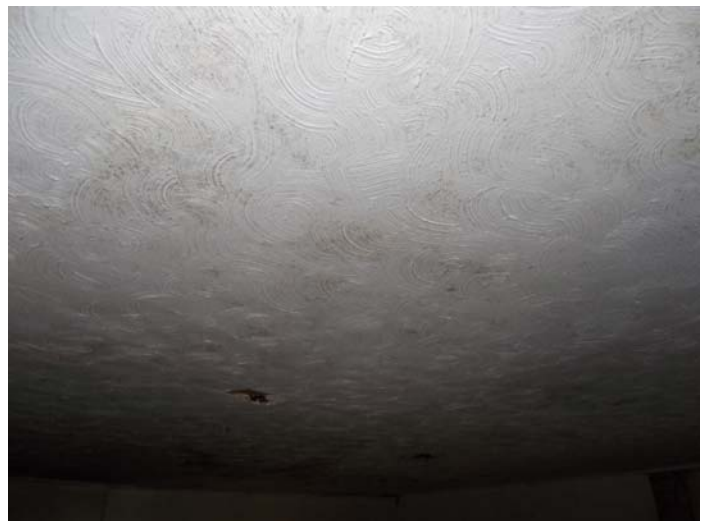
Photo 12 – Swirl ceiling texture on the living room ceiling.

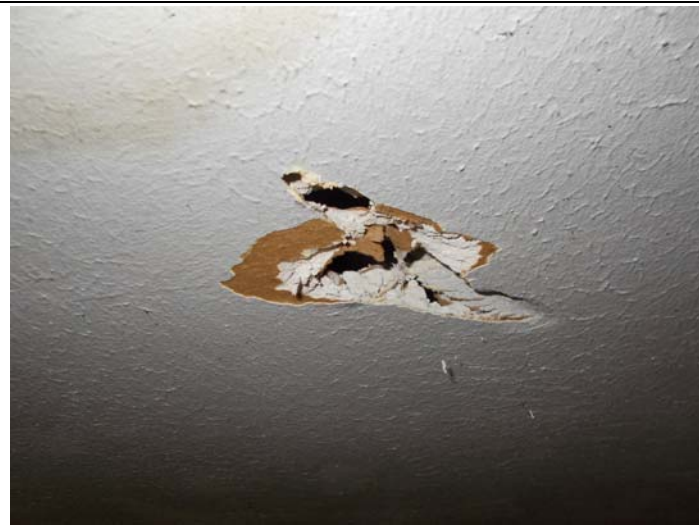
Photo 13 – Light ceiling texture in the front left bedroom and back left bedroom.

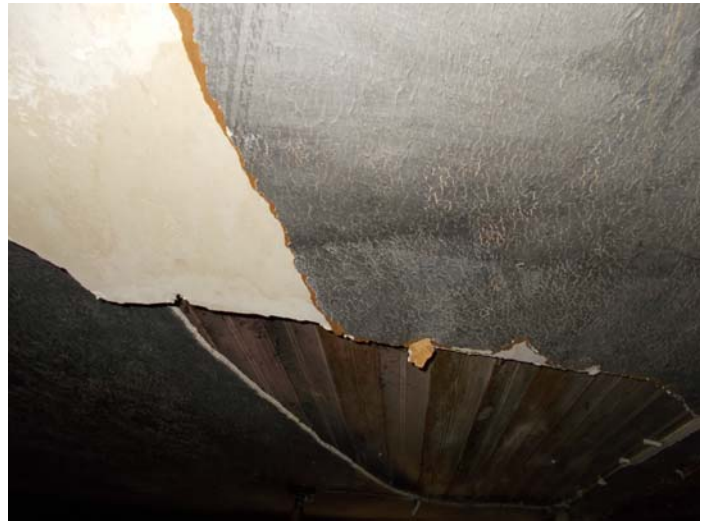
Photo 14 – Light ceiling texture in the back left bedroom.

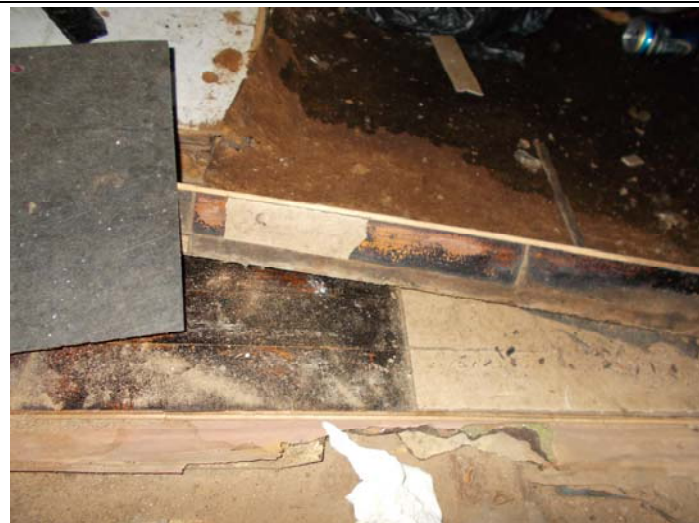
Photo 15 – Multiple layers of vinyl flooring with and without mastic in the large middle room in front of the kitchen.

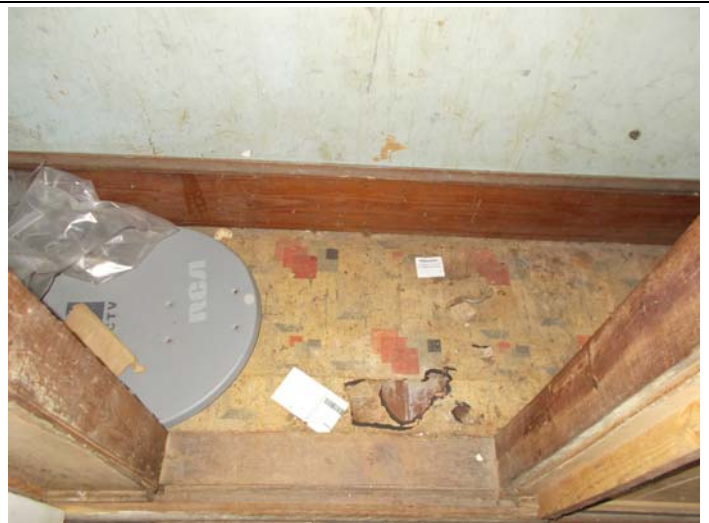
Photo 16 – Two layers of vinyl flooring with no mastic in the closet of the large middle room in front of the kitchen.

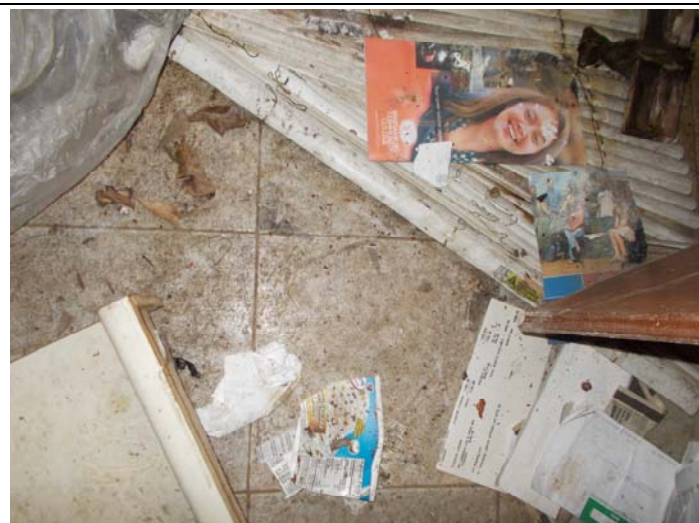
Photo 17 – Beige large square pattern vinyl flooring with no mastic in the kitchen.

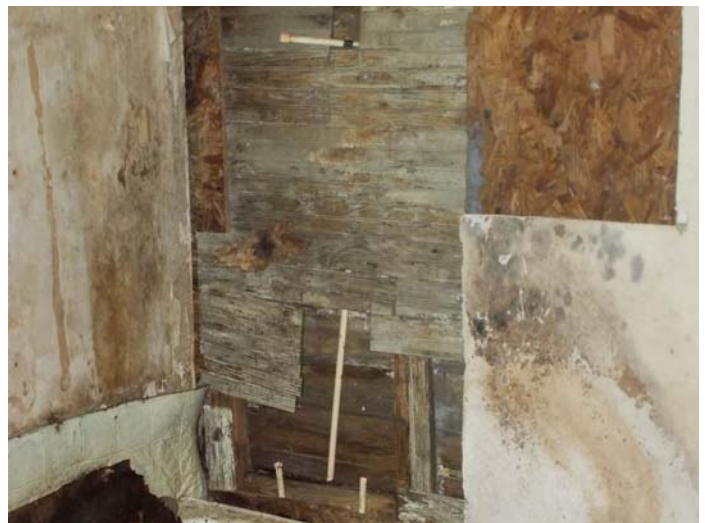
Photo 18 – Wall panel mastic in the bathroom.

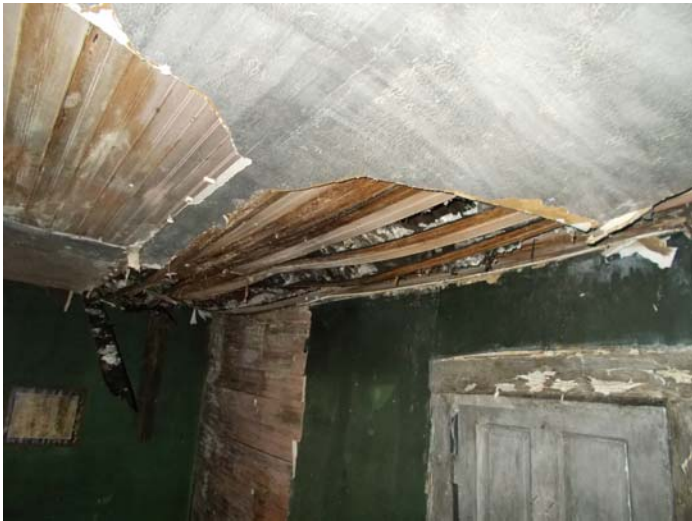
Photo 19 – Drywall, joint compound and tape throughout.

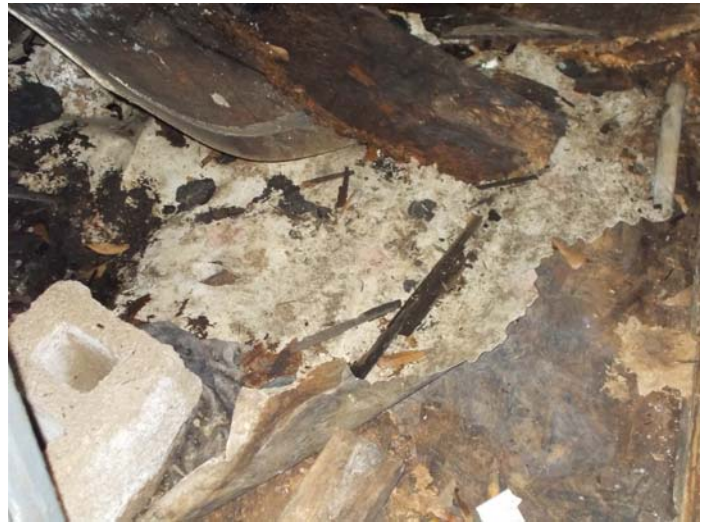
Photo 20 – Tan pattern vinyl flooring with mastic throughout bathroom.

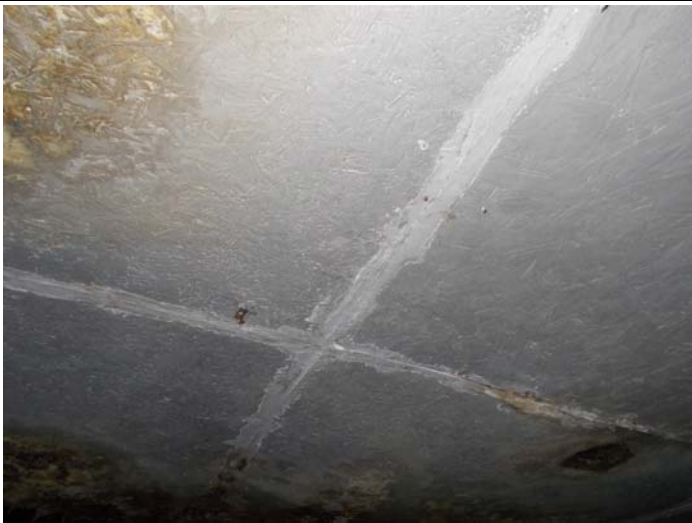
Photo 21 – Skim coating on seams of plywood ceiling in the large middle room in front of kitchen.

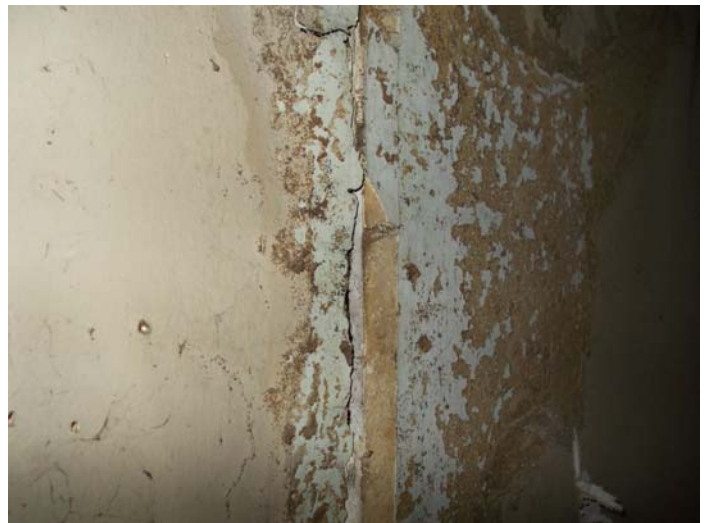
Photo 22 – Drywall, joint compound and tape throughout.
