Howland Company, LLC

Ref. No.: H211009-1500
October 29, 2021

**LIMITED ASBESTOS SAMPLING
2206 13TH STREET NE
CANTON, STARK COUNTY, OHIO 44705**

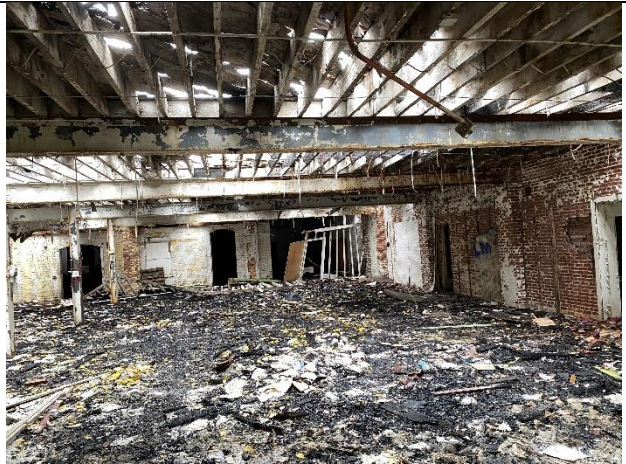
1st Floor Level – North East Section (Fire Damaged)

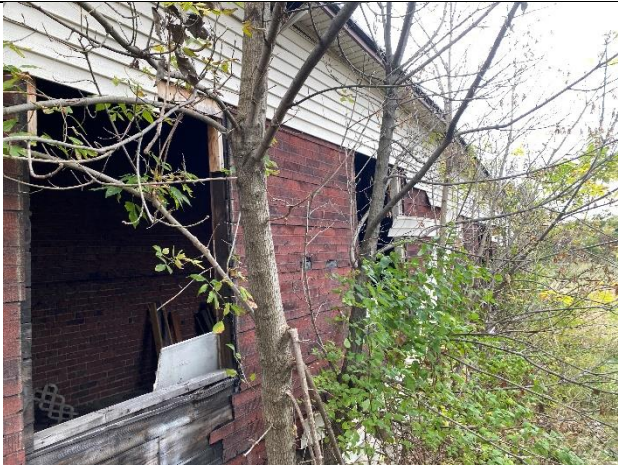
SE Section Exterior – Vinyl Siding over Asphalt Siding

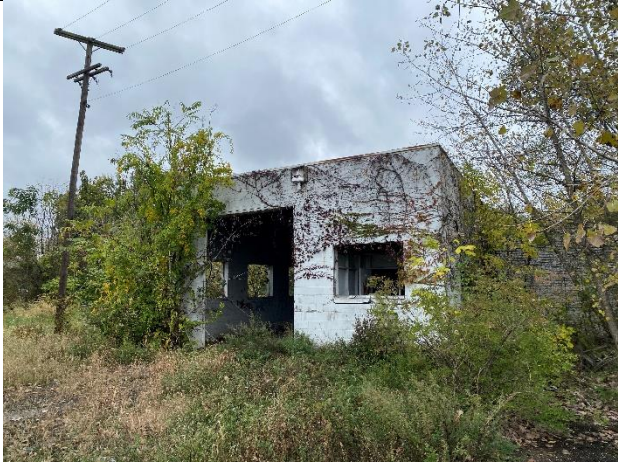
- **Miscellaneous material in the form of window glazing located on the exterior window of the former CMU car wash structure in the SE section of the facility (approximately 100-ft², Cat II, Non-friable, good);**

Former Car Wash Building (SE Section of Facility)

Category II Non-Friable ACMs are required to be removed prior to the on-set of demolition, if they can be safely removed without subjecting the workers to unsafe work conditions. Category II non-friable ACMs are required to be disposed of at a licensed asbestos landfill permitted to accept friable ACMs.

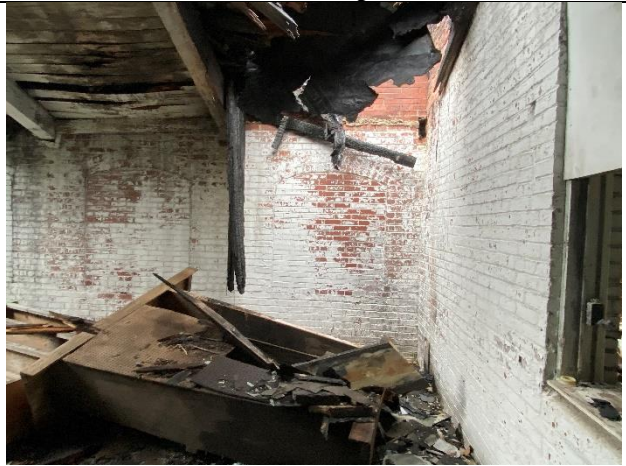
South Bay of Facility – Damaged Roof

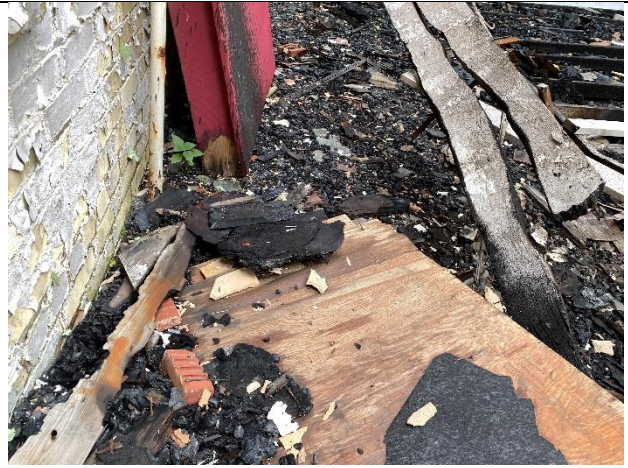
Fire Damaged Roof – NE Section of Facility

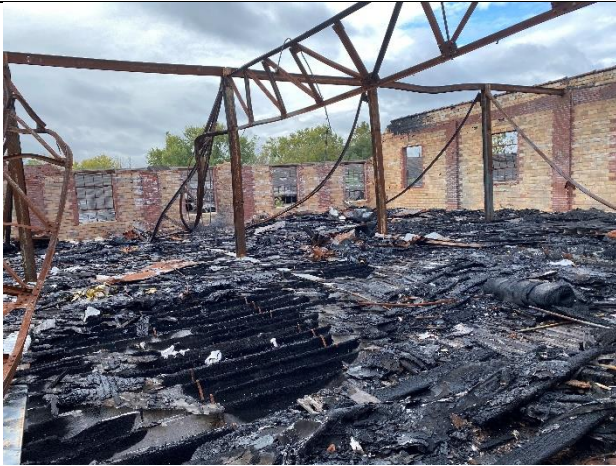
Fire Damaged 2nd Floor – NE Section

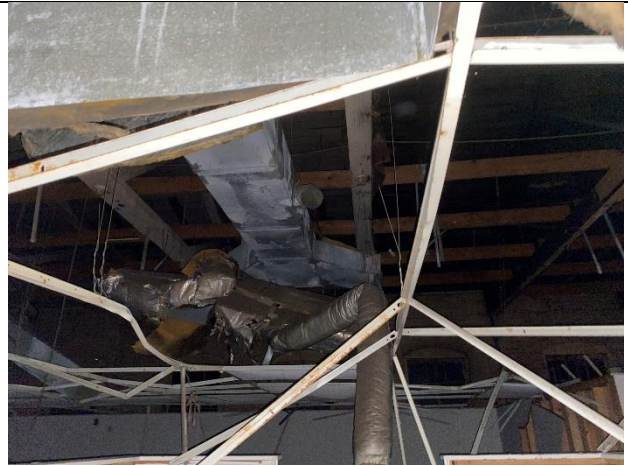
HVAC (Fiberglass) – North Office Section

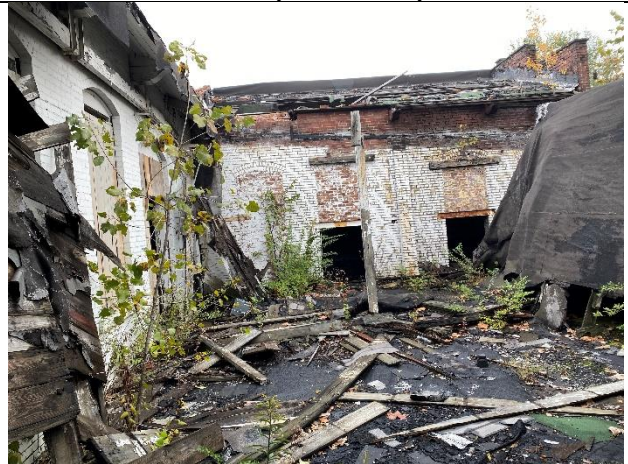
Fire Damaged South Section of the Facility

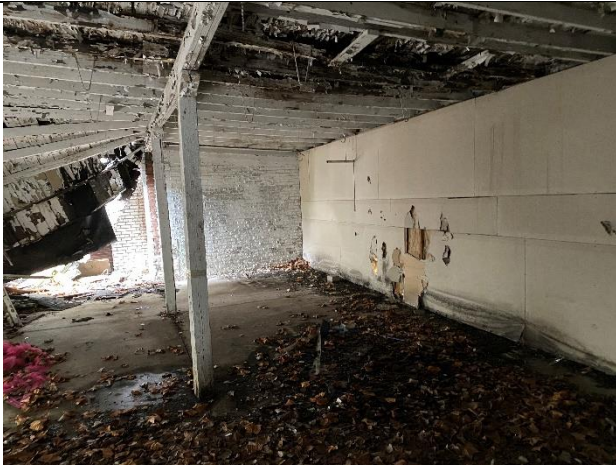
South Storage Section (Drywall Section Remains)

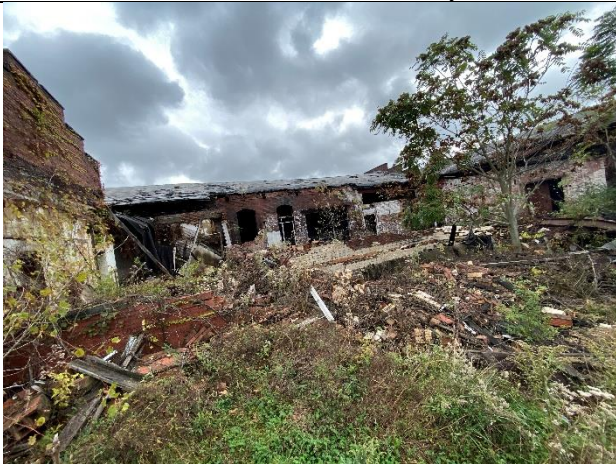
- **The western portion of the facility had an approximate 2,000-ft² fire damaged section of building that was burned down to the basement/pits. Due to the extent of the damage, the materials in this area could not be properly assessed and therefore no samples were taken. All material from this section must be treated as RACM and disposed of at a properly licensed facility.**

- **RACM in the form of a fire damaged debris pile located on the west end of the facility (approximately 6,000-ft³, RACM, Friable);**
- **Surfacing material in the form of hard wall plaster located on the NW tower walls (All 3 Floors) (approximately 4,654-ft², RACM, Friable);**
- **Miscellaneous material in the form of roofing material located in the fire damaged NE section of the facility (approximately 16,311-ft², RACM, Friable, good); and**
- **Miscellaneous material in the form of roofing material located in the fire damaged south section of the facility (approximately 2,021-ft², RACM, Friable, good).**

West Fire Damaged Section of Facility

RACMs, Category I and Category II materials that has been rendered friable must be treated as a RACM, removed prior to demolition activities, and disposed of at a licensed asbestos landfill that is permitted to accept friable ACMs.

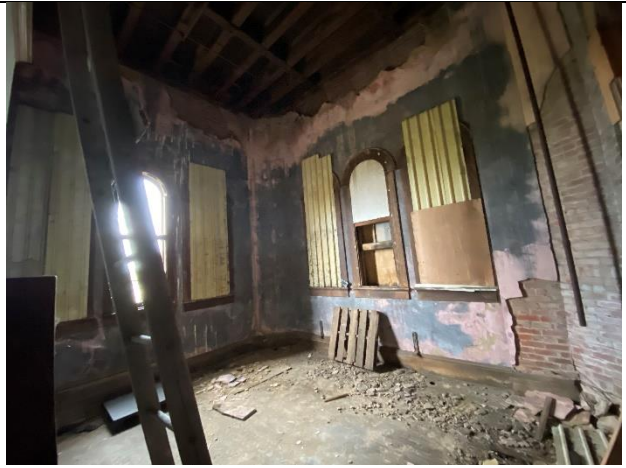
- **Sample 17-034 (Texture) yielded an asbestos content of 1.3% and was taken from the hard wall plaster located on the NW tower walls.**

Interior NW Tower View
