## Oconee County Board of Commissioners

### Addendum 3

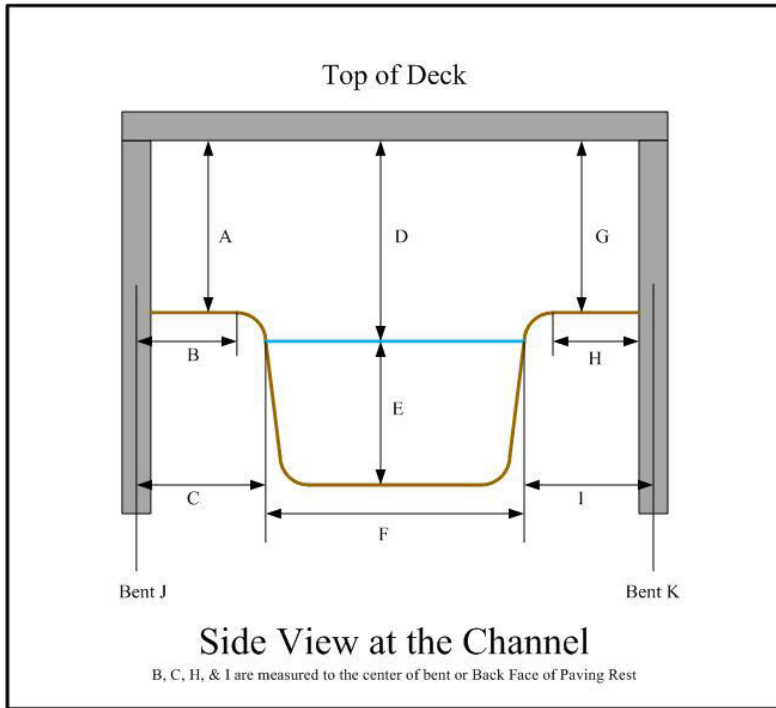
- A :** 42.5
- B :** 78.2
- C :** 105.1
- D :** 44.0
- E :** 1.0
- F :** 43
- G :** 35.7
- H :** 44.3
- I :** 59.7
- J :** 2
- K :** 4

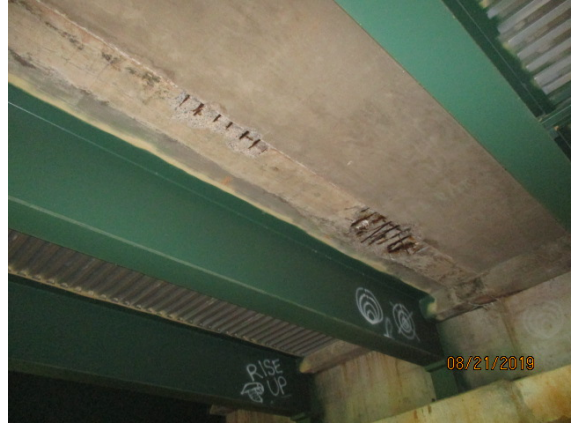
Spall/delamination with exposed rebar in deck underside in span 4.

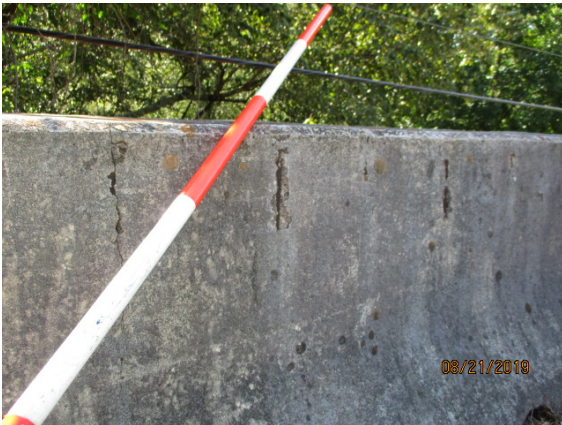
Typical spall with exposed rebar in the barrier walls in span 2

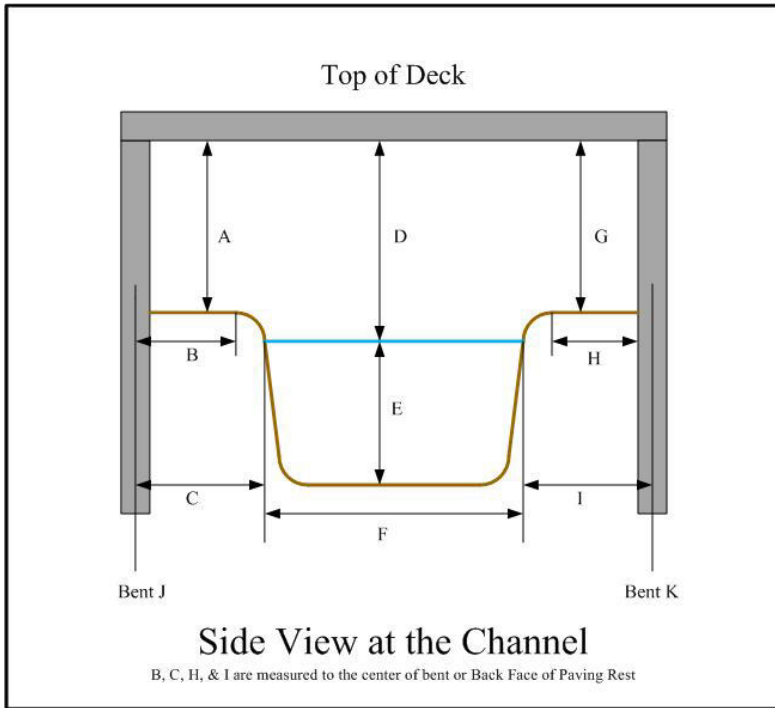
- A : 7.3
- B : 4
- C : 7
- D : 10.7
- E : 0.5
- F : 14
- G : 7.9
- H : 0
- I :
- J : 2
- K : 4

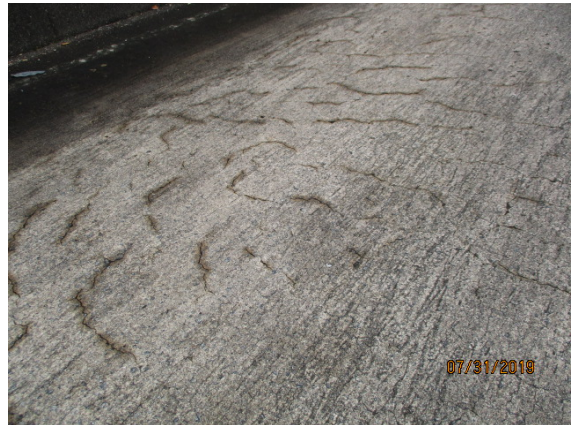
Typical cracking in the deck top. Span 2 shown.

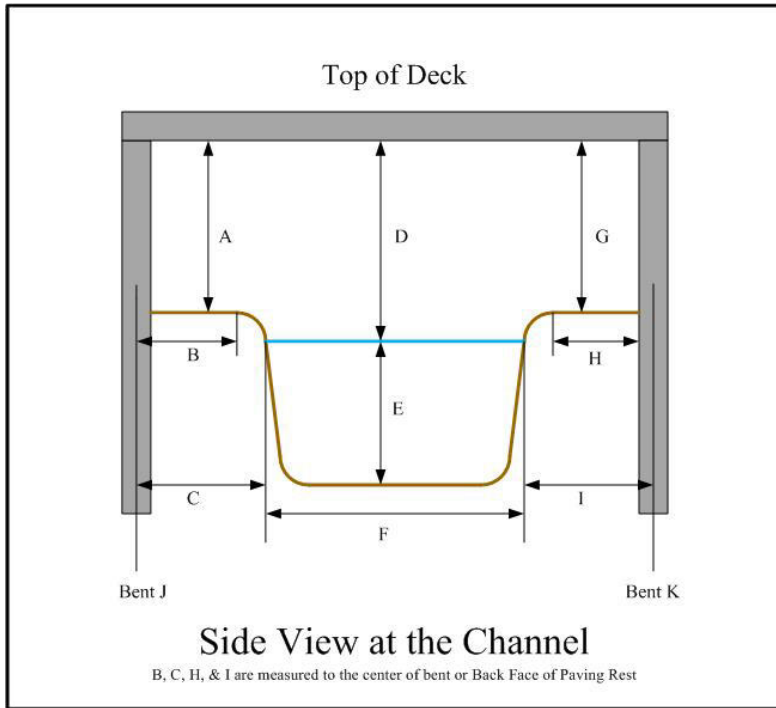
- A : 14
- B : 21
- C : 31
- D : 28.0
- E : 7.0
- F : 145
- G : 15
- H : 12
- I : 25
- J : 1
- K : 5

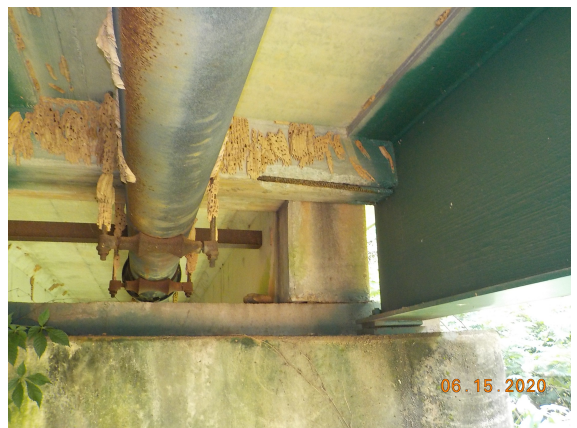
Span 4 bay 4 forward edge beam has a spall with 24" of exposed rebar. ( Specialized )

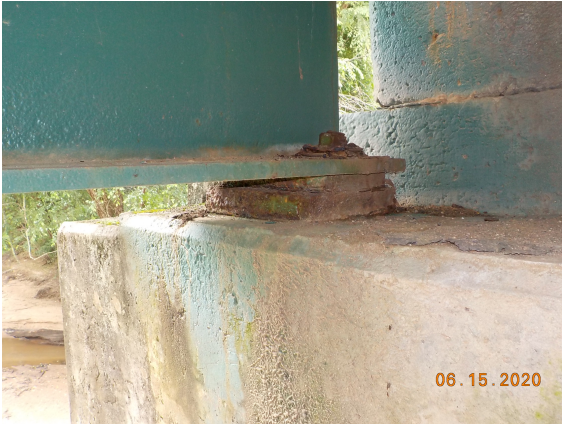
Span 3 rear, bearing 5 has moderate corrosion. ( Specialized )

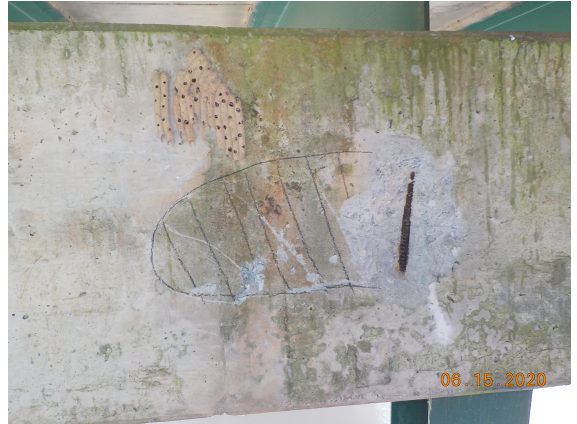
Bent 3 cap, rear face has a 10" x 14" x 2" D spall with exposed rebar and a 18" x 12" area of delamination under beam 1. ( Specialized )

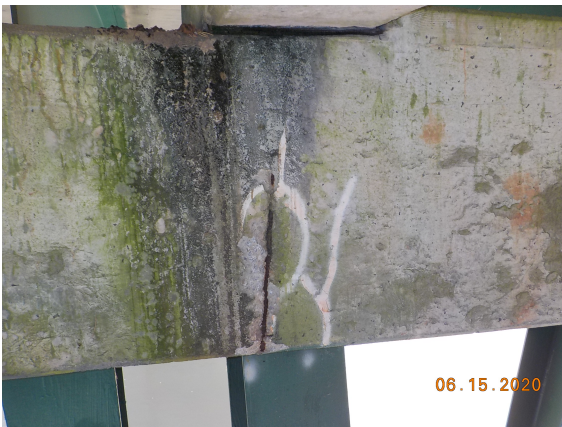
Bent 3 cap, rear face has a 4" x 19" x 1" D spall with exposed rebar under beam 2. ( Specialized )

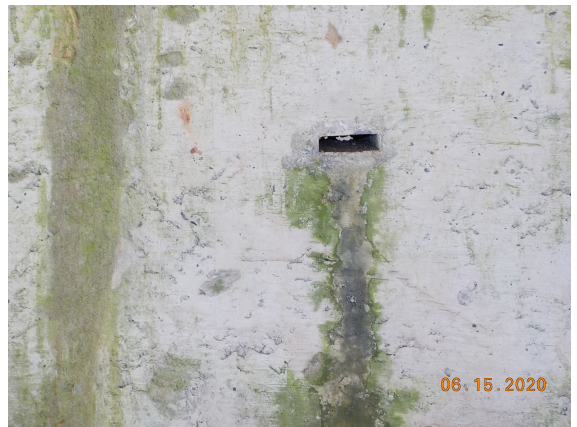
Bent 3 cap has a 1" x 3" void from a piece of wood from construction, extending all the way through the cap. ( Specialized )

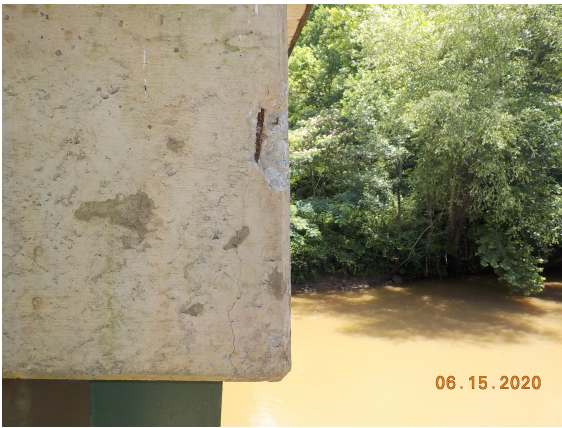
Bent 3 cap, right rear corner has a 4" x 14" delamination with a 3" x 6" x 1.5" D spall with exposed rebar. ( Specialized )

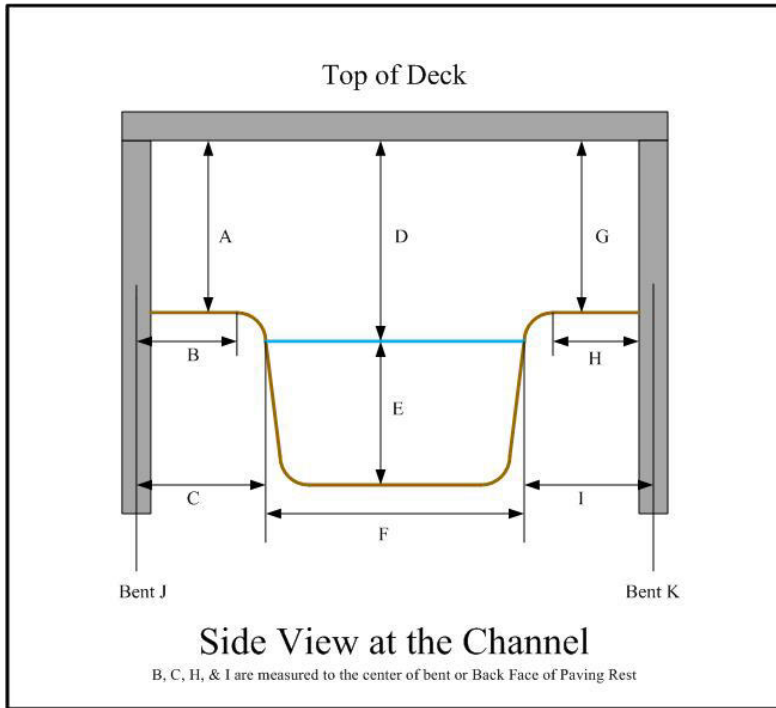
- A : 16.4
- B : 25
- C : 31
- D : 15.8
- E : 1.9
- F : 36
- G : 10.3
- H : 18
- I : 23
- J : 1
- K : 4

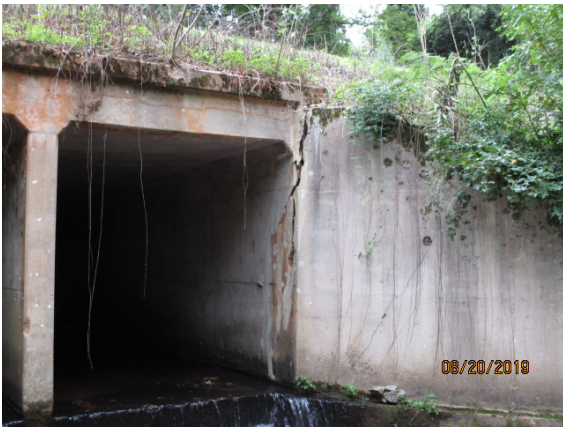
Crack has re-opened in rear outlet wing

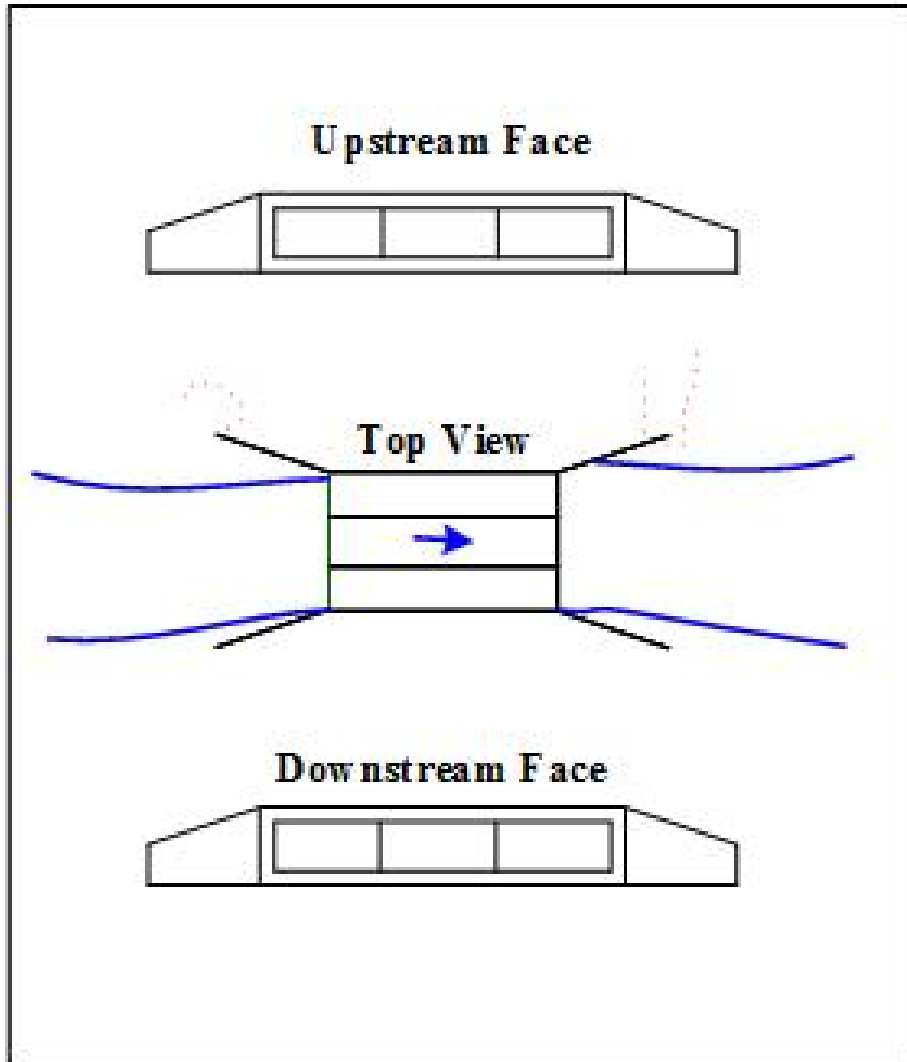
<b>Bridge Height Location</b>	UPSTREAM
<b>Bridge Height (Ft)</b>	9.7
<b>Water Depth (Ft)</b>	0.3
<b>Stream Velocity</b>	Moderate
<b>Channel Soil Type</b>	Sand
<b>Scour Critical</b>	8. Foundation stable for conditions; scour above footing
<b>Slope Protection</b>	0- None

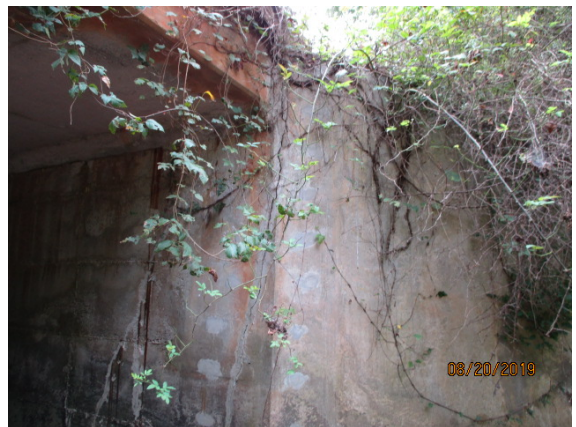
Cracking at the rear inlet wingwall

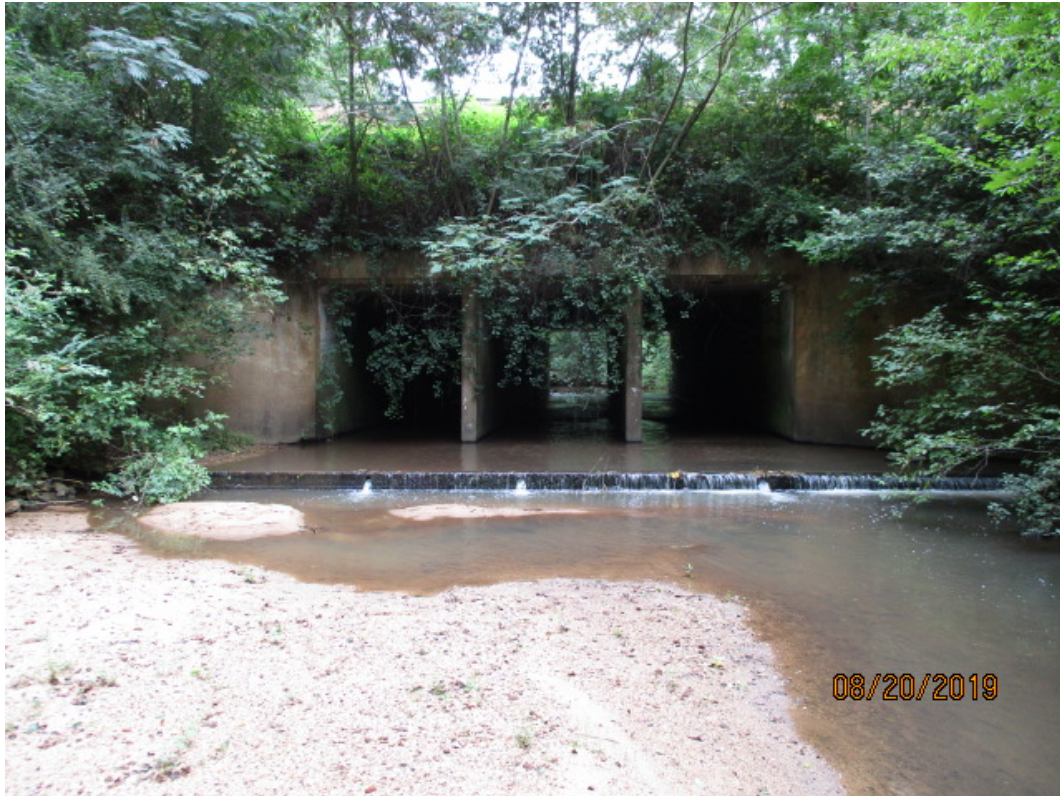
District: 4841100000 - D1 DISTRICT  
 Location ID: 219-00262X-006.77E  
 Structure ID: 219-5028-0

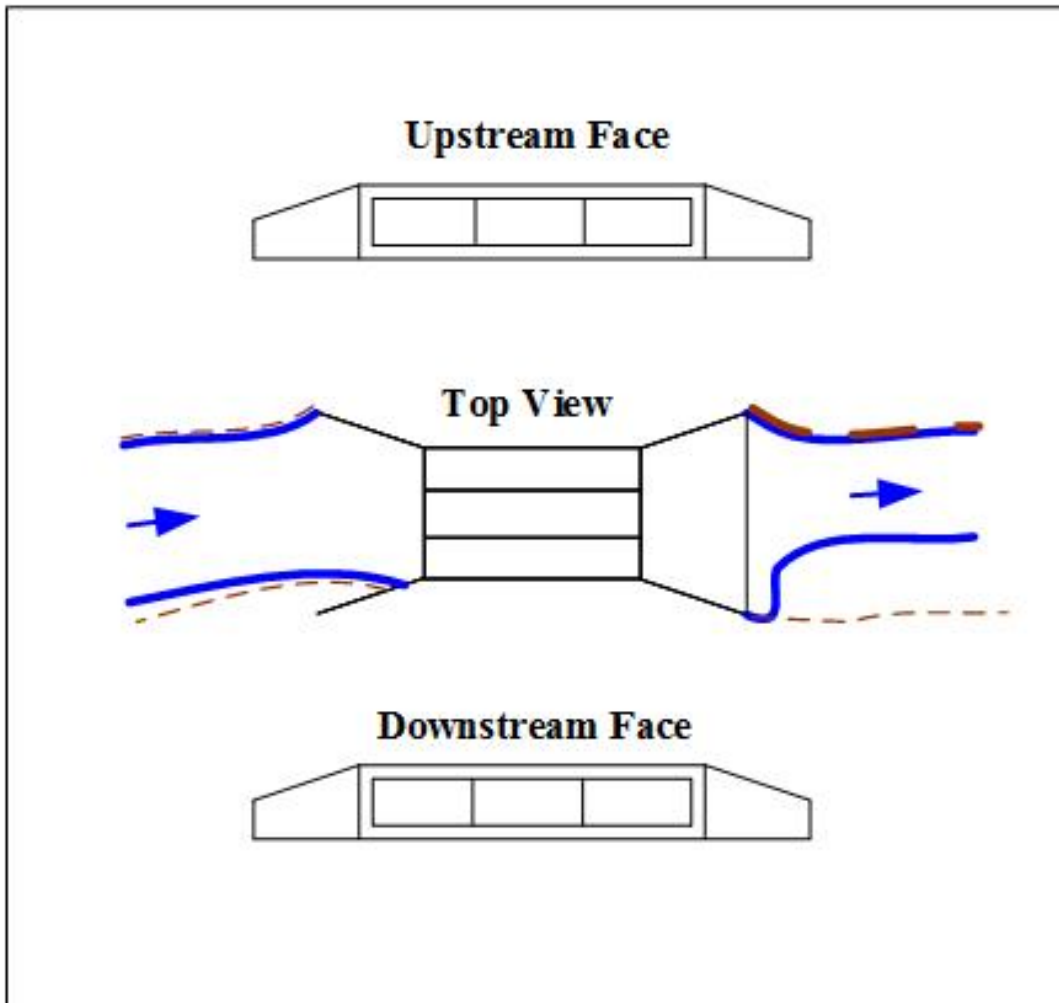
<b>Bridge Height Location</b>	UPSTREAM
<b>Bridge Height (Ft)</b>	10.5
<b>Water Depth (Ft)</b>	3.5
<b>Stream Velocity</b>	
<b>Channel Soil Type</b>	
<b>Scour Critical</b>	8. Foundation stable for conditions; scour above footing
<b>Slope Protection</b>	0- None

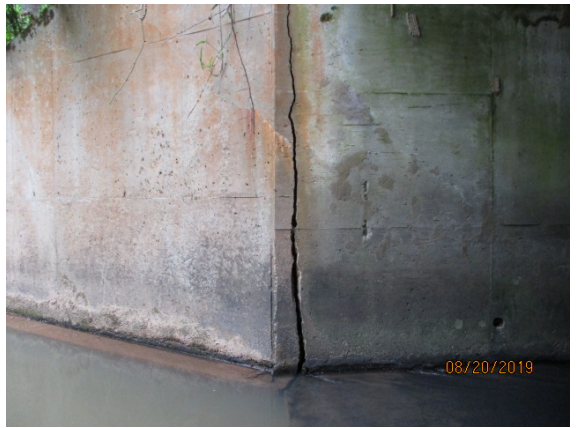
Crack measuring 3" wide x 11' tall

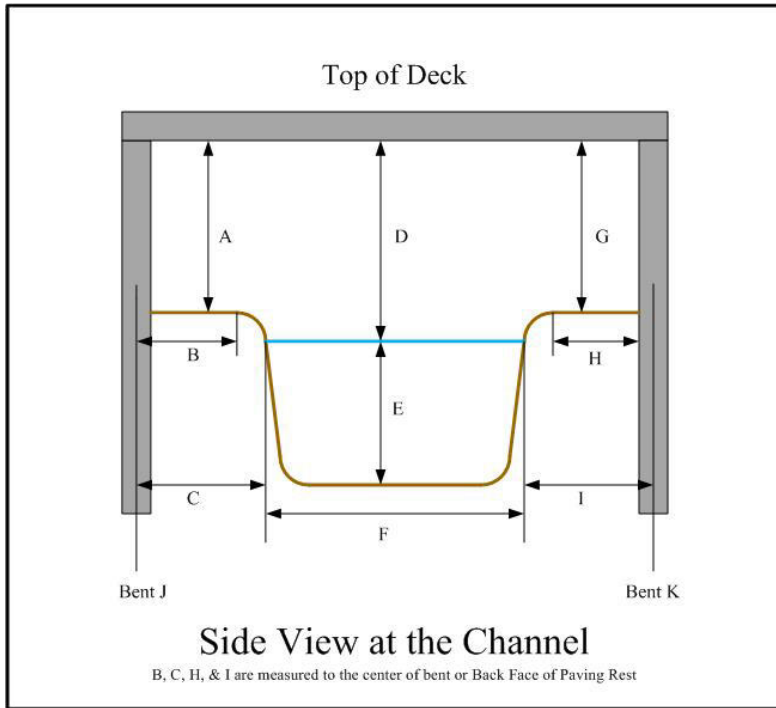
- A : 19.8
- B : 0
- C : 3
- D : 22.5
- E : 2.5
- F : 28
- G : 19
- H : 0
- I : 9
- J : 2
- K : 3

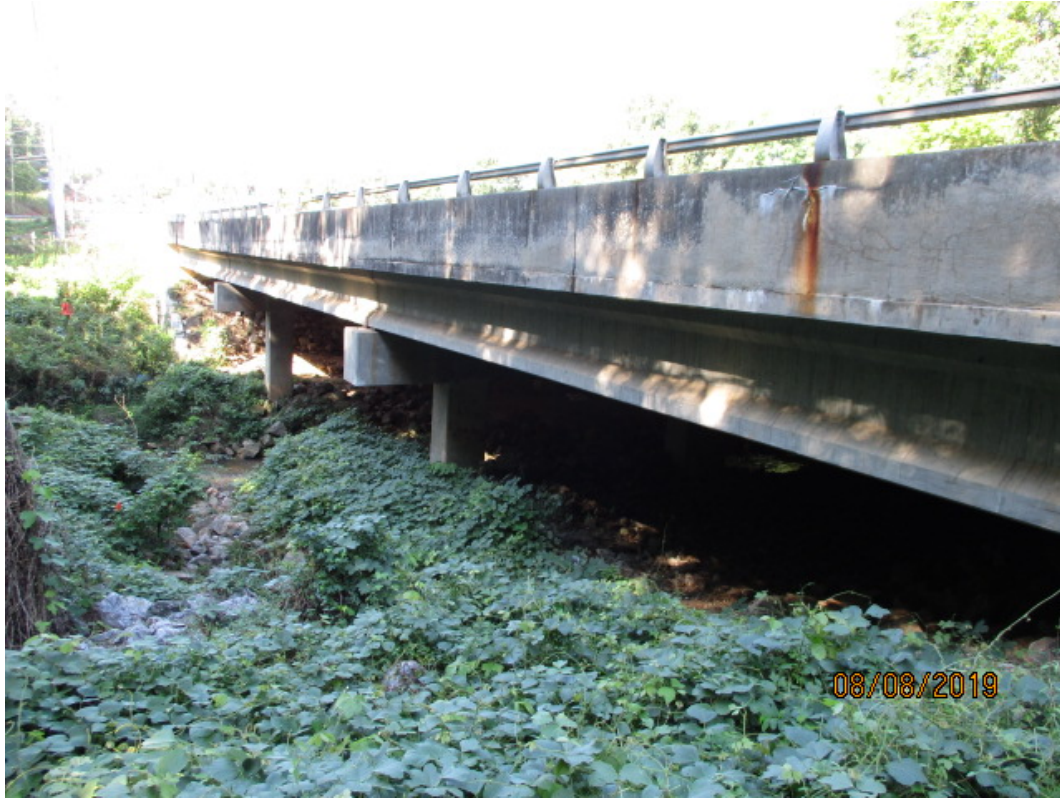
**District:** 4841100000 - D1 DISTRICT  
**Location ID:** 219-00344X-000.97N  
**Structure ID:** 219-5035-0

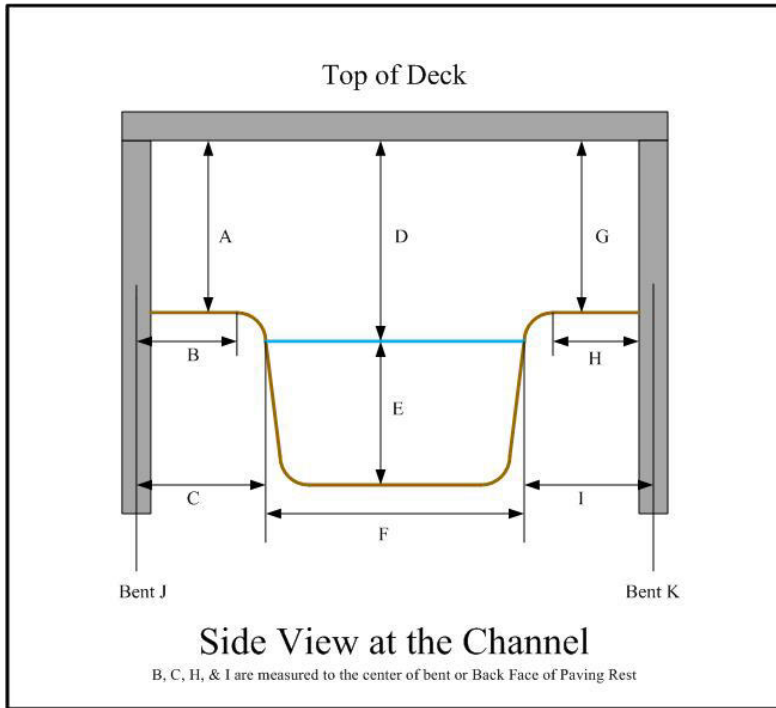
- A :** 18.3
- B :** 20
- C :** 35
- D :** 24.4
- E :** 1.6
- F :** 17
- G :** 16.1
- H :** 50
- I :** 68
- J :** 2
- K :** 4
