Asbestos & Lead Based Paint Assessment

City of Spartanburg
458 Colton Street
Spartanburg, South Carolina 29301

Project Number: 0123-01

November 10, 2023

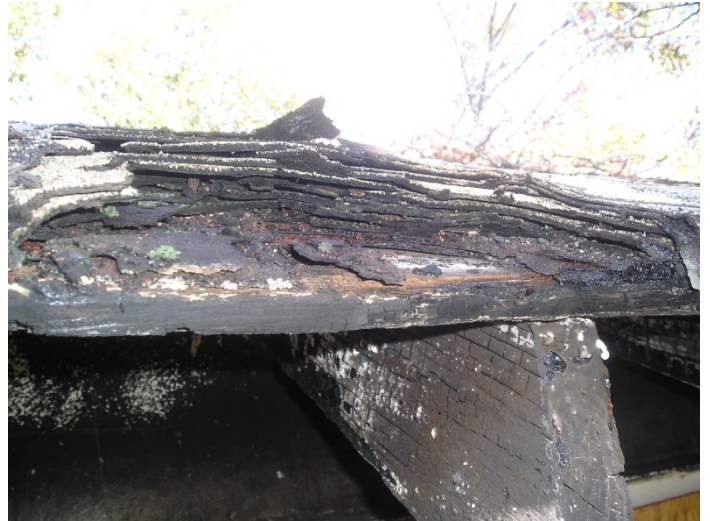
At the time of the assessment, the residence was found to have fire structural damage throughout the interiors and exteriors. Roofing shingle layers were sampled. PLM & TEM analysis identified no asbestos in the roof system. Safety concerns while performing sampling were addressed and no interior samples were collected during the assessment. Subsequently, the building materials and finishes not sampled during the survey should be presumed to be ACM. Apex recommends that the residence except for the roof be demolished in place and materials be treated and disposed of as regulated asbestos containing materials (RACM). The roof system can be segregated and disposed of as CND waste.

Photo 2 – Multi-layers of roof shingles.

1. Demolish the roofing system separately from the residence and dispose of as demolition waste.
2. Demolish the remaining residence with presumed ACM in place and dispose of the waste stream as friable Regulated Asbestos Containing Materials (RACM) and delivered to an asbestos approved hazardous waste landfill for disposal.
3. Perimeter asbestos air monitoring should be performed during abatement by demolition activities and a visual clearance conducted at the conclusion of the project.
4. Follow applicable asbestos regulations during renovation or demolition of the structure. You should be aware that stringent requirements are imposed upon anyone renovating or demolishing a structure in which ACM will be disturbed. This work must be performed in

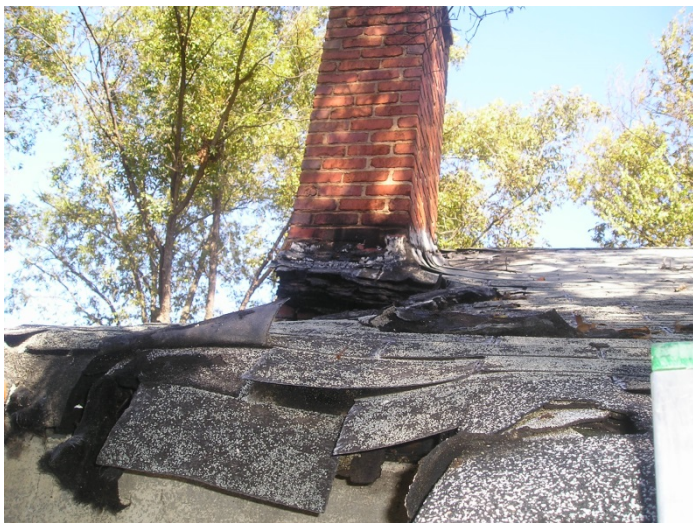
Photo 3 – Chimney with tar.

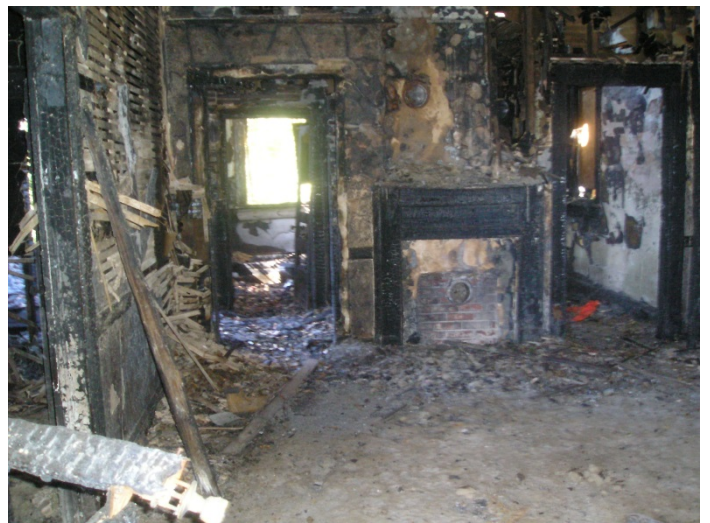
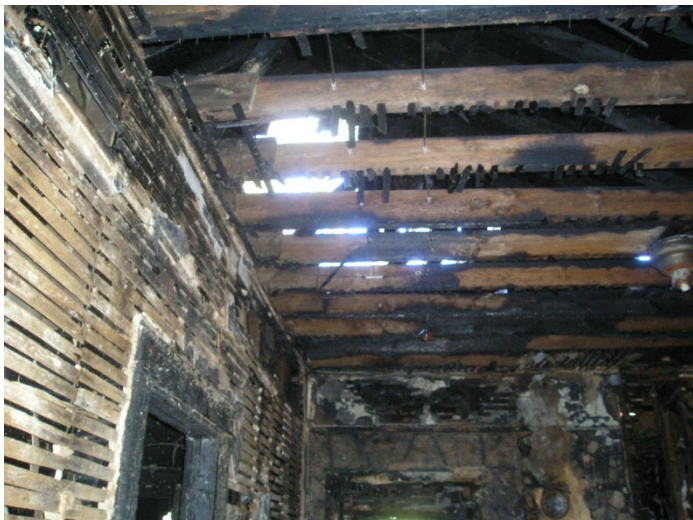
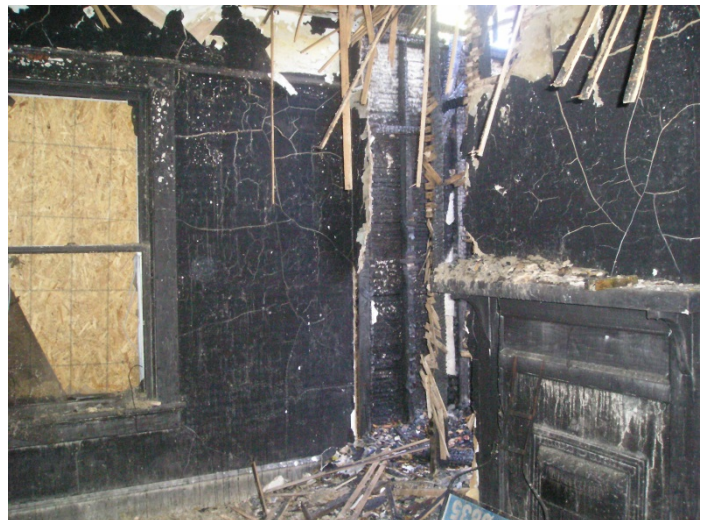
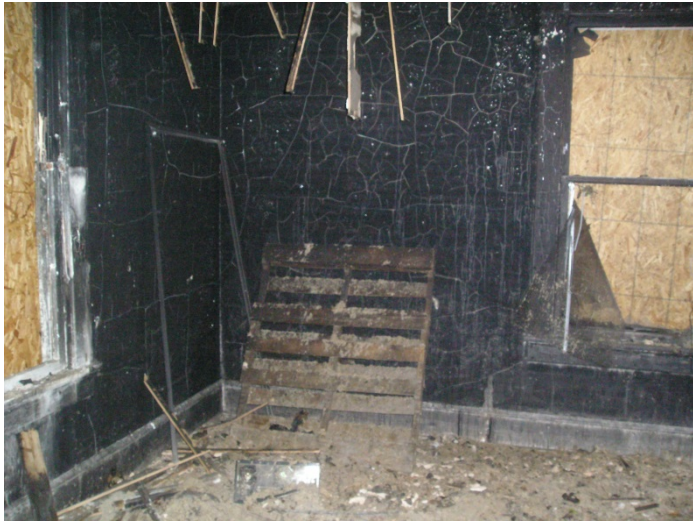
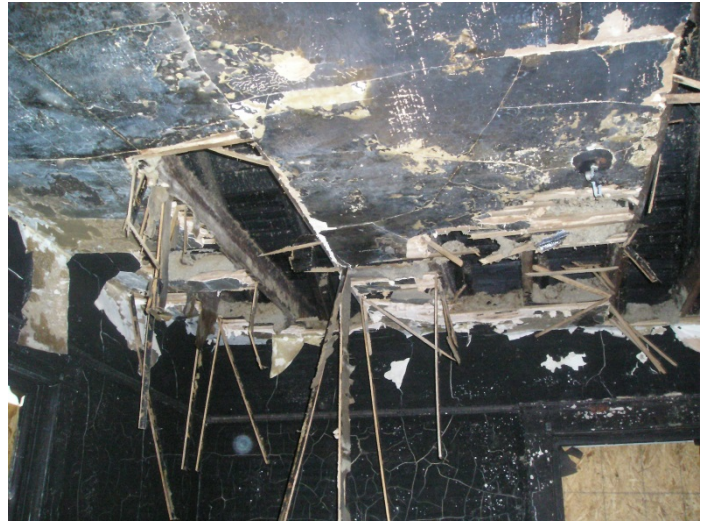
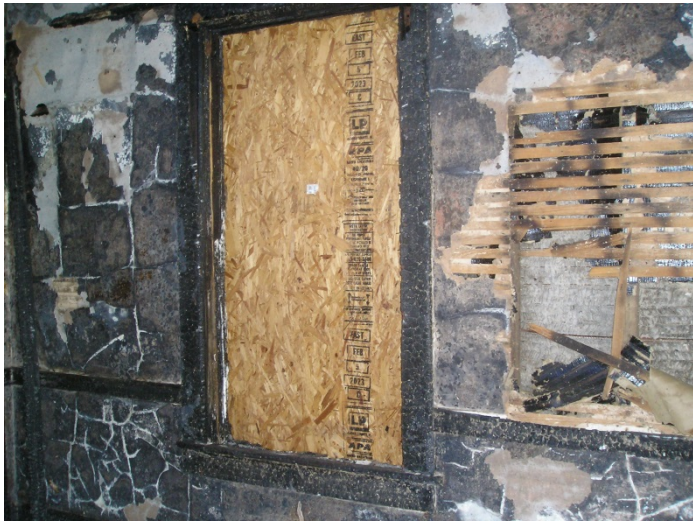
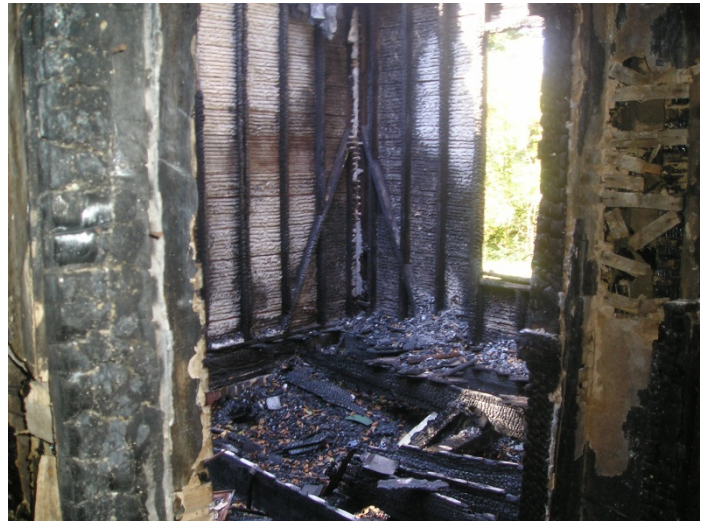
- Interior building materials were not assessed due to fire & structural damage throughout the residence.
- Due to safety concerns no asbestos samples were collected from within the residence.
- The residence and associated debris piles are presumed to be positive for ACM (1,200 SF).

Photo 4 – Typical view of fire damage

Photo 5 – Typical view of fire damage.

Photo 6 – Typical view of fire damage.

Photo 7 – Typical view of fire damage.

Photo 8 – Typical view of fire damage.

Photo 9 – Typical view of fire damage.

Photo 10 – Typical view of fire damage.

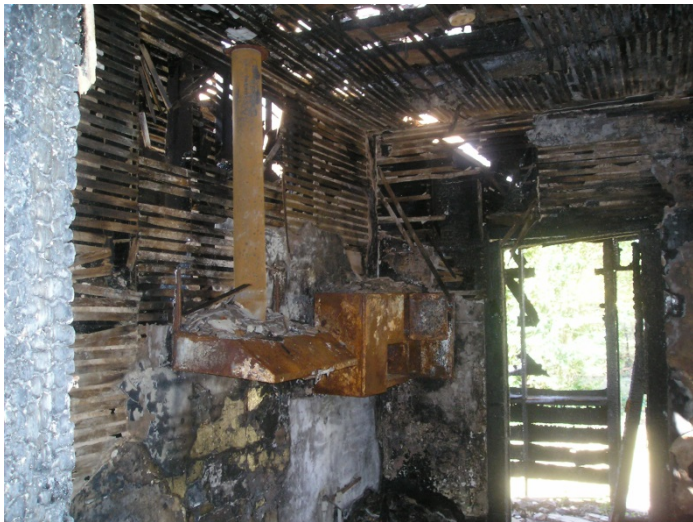
Photo 11 – Kitchen fire damage.

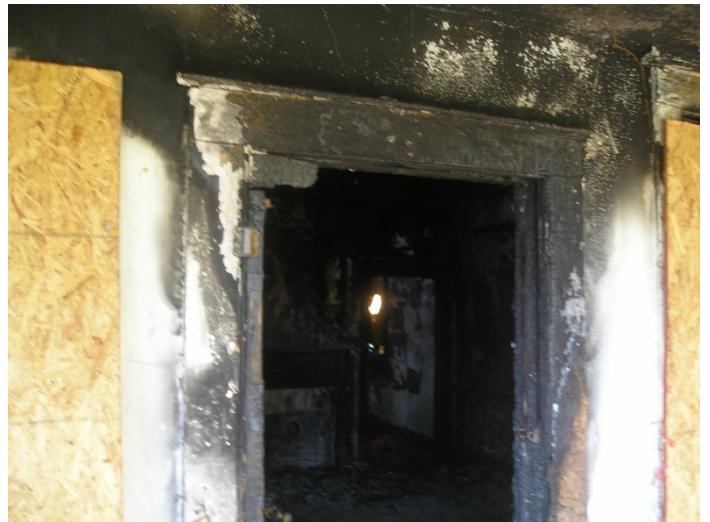
Photo 12 – Front door fire damage.
