STRUCTURE S-252B
INSPECTION DATE: 4/2/2020

Two Barrel, 60" Diameter x 126' Long

Location:	USJRB South
	Levee L-78
Latitude:	27.6409 N
Longitude:	80.7168 W
Type:	Culvert (No gates)
No. Barrels:	Two
Inspection	
Start Date:	4/2/2020
End Date:	4/2/2020

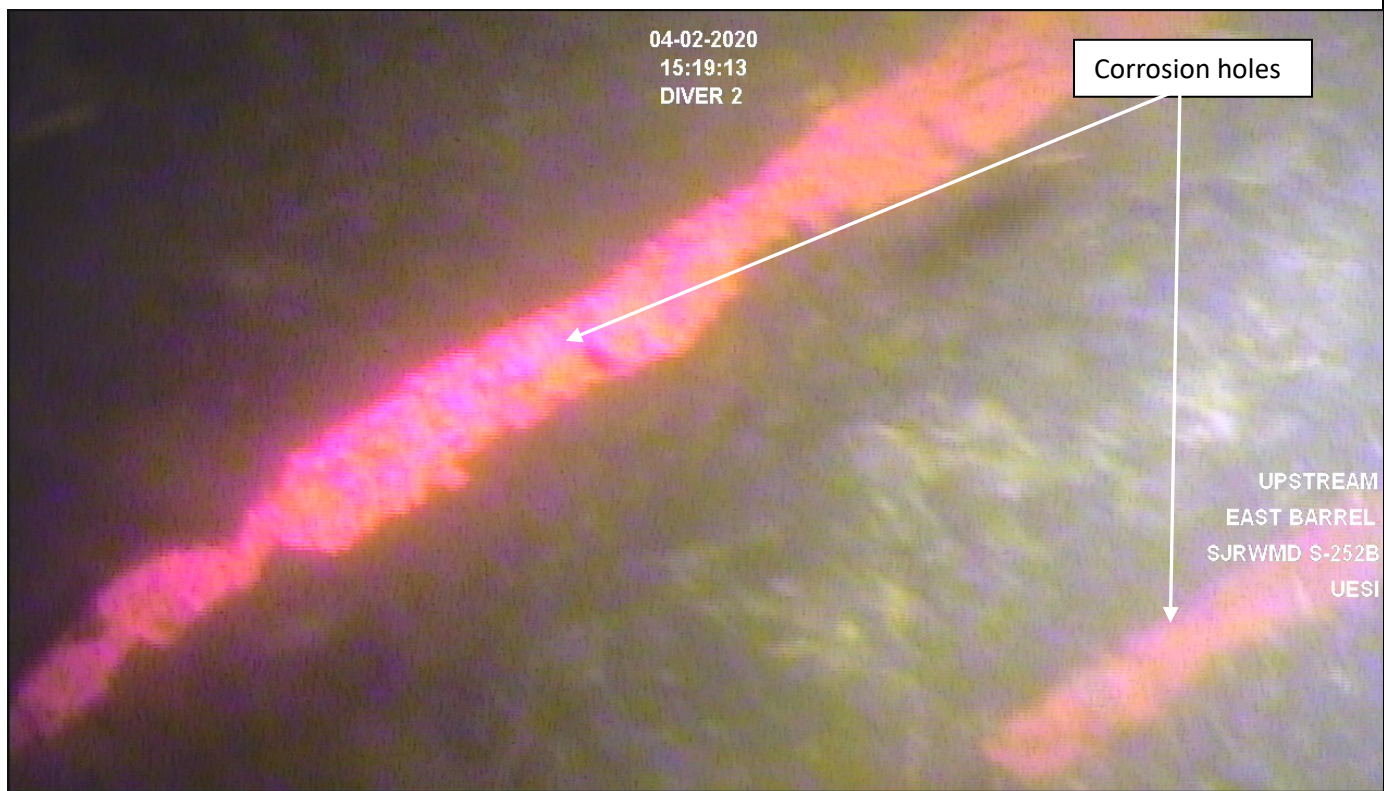
- Item US115: The culverts were inspected from the upstream end. (1) The upstream 10' and the downstream 25' have moderate to heavy corrosion with multiple corrosion holes from 10:00 to 2:00. These are the extension (exposed) areas beyond the embankment. (2) The west barrel has corrosion holes under the embankment portion from 97' to 100' from the upstream end. One hole extends from 09:00 to 12:00 and is 13" wide with a large rock protruding and other rocks behind the hole. There is a second hole slightly larger, 2' to the north on the same side of the culvert. (3) The downstream 20' of the western barrel was inspected from the downstream end due to safety concerns. There are large sections of the barrel missing from corrosion. (4) The remainder of the culvert typically has corrosion pitting of 1/64" covering 40% of the area.

Item No.: US115 Culverts	Rating: C-4	Photo Description: Heavy corrosion on barrels
<p>Deficiency: The culverts were inspected from the upstream end. (1) The upstream 10' and the downstream 25' have moderate to heavy corrosion with multiple corrosion holes from 10:00 to 2:00. These are the extension (exposed) areas beyond the embankment. (2) The west barrel has corrosion holes under the embankment portion from 97' to 100' from the upstream end. One hole extends from 09:00 to 12:00 and is 13" wide with a large rock protruding and other rocks behind the hole. There is a second hole slightly larger, 2' to the north on the same side of the culvert. (3) The downstream 20' of the western barrel was inspected from the downstream end due to safety concerns. There are large sections of the barrel missing from corrosion. (4) The remainder of the culvert typically has corrosion pitting of 1/64" covering 40% of the area.</p>

<p>Probable Cause: The corrosion was due to chemical attack from the water.</p>		
<p>Recommendation: Schedule relining or replacement of both culverts.</p>

- Recommended Action: Schedule relining or replacement of both culverts.

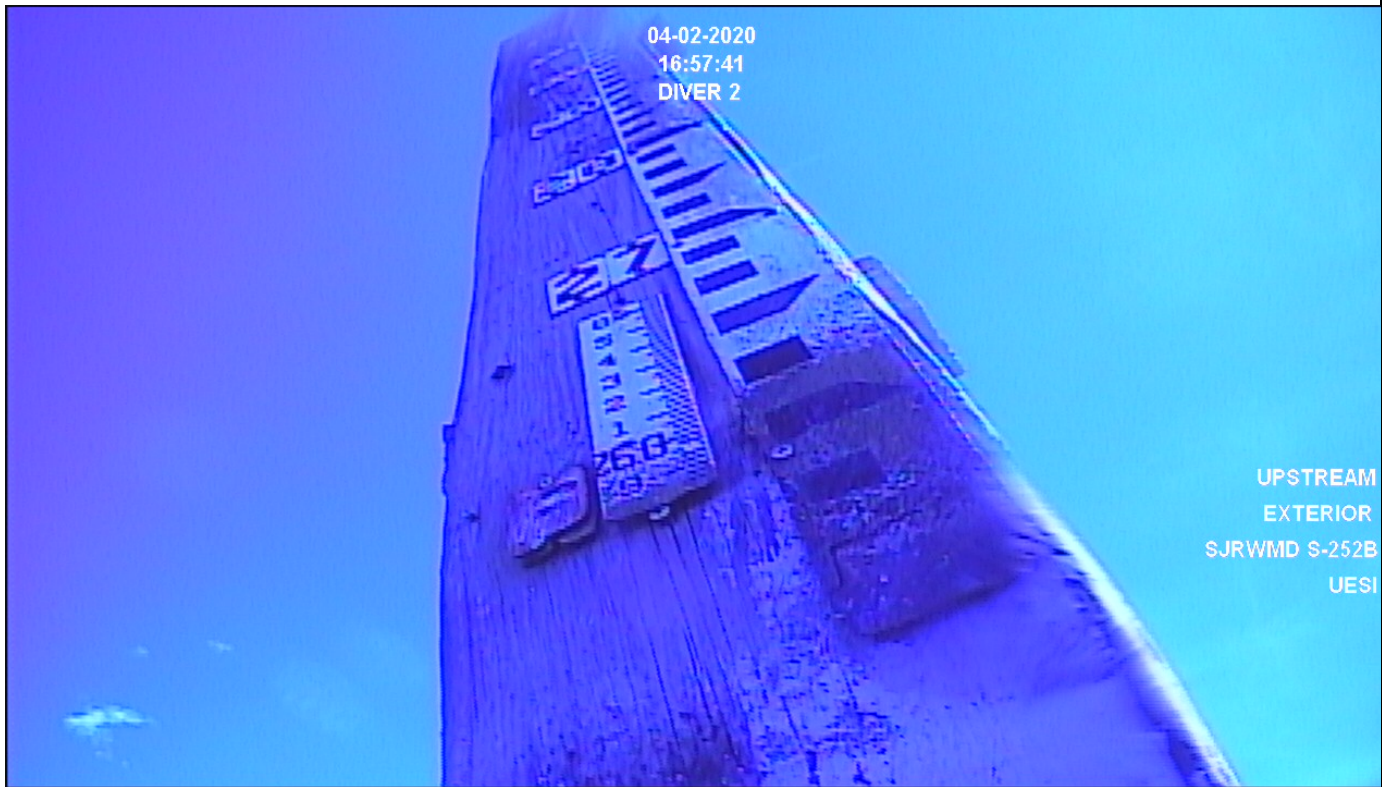
Item No.: DS1000 Additional Items	Rating: C-3	Photo Description: Missing numbers on SW staff gauge
Deficiency: The upstream SW staff gauge is missing numbers from 26' and below.		
Probable Cause: The numbers failed from galvanic corrosion on the plate in contact with the stainless steel screws.		
Recommendation: Install new numbering for the upstream staff gauge below the 26' mark if still used.
