STRUCTURE S-252C
INSPECTION DATE: 4/3/2020

Location:	USJRB South
	Levee L-78
Latitude:	27.6407 N
Longitude:	80.7046 W
Type:	Culvert (No gates)
No. Barrels:	One
Inspection	
Start Date:	4/2/2020
End Date:	4/2/2020

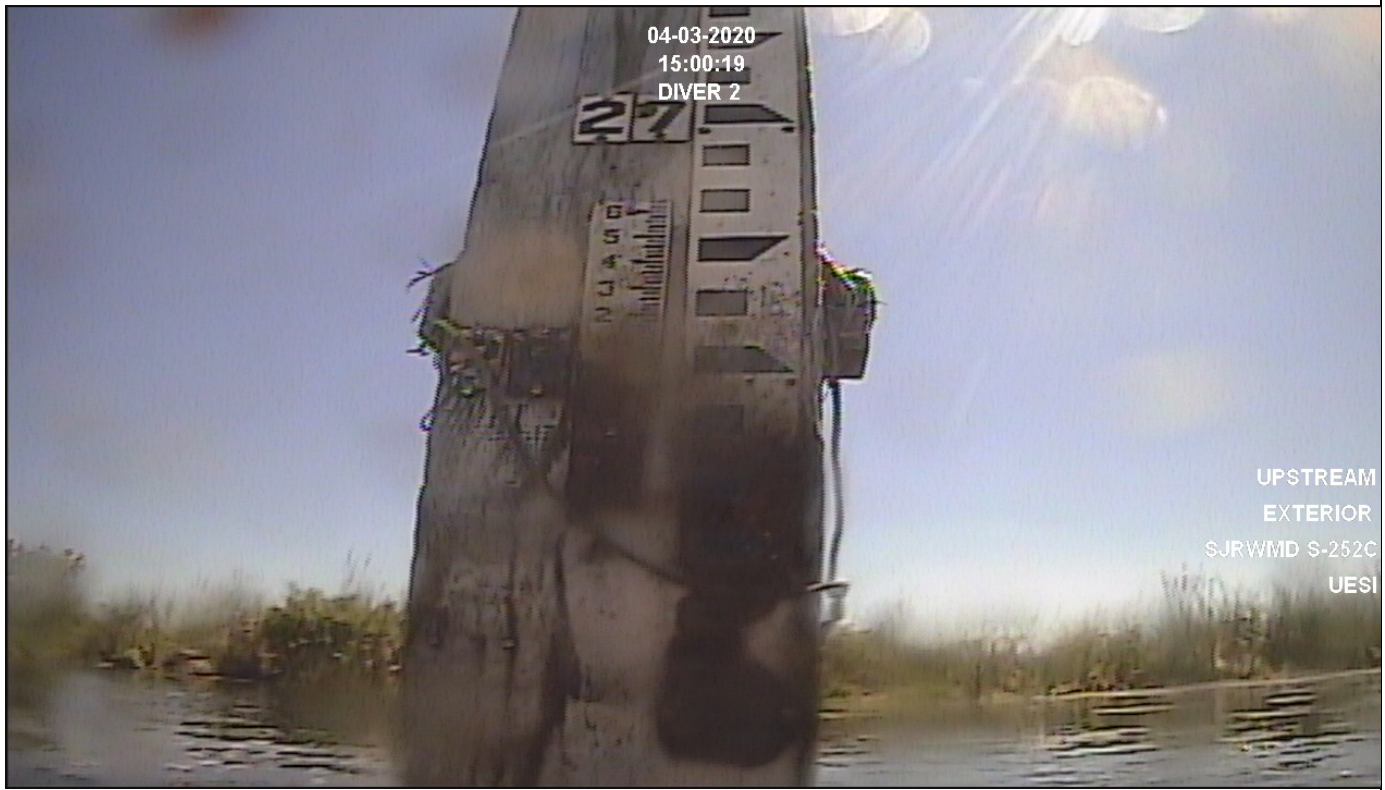
Item No.: DS1000 Additional Items	Rating: C-3	Photo Description: Missing gauge numbers on US staff gauge
Deficiency: The upstream staff gauge has numbers missing from 26' and below and has hardware missing below the waterline.		
Probable Cause: The missing numbers and hardware is due to corrosion from chemical attack from the water.		
Recommendation: Replace the staff gauge numbers. Install hardware below waterline.

- Item DS1000: The upstream staff gauge has numbers missing from 26' and below and has hardware missing below the waterline.
 - Recommended Action: Replace the staff gauge numbers. Install hardware below waterline.
