STRUCTURE S-252A
INSPECTION DATE: 4/2/2020

Two Barrels, 60" Diameter x 126' Long

Location:	USJRB South
	Levee L-78
Latitude:	27.6411 N
Longitude:	80.7255 W
Type:	Gated Culvert
No. Barrels:	Two
Inspection	
Start Date:	4/2/2020
End Date:	4/2/2020

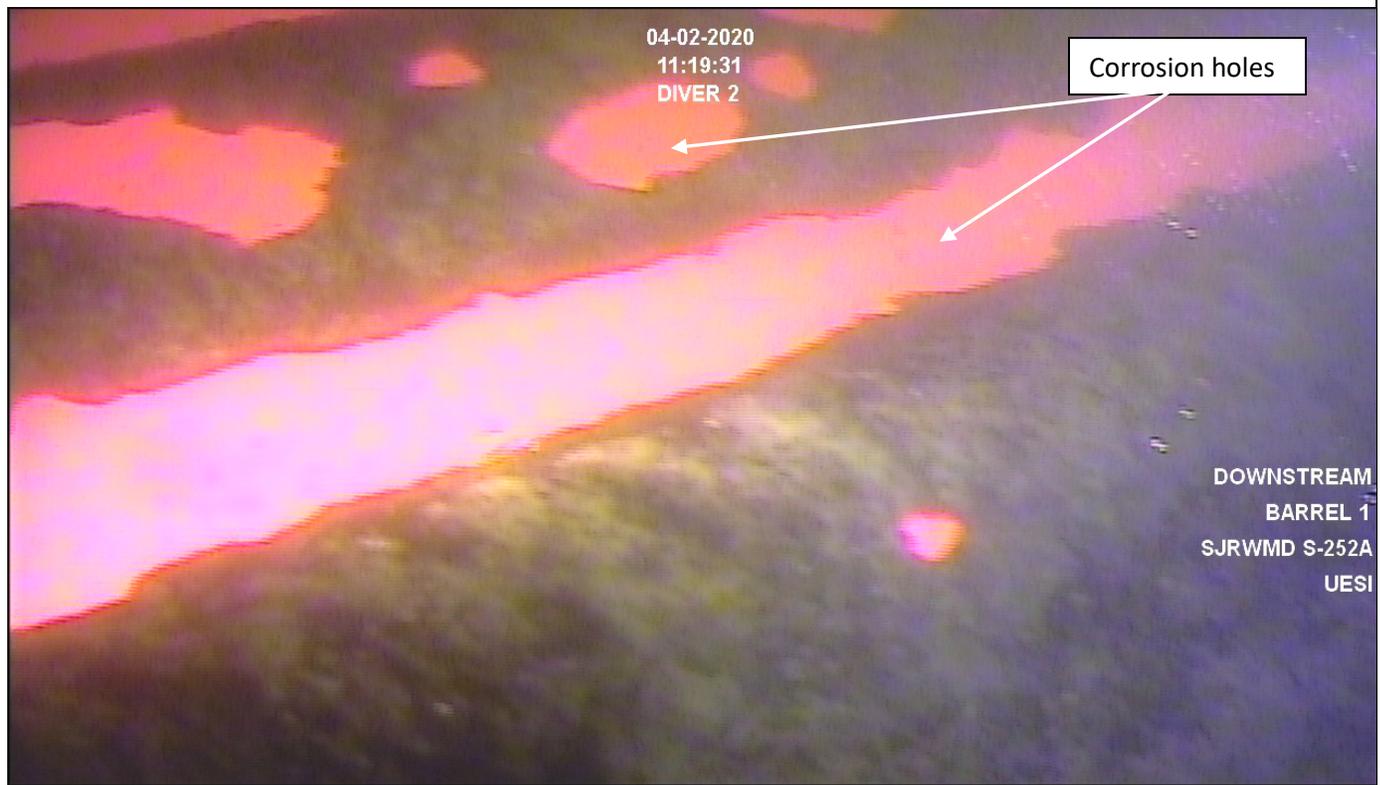
Item No.: DS115 Culverts	Rating: C-4	Photo Description: Heavy corrosion on barrels
-----------------------------	-------------	--

Deficiency: (1) The downstream 20' of each barrel has moderate to major corrosion with corrosion holes. The crown of the barrels has full section loss from corrosion. (2) Both barrels have moderate corrosion throughout the length covering 50-70% of the surface area with pitting up to 1/64" deep. (3) The southern 20' of each barrel, up to the gates, had small corrosion holes across the crown from 10:00 to 02:00.

Probable Cause: The corrosion was due to chemical attack from the water and galvanic corrosion due to contact of dissimilar metals.

DS115	Culverts	4	<p>(1) C-4: The downstream 20' of each barrel has moderate to major corrosion with corrosion holes. The crown of the barrels has full section loss from corrosion [10:56, 11:46]. (2) C-4: Both barrels have moderate corrosion throughout the length covering 50-70% of the surface area with pitting up to 1/64" deep [10:56 to 12:12]. (3) C-4: The southern 20' of each barrel, up to the gates, had small corrosion holes across the crown from 10:00 to 02:00 [11:13, 12:08]. (4) C-2: Barrel 1 has an offset at the joint at 41' in from the downstream end. the north section is lower by 1/2" to 1". Gasket is present all around [11:05]. (5) Note: Both barrels switch from steel to aluminum at 121' in from the downstream end.</p>	Schedule culvert relining or replacement for both barrels.	The corrosion was due to chemical attack from the water.
-------	----------	---	--	--	--

Recommendation: Schedule culvert relining or replacement for both barrels.

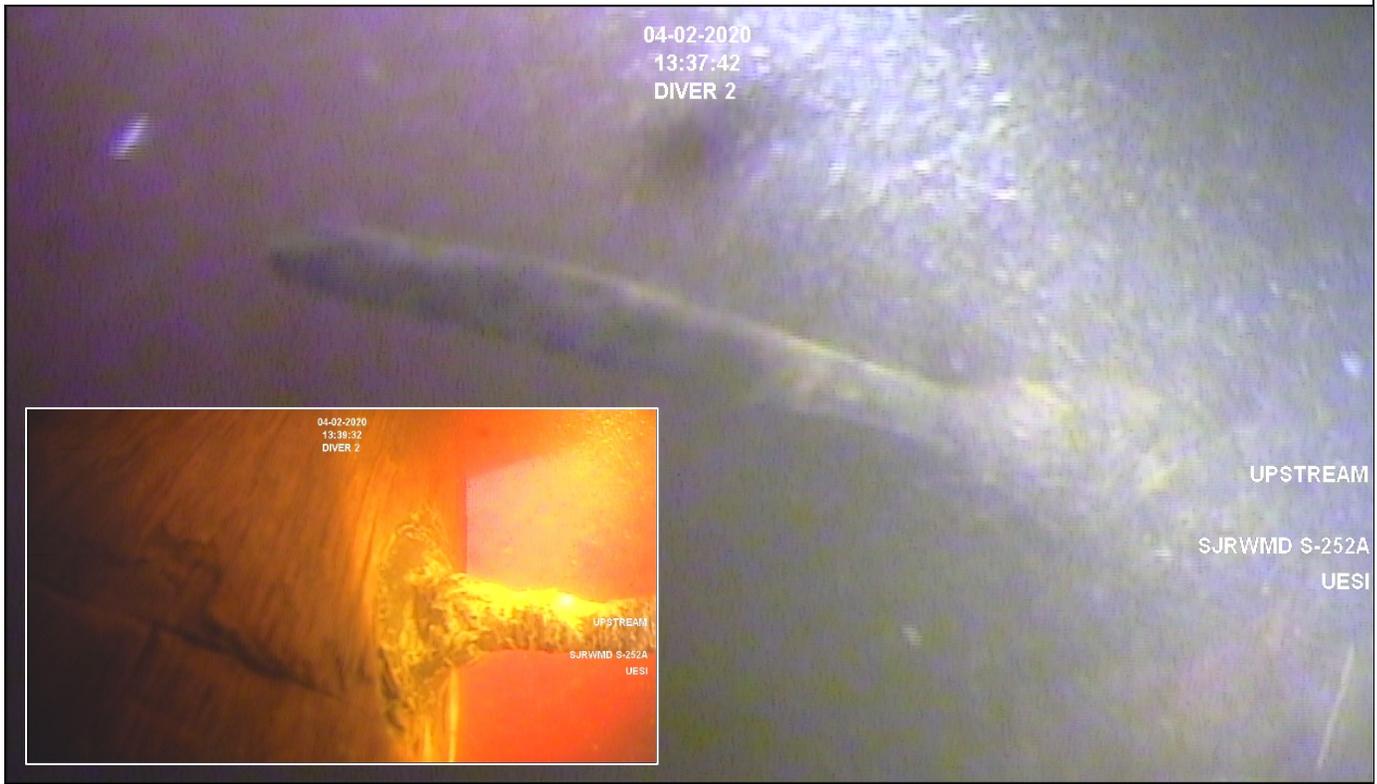
- Item US114: The hardware for the cross bracing for the timber pier has heavy corrosion below water with 50% section loss.
 - Recommended Action: Replace the timber pier hardware below the waterline.
- Item DS1000: The upstream side has two staff gauges. The southwestern staff gauge timber 2x12 board has moderate wood rot just above the waterline, 2' tall x 6" wide x 1" deep. The gauge is missing numbers below 26.5 Ft.
 - Recommended Action: Replace the southwest staff gauge timber and metal boards if they are still used.

Item No.: US114 Structural Support	Rating: C-3	Photo Description: Corrosion on hardware underwater
Deficiency: The hardware for the cross bracing for the timber pier has heavy corrosion below water with 50% section loss.		
Probable Cause: The corrosion was due to chemical attack from the water.		
Recommendation: Replace the timber pier hardware below the waterline.

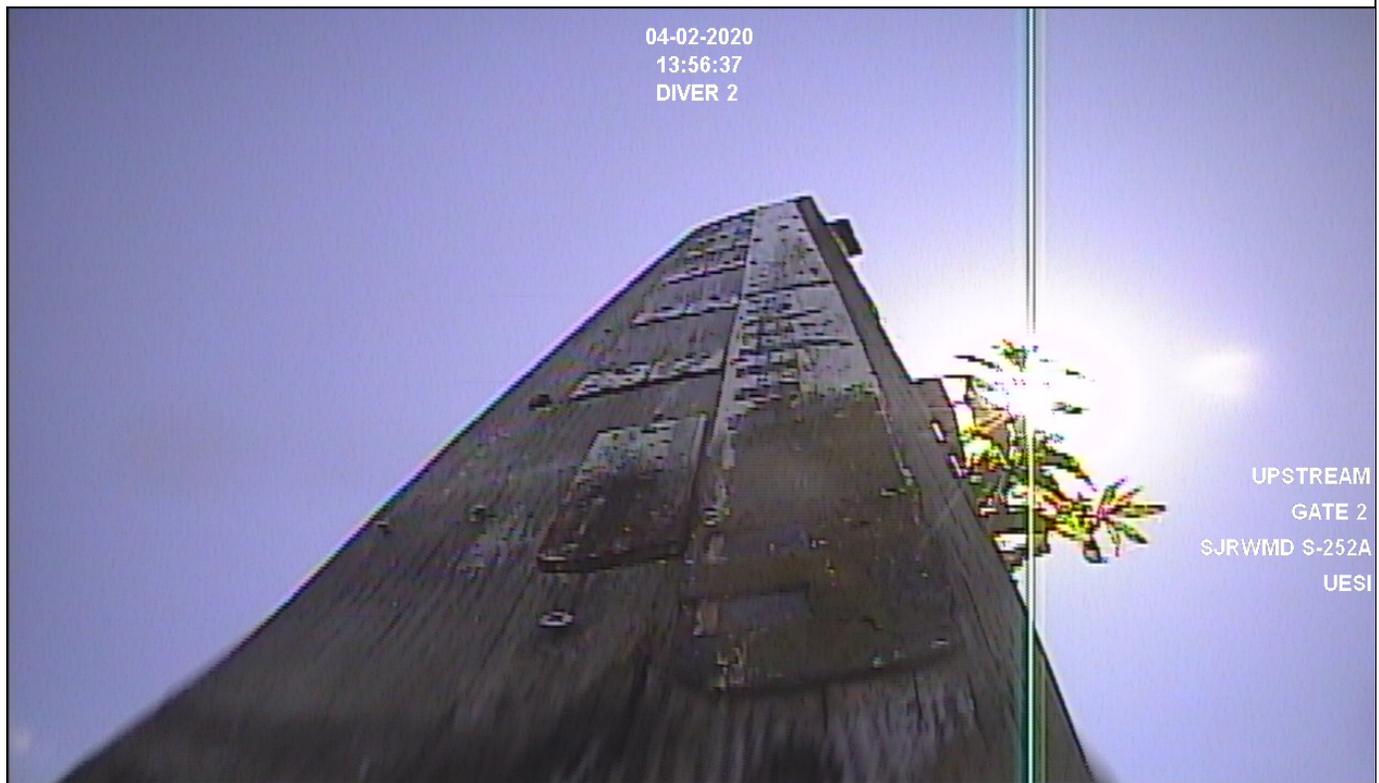
Item No.: DS1000 Additional Items	Rating: C-3	Photo Description: Missing gauge numbers on SW gauge
Deficiency: The upstream side has two staff gauges. The southwestern staff gauge timber 2x12 board has moderate wood rot just above the waterline, 2' tall x 6" wide x 1" deep. The gauge is missing numbers below 26.5 Ft.		
Probable Cause: The timber decay is normal damage from its age and environment. The loss of numbers is from loss of screws due to corrosion.		
Recommendation: Replace the southwest staff gauge timber and metal boards if they are still used.
