**STRUCTURE S-6A**  
**INSPECTION DATE: 2/13/2020**

Single Barrel, 48" Diameter x 102' Long

Location:	USJRB South
	Levee L-75
Latitude:	27.7000 N
Longitude:	80.6759 W
Type:	Gated Culvert
No. Barrels:	One
Inspection	
Start Date:	2/13/2020
End Date:	2/14/2020

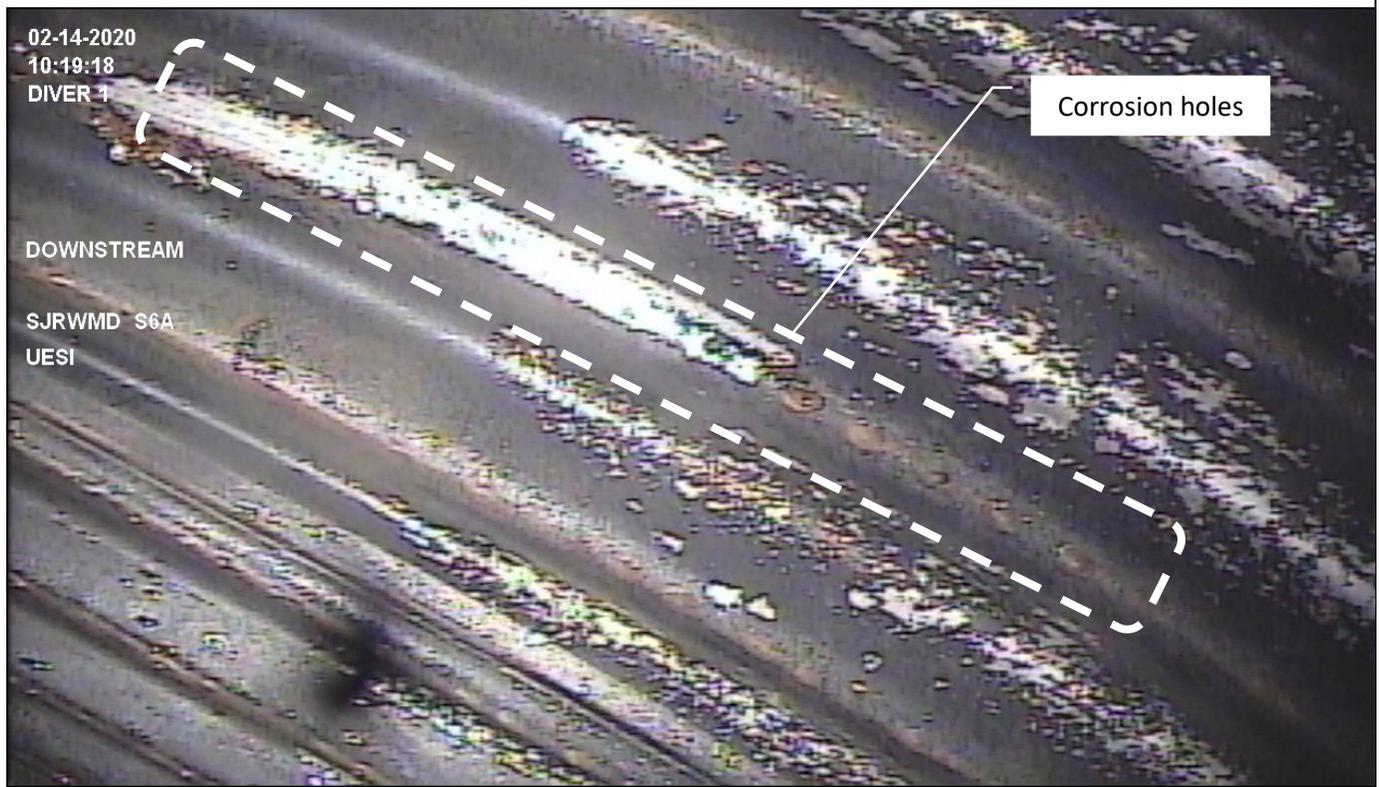
- Item DS115: The culvert has small holes throughout the length. The holes are typically 1/16" to 1/8" wide by 1/8" to 1" long with soil intrusion observed. The first hole is at 45' in from the downstream end. Other holes are found at 48', 51', 62', 63' 76', 82' and 86'. Most are on the crown from 09:00 to 03:00.
  - Recommended Action: Schedule the culvert for relining.

Item No.: DS115 Culvert	Rating: C-4	Photo Description: Small holes with soil intrusion
Deficiency: The culvert has small holes throughout the length. The holes are typically 1/16" to 1/8" wide by 1/8" to 1" long with soil intrusion observed. The first hole is at 45' in from the downstream end. Other holes are found at 48', 51', 62', 63' 76', 82' and 86'. Most are on the crown from 09:00 to 03:00.		
Probable Cause: The holes are from corrosion caused by failed coating and chemical attack from the water.		
Recommendation: Schedule culvert lining.

- Recommended Action: Per the C-4 rating above, schedule the culvert for relining.
