VISUAL ROOF SURVEY

OAKVIEW APARTMENTS

650 Howard Street
Spartanburg, South Carolina

Reference: Report of Roof Survey
Oakview Apartments
650 Howard Street
Spartanburg, South Carolina
REI Project No. GSP1033.001

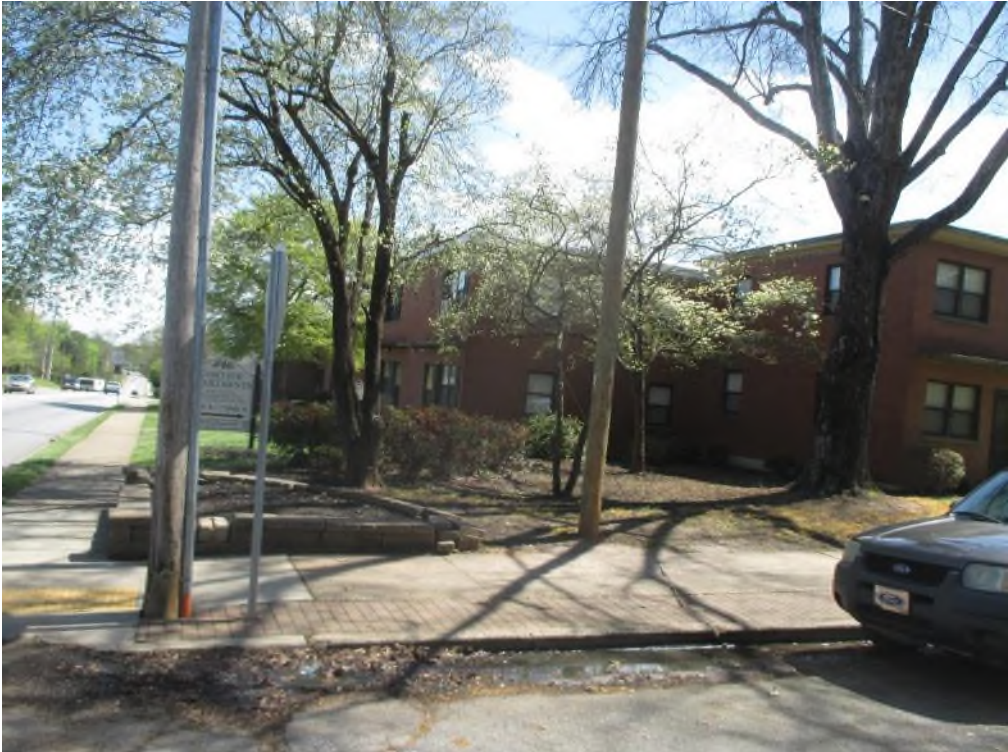
Photograph 1 - North elevation

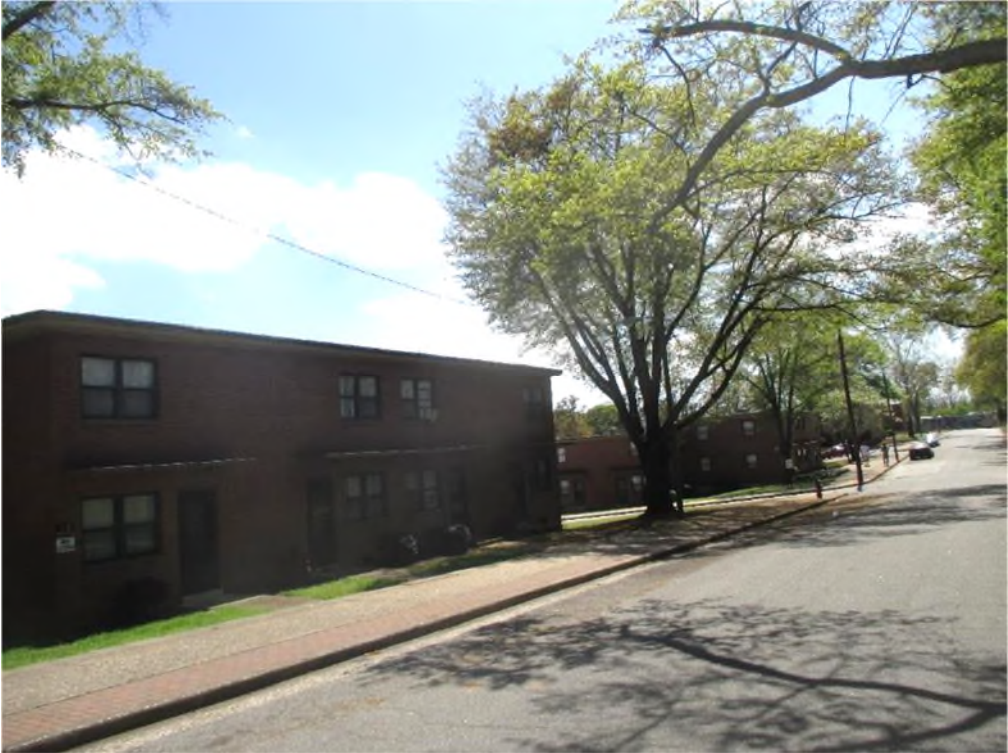
Photograph 2 - West Elevation

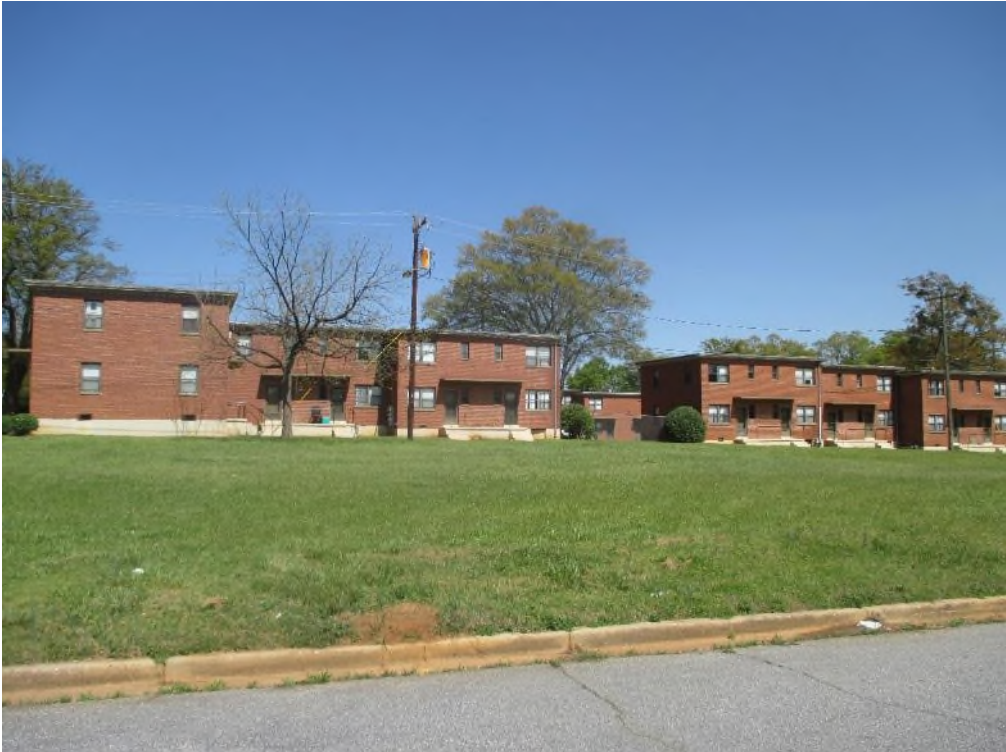
Photograph 3 - South Elevation

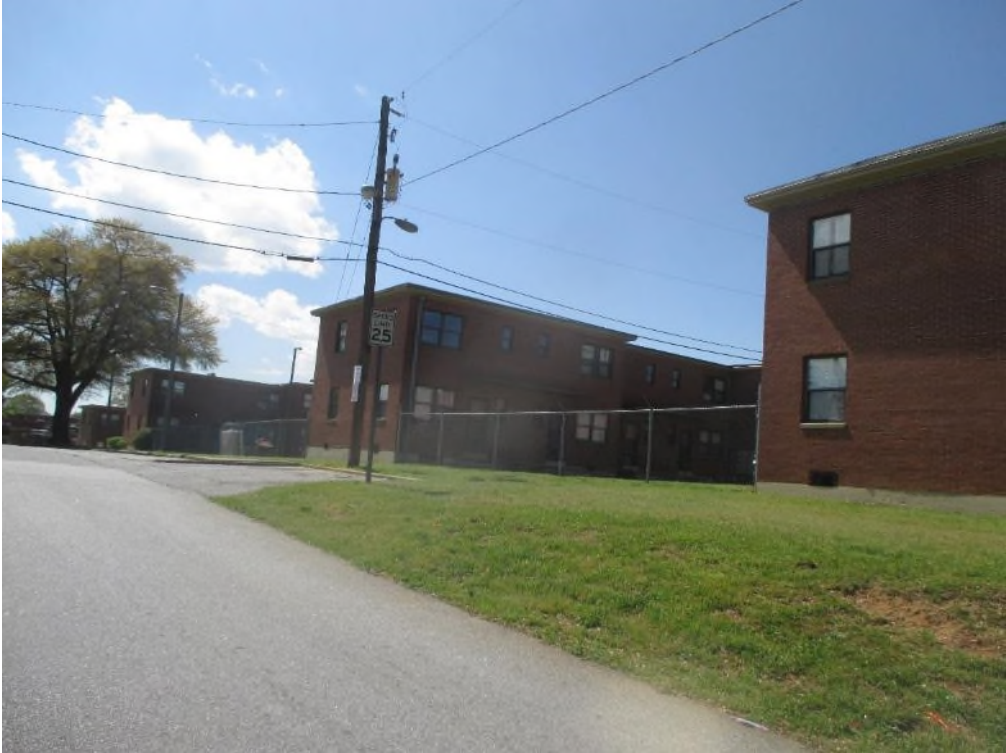
Photograph 4 - East Elevation

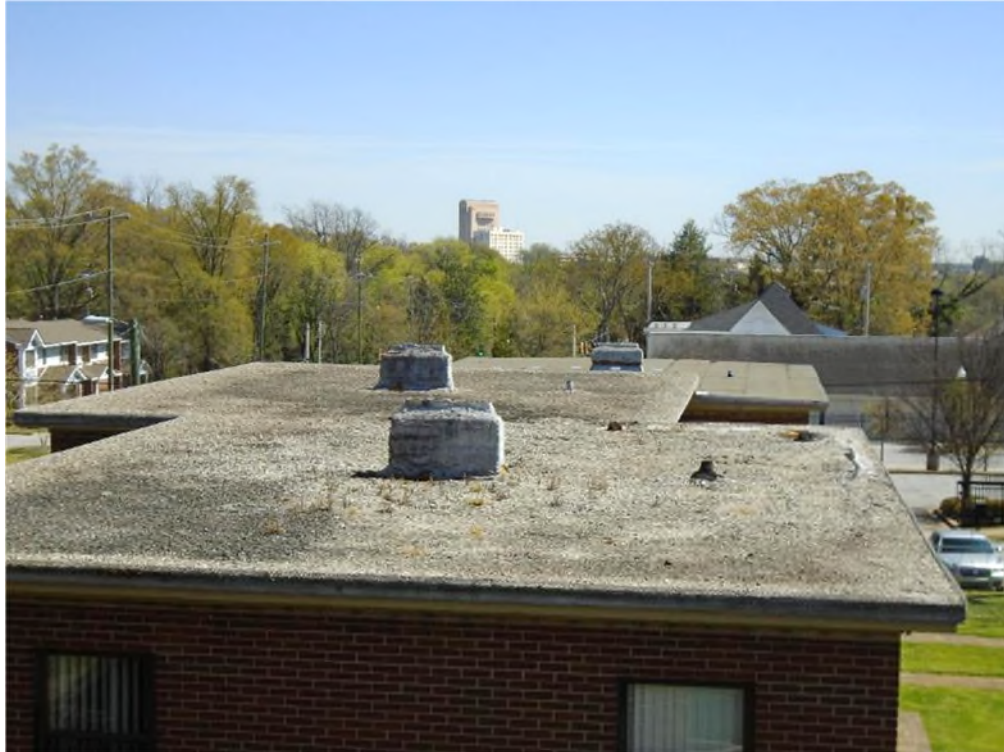
Photograph 5 - BLDG 1 - Overview

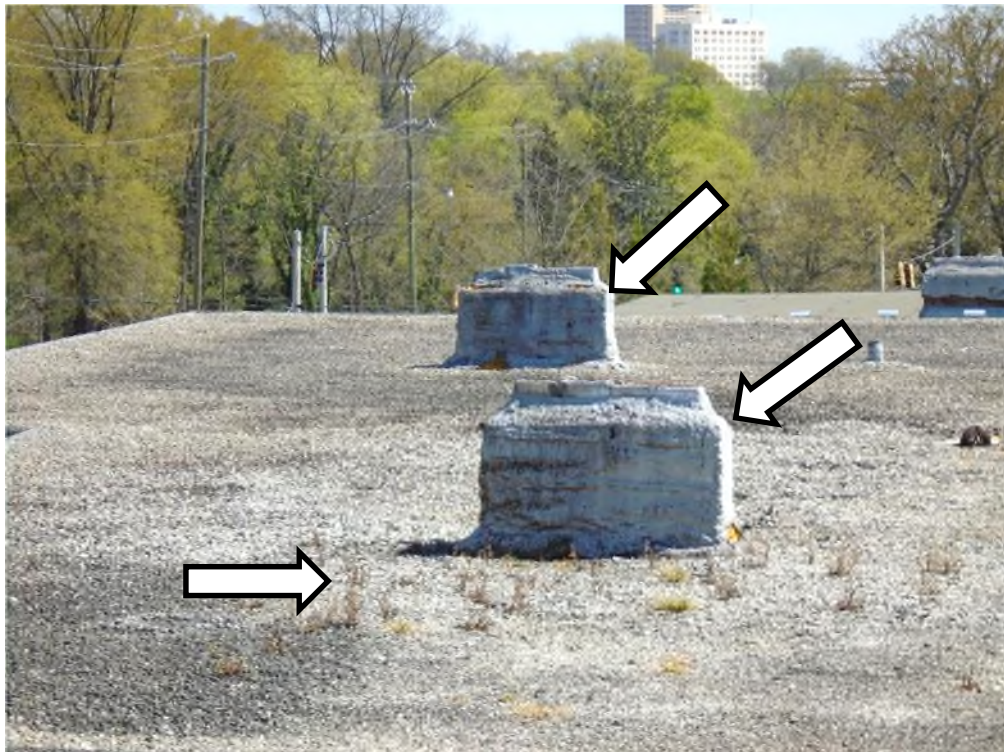
Organic materials were observed on the roof surfaces adjacent to the trees. These roofs were covered with acorns and leaves from the adjacent oak trees. Several of the other roofs, away from the adjacent trees, had grasses and weeds established on the roof membranes. The majority of the modified style gravel stop had vegetation growing through the sides. The attached photographs depict several of these deviations to the roof.

Photograph 6 - BLDG 1- Vegetation growth and improper repair to chimney

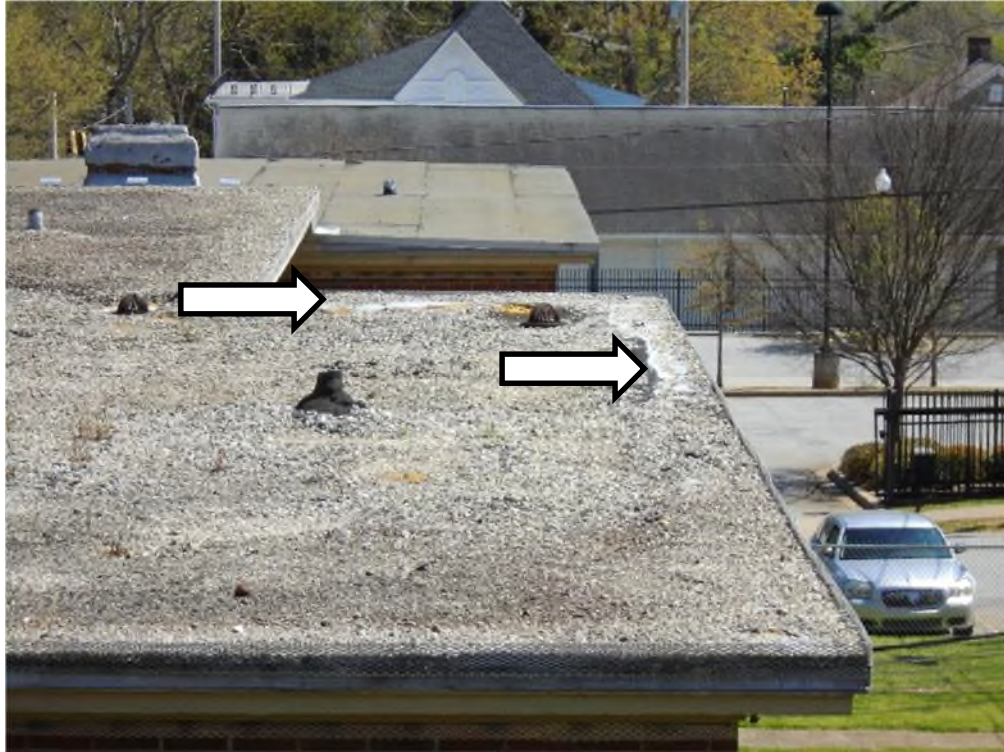
Photograph 7 - BLDG 1 - Displaced aggregate along roof edges

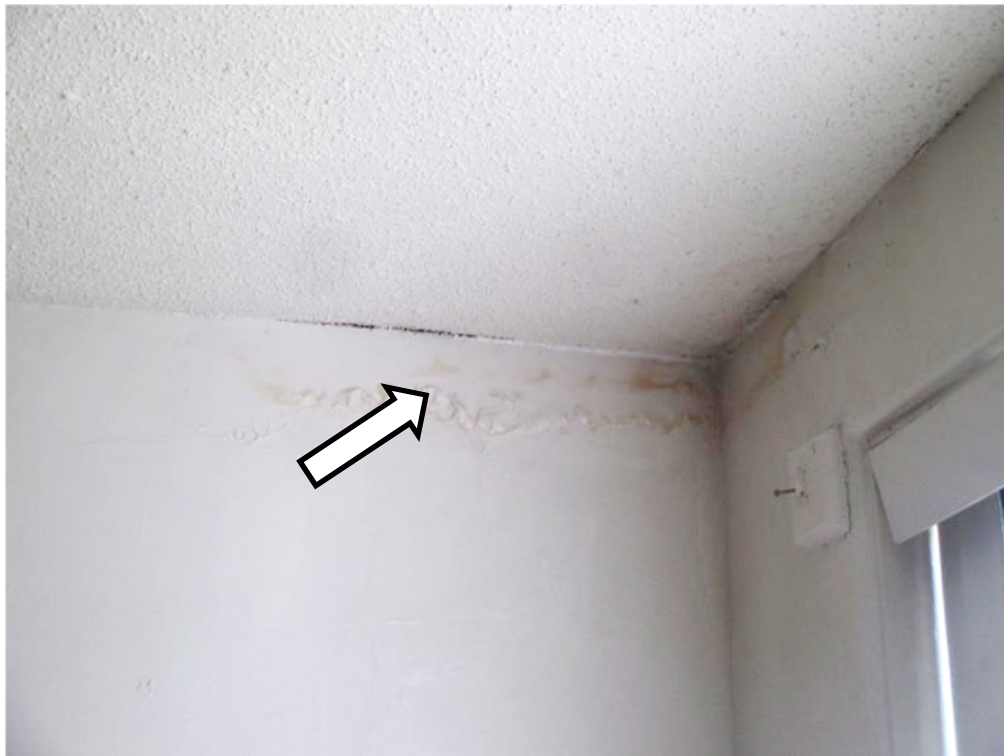
Photograph 8 - BLDG 1 - Moisture staining on ceiling

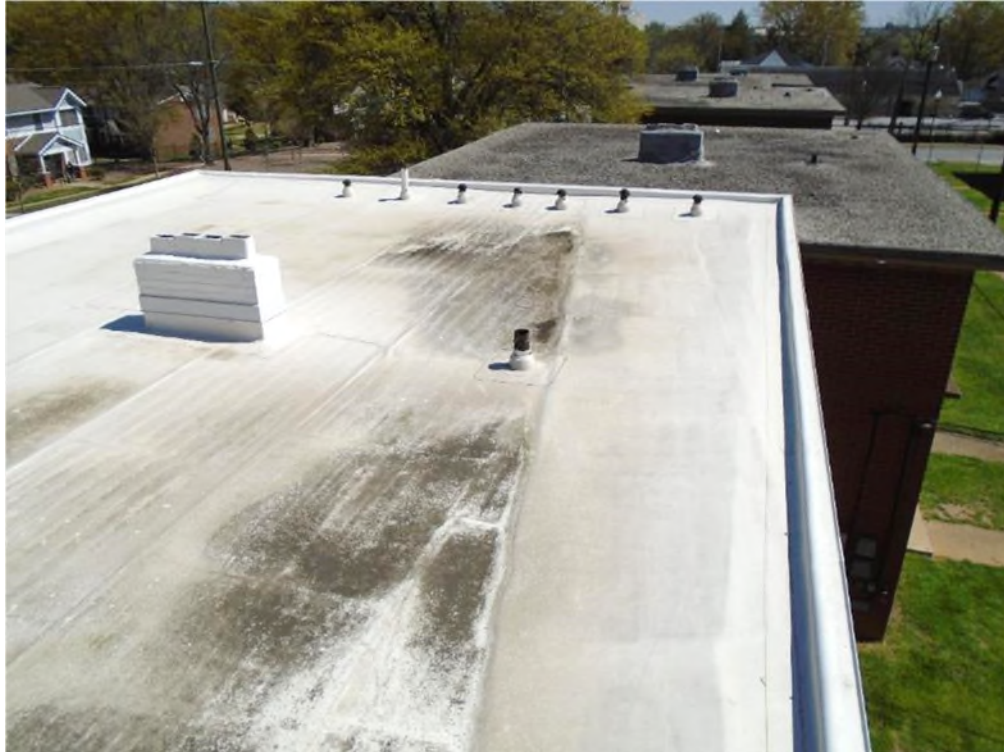
Photograph 9 - BLDG 2 - TPO roof overview

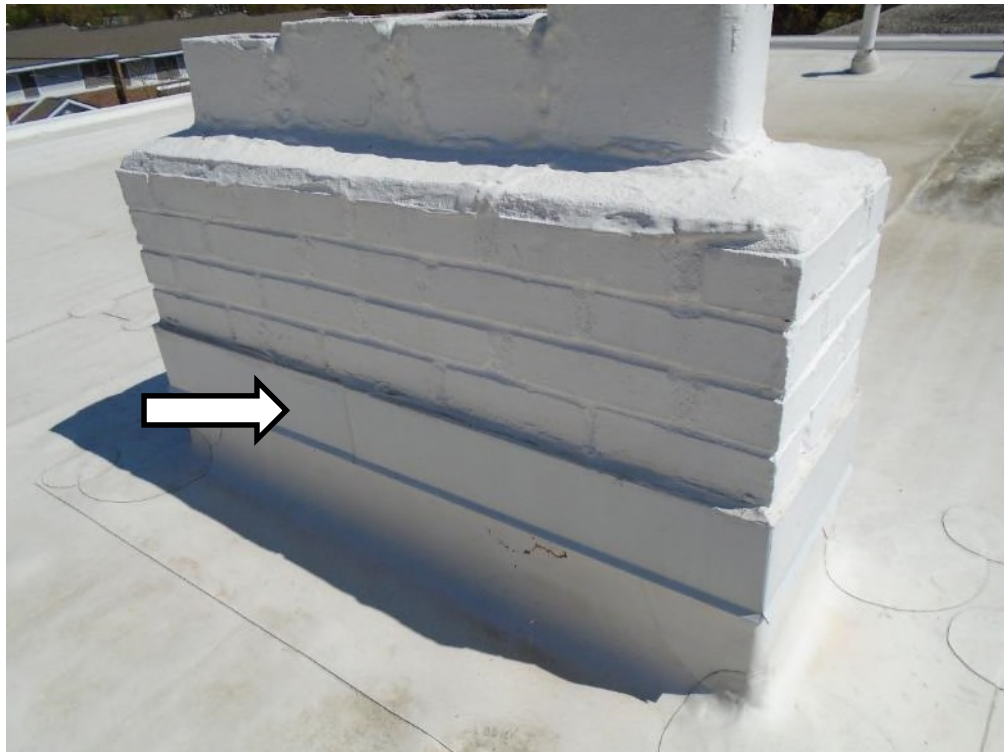
Photograph 10 - BLDG 2 - Chimney flashing and coating on TPO roof

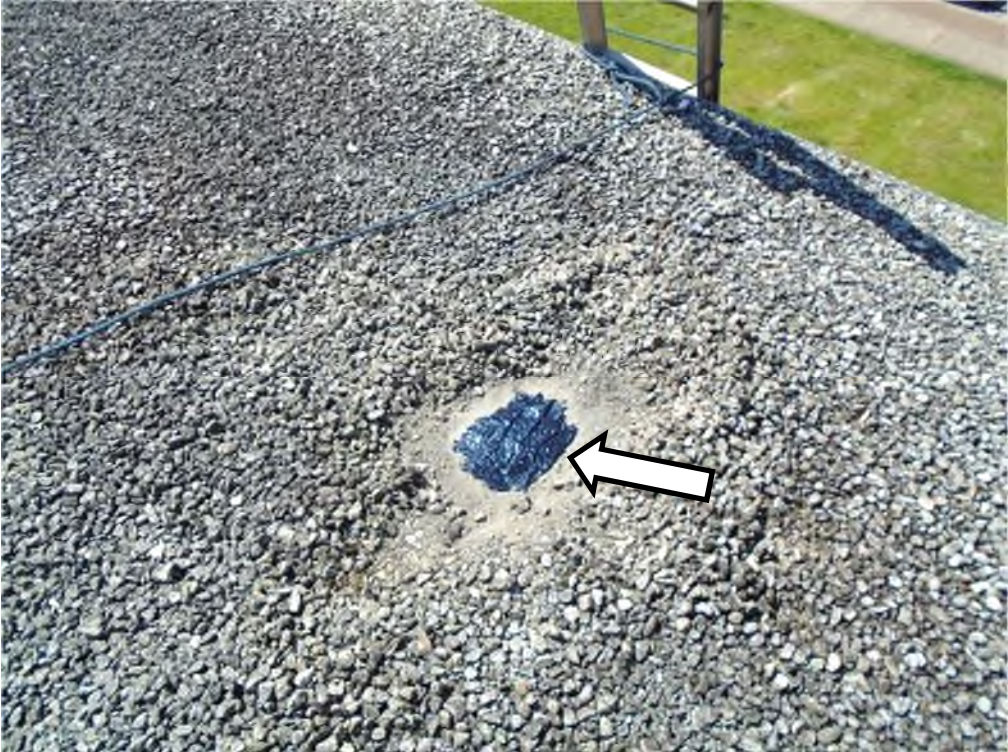
- Roof coring – the roof membrane was sampled by twisting a sharpened steel core barrel through the substrate. The sample was extracted for visual observations and additional testing. The insulation was moist or wet in 6 of the 8 cores performed. The roofing materials collected were placed in an individually sealed container and labeled. The core was repaired using a two ply seal surfacing material with an all-weather roofing cement.
- The 8 samples were forward to an environmental laboratory, using a chain of custody, where asbestos analysis was performed. Polarized Light Microscopy (PLM) analysis revealed Chrysotile fibers ranging from 5 to 25 percent in 5 of the 8 samples. The individual test results are presented in this report.

Photograph 11 - BLDG 2 – Wet insulation in test core

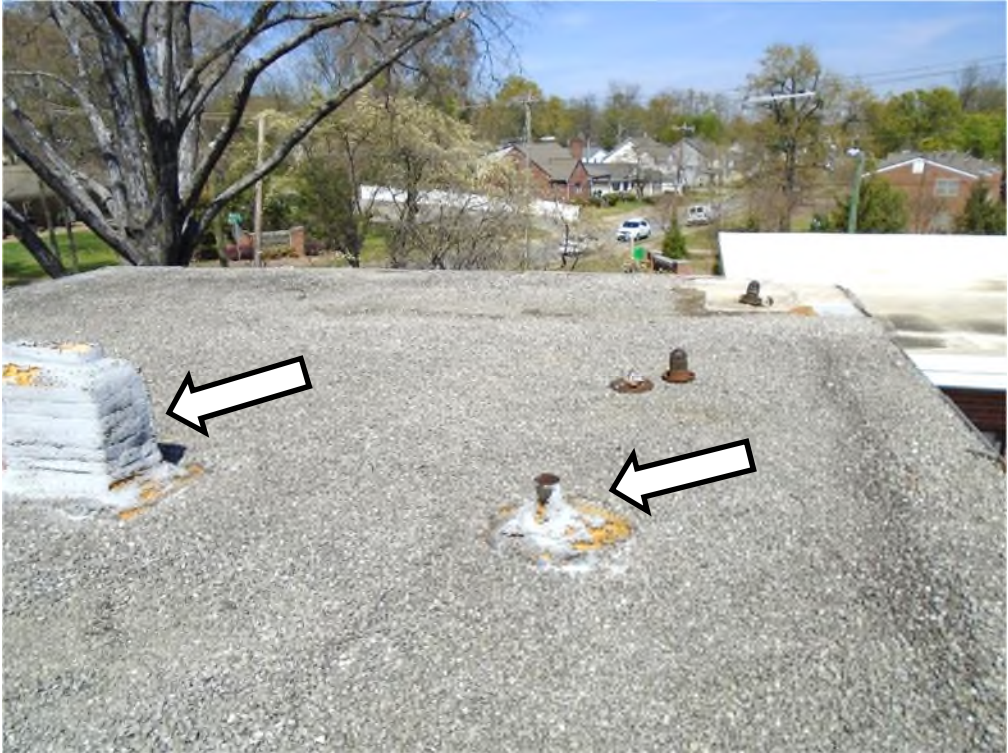
Photograph 12 - BLDG 2 – Deteriorated foam

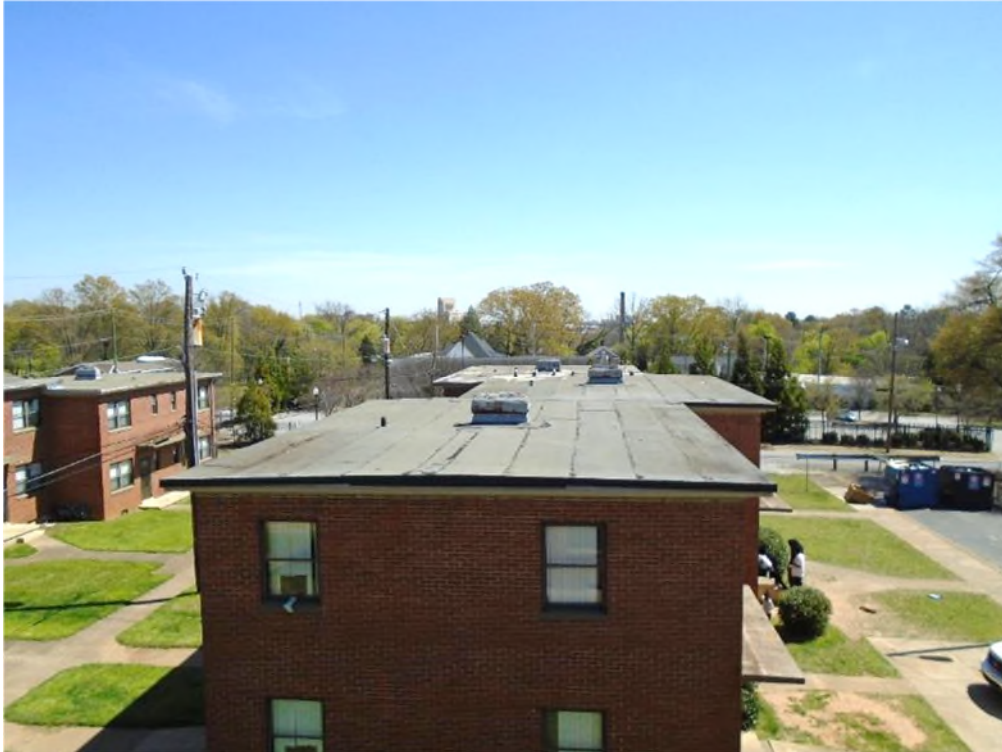
- Modified Bitumen - A two ply modified bitumen roof was observed on five of the roof areas (approximately 5,000 square feet). This roof appeared to have been installed over the original built-up roof (BUR), as well as the spray foam roof. The exposed asphalt on the membrane laps and flashings had severe cracking. The membrane laps were loose and open at several locations. Exposed fasteners were found in the laps and around the perimeter of the roof. Multiple repairs were found throughout with evidence of cracking and lack of adhesion to the elastomeric coating; and

Photograph 13 - BLDG 3 – Overview of Modified Bitumen roof

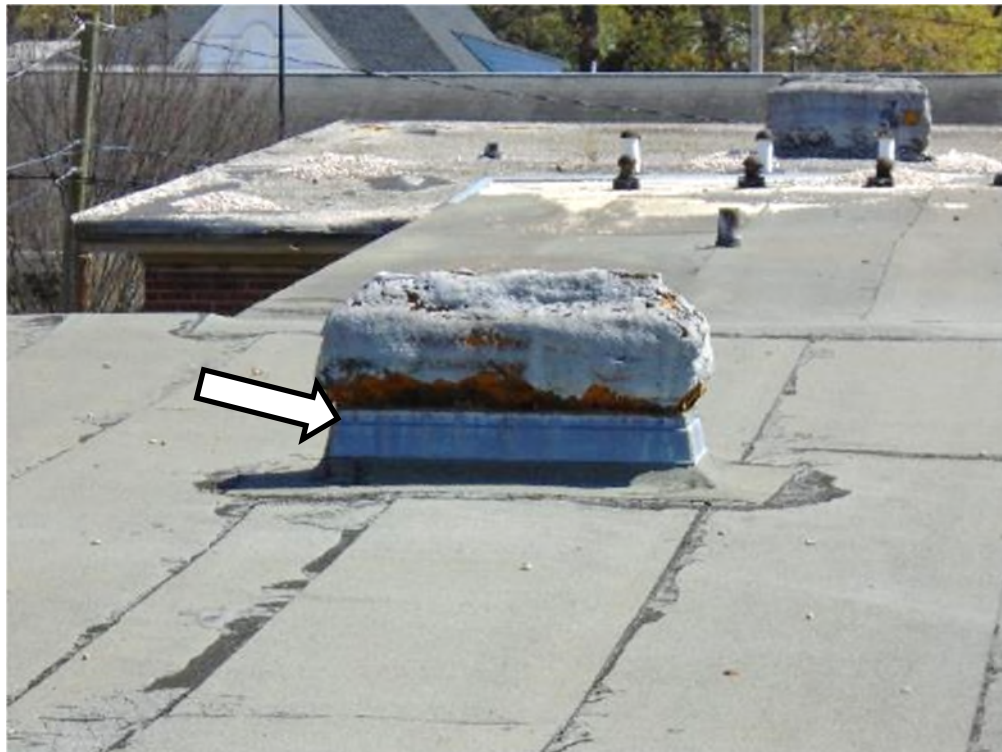
Photograph 14 - BLDG 3 – Counter flashing in fair condition

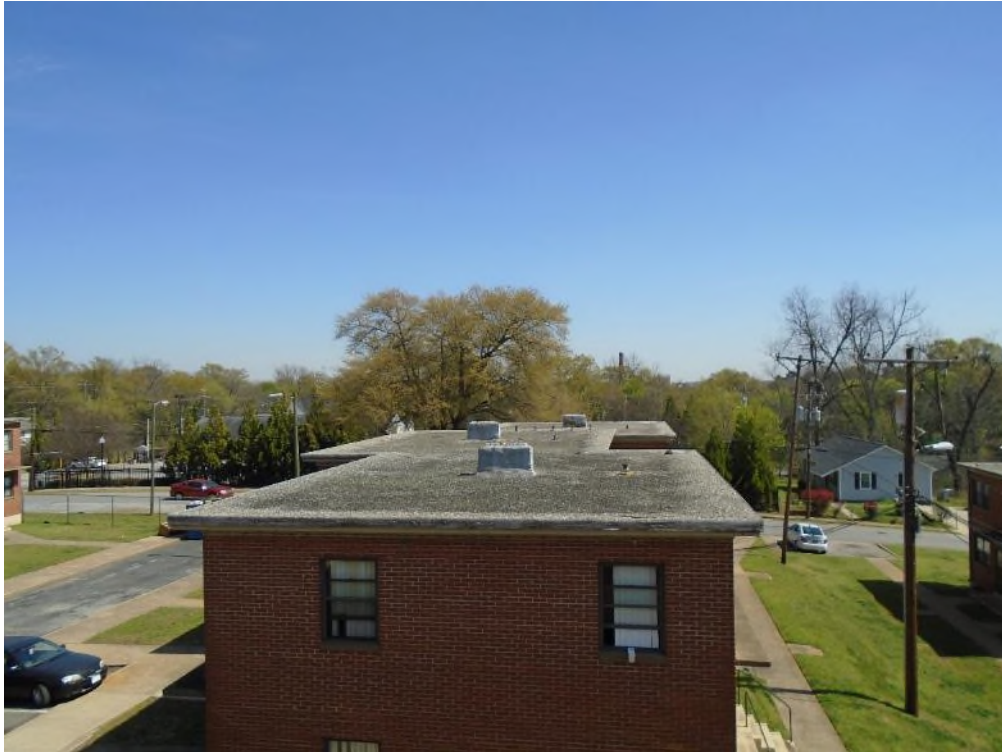
Photograph 15 - BLDG 4 – Overview looking east

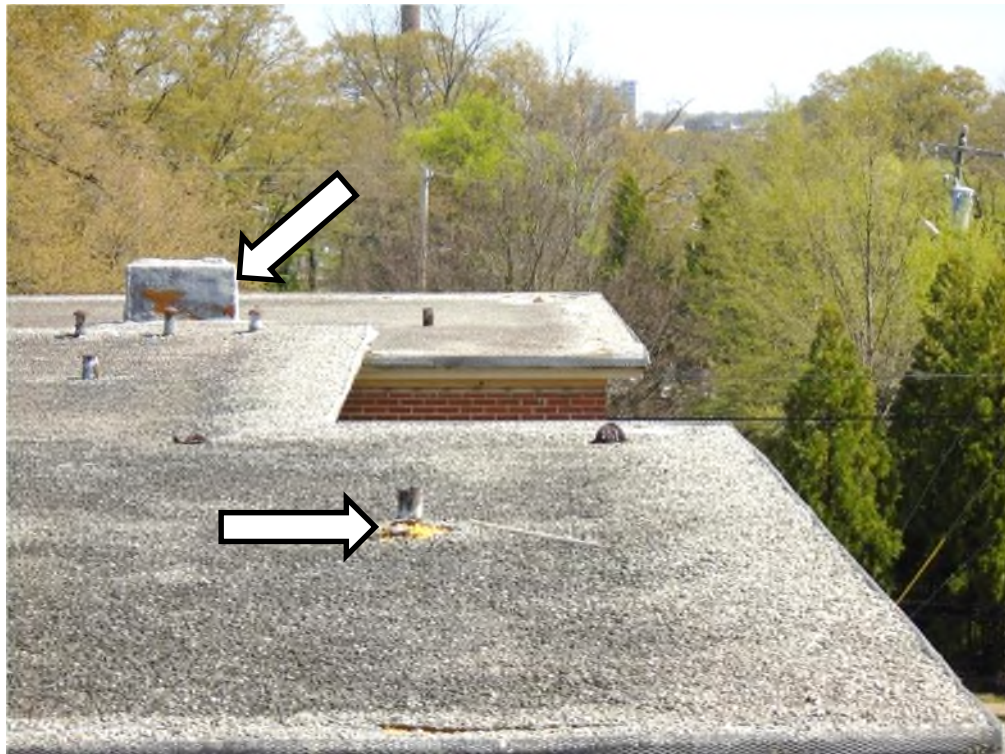
Photograph 16 - BLDG 4 - Deteriorated foam at chimney and penetrations

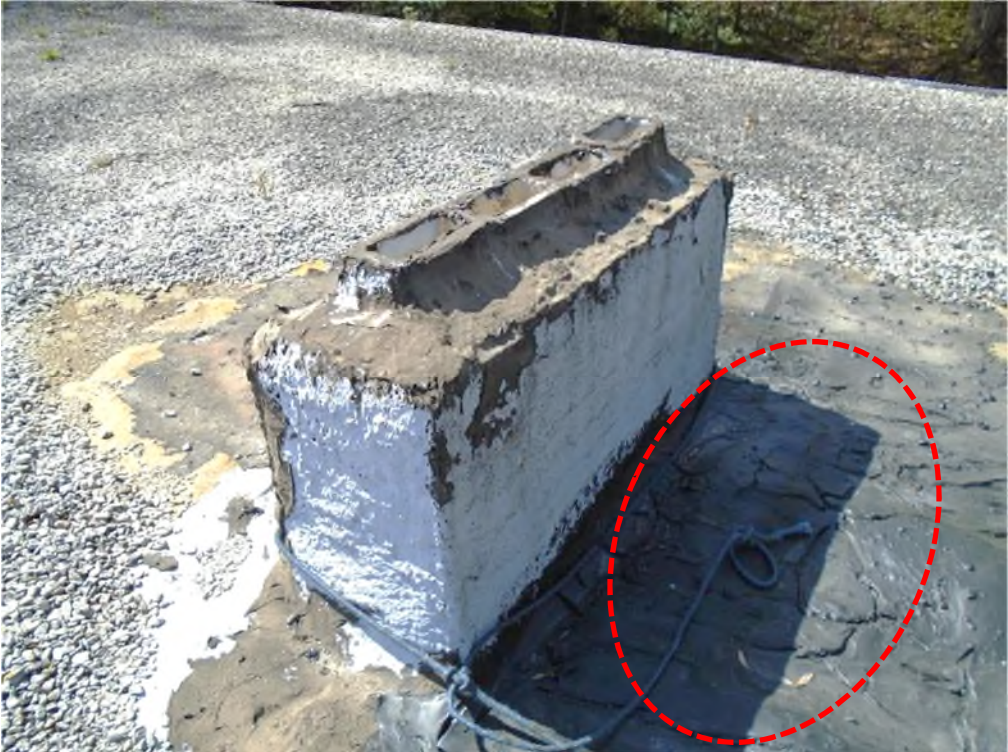
Photograph 17 - BLDG 5 - Failed repair to chimney

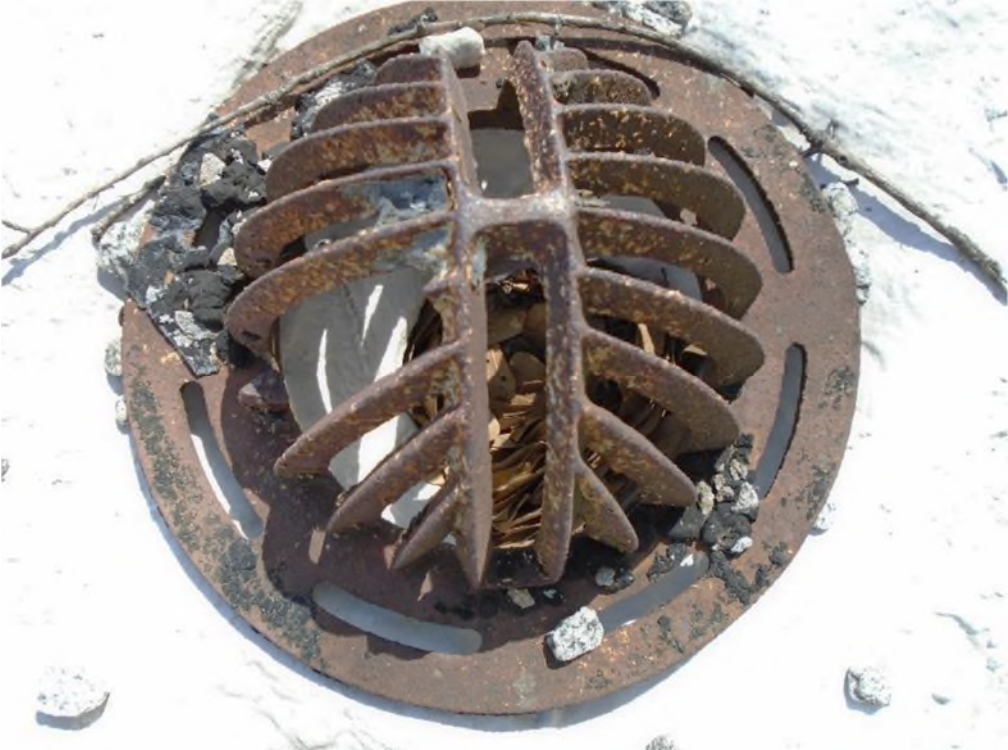
Photograph 18 - BLDG 5 - Damaged strainer and clogged drain

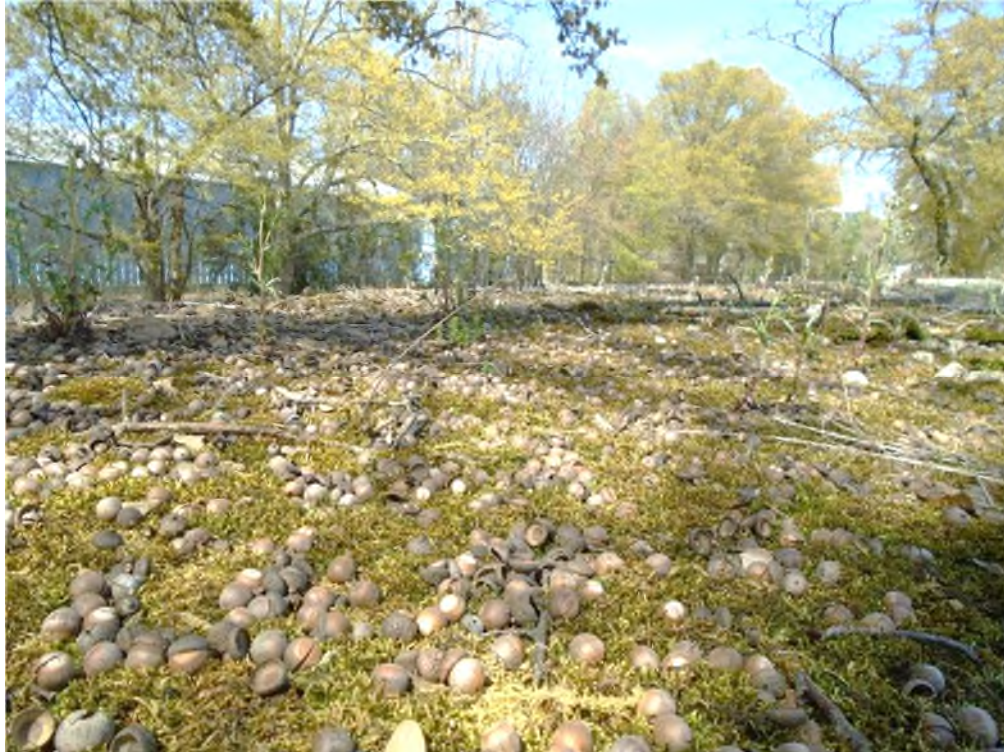
Photograph 19 - BLDG 5 – Vegetation growth

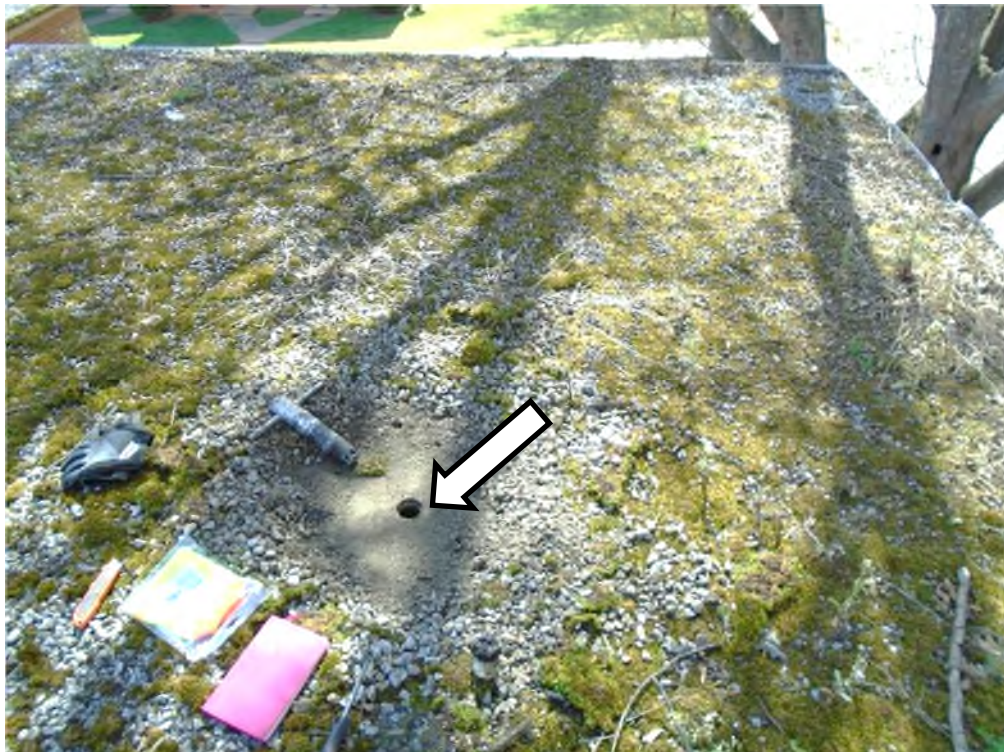
Photograph 20 - BLDG 5 – Wet insulation at core location

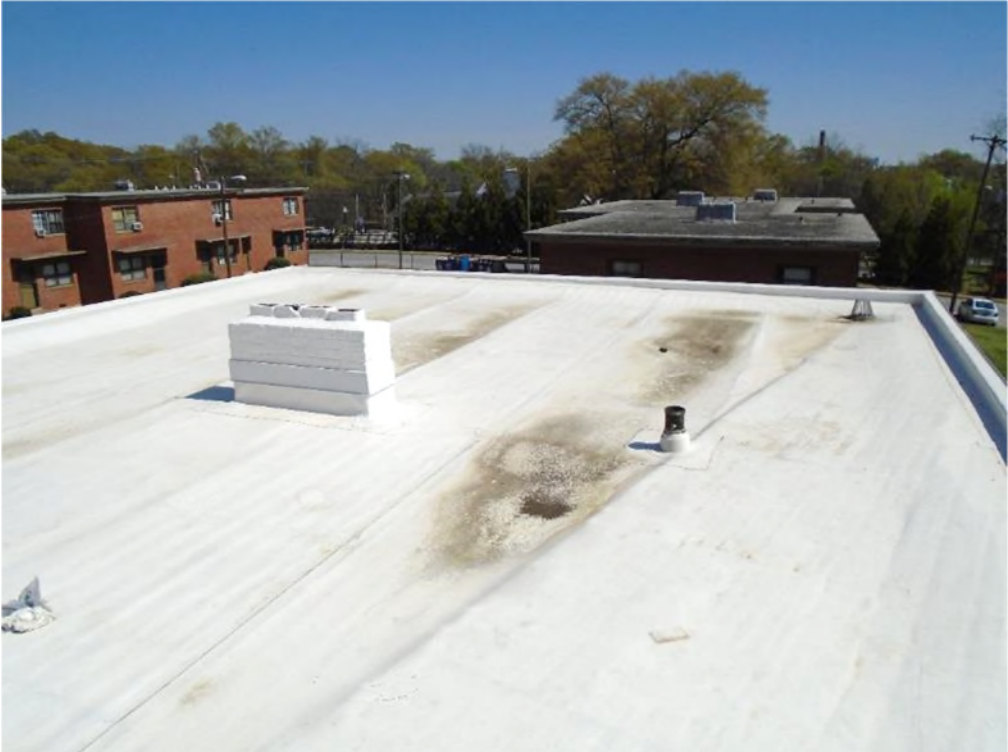
Photograph 21 - BLDG 5 – Minor staining on TPO roof

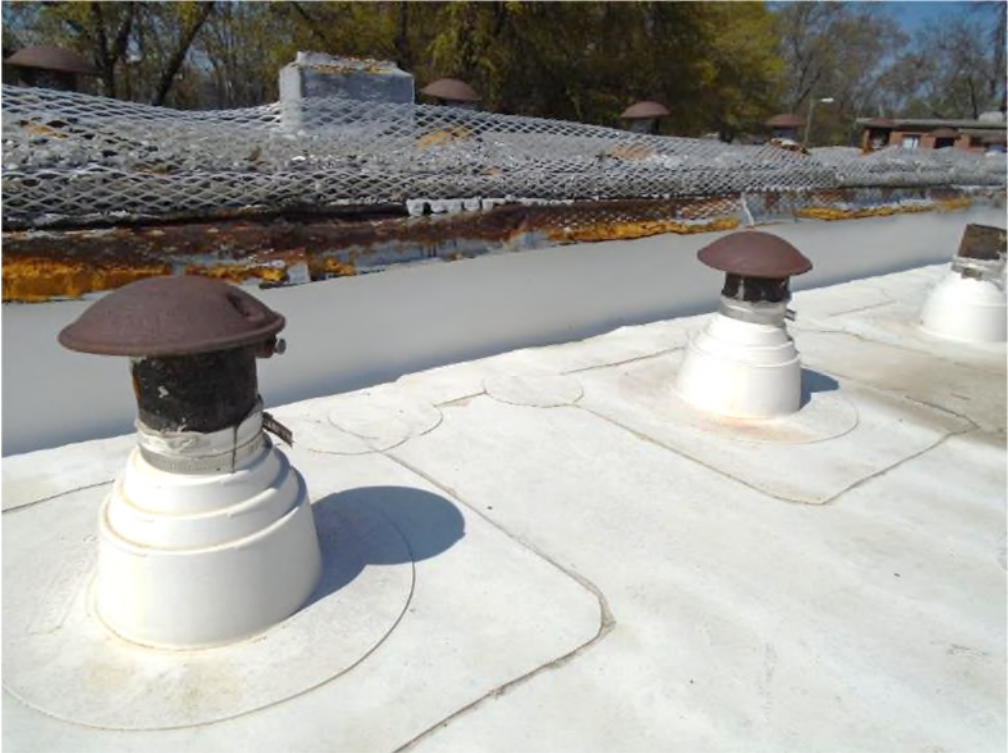
Photograph 22 - BLDG 5 – Vent pipe flashings in good condition

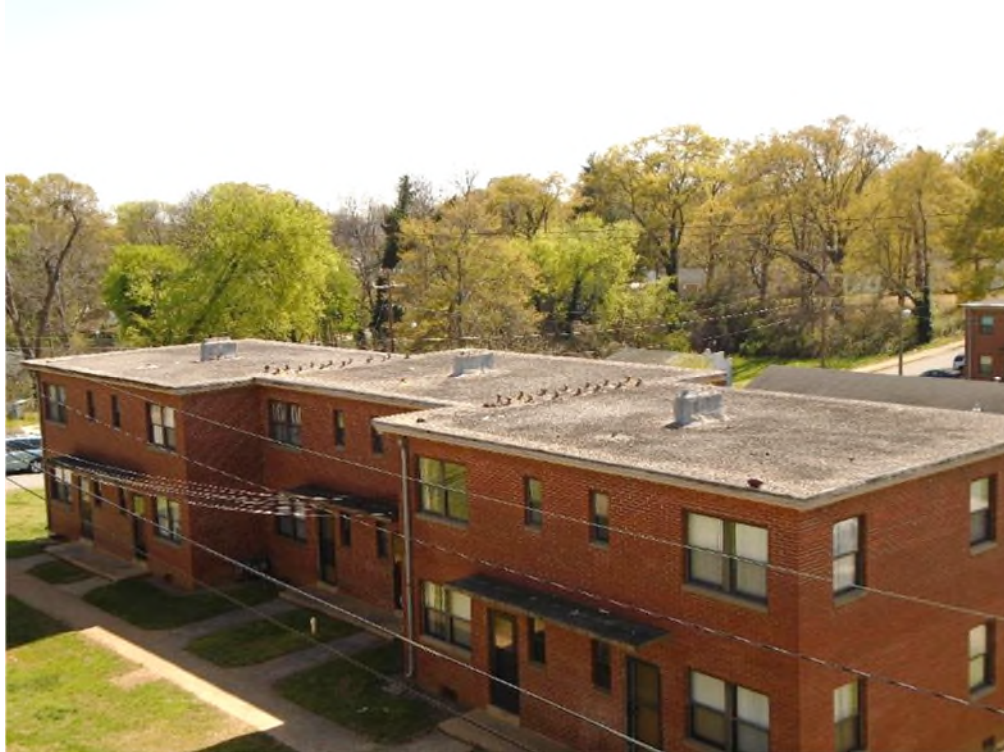
Photograph 23 - BLDG 6 - Overview

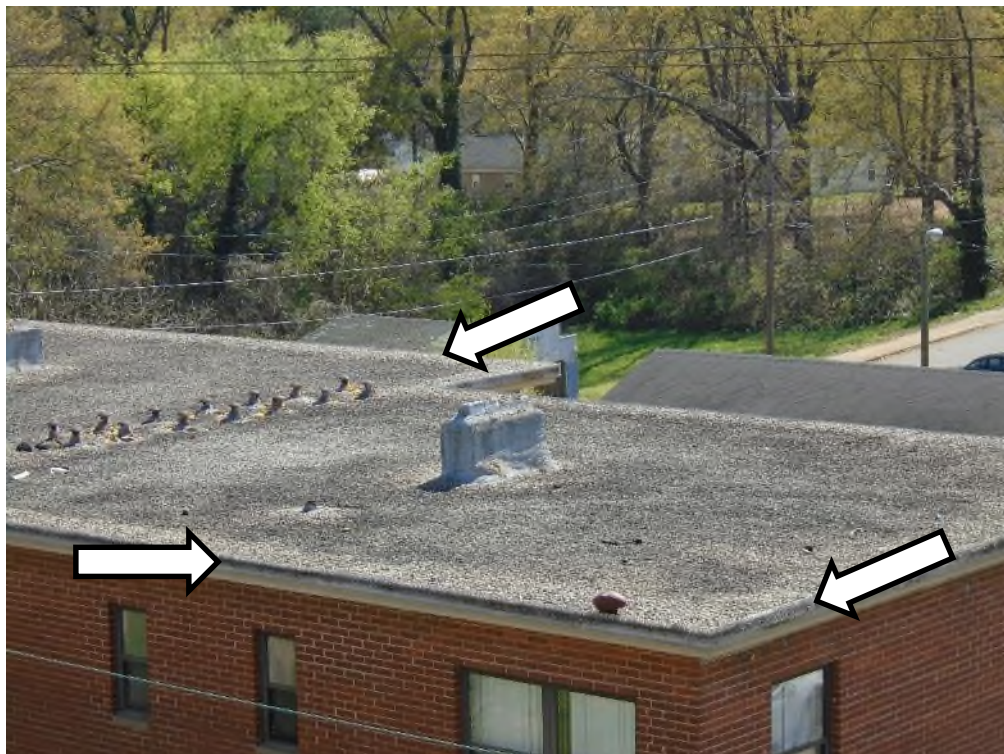
foam insulation with deterioration and gaps in the protective coating. The outer edge, or gravel stop, had a wire mesh attached to the side to hold the excess gravel on the roof. In addition to the visual observations, 8 separate roof locations were selected for additional core sampling and analysis. The approximate test locations are shown on the attached Roof Plan at the end of this report. The following testing was performed:

Photograph 24 - BLDG 6 – Wire mesh used as gravel stop

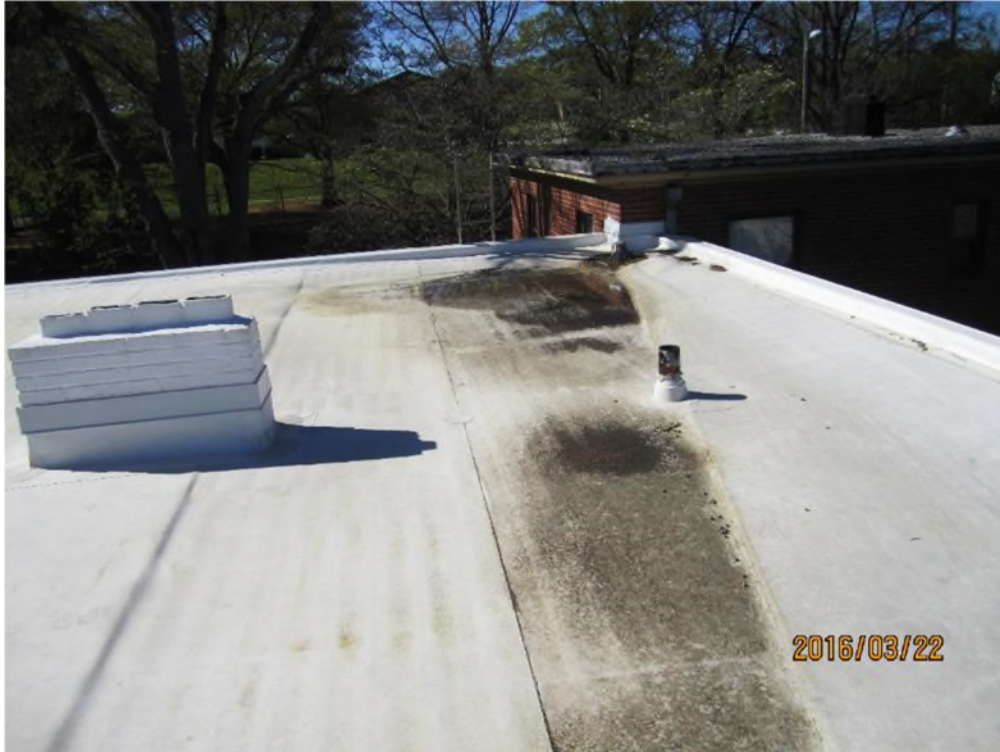
Photograph 25 - BLDG 7 – Minor staining on TPO roof

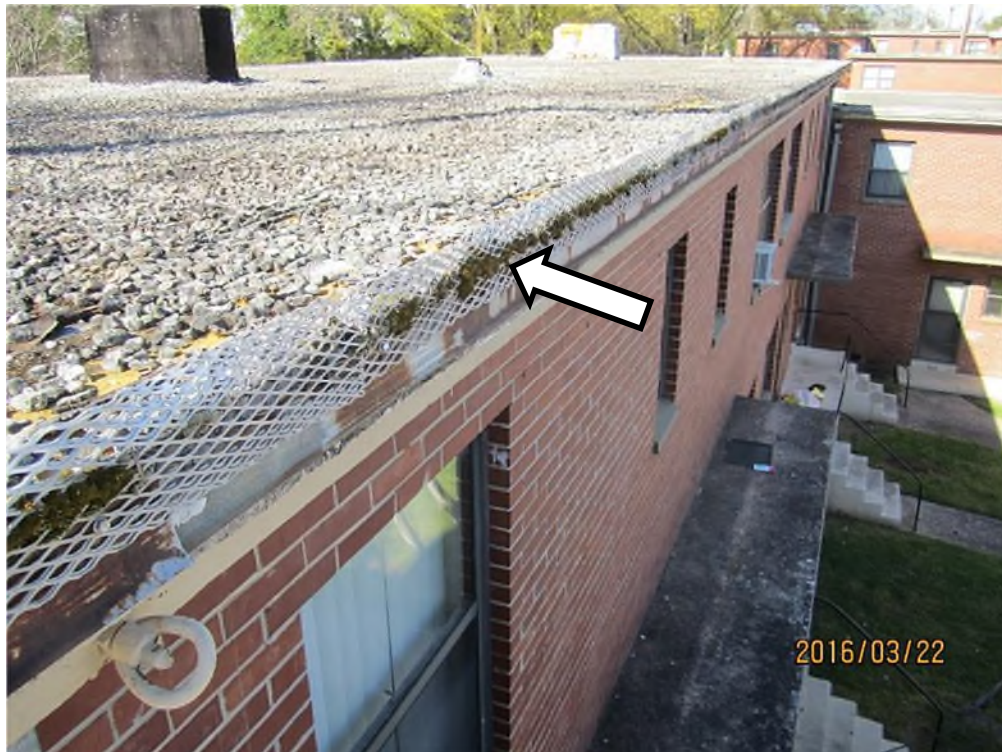
Photograph 26 - BLDG 7 - Vegetation along roof edge

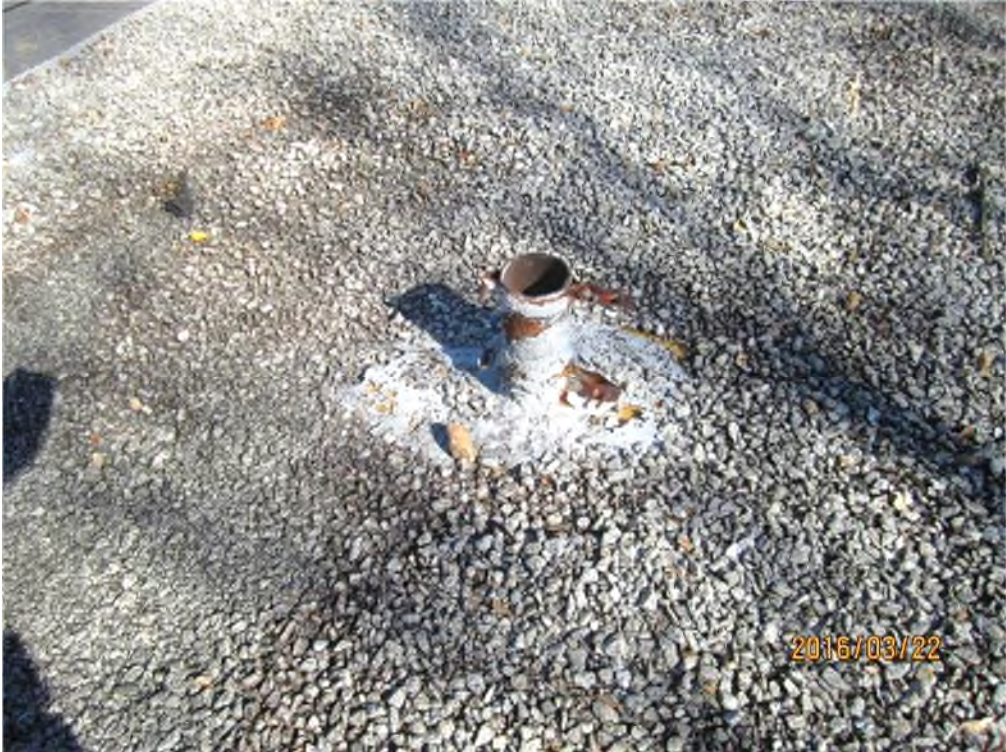
Photograph 27 - BLDG 7 – Deteriorated pipe flashing

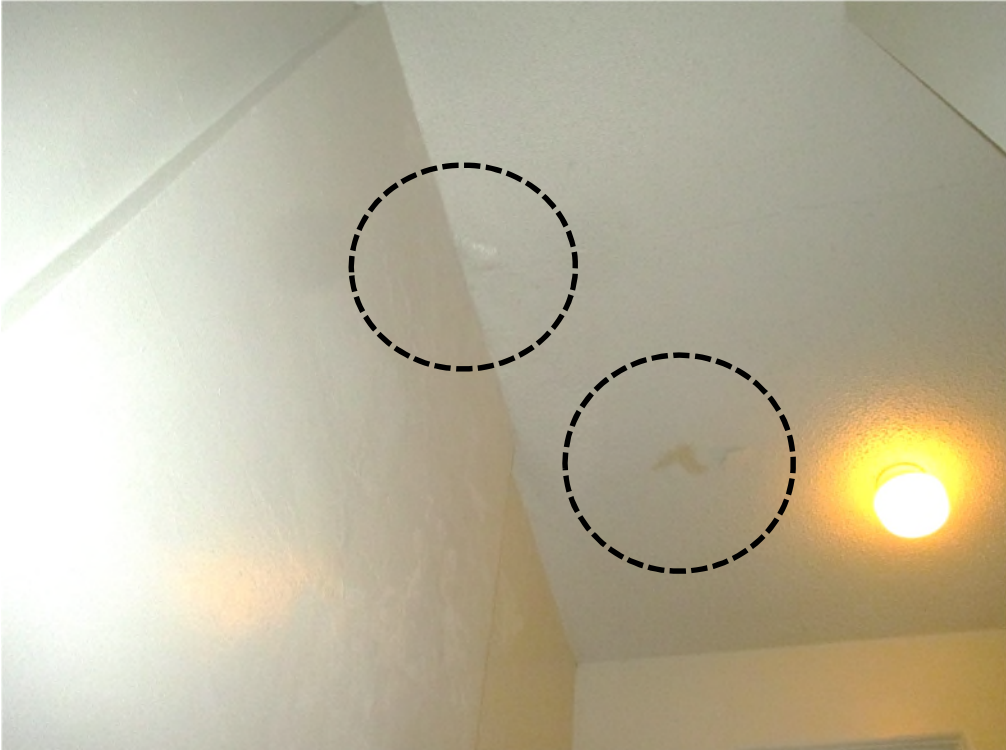
Photograph 28 - BLDG 7 – Moisture staining

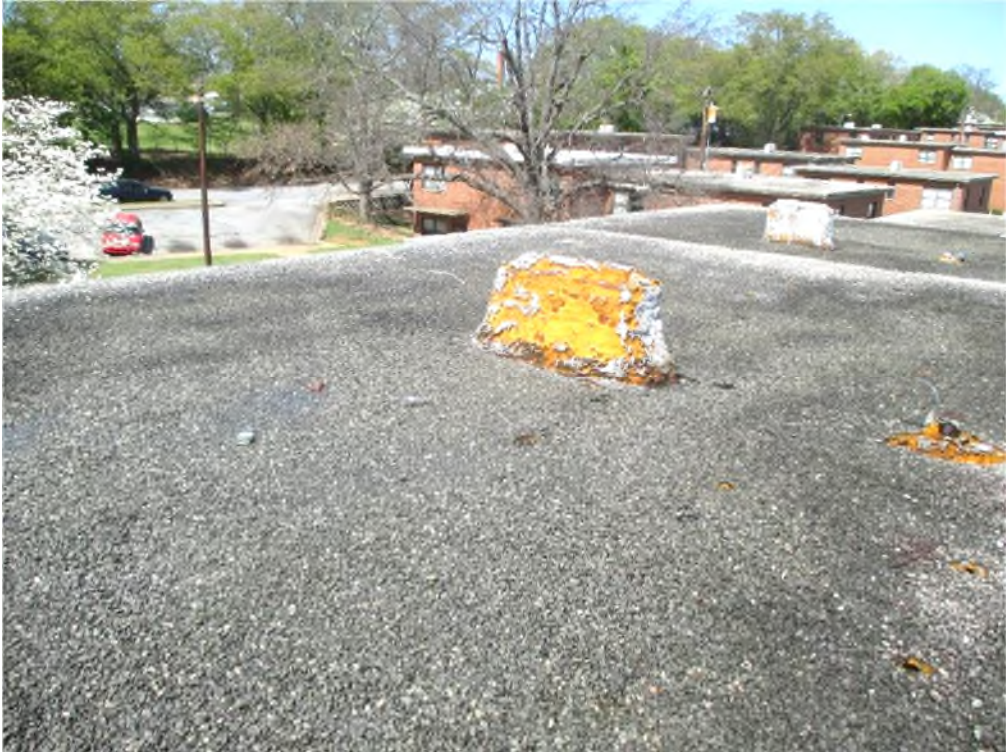
Photograph 29 - BLDG 8 – Overview looking west
