VISUAL ROOF SURVEY

OAKVIEW APARTMENTS

650 Howard Street
Spartanburg, South Carolina

Reference: Report of Roof Survey
Oakview Apartments
650 Howard Street
Spartanburg, South Carolina
REI Project No. GSP1033.001

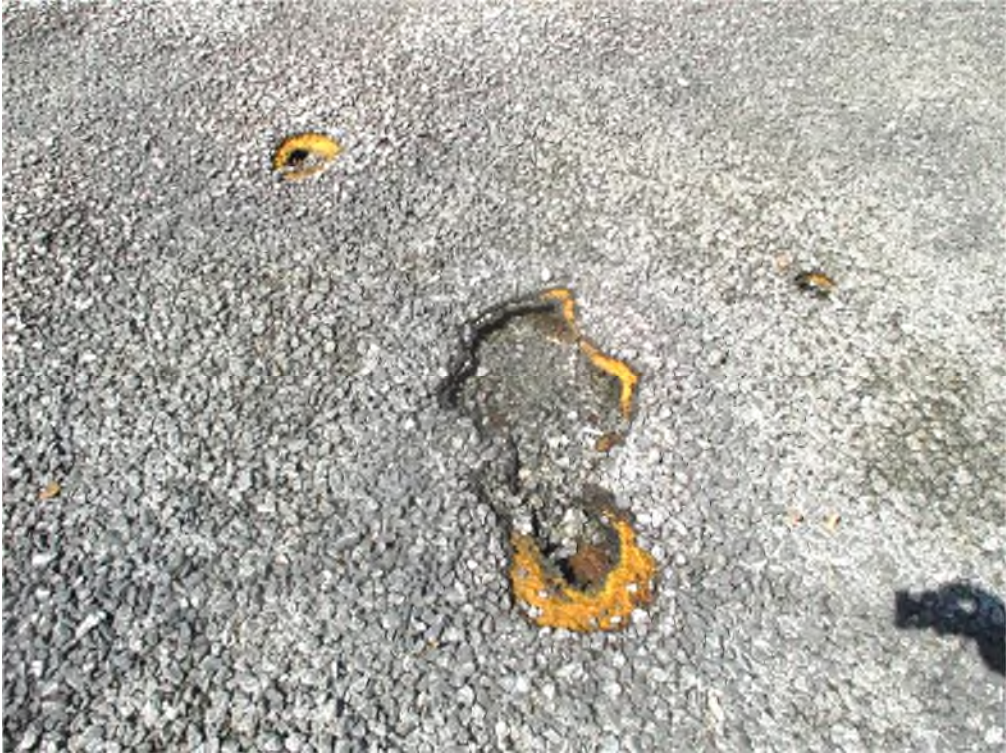
Photograph 30 - BLDG 8 – Voids in roof surface

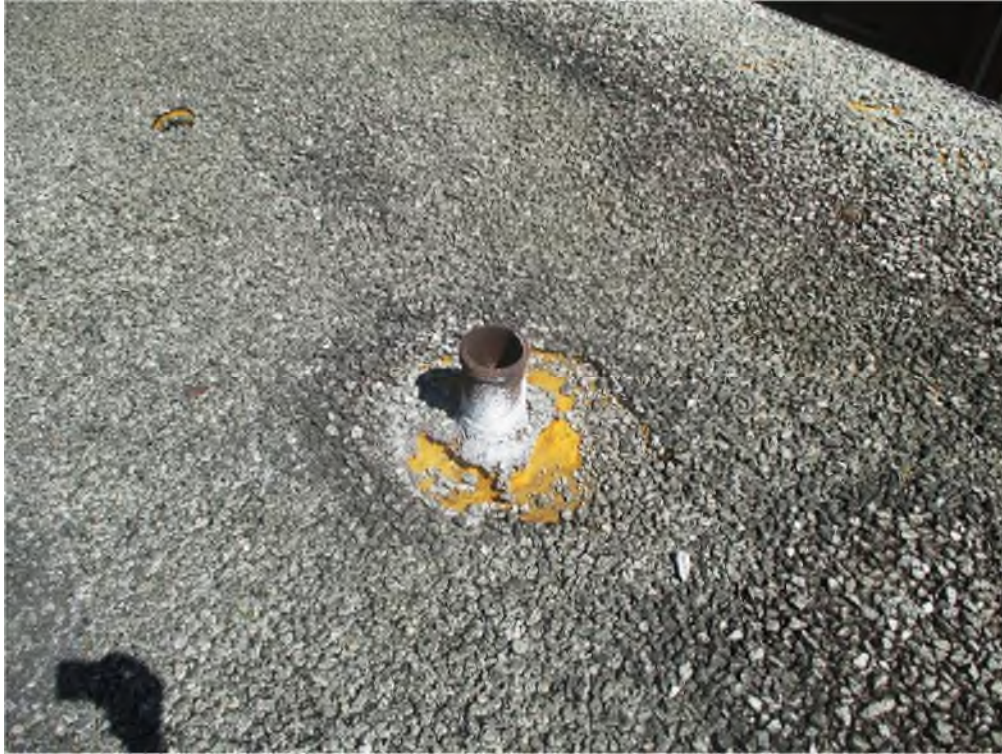
Photograph 31 - BLDG 8 – Deteriorated foam at pipe penetration

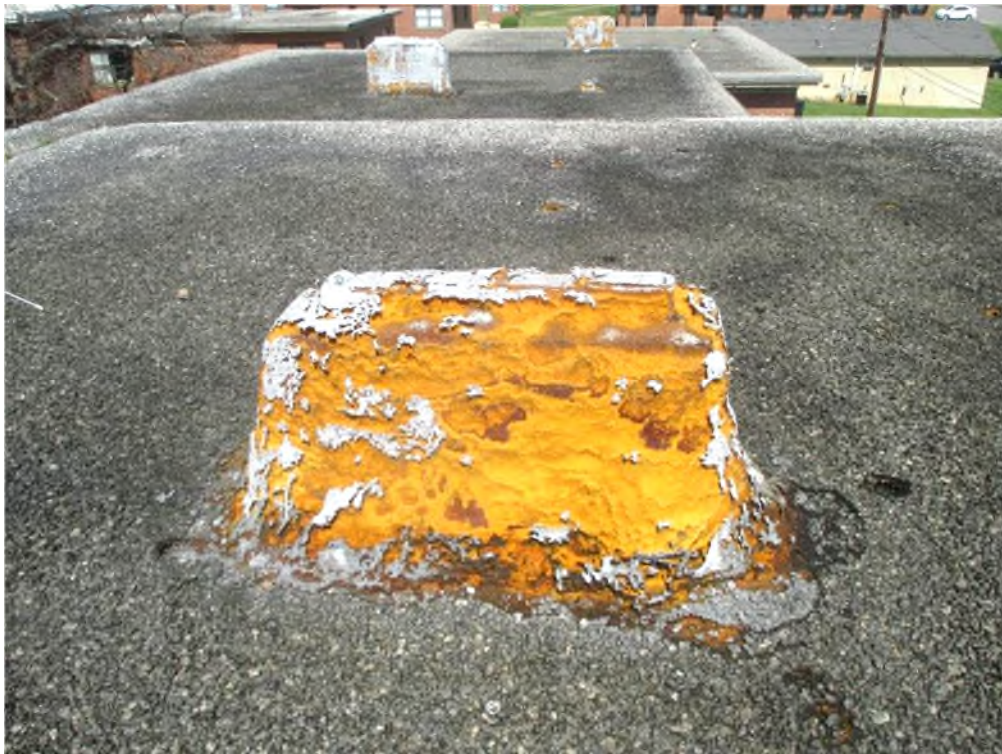
Photograph 32 - Deteriorated foam at chimney

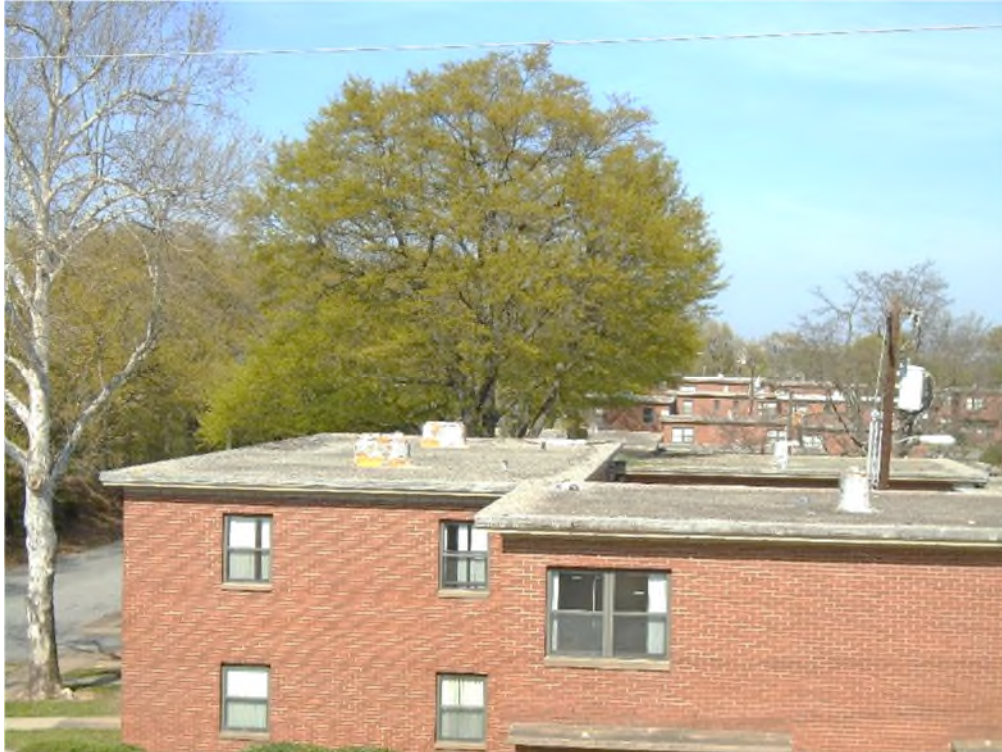
Photograph 33 - BLDG 9 – Overview

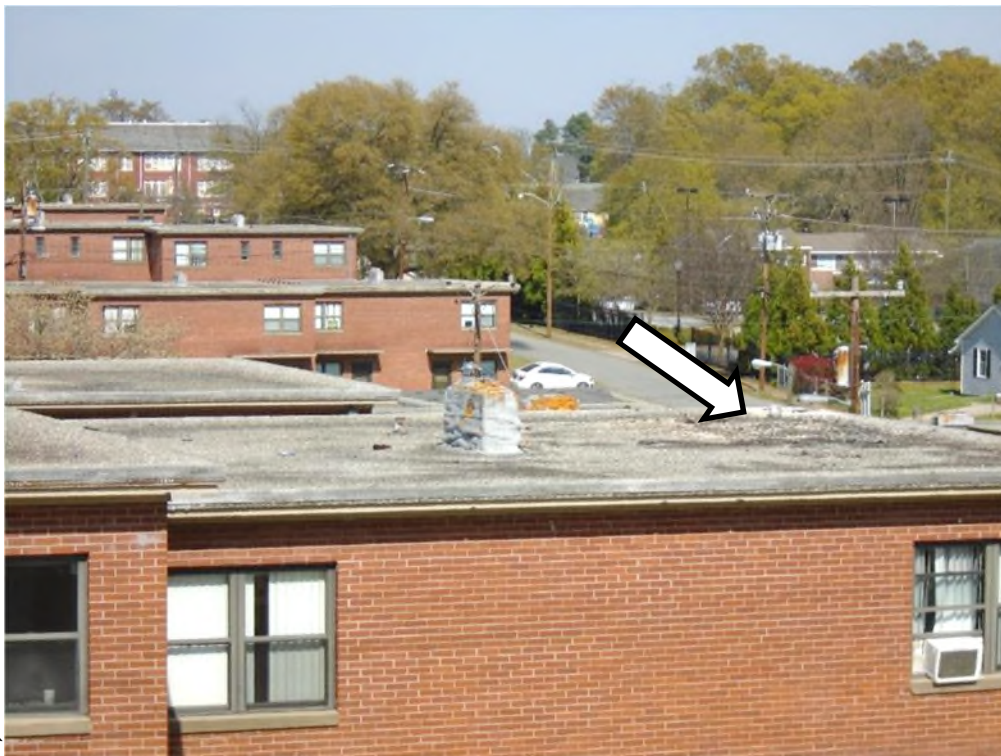
Photograph 34 - BLDG 9 – Repair attempted at northeast corner

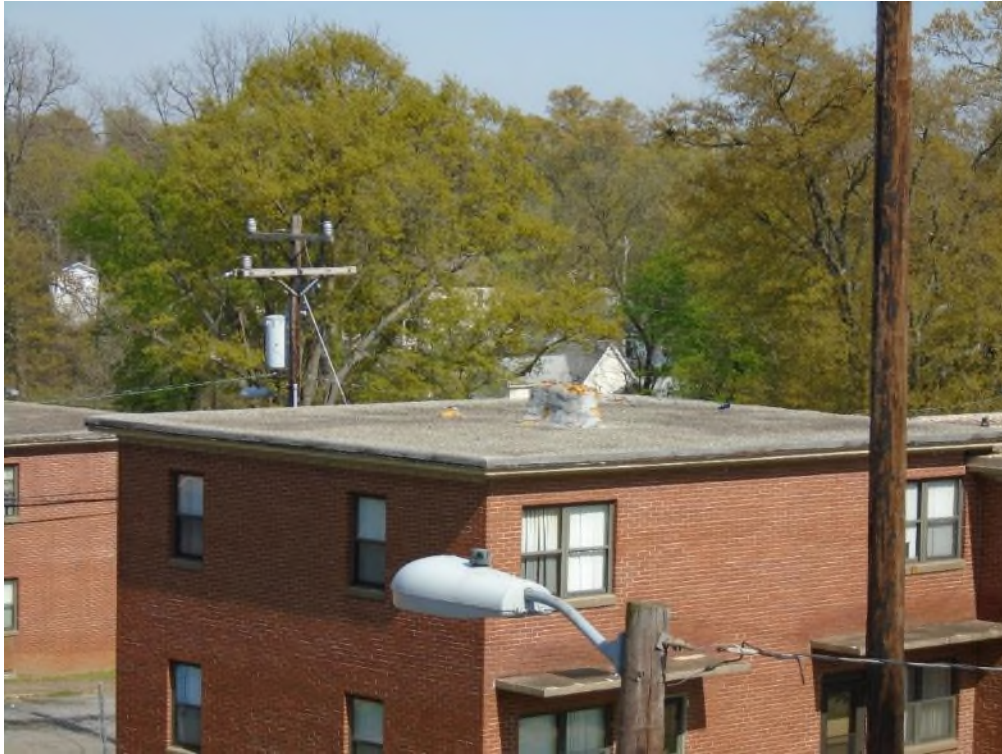
Photograph 35 - BLDG 10 - Overview

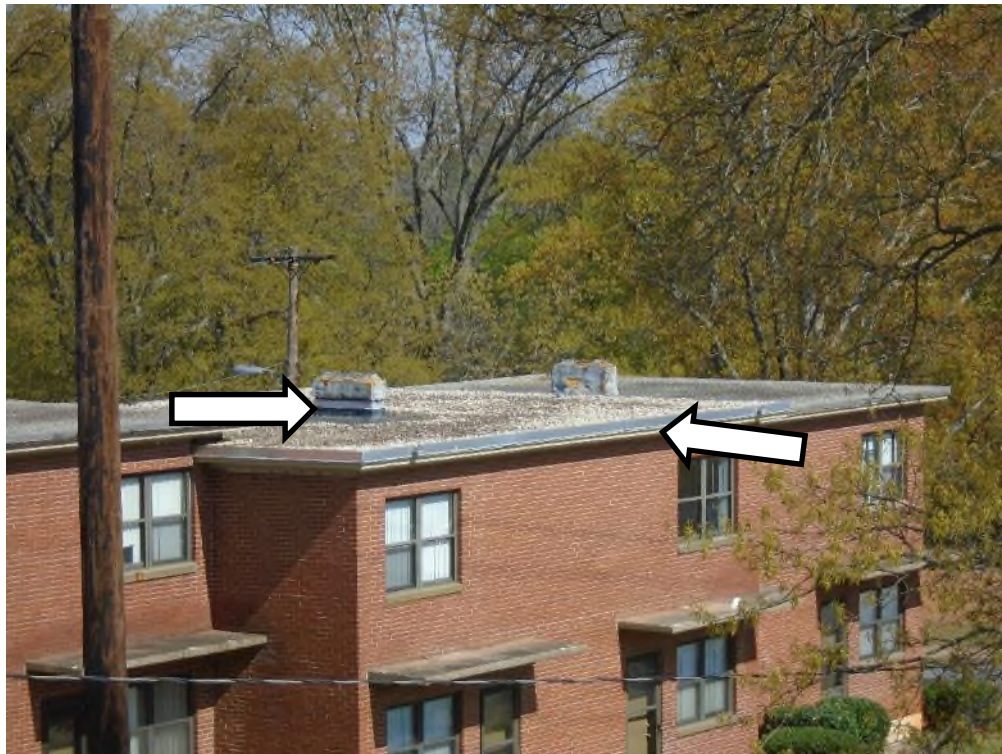
Photograph 36 - BLDG 10 - Metal flashing upgraded after roof installation

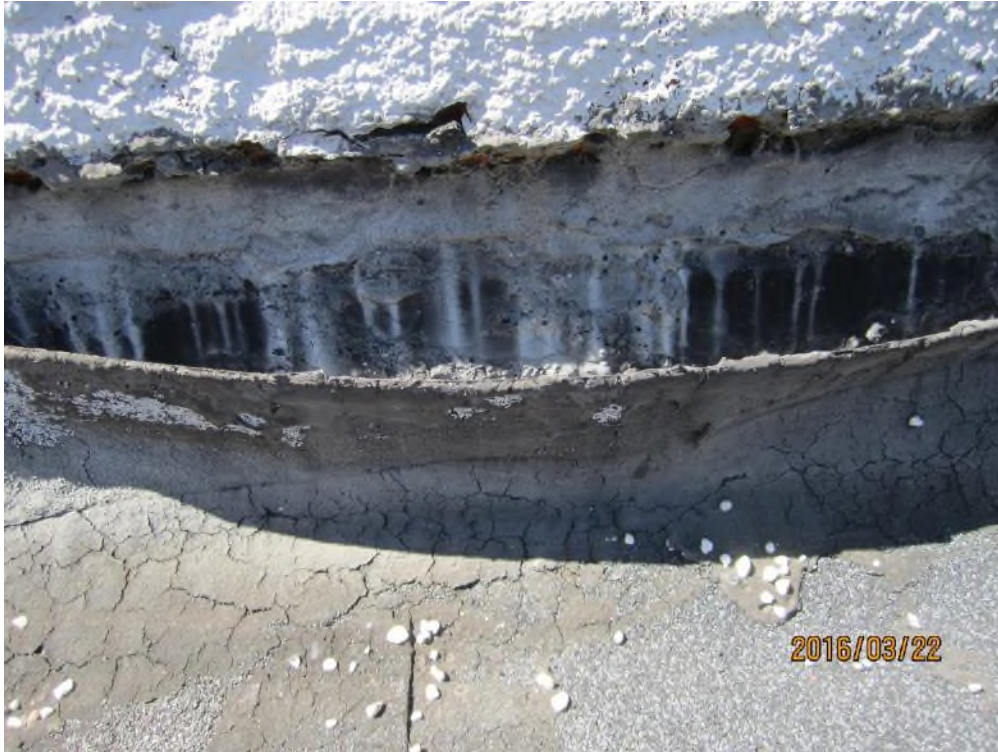
Photograph 37 - BLDG 11 – Loose base flashing at chimney

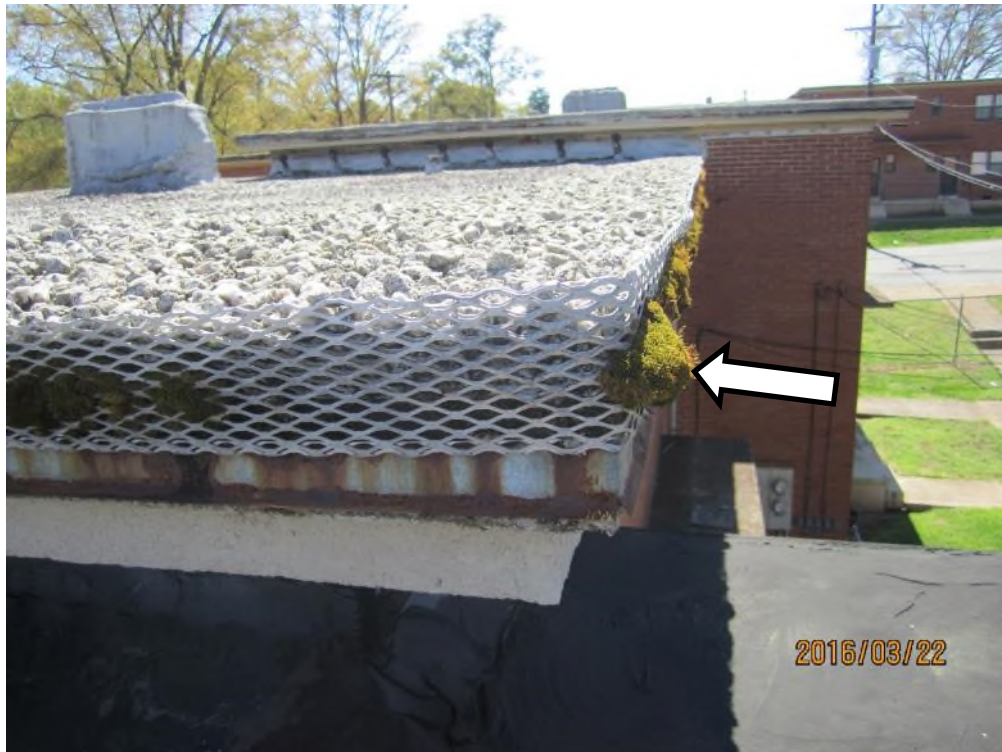
Photograph 38 - BLDG 11 – Vegetation along roof edge

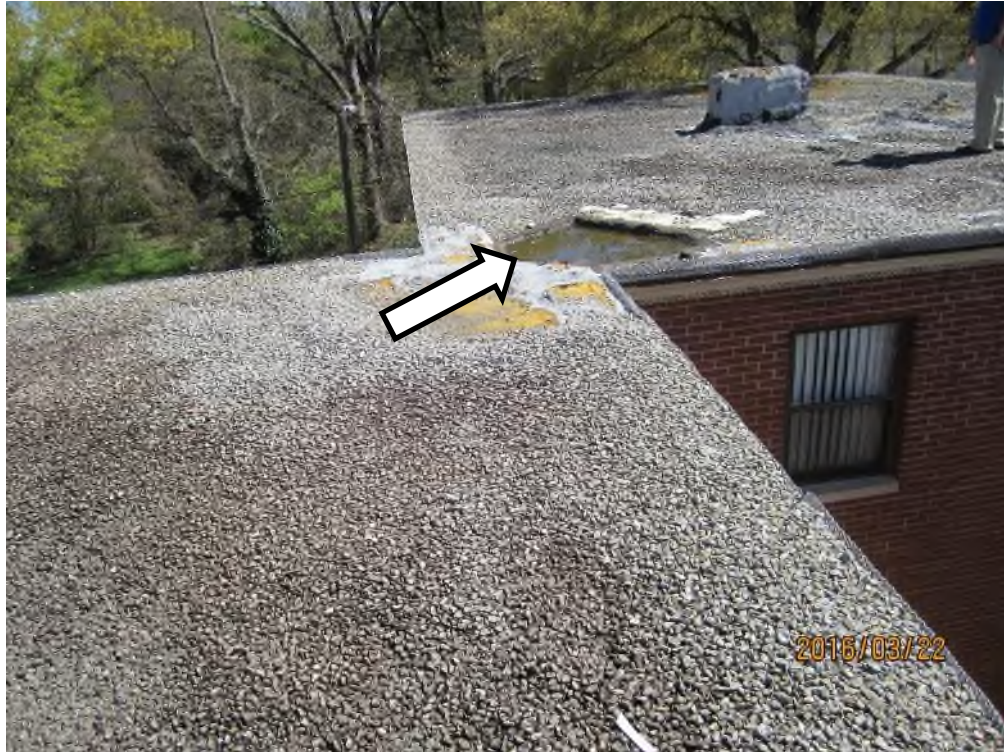
Photograph 39 - BLDG 11 – Water ponded by improper scupper construction

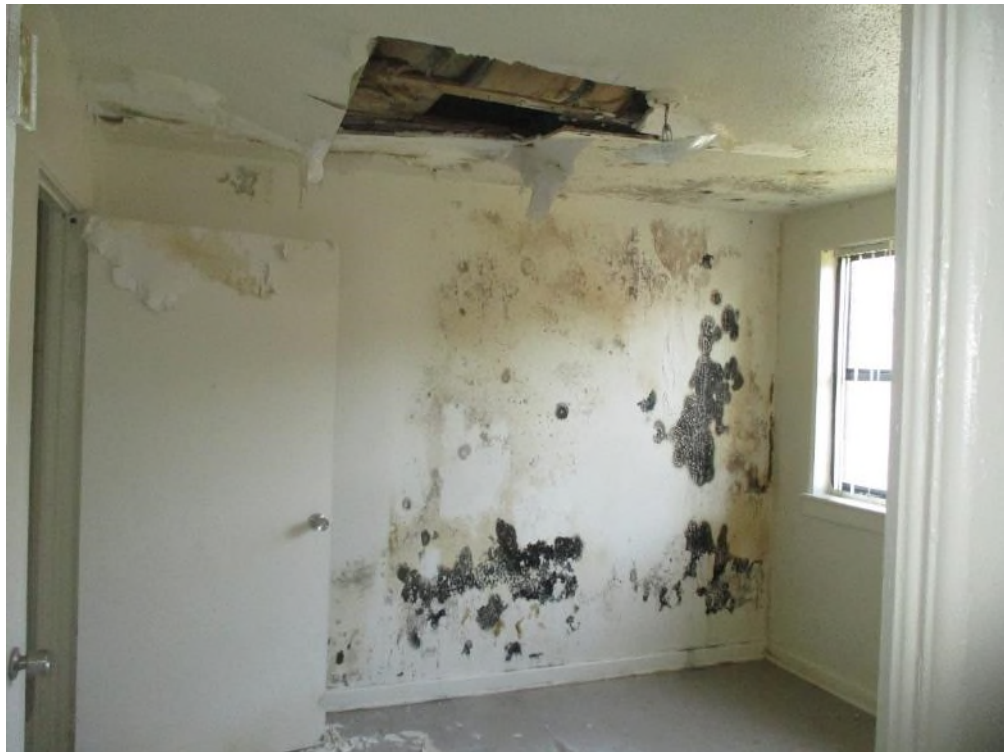
Photograph 40 - BLDG 11 – Partial ceiling collapse and microbial growth

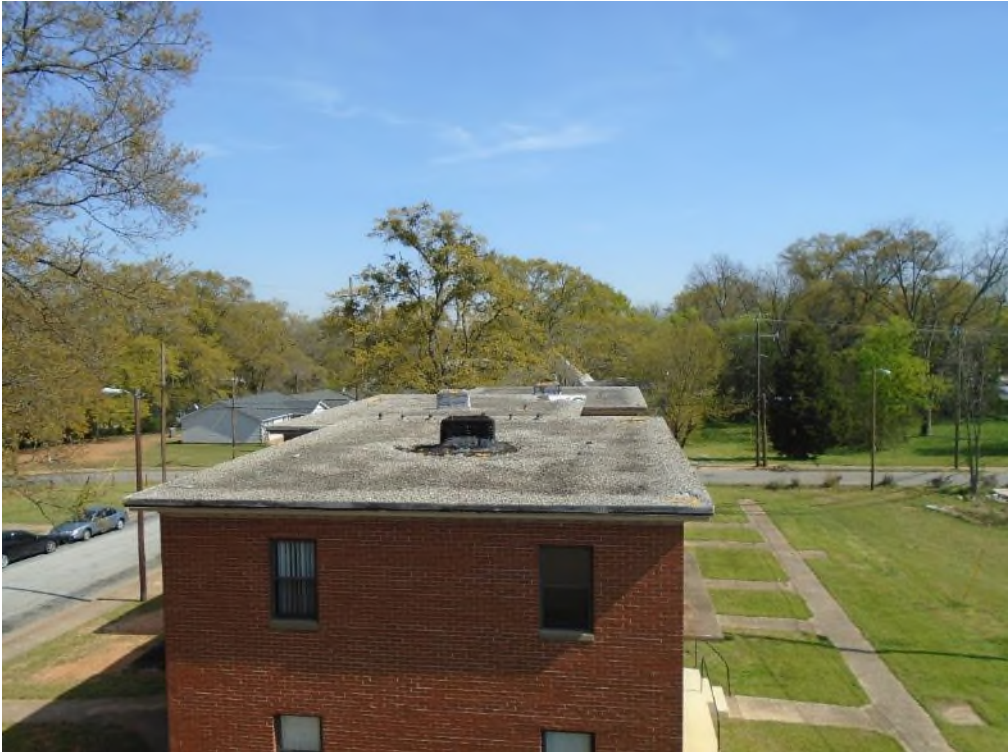
Photograph 41 - BLDG 12 – Overview looking east

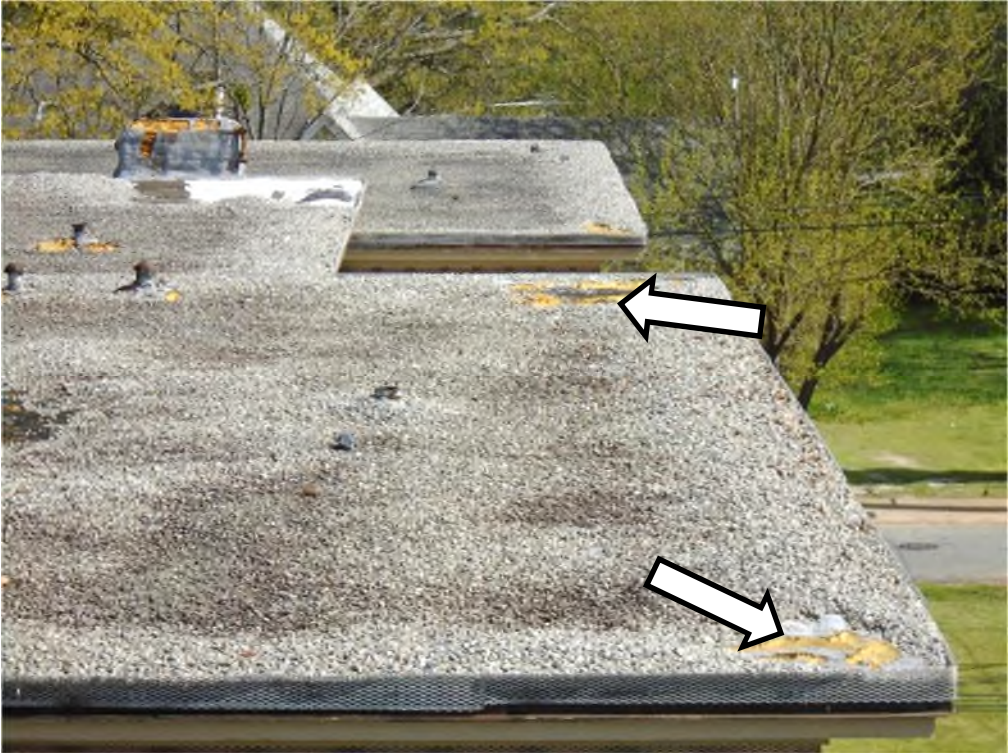
Photograph 42 - BLDG 12 – Deteriorated foam at roof corners

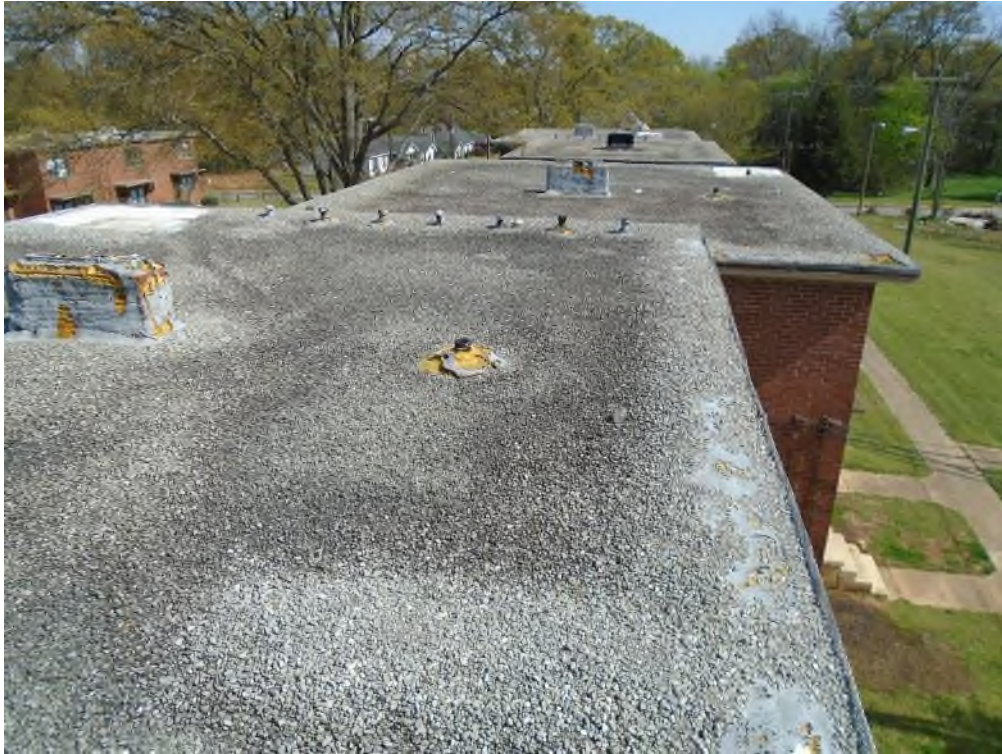
Photograph 43 - BLDG 13 – Overview looking east

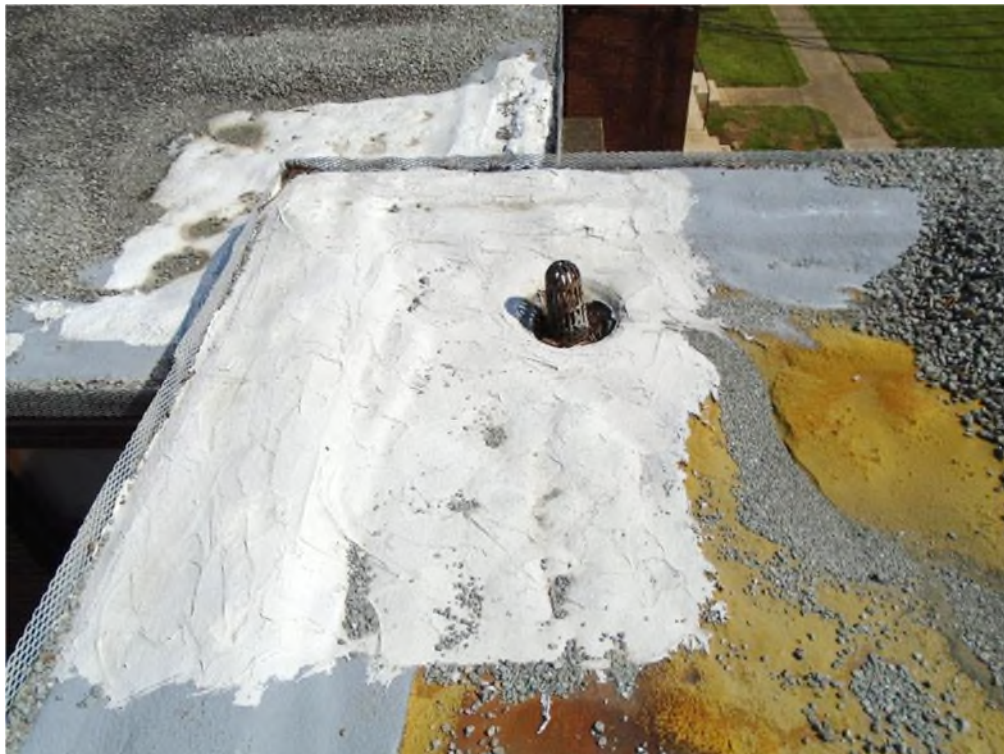
Photograph 44 - BLDG 13 – Multiple repairs made to roof at drain

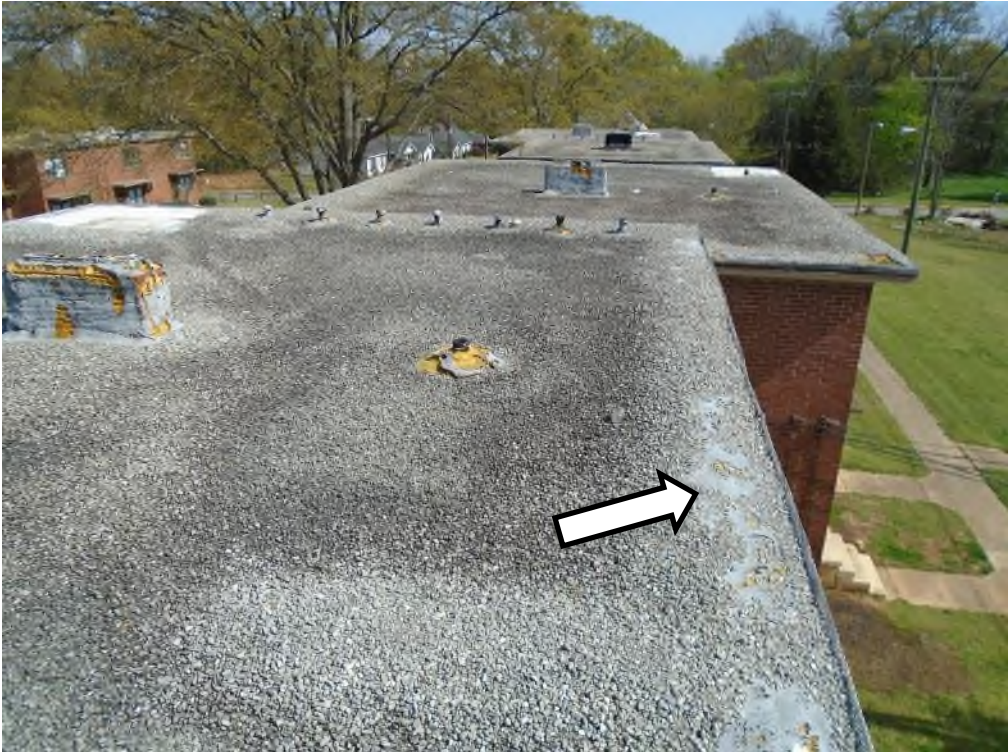
Photograph 45 - BLDG 13 – Deteriorated foam along roof edge

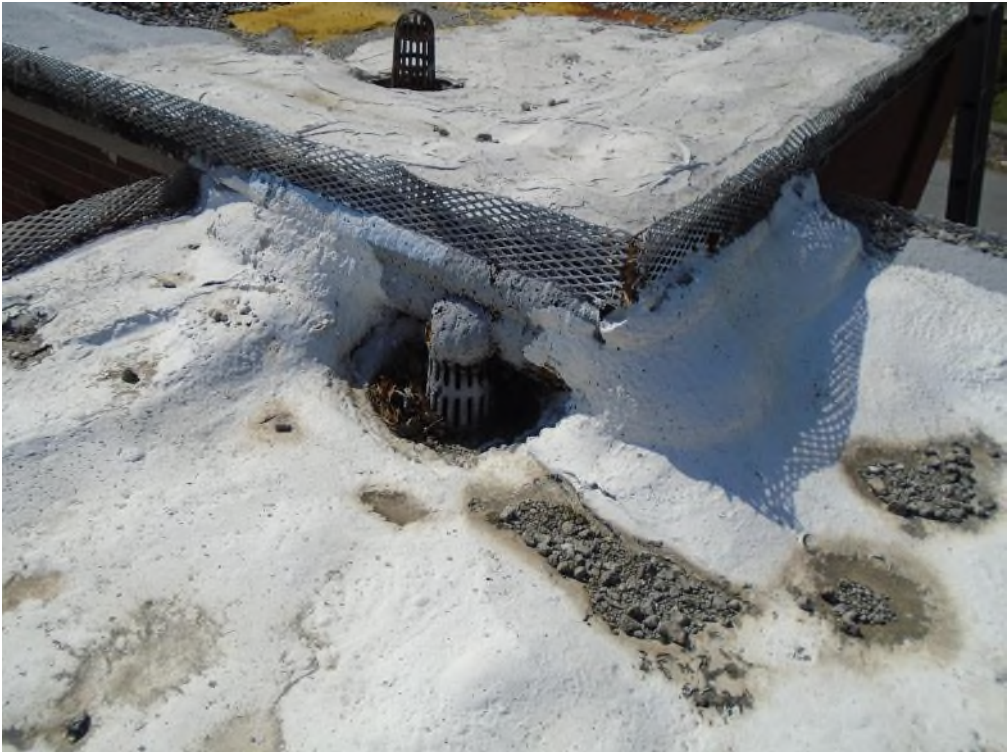
Photograph 46 - BLDG 13 – Multiple repairs to roof at drain
