ADDENDUM # 1

TITLE: Clearing & Demolition of BCU Properties

ASSESSMENT REPORT

COMMERCIAL BUILDING
145 NEW TOWN AVENUE
BATTLE CREEK, MICHIGAN

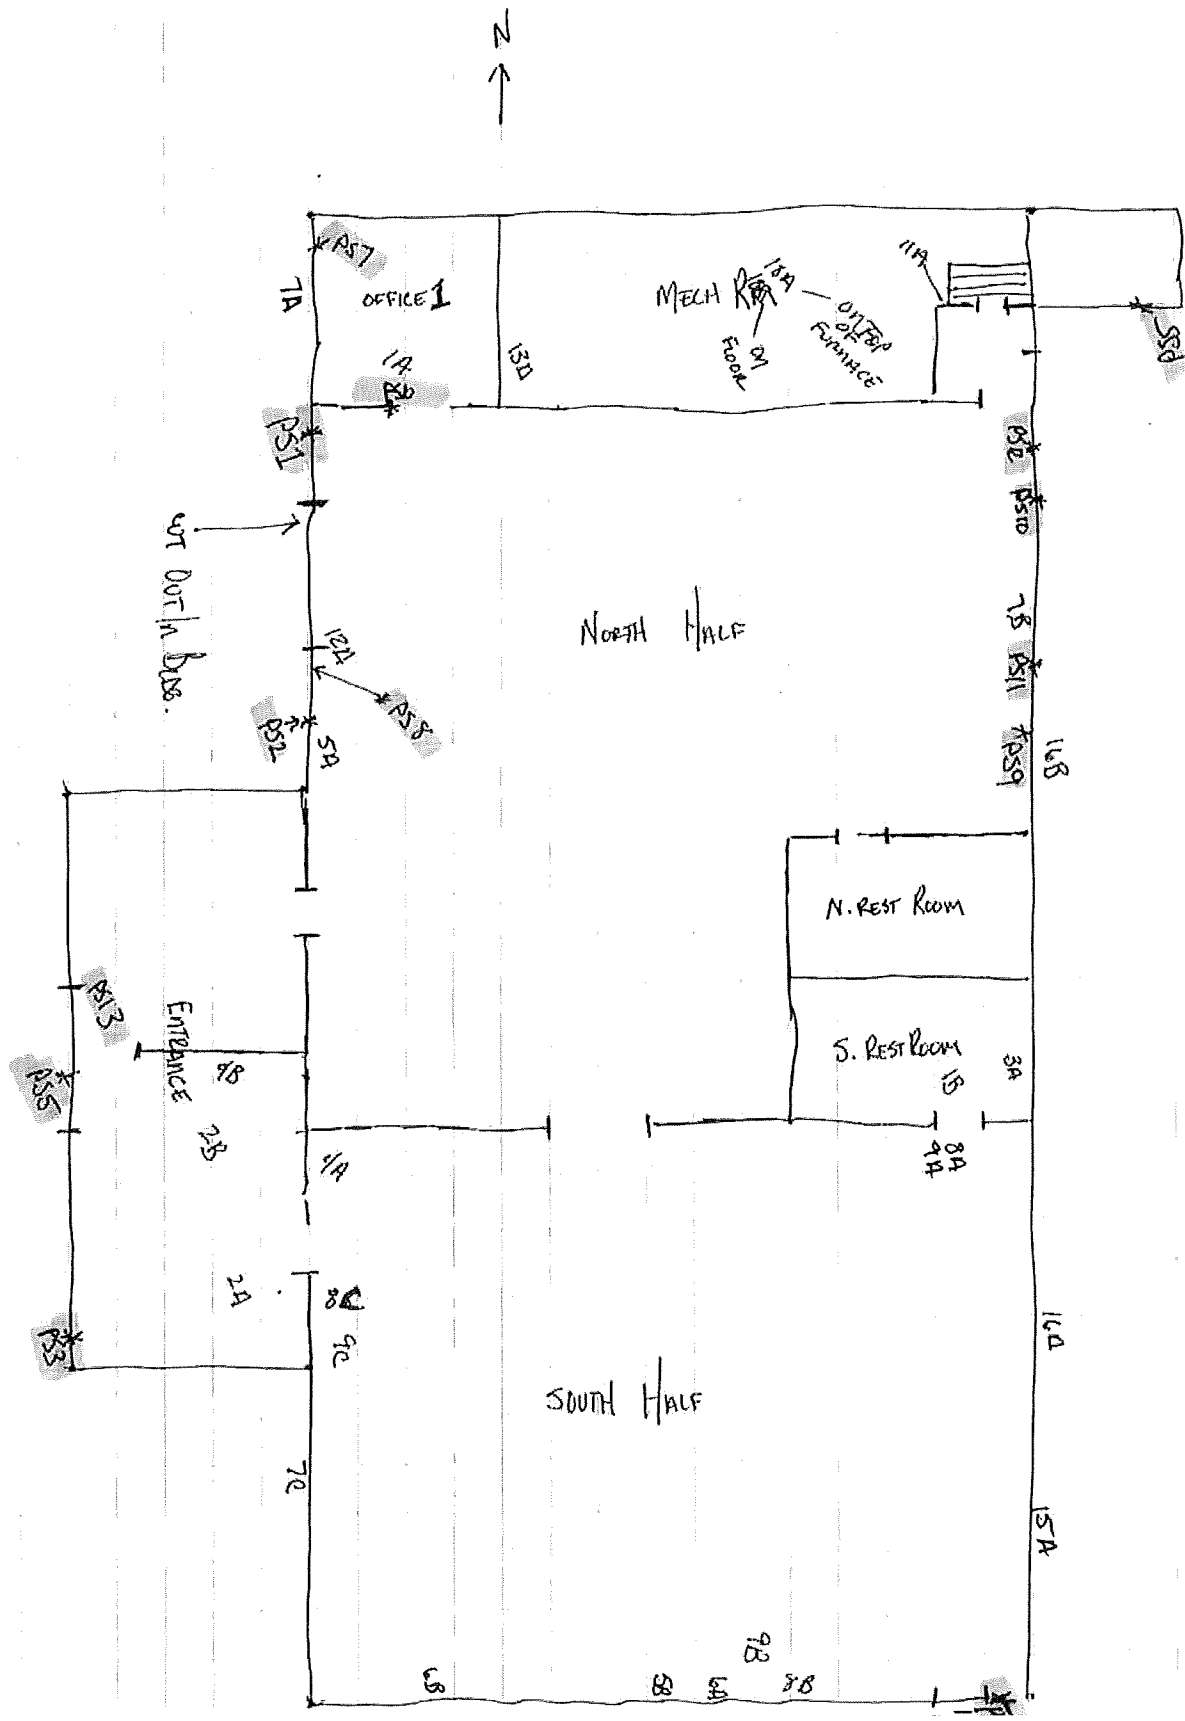
APPENDIX A
FIELD SAMPLING LOCATION SKETCH

PAINT Samples 1-5 on GYM Block

PAINT Samples
