Defect Listing

Pipe Segment Reference 1829_1828	City GEORGETOWN	Street FRASER ST.	Material Vitrified Clay Pipe	Location Code <small>Primary major arterial roads, interstates, numbered roads</small>	Pipe Use Sanitary Sewage Pipe
Upstream MH 1829	Total Length	Year Constructed	Shape Circular	Location Details WINYAH/S FRASER	
Downstream MH 1828	Length surveyed 506.3	Year Renewed	Height 12	Width	Pipe Joint Length

SPR 78	MPR 13	PO Number		Customer CITY OF GEORGETOWN	
SPRI 3.4	MPRI 3.3	Work Order Number		Purpose Maintenance Related	
QSR 524A	QMR 4231			Media label	
OPR 91	Surveyed By Eddie Newman	Direction Downstream	Date 08/10/2023		Weather
OPRI 3.4	Certificate Number U-1018-0703003236	Pre-Cleaning Heavy Cleaning	Time 04:38	Additional Info	
Date Cleaned			End Time 05:26

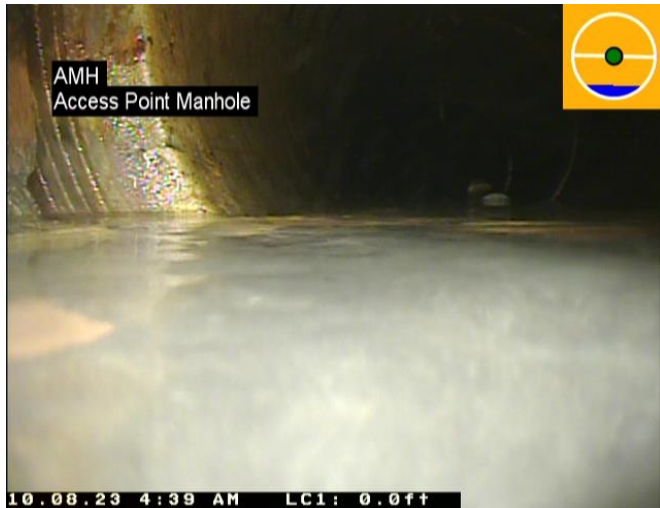
AMH
Access Point Manhole

Distance: 0.0 ft. Grade: 0
Condition: Access Point Manhole
Remarks: 1829

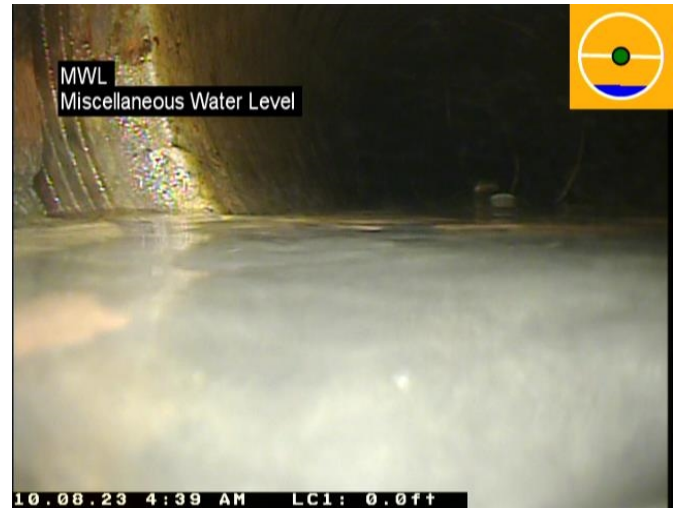
MWL
Miscellaneous Water Level

Distance: 0.0 ft. Grade: 0
Condition: Miscellaneous Water Level
Remarks: N/A

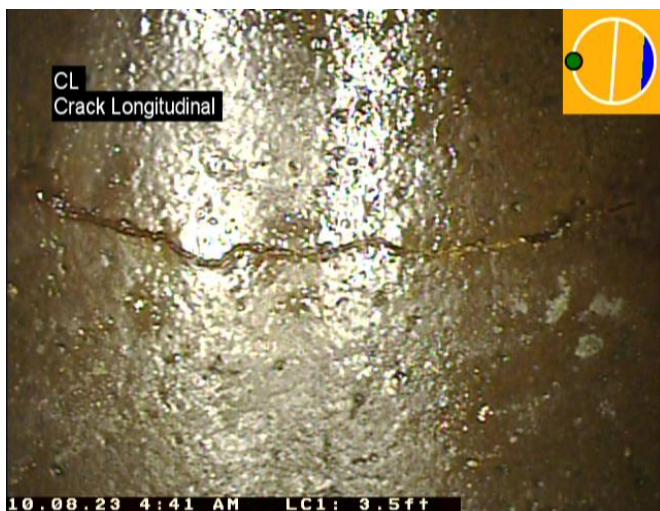
CL
Crack Longitudinal

Distance: 3.5 ft. Grade: 2
Condition: Crack Longitudinal
Remarks: CRACK STARTS AT MH

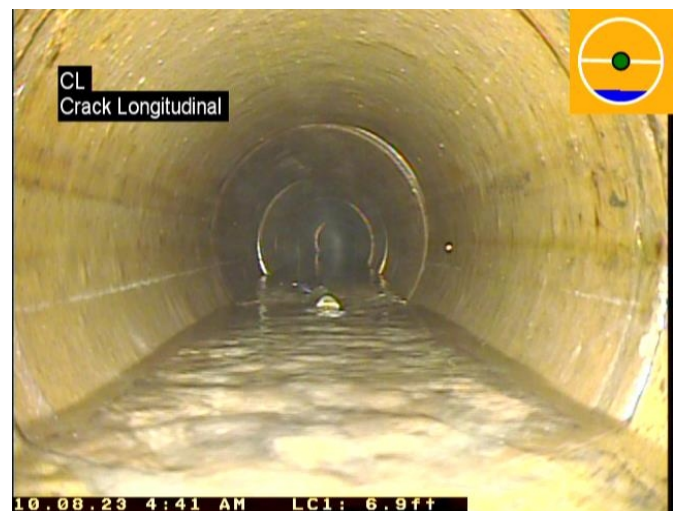
CL
Crack Longitudinal

Distance: 6.9 ft. Grade: 2
Condition: Crack Longitudinal
Remarks: CRACK STARTS AT MH

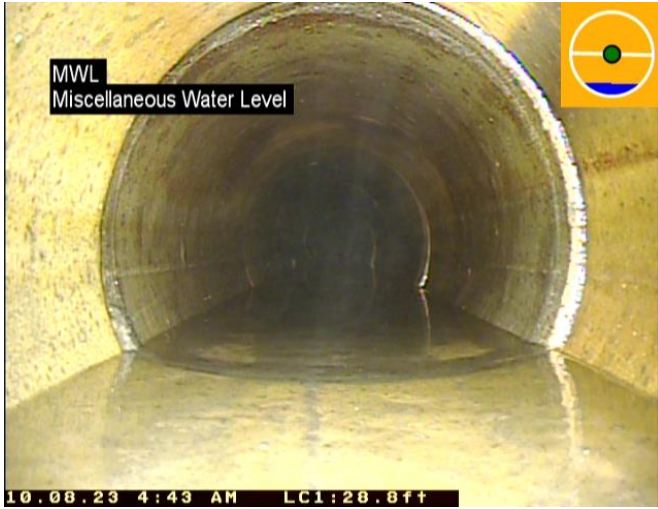
Distance: 28.7 ft. Grade: 0
 Condition: Miscellaneous Water Level
 Remarks: N/A

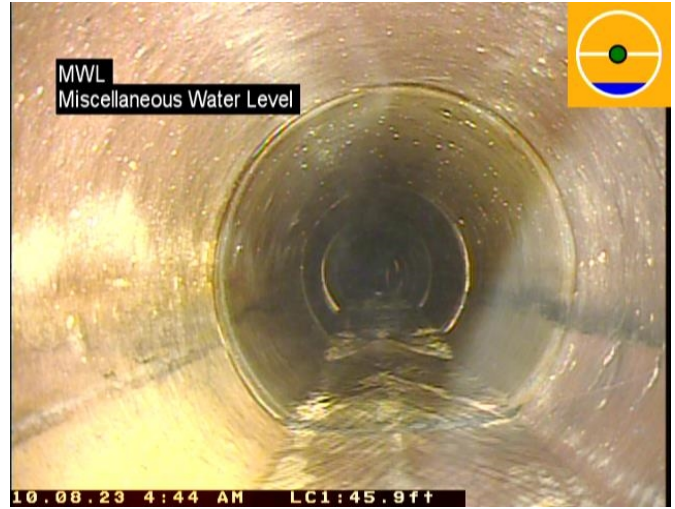
Distance: 45.9 ft. Grade: 0
 Condition: Miscellaneous Water Level
 Remarks: N/A

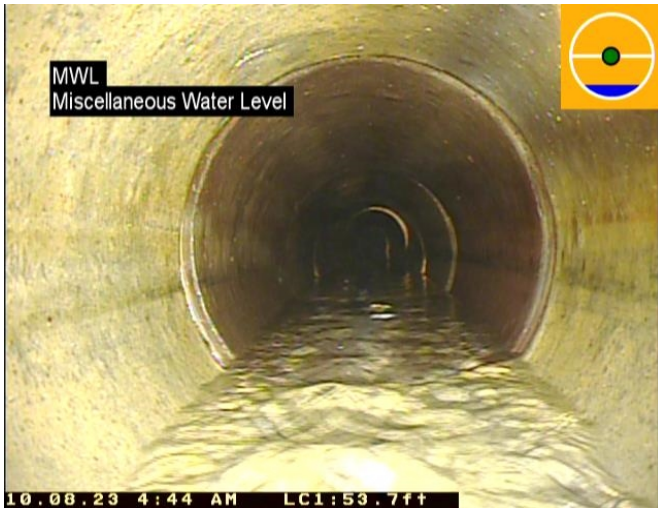
Distance: 53.7 ft. Grade: 0
 Condition: Miscellaneous Water Level
 Remarks: N/A

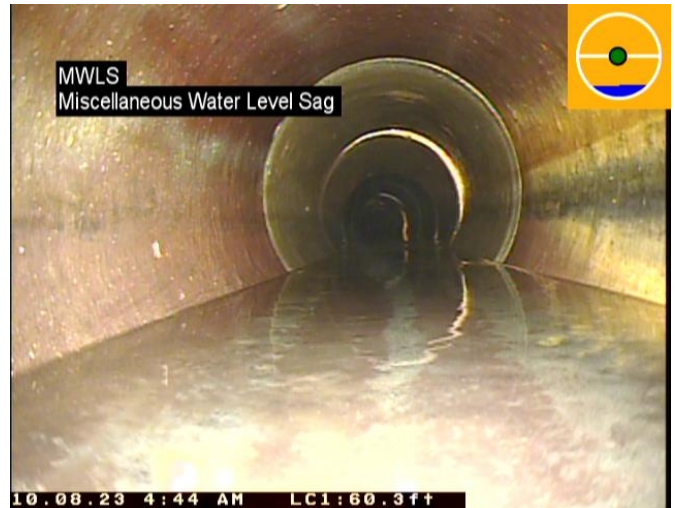
Distance: 60.2 ft. Grade: 2
 Condition: Miscellaneous Water Level Sag
 Remarks: SAG

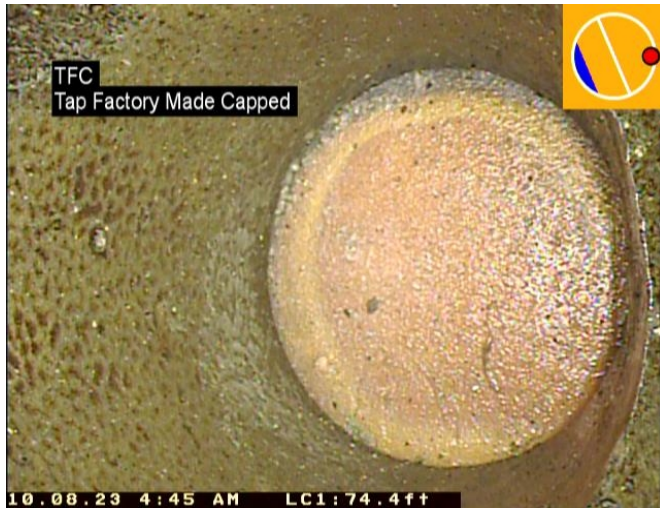
Distance: 74.4 ft. Grade: 0
 Condition: Tap Factory Made Capped
 Remarks: N/A

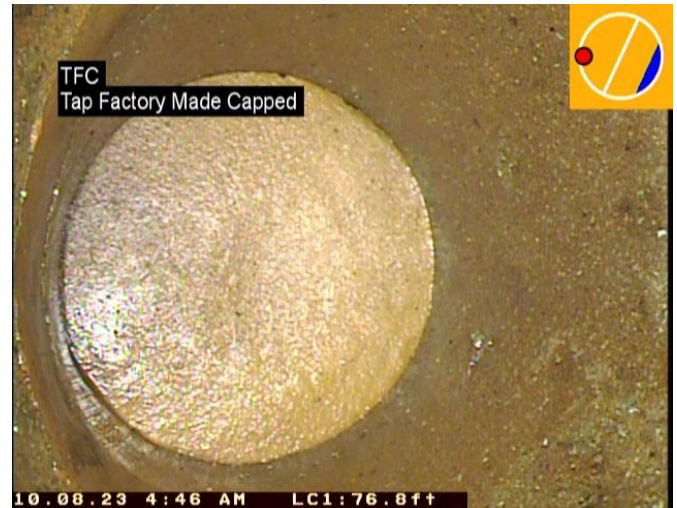
Distance: 76.8 ft. Grade: 0
 Condition: Tap Factory Made Capped
 Remarks: N/A

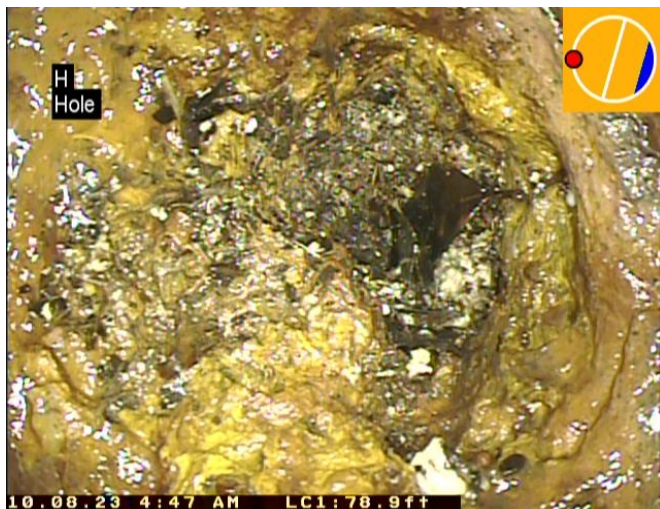
Distance: 78.9 ft. Grade: 4
 Condition: Hole
 Remarks: HOLE OR POSSIBLE LATERAL

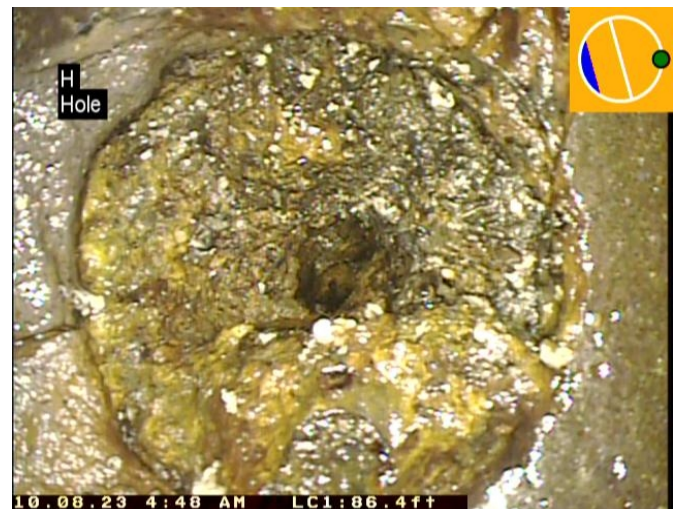
Distance: 86.4 ft. Grade: 4
 Condition: Hole
 Remarks: HOLE OR POSSIBLE LATERAL

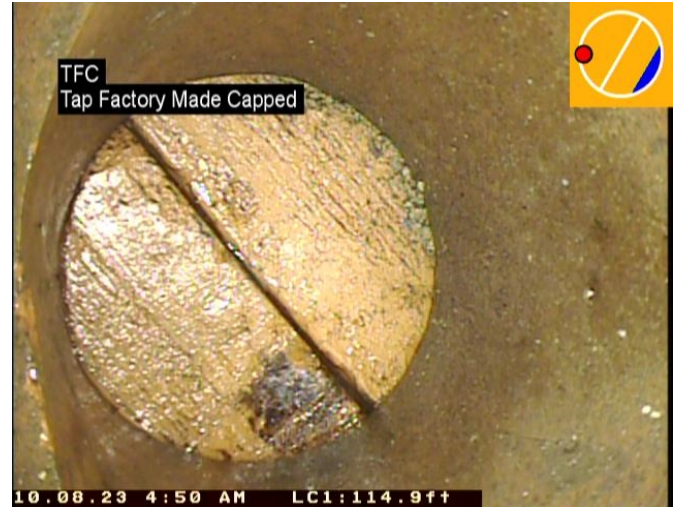
TFC
Tap Factory Made Capped

Distance: 114.9 ft. Grade: 0
 Condition: Tap Factory Made Capped
 Remarks: CAPPED WITH BRICK

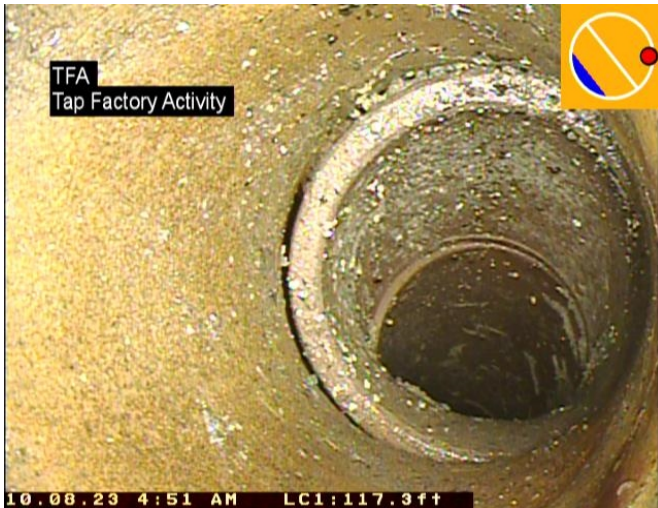
TFA
Tap Factory Activity

Distance: 117.3 ft. Grade: 0
 Condition: Tap Factory Activity
 Remarks: UNKNOWN IF ACTUALLY ACTIVE

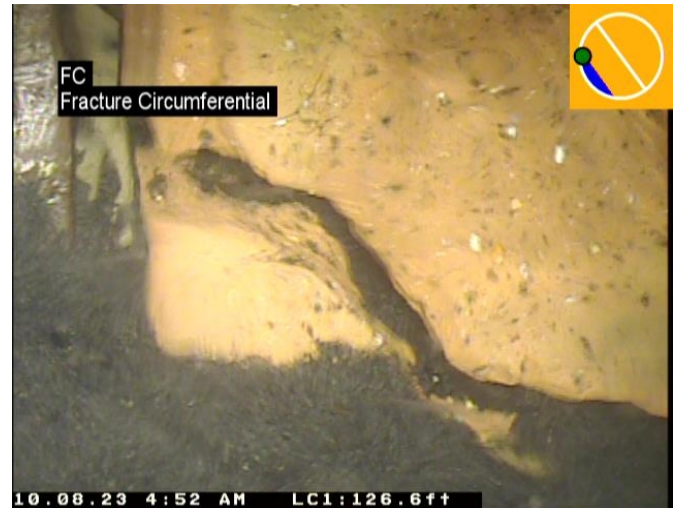
FC
Fracture Circumferential

Distance: 126.5 ft. Grade: 2
 Condition: Fracture Circumferential
 Remarks: FRACTURE IN BOTTOM OF PIPE

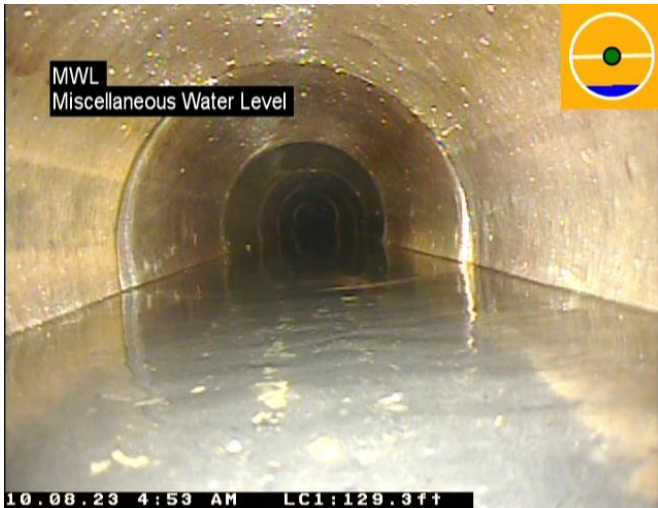
Distance: 129.3 ft. Grade: 0
 Condition: Miscellaneous Water Level
 Remarks: N/A

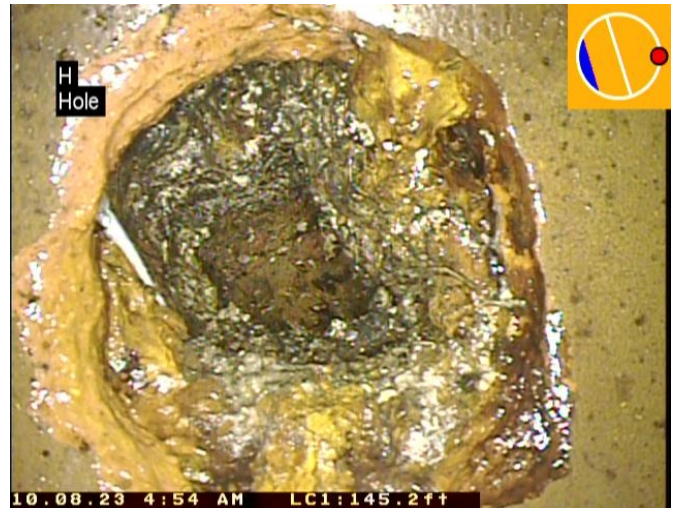
Distance: 145.1 ft. Grade: 4
 Condition: Hole
 Remarks: HOLE OR POSSIBEL OLD LATERAL

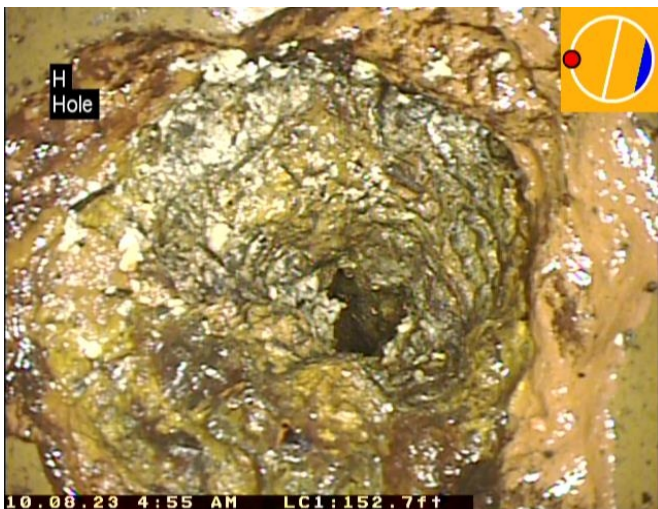
Distance: 152.6 ft. Grade: 4
 Condition: Hole
 Remarks: HOLE OR POSSIBLE OLD LATERAL

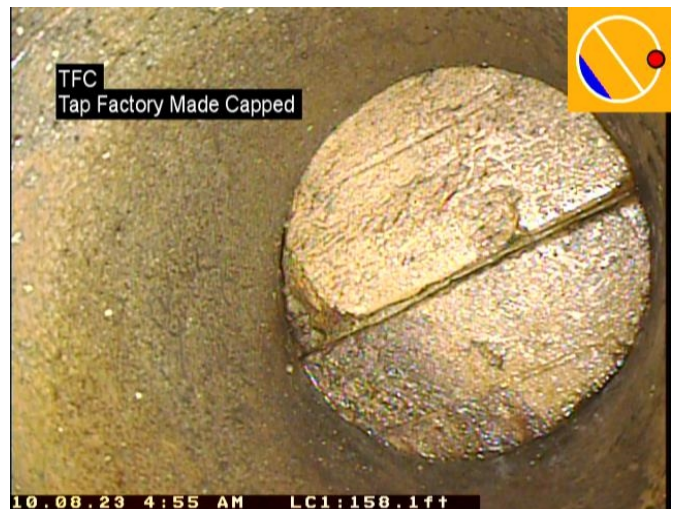
Distance: 158.1 ft. Grade: 0
 Condition: Tap Factory Made Capped
 Remarks: CAPPED OFF WITH BRICK

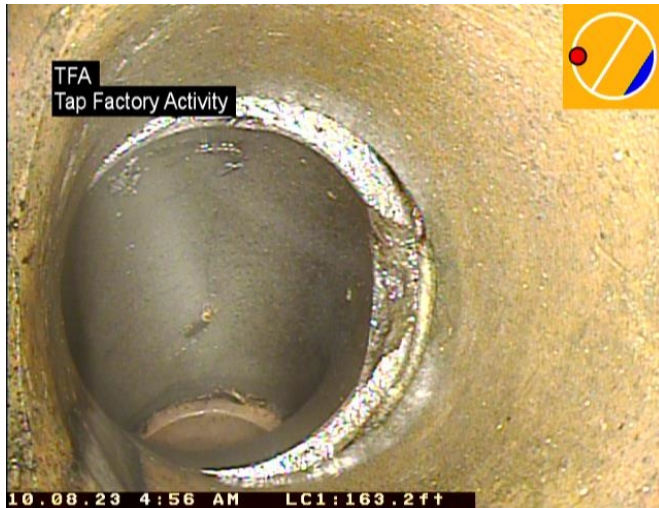
Distance: 163.1 ft. **Grade:** 0
Condition: Tap Factory Activity
Remarks: N/A

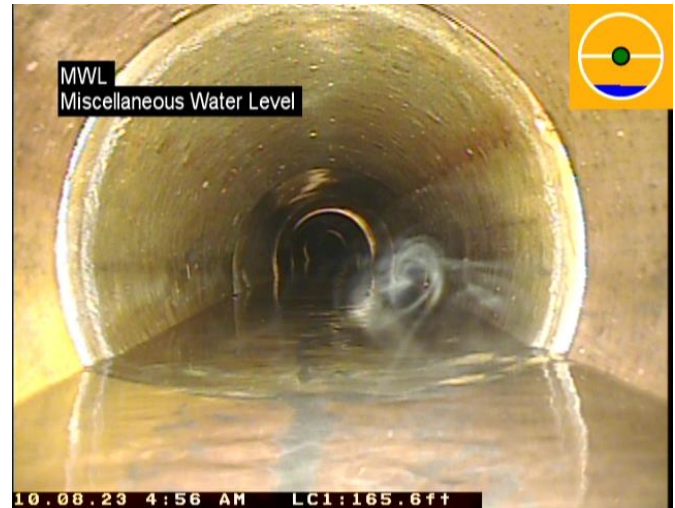
Distance: 165.3 ft. **Grade:** 0
Condition: Miscellaneous Water Level
Remarks: N/A

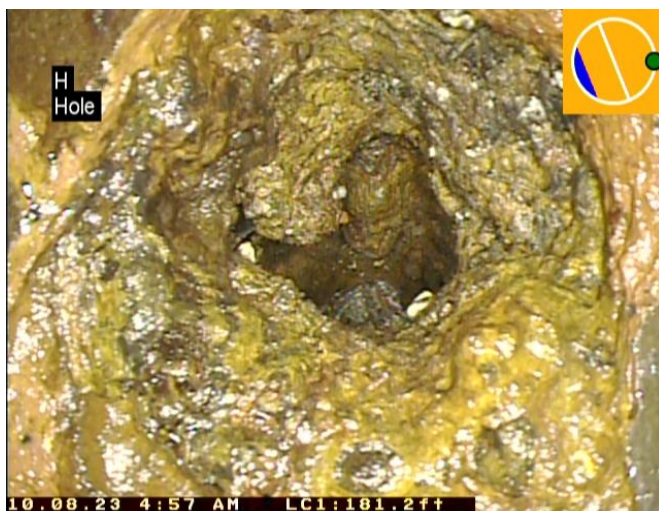
Distance: 181.1 ft. **Grade:** 4
Condition: Hole
Remarks: HOLE OR OLD LATERAL

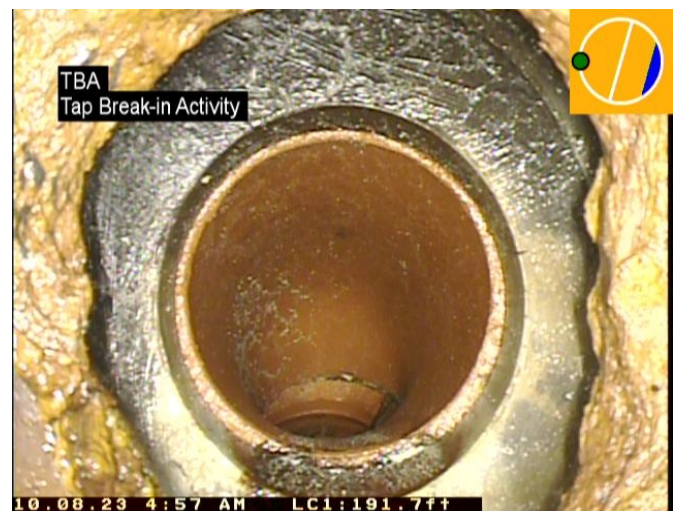
Distance: 191.6 ft. **Grade:** 0
Condition: Tap Break-in Activity
Remarks: WITH INFILTRATION

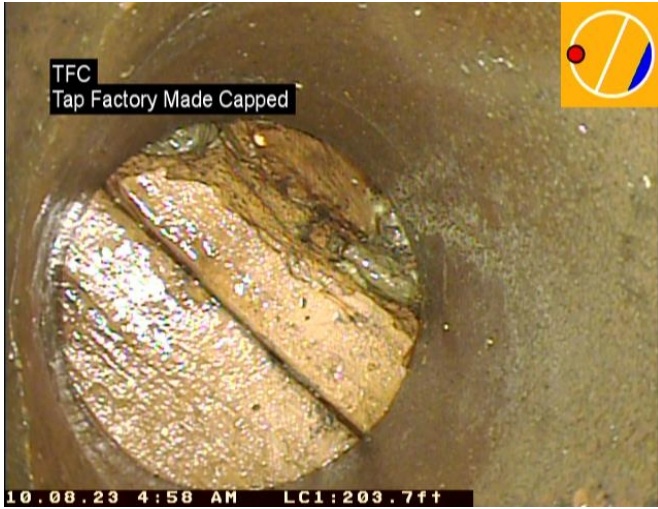
Distance: 203.6 ft. Grade: 0
 Condition: Tap Factory Made Capped
 Remarks: CAPPED WITH BRICK

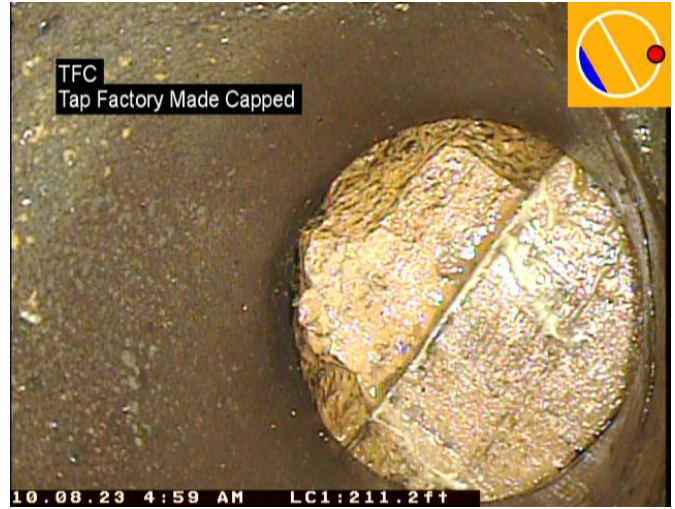
Distance: 211.1 ft. Grade: 0
 Condition: Tap Factory Made Capped
 Remarks: CAPPED WITH BRICK

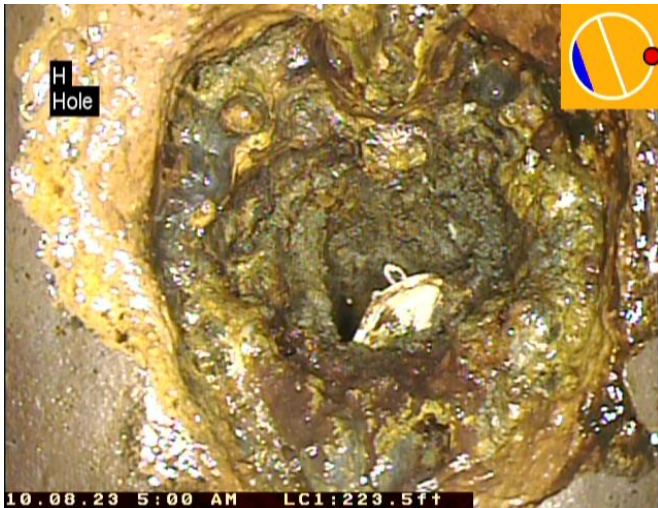
Distance: 223.5 ft. Grade: 4
 Condition: Hole
 Remarks: HOLE OR OLD LATERAL

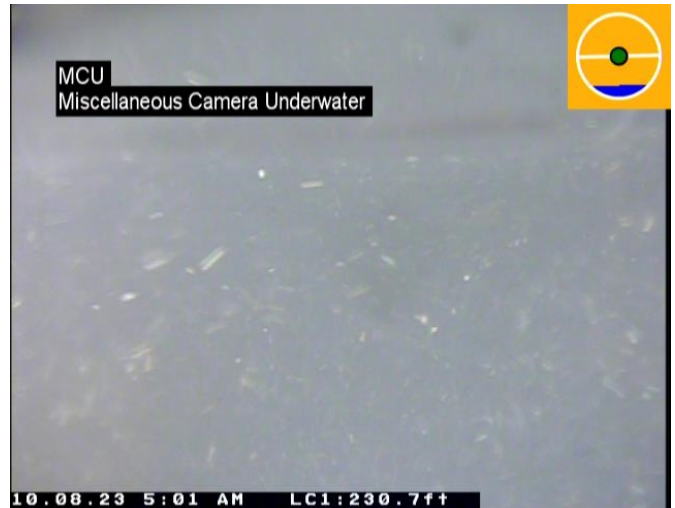
Distance: 230.6 ft. Grade: 4
 Condition: Miscellaneous Camera Underwater
 Remarks: N/A

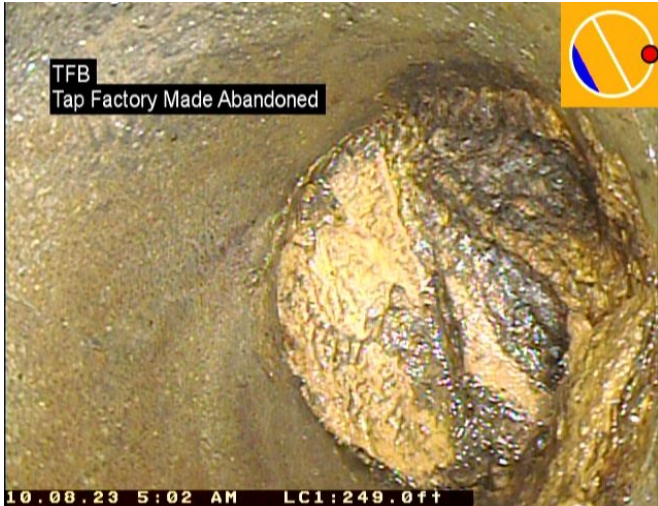
Distance: 249.0 ft. **Grade:** 0
Condition: Tap Factory Made Abandoned
Remarks: FILLED WITH UNKNOWN SUBSTANCE

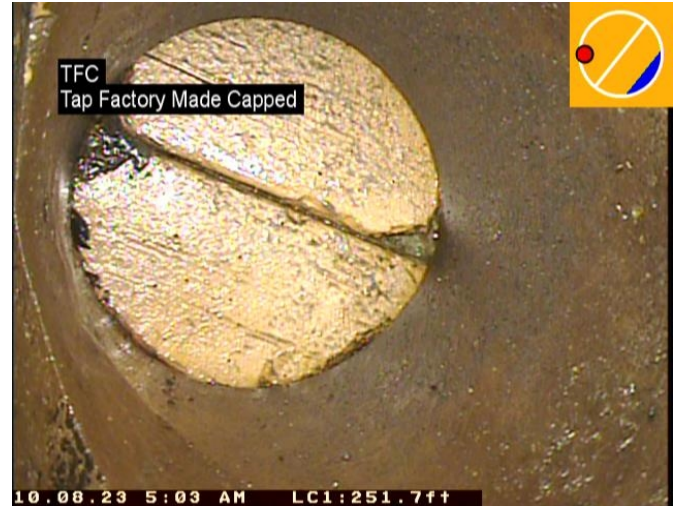
Distance: 251.6 ft. **Grade:** 0
Condition: Tap Factory Made Capped
Remarks: CAPPED WITH BRICK

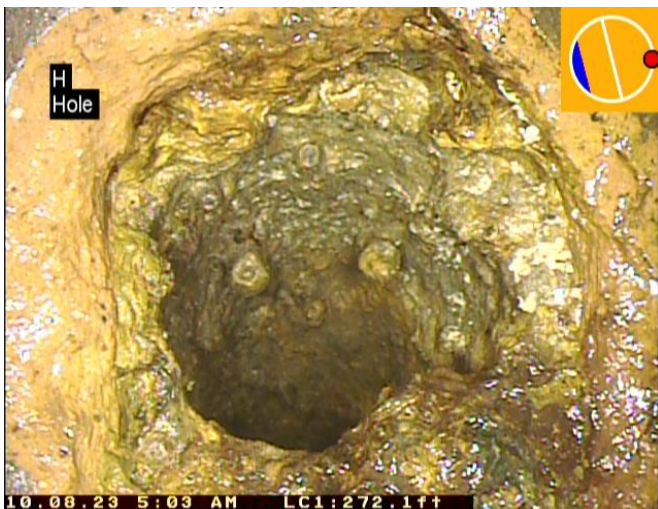
Distance: 272.1 ft. **Grade:** 4
Condition: Hole
Remarks: HOLE OR OLD LATERAL

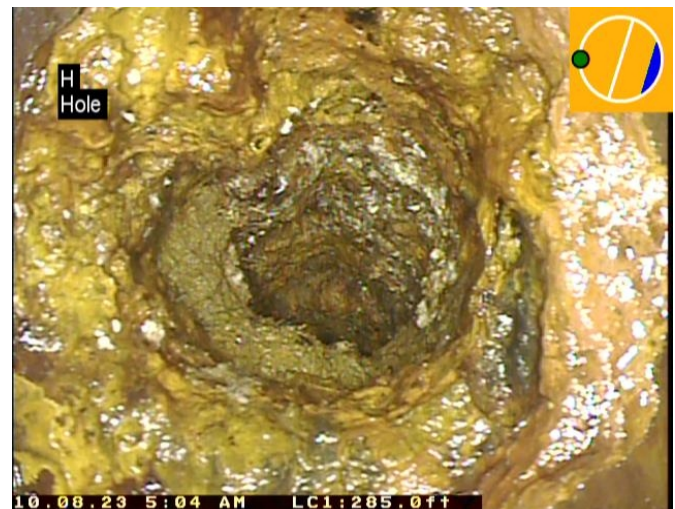
Distance: 285.0 ft. **Grade:** 4
Condition: Hole
Remarks: HOLE OR OLD LATERAL

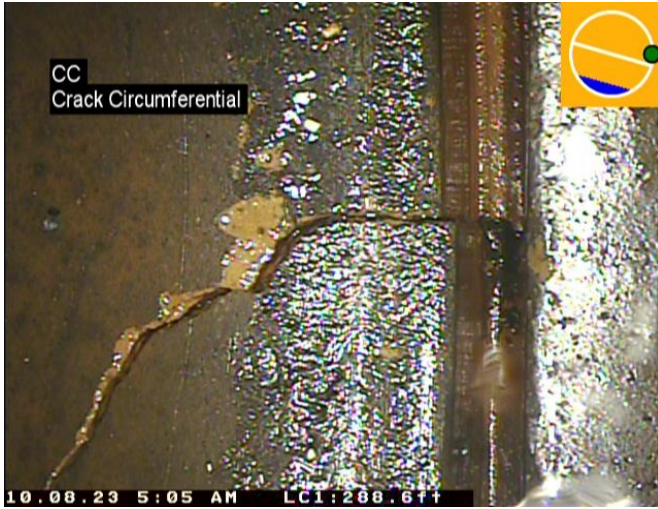
CC
Crack Circumferential

Distance: 288.6 ft. Grade: 1
 Condition: Crack Circumferential
 Remarks: CRACK AT JOINT

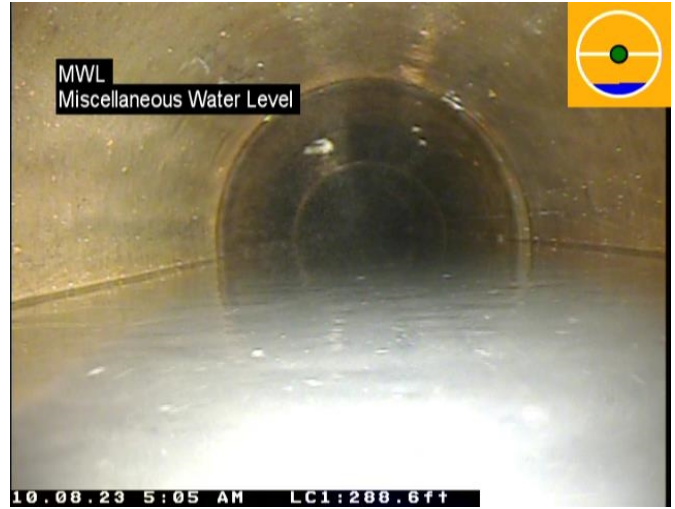
MWL
Miscellaneous Water Level

Distance: 288.6 ft. Grade: 0
 Condition: Miscellaneous Water Level
 Remarks: N/A

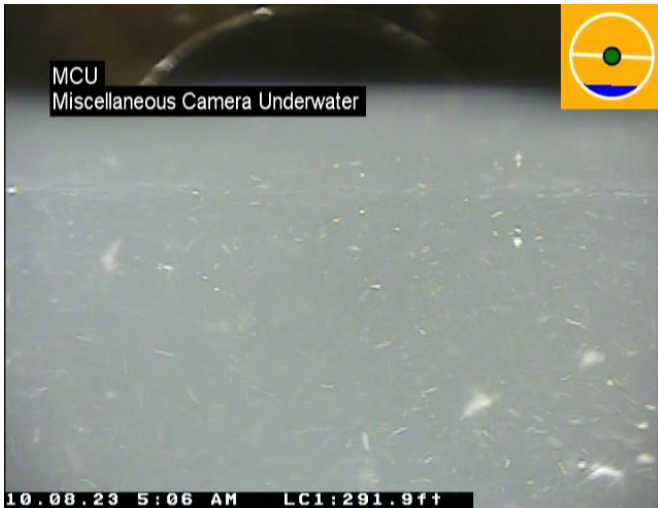
MCU
Miscellaneous Camera Underwater

Distance: 291.8 ft. Grade: 4
 Condition: Miscellaneous Camera Underwater
 Remarks: CAMERA UNDERWATER

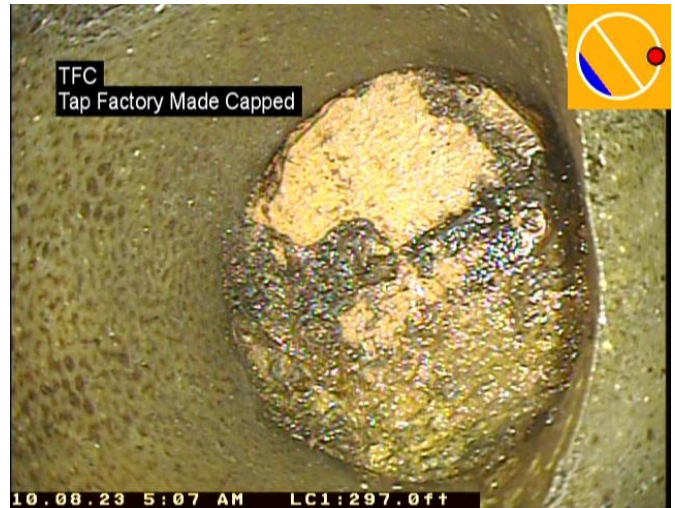
TFC
Tap Factory Made Capped

Distance: 297.0 ft. Grade: 0
 Condition: Tap Factory Made Capped
 Remarks: CAPPED WITH BRICK

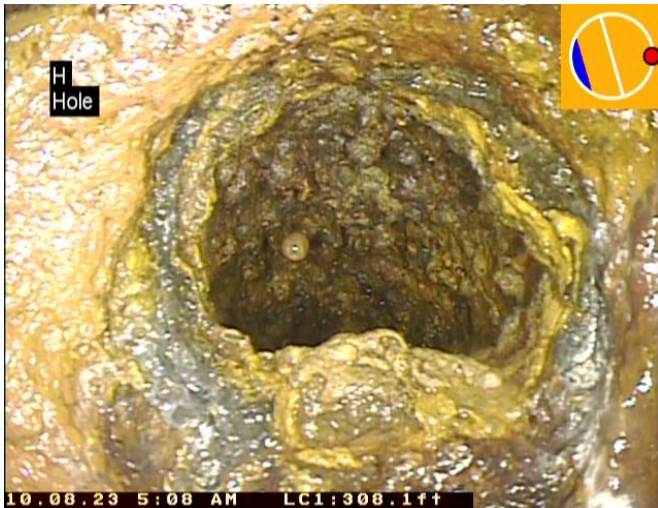
Distance: 308.1 ft. **Grade:** 4
Condition: Hole
Remarks: ;HOLE OR OLD LATERAL

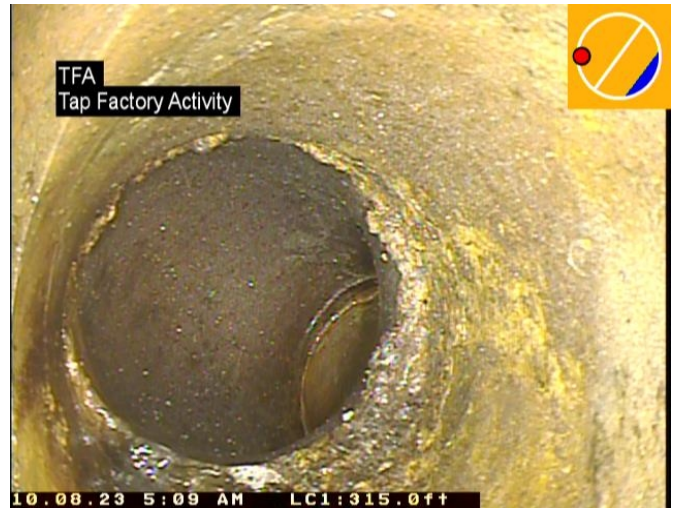
Distance: 315.0 ft. **Grade:** 0
Condition: Tap Factory Activity
Remarks: N/A

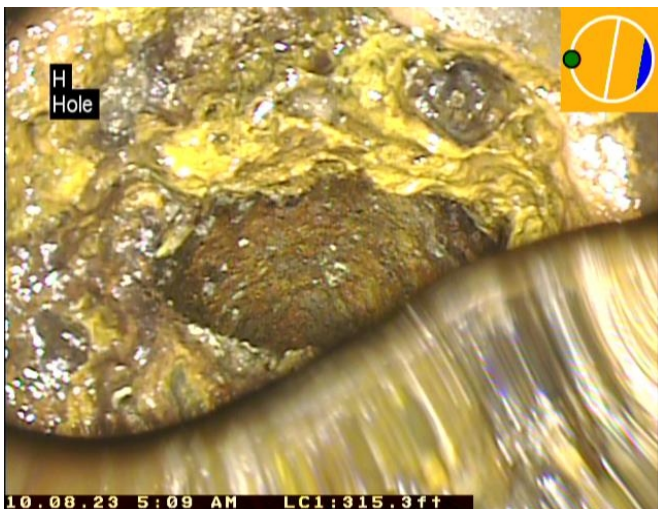
Distance: 315.2 ft. **Grade:** 4
Condition: Hole
Remarks: HOLE OR OLD LATERAL

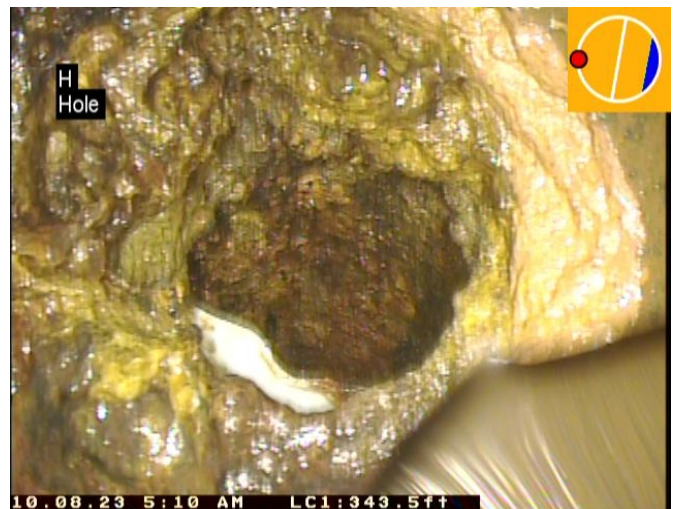
Distance: 343.5 ft. **Grade:** 4
Condition: Hole
Remarks: HOLE OR OLD LATERAL

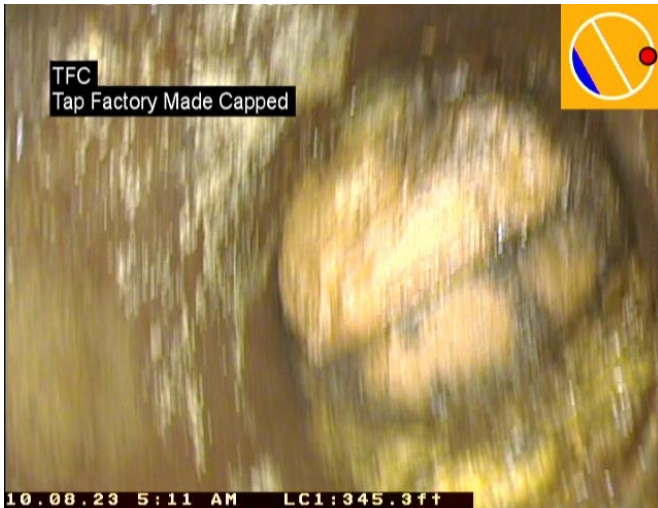
Distance: 345.2 ft. Grade: 0
 Condition: Tap Factory Made Capped
 Remarks: CAPPED WITH BRICK

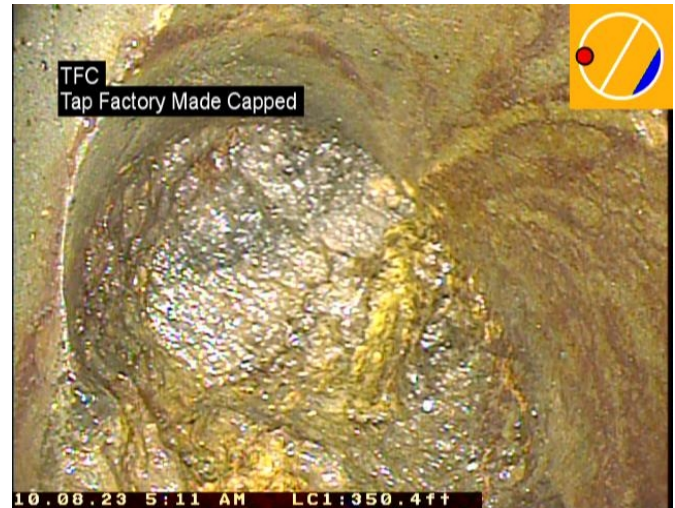
Distance: 350.3 ft. Grade: 0
 Condition: Tap Factory Made Capped
 Remarks: CAPPED DEFECTIVE

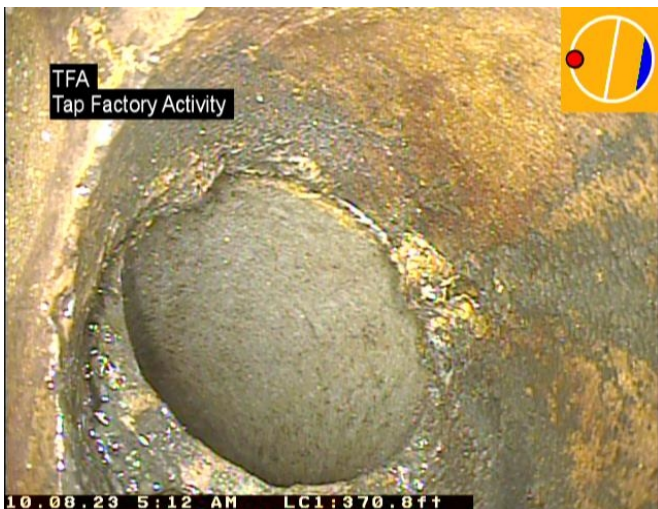
Distance: 370.7 ft. Grade: 0
 Condition: Tap Factory Activity
 Remarks: N/A

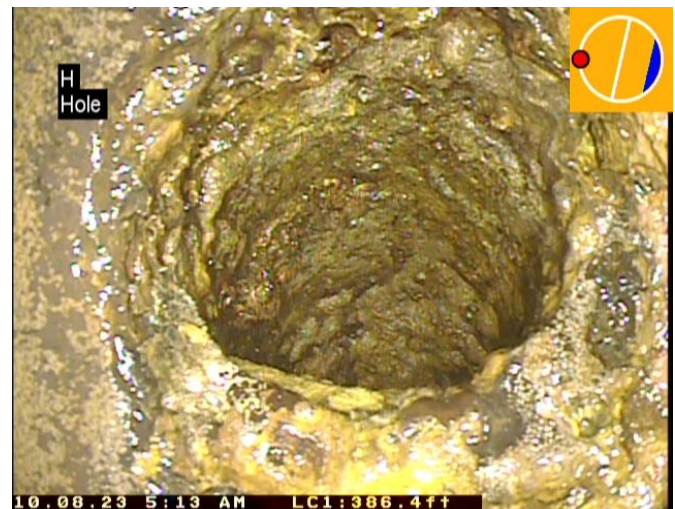
Distance: 386.3 ft. Grade: 4
 Condition: Hole
 Remarks: HOLE OR OLD LATERAL

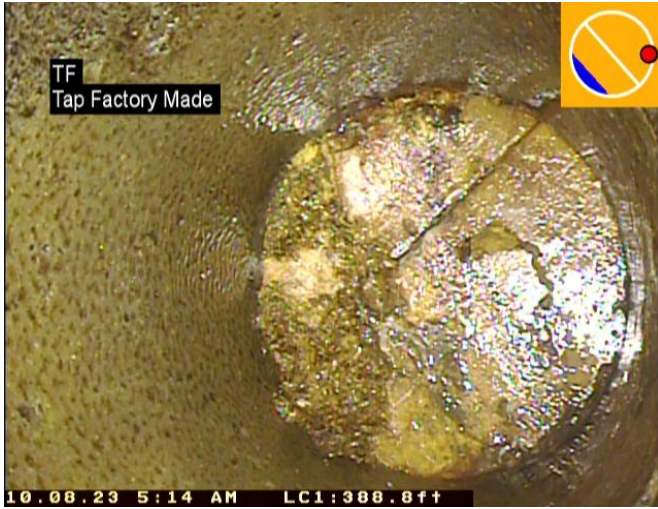
TF
Tap Factory Made

Distance: 388.7 ft. Grade: 0
 Condition: Tap Factory Made
 Remarks: CAPPED WITH BRICK

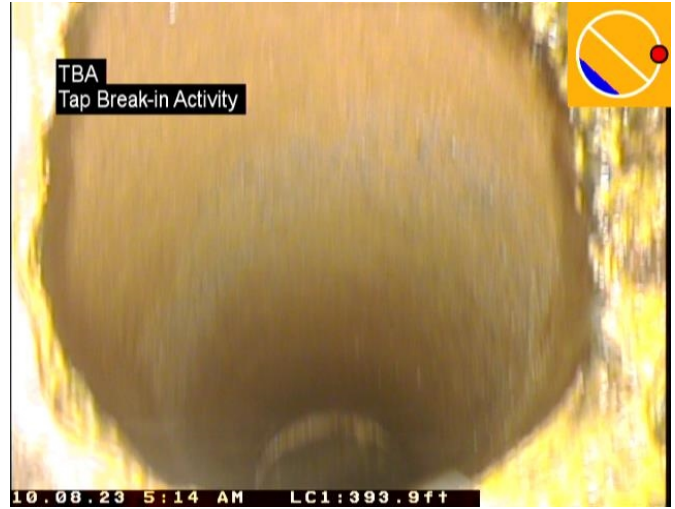
TBA
Tap Break-in Activity

Distance: 393.8 ft. Grade: 0
 Condition: Tap Break-in Activity
 Remarks: N/A

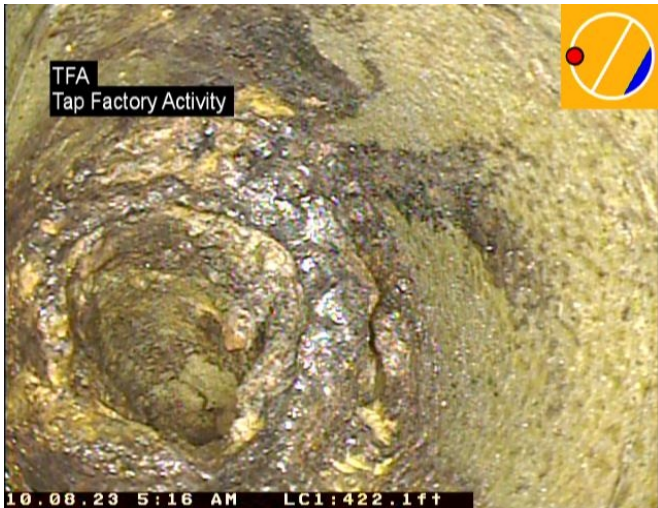
TFA
Tap Factory Activity

Distance: 422.1 ft. Grade: 0
 Condition: Tap Factory Activity
 Remarks: SMALLER PIPE INSIDE TF

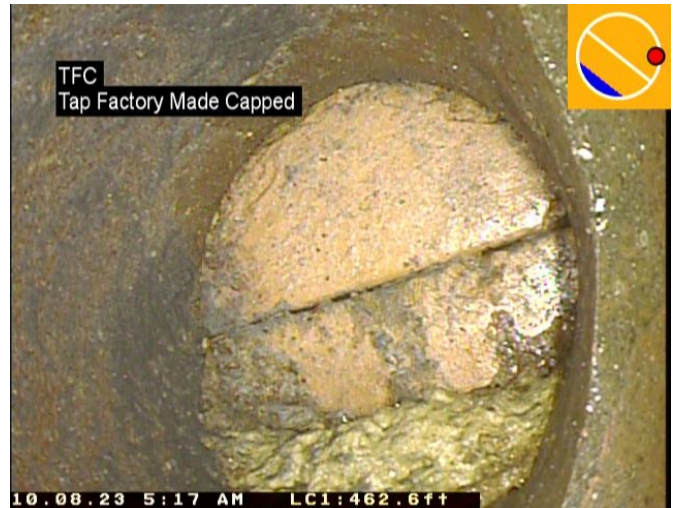
TFC
Tap Factory Made Capped

Distance: 462.6 ft. Grade: 0
 Condition: Tap Factory Made Capped
 Remarks: CAPPED WITH BRICK

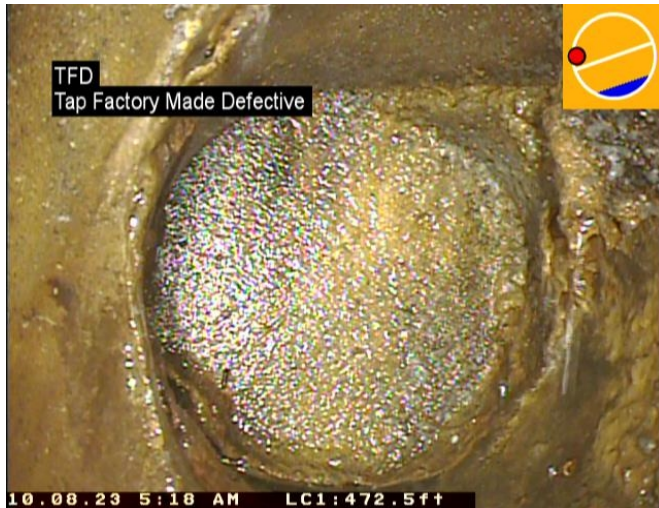
TFD
Tap Factory Made Defective

Distance: 472.5 ft. Grade: 3
 Condition: Tap Factory Made Defective
 Remarks: INFILTRATION

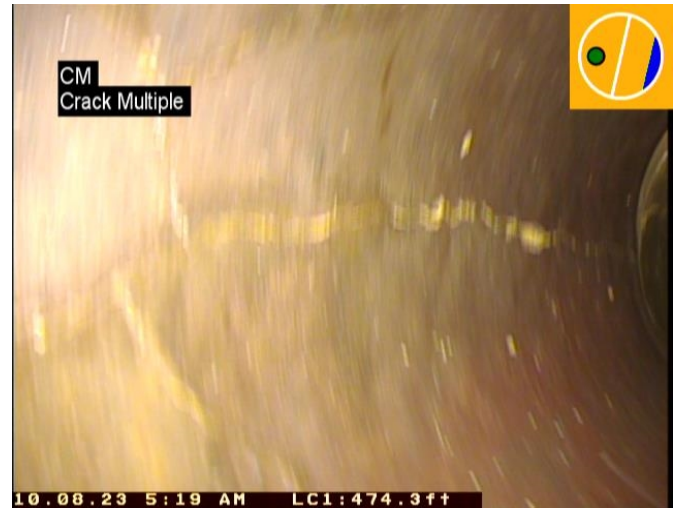
CM
Crack Multiple

Distance: 474.2 ft. Grade: 3
 Condition: Crack Multiple
 Remarks: MULTIPLE CRACKS

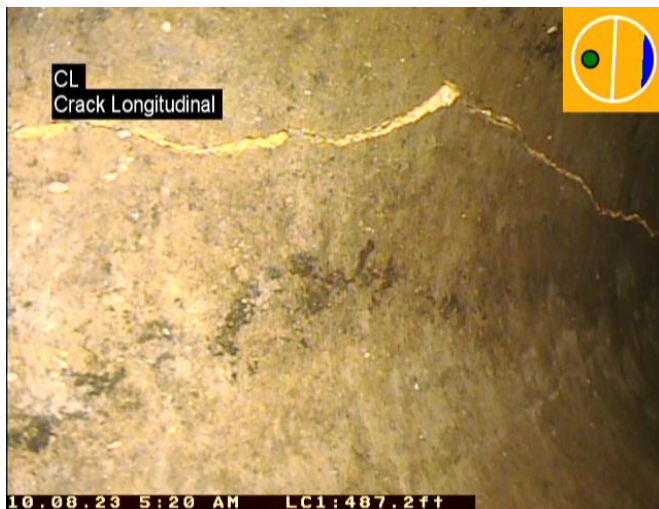
CL
Crack Longitudinal

Distance: 487.2 ft. Grade: 2
 Condition: Crack Longitudinal
 Remarks: CRACK IN TOP OF PIPE

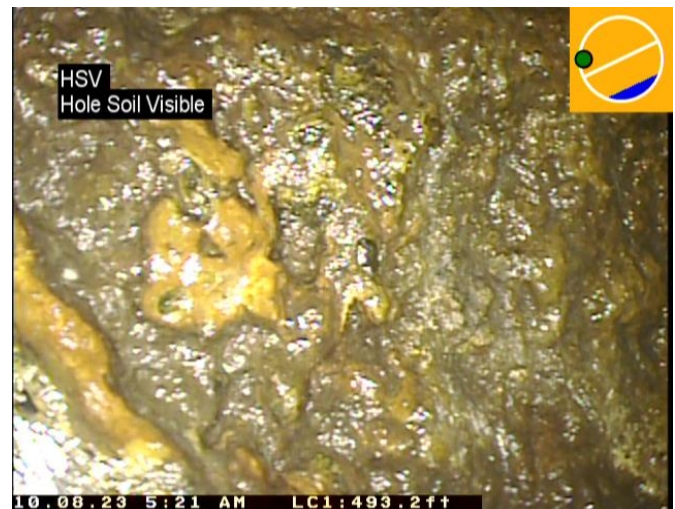
HSV
Hole Soil Visible

Distance: 493.2 ft. Grade: 5
 Condition: Broken Pipe Soil Visible
 Remarks: PIECE OF PIPE MISSING THROUGHOUT MOST OF JOINT WITH SOIL VISIBLE

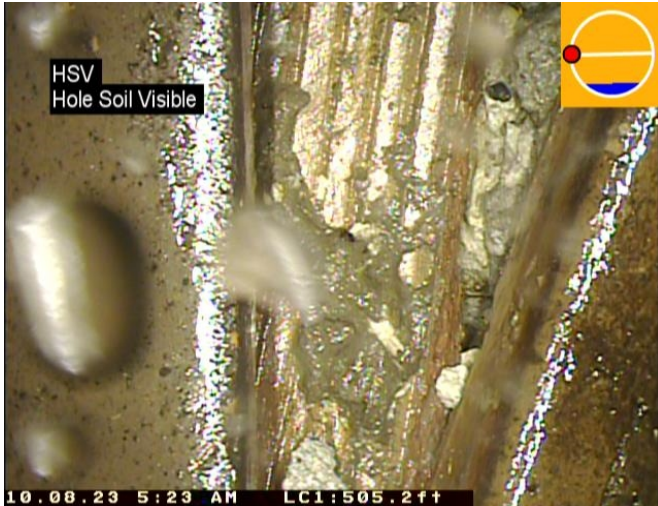
Distance: 505.2 ft. **Grade:** 5
Condition: Hole Soil Visible
Remarks: PIPW IS BROKEN WITH HOLE AND SOIL VISIBLE

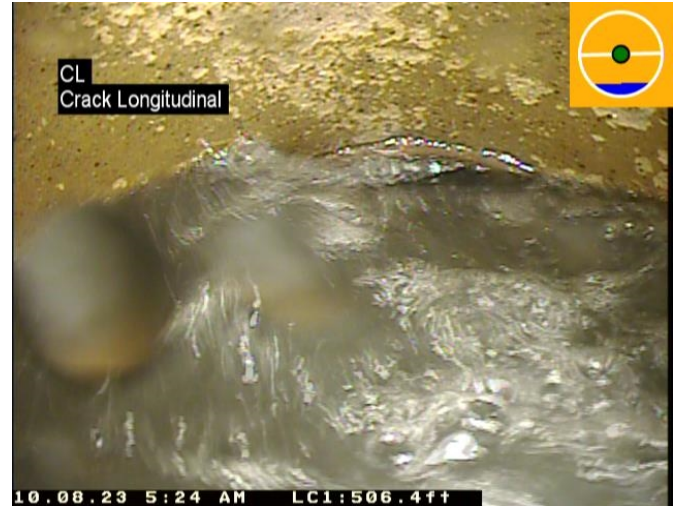
Distance: 506.3 ft. **Grade:** 2
Condition: Crack Longitudinal
Remarks: CRACK IN TOP OF PIPE

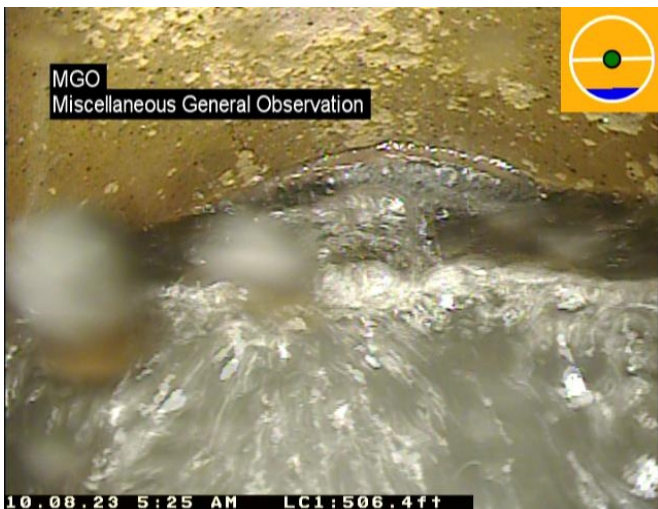
Distance: 506.3 ft. **Grade:** 0
Condition: Miscellaneous General Observation
Remarks: PIPE IS OFFSET SEVERELY NEAR MH CAN NOT PROCEED

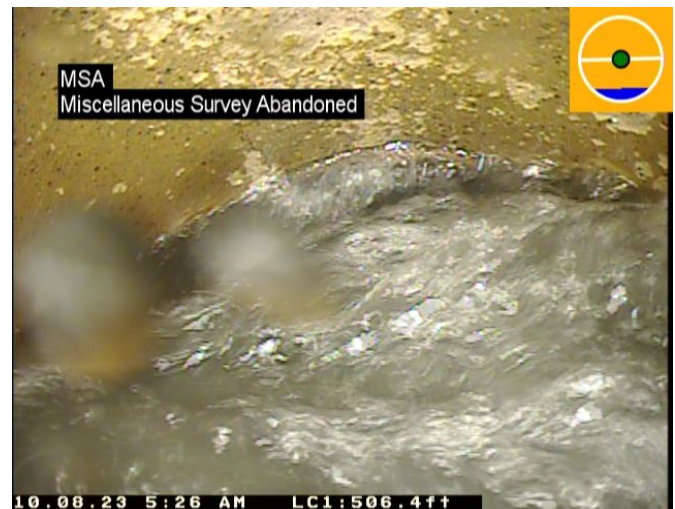
Distance: 506.3 ft. **Grade:** 0
Condition: Miscellaneous Survey Abandoned
Remarks: END OF SURVEY CAN NOT PROCEED

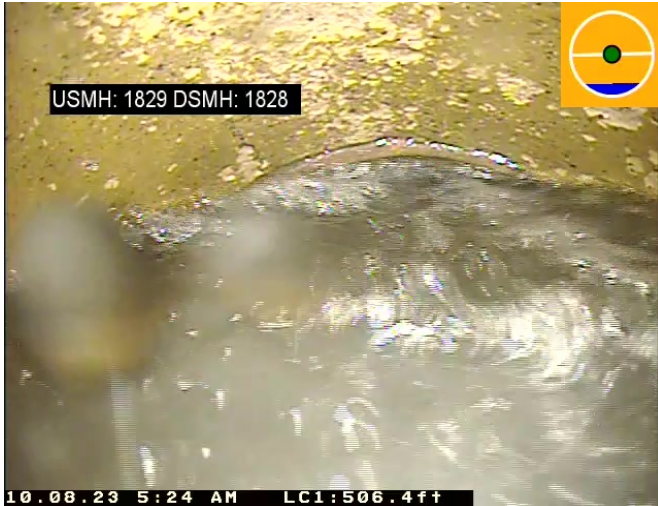
Distance: 505.2 ft. Grade: 4
 Condition: Joint Offset Large Defective
 Remarks: PIPE HAS BECOME DISLODGED AT JOINT WITH SOIL VISIBLE

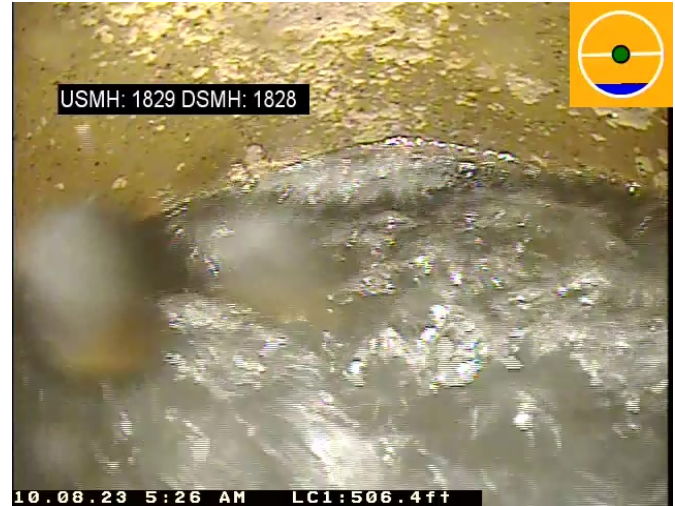
Distance: 506.3 ft. Grade: 0
 Condition: Miscellaneous General Observation
 Remarks: NOTE* POSSIBLE JOLD AT NEXT JOINT ALSO, UNABLE TO PROCEED AT THIS POINT
