To:	Addendum #1 Charleston Farms Neighborhood, Village Renaissance Project for City of Hanahan	From:	Josh Lilly, PE 4969 Centre Pointe Drive, Suite 200 North Charleston SC 29418-6952
File:	178420944	Date:	January 9, 2020

COMPREHENSIVE ASBESTOS SURVEY

**SINGLE-FAMILY RESIDENCE
5813 KNIGHT STREET
HANAHAN, SOUTH CAROLINA 29410**

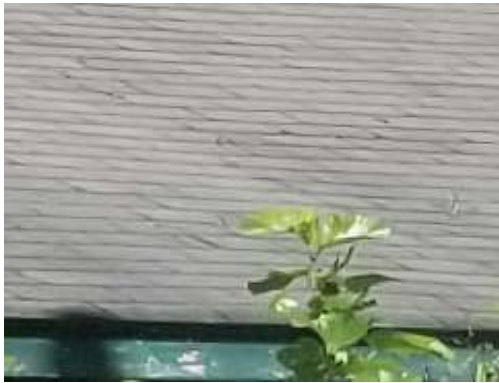
HOMOGENEOUS AREAS 01, 02
ROOF SHINGLE W/FELT PAPER

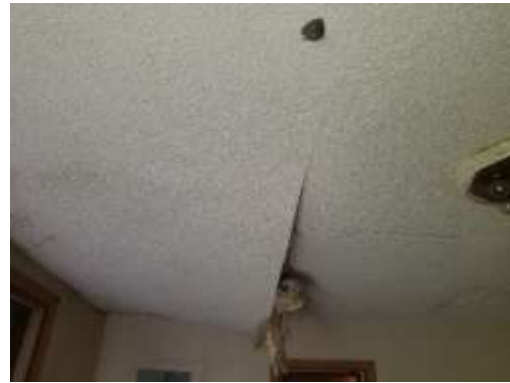
HOMOGENEOUS AREA 03
CEILING TEXTURE

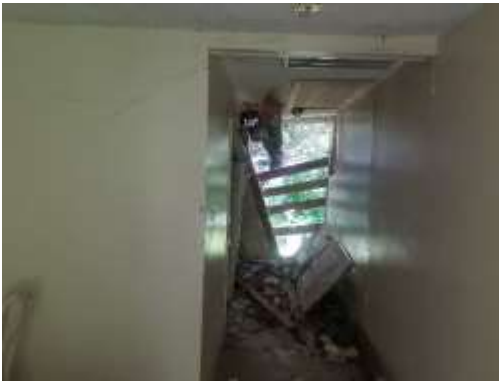
HOMOGENEOUS AREA 04
DRYWALL

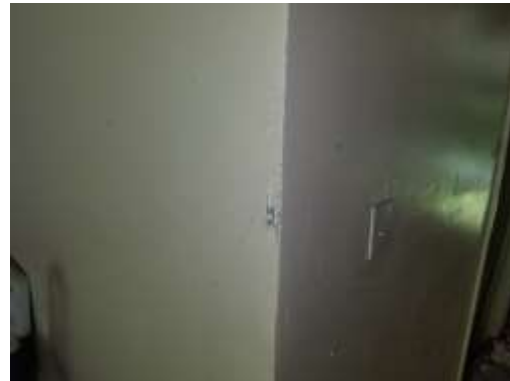
HOMOGENEOUS AREA 05
JOINT COMPOUND

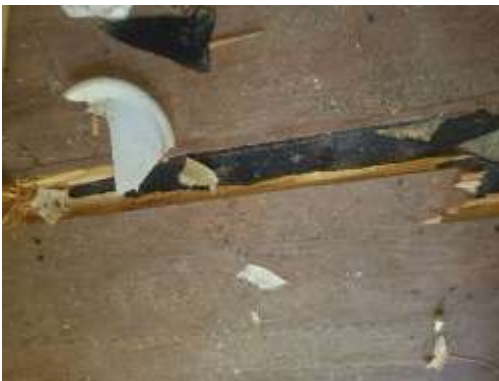
HOMOGENEOUS AREA 06
FLOOR FELT PAPER

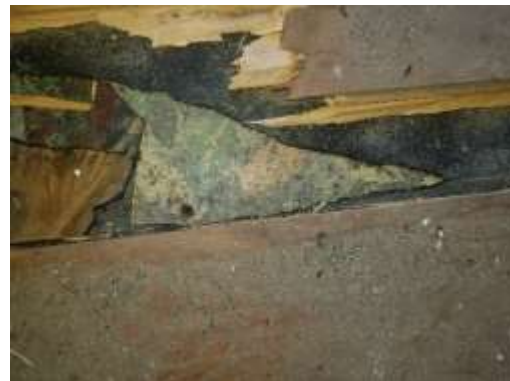
HOMOGENEOUS AREA 07
VINYL SHEET FLOORING (GREEN/BEIGE)

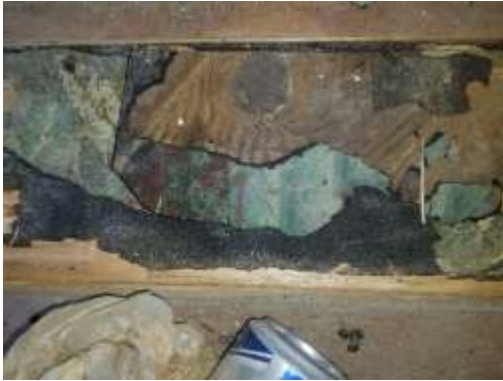
HOMOGENEOUS AREA 08
VINYL SHEET FLOORING (GREEN/RED)

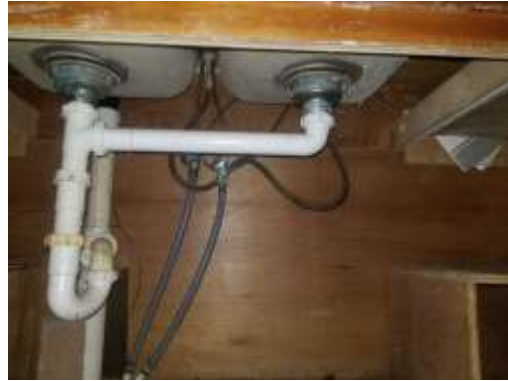
HOMOGENEOUS AREA 09
SINK COATING (WHITE)

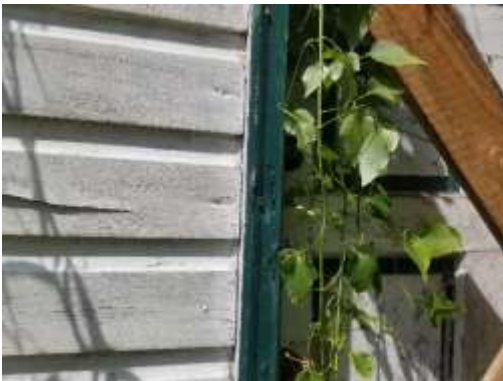
HOMOGENEOUS AREA 10
EXTERIOR CAULKING
