MILLER LANE BRIDGE ASBESTOS SURVEY REPORT

Miller Lane Bridge
Johnson City, Tennessee

February 26, 2020
S&ME Project No. 4140-20-003

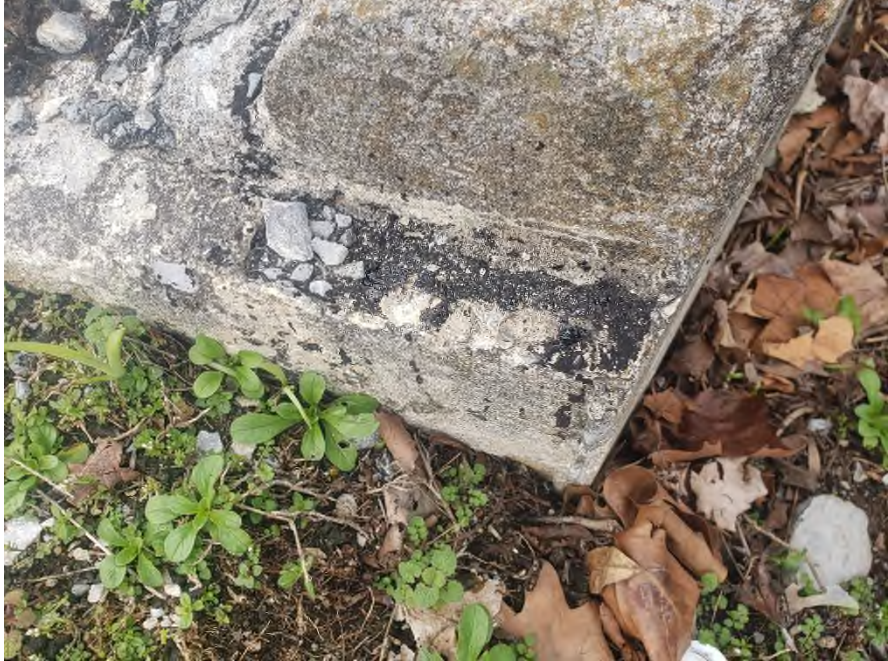
Construction materials that comprise the bridge includes sections of asphaltic wearing surface at the entrance and exit of the bridge over concrete decking with metal I-beams. Suspect ACM was sampled from the asphaltic wearing surface. Three samples labeled 0217-1A, 0217-1B, and 0217-1C were collected from the upper asphaltic coating.

<p>Date: 02/17/2020</p>	
<p>Description: Photograph 1 – Homogeneous Area 1 Asphaltic Coating Sample Locations 0217-1A 0217-1B 0217-1C</p>	
<p>Photographer: Patsy L. Shupe</p>

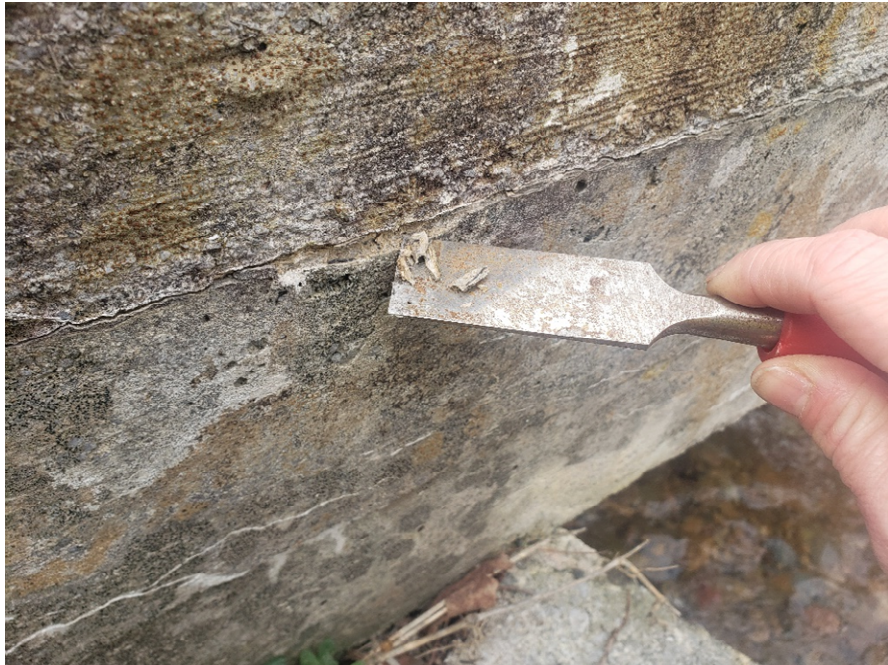
The bridge is constructed with short concrete curbs; three samples labeled 0217-2A, 0217-2B, and 0217-2C were collected from the filler material between concrete gaps along the bridge curbs. The concrete curbs exhibited a concrete coating along the exterior sides of the curbs, and three samples labeled 0217-3A, 0217-3B, and 0217-3C were collected of the coating.

<p>Date: 02/17/2020</p>	
<p>Description: Photograph 2 – Homogeneous Area 2 Concrete Gap Fill Sample Locations 0217-2A 0217-2B 0217-2C</p>

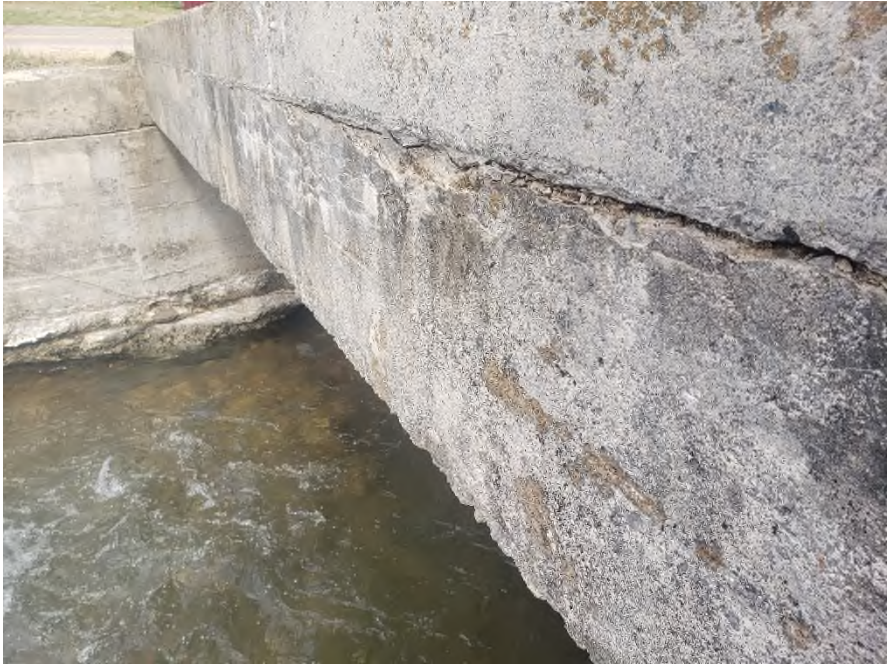
<p>Date: 02-17-2020</p>	
<p>Description: Photograph 3 – Homogeneous Area 3 Bridge Wall Coating Sample Locations 0217-3A 0217-3B 0217-3C</p>	
<p>Photographer: Patsy L. Shupe</p>

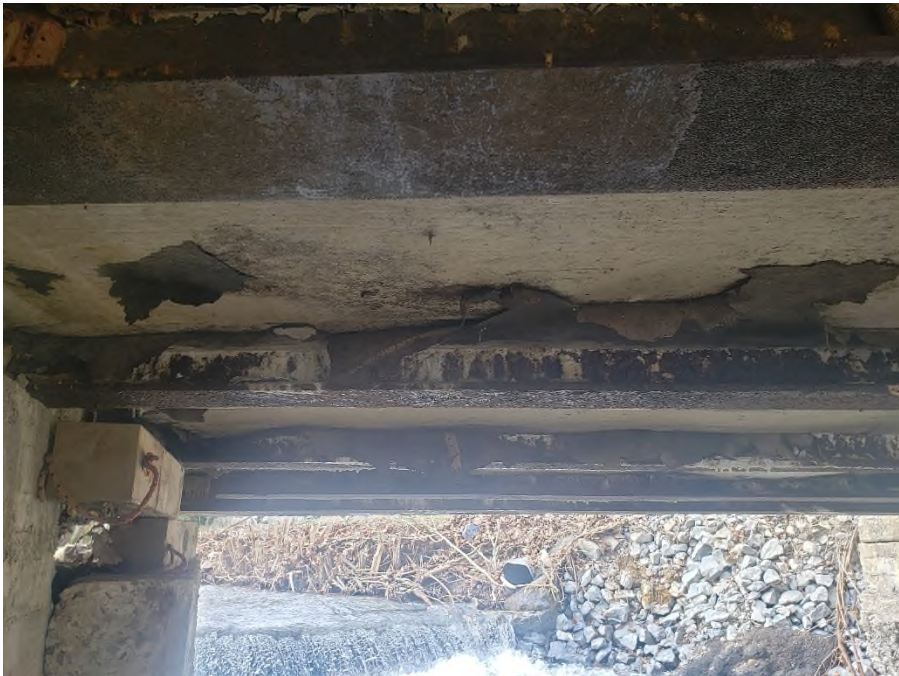
Below the decking, along the underside of the bridge contained a white trowel-applied coating, and three samples labeled 0217-5A, 0217-5B, and 0217-5C were collected from the coating. Black felt paper was also observed along the underside of the bridge. Three samples labeled 0217-4A, 0217-4B, and 0217-4C were collected of the black felt paper.

<p>Date: 02/17/2020</p>	
<p>Description: Photograph 4 – Homogeneous Area 4 Black Felt Paper Sample Locations 0217-4A 0217-4B 0217-4C</p>

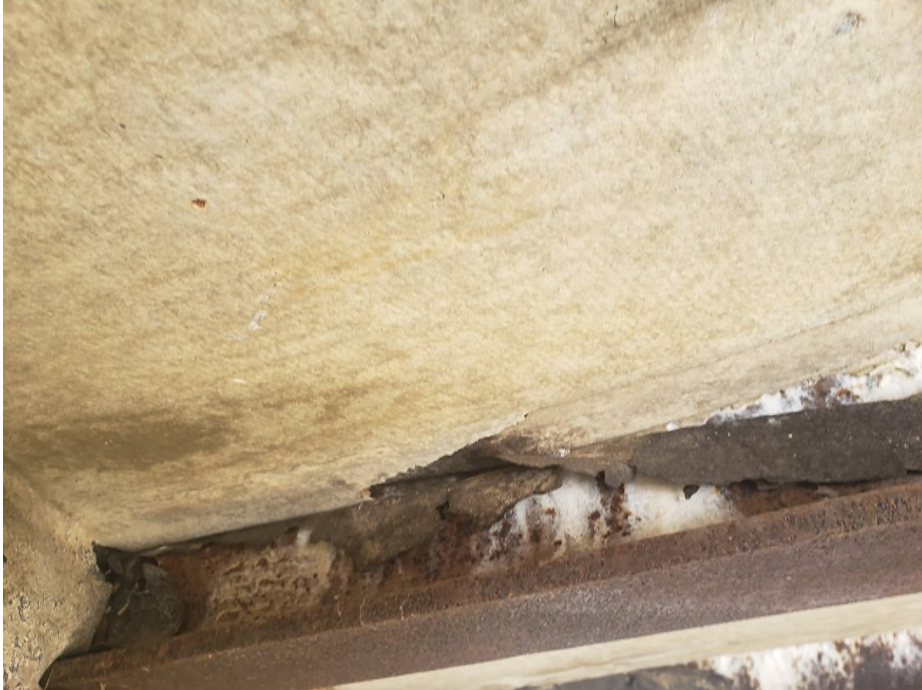
<p>Date: 02/17/2020</p>	
<p>Description: Photograph 5 – Homogeneous Area 5 White Coating Sample Locations 0217-5A 0217-5B 0217-5C</p>	
<p>Photographer: Patsy L. Shupe</p>

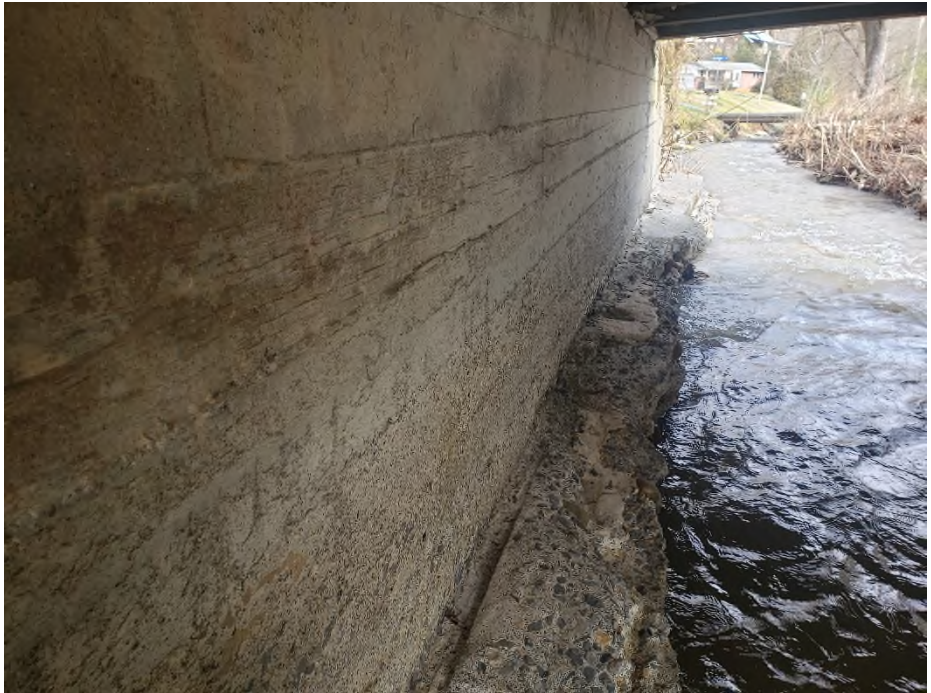
The bridge abutments are constructed of concrete. Three samples labeled 0217-7A, 0217-7B, and 0217-7C were collected from the coating on the concrete bridge abutments. The bridge abutments were constructed on concrete footings of different apparent construction material and three samples labeled 0217-6A, 0217-6B, and 0217-6C were collected from the coating on the footings.

<p>Date: 02/17/2020</p>	
<p>Description: Photograph 1 – Homogeneous Area 6 Coating on Bridge Footing Sample Locations 0217-6A 0217-6B 0217-6C</p>

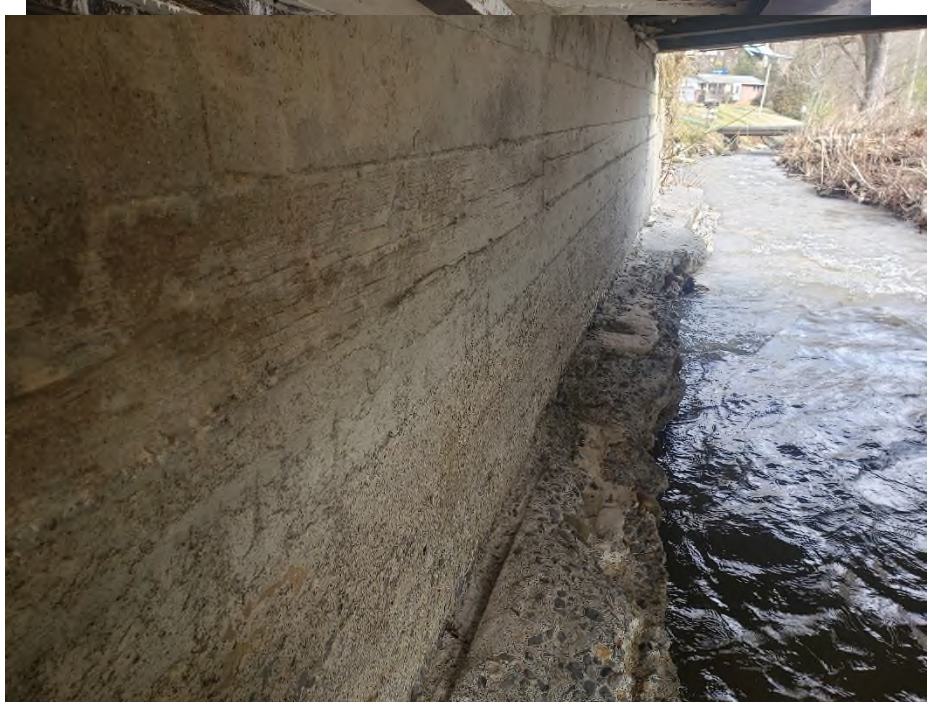
<p>Date: 02/17/2020</p>	
<p>Description: Photograph 7 – Homogeneous Area 7 Abutment Wall Coating Sample Locations 0217-7A 0217-7B 0217-7C</p>
