# Board of County Commissioners • Escambia County, Florida

Re: Re-Bid Old Courthouse 2nd Floor Restroom ADA Modifications; Specification Number

ASBESTOS AND LEAD-BASED PAINT SURVEY REPORT OLD COUNTY COURTHOUSE PENSACOLA, FLORIDA

PSI PROJECT NO.: 783-8A015

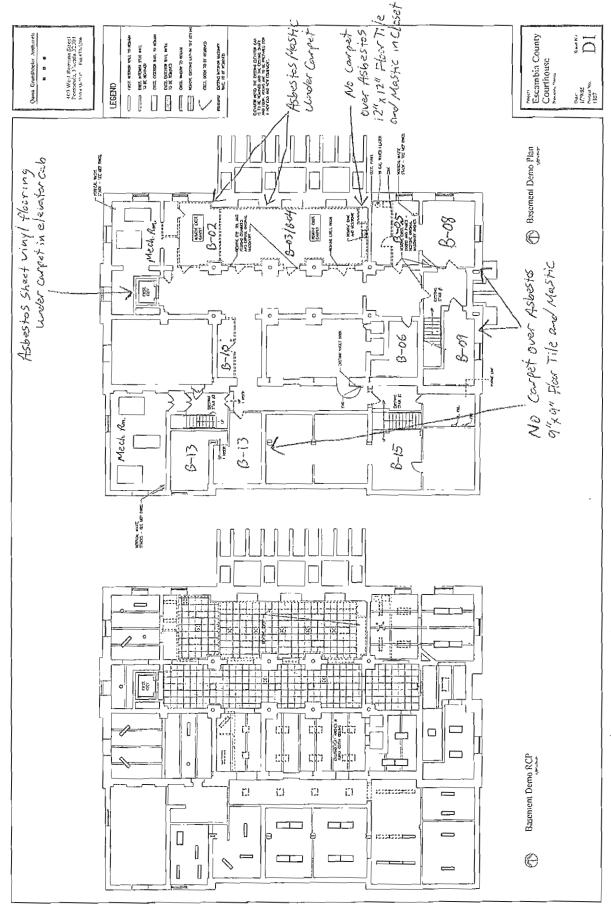
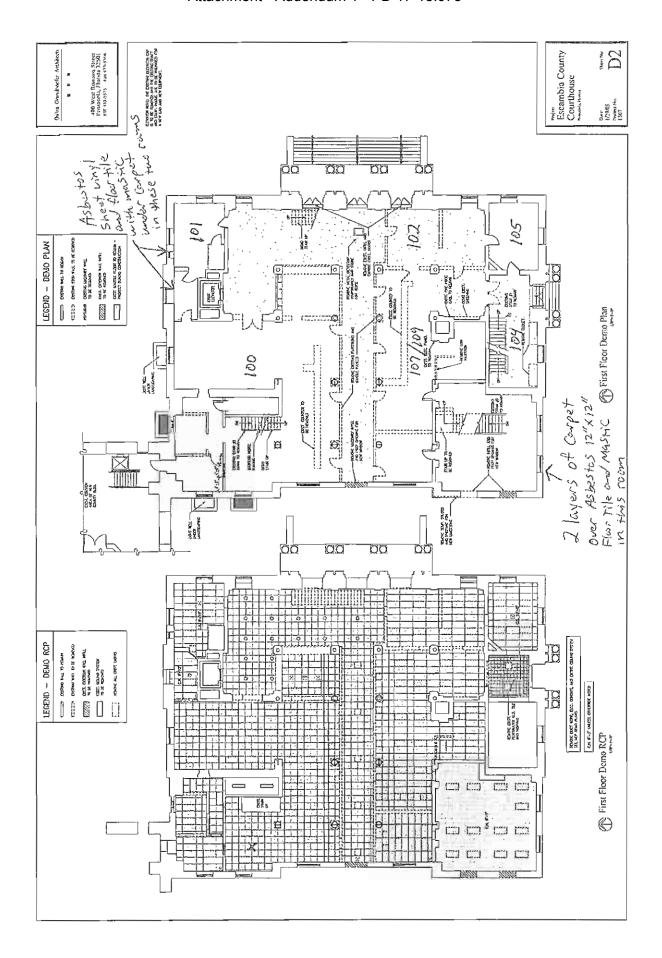
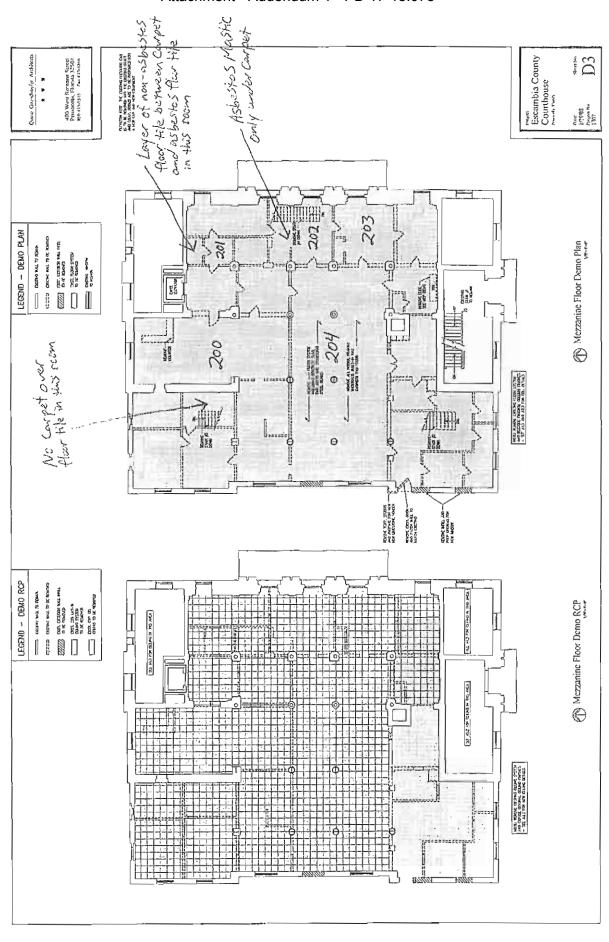
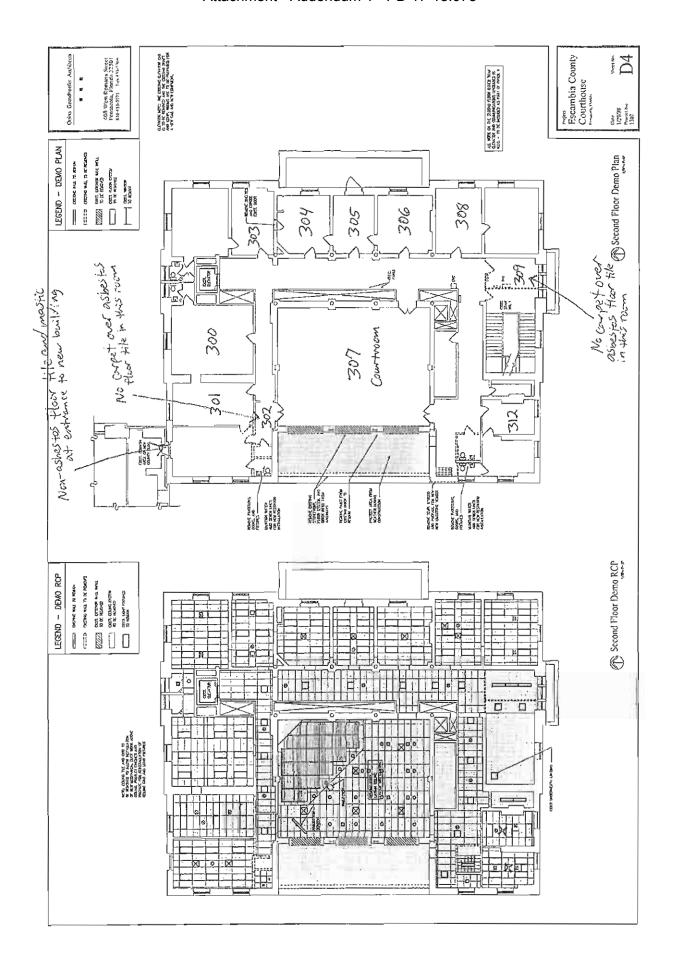
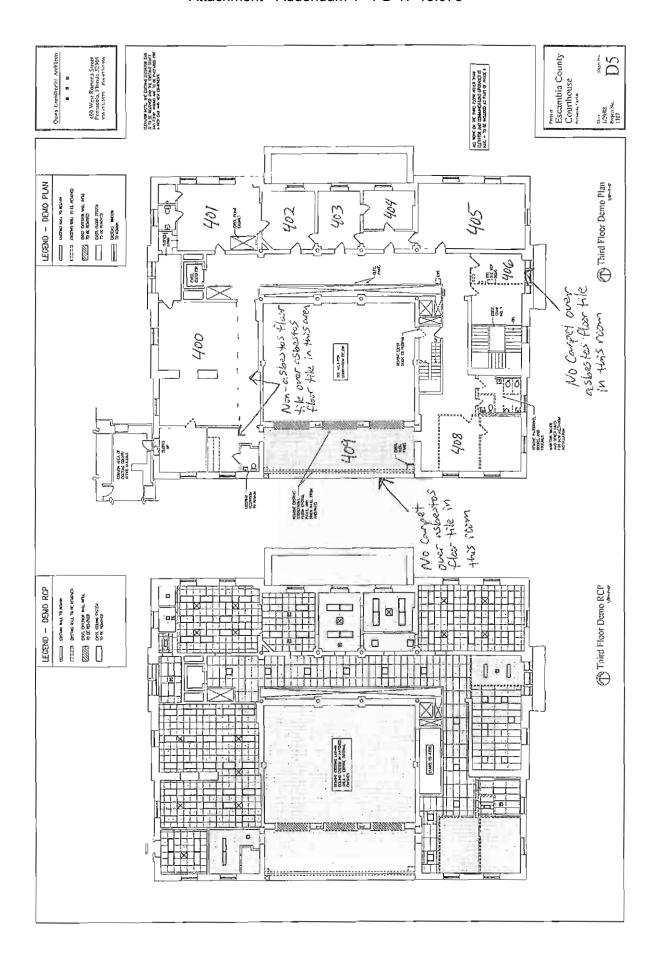
# FLOOR PLANS WITH ASBESTOS FLOORING MATERIAL LOCATIONS

asbestos flooring highlighted in blue. Covered by a Carpet unless otherwise noted 7 Locations layer of

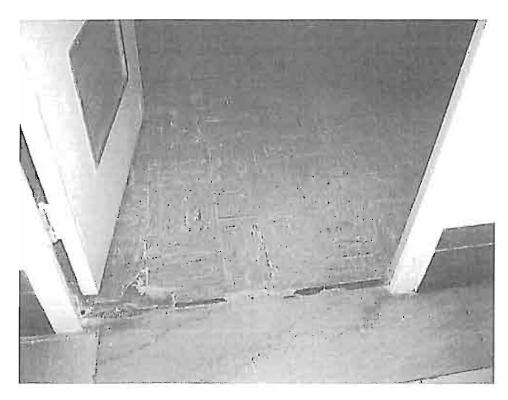
Asbestos-Containing Gray 9"x9" Floor Tile (Various rooms in Basement, 1<sup>st</sup> Floor, 2<sup>nd</sup> Floor and 3<sup>rd</sup> Floor

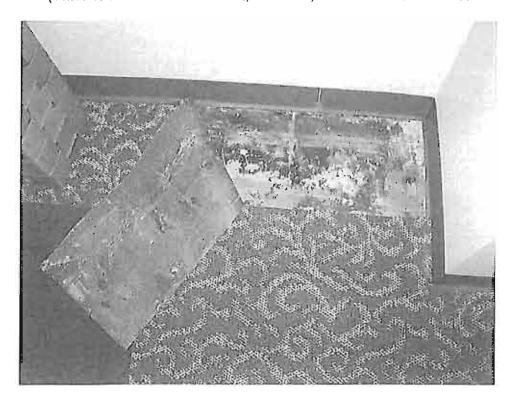
Asbestos-Containing Black Flooring Mastic Under Carpet (Rooms B-02 and B-03/B-04 in Basement and Room 202 on Mezzanine Level)

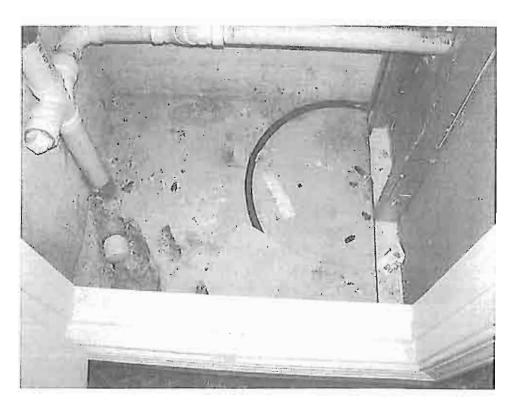
Asbestos-Containing White 12"x12" Floor Tile (Closet at Southeast Corner of Room B-03/B-04)

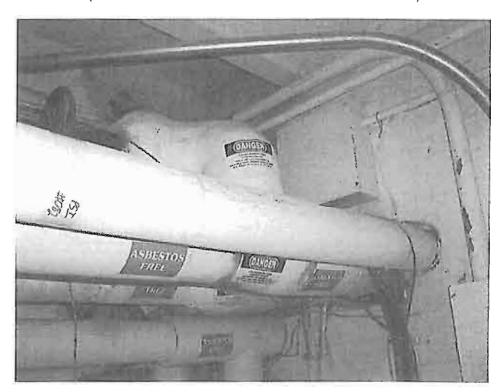
Asbestos-Containing Gray Pipe Elbow/Fitting Insulation (Basement Mechanical Rooms) (Note Non-asbestos Insulation on Straight Runs of Pipe)

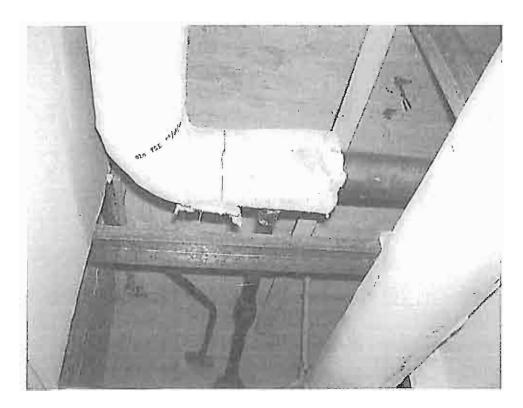
Asbestos-Containing Gray Pipe Insulation (Domestic Water Lines Throughout Building-Photo Taken in Closet at Southeast Corner of Room B-03/B-04 in Basement)

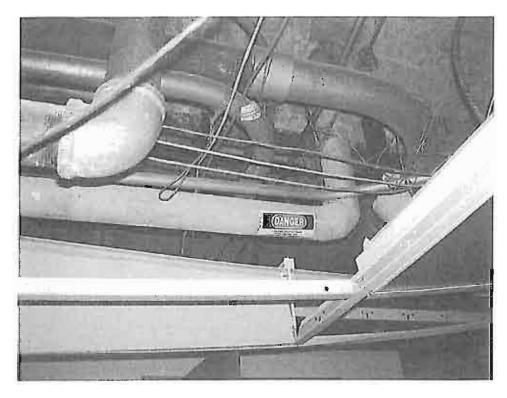
Asbestos-Containing Gray Pipe Insulation
(Photo Taken in Room South of the East End of Room 204 on the Mezzanine Level)

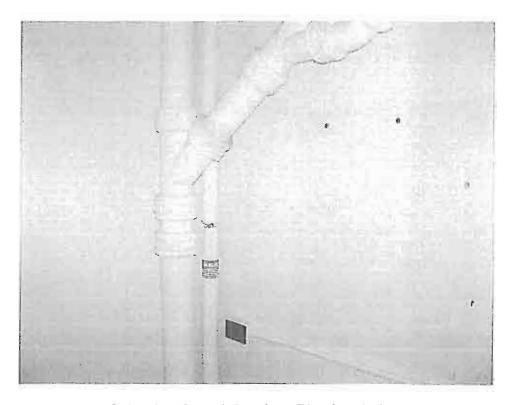
Asbestos-Containing Gray Pipe Insulation (Photo Taken in Southwest Corner of the Southwest Room on the Mezzanine Level)

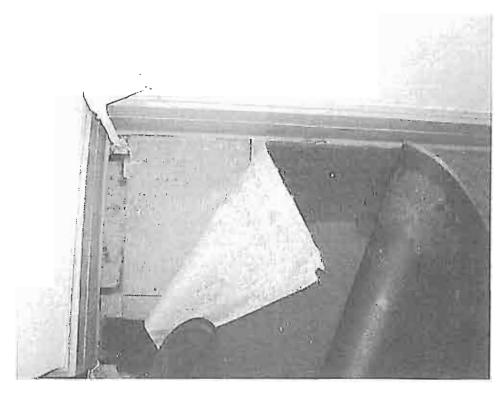
Asbestos-Containing Green 12"x12" Floor Tile (Southwest Corner Room on 1<sup>st</sup> Floor)

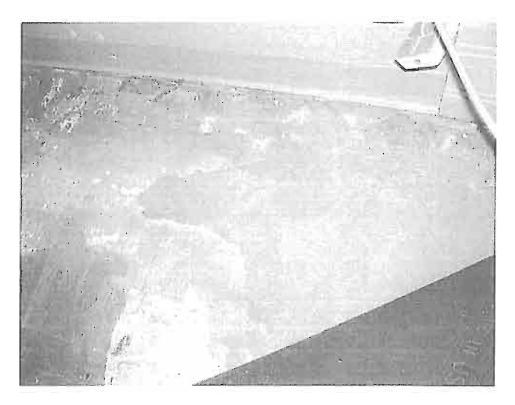
Asbestos-Containing Green and Tan Sheet Vinyl Flooring Over Asbestos-Containing Brown 9"x9" Floor Tile (Room 101 and Room North of Elevator on 1<sup>st</sup> Floor)

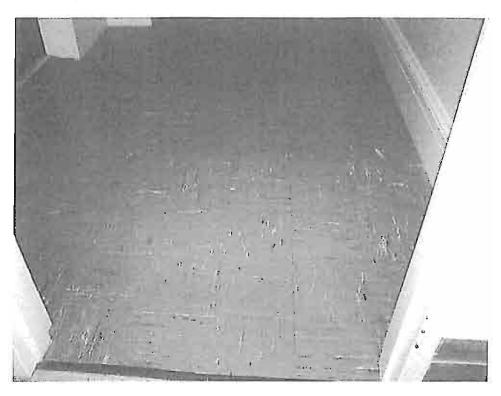
Asbestos-Containing Brown 9"x9" Floor Tile (Various rooms in Basement, 1<sup>st</sup> Floor, 2<sup>nd</sup> Floor and 3<sup>rd</sup> Floor)

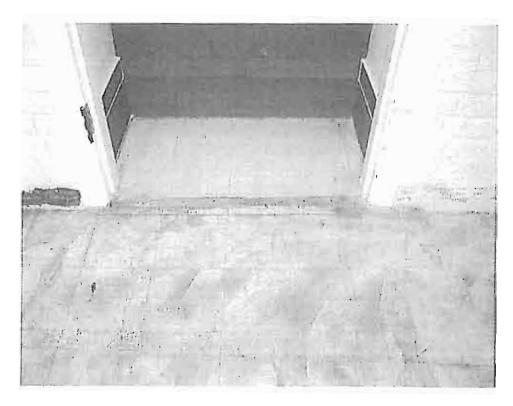
Asbestos-Containing White 9"x9" Floor Tile (Throughout Various Mezzanine Rooms, Room West of Courtroom on 2<sup>nd</sup> Floor and Room West of Courtroom on 3<sup>rd</sup> Floor)

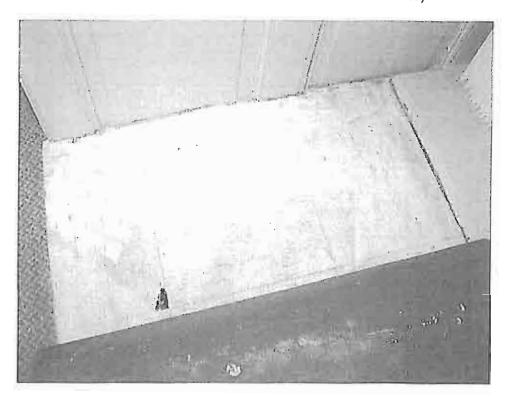
Asbestos-Containing White 12"x12" Floor Tile ((Throughout Various Mezzanine Rooms)

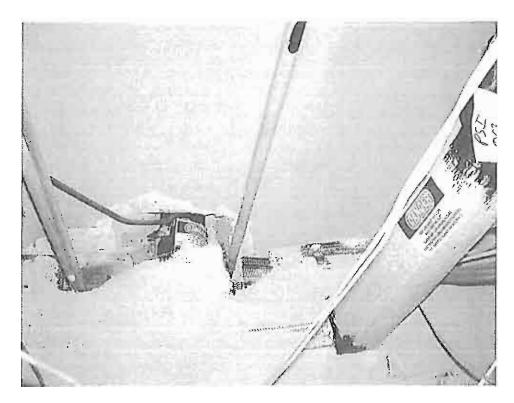
Black and Tan Pipe Insulation Wrap (Mezzanine Level in Room 204)

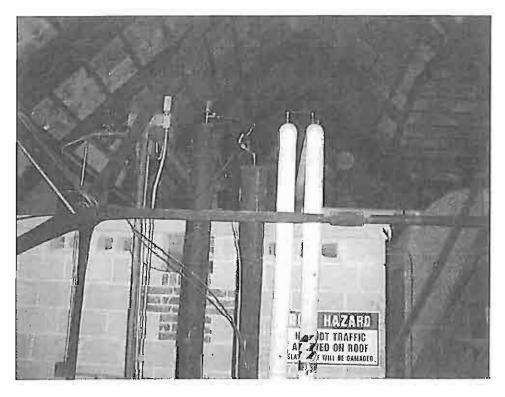
Asbestos-Containing Black and Tan Pipe Insulation Wrap (Adjacent to Elevator Equipment Room in Attic – Pipes Run Down Chase Beside Elevator Shaft to East Mechanical Room in the Basement)

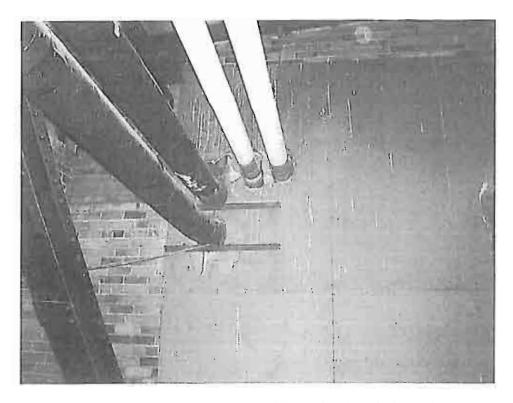
Asbestos-Containing Black and Tan Pipe Insulation Wrap (From Above Elevator Shaft Going Through Wall to Air Handling Unit in Attic Mechanical Room)

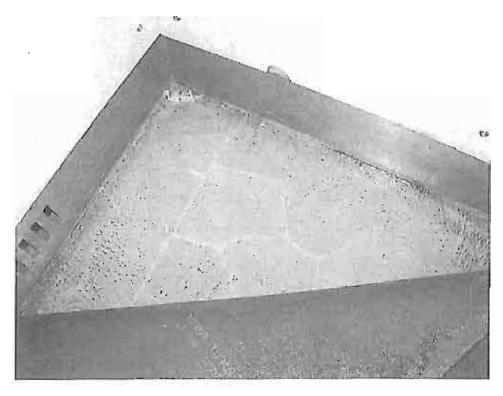
Asbestos-Containing Brown Sheet Vinyl Flooring (Elevator Cab)

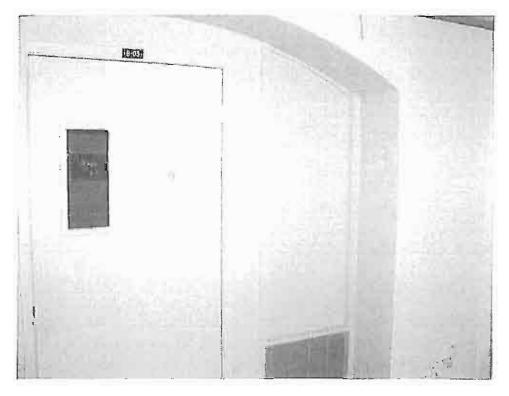
In addition, the gray panel in the wall south of the door to Room B-03 was not sampled but was assumed to be an asbestos-cement product, commonly referred to as Transite.

Assumed Gray Asbestos-Cement (Transite) Panel (South of Door in West Wall of Room B-03/B-04 in Basement)

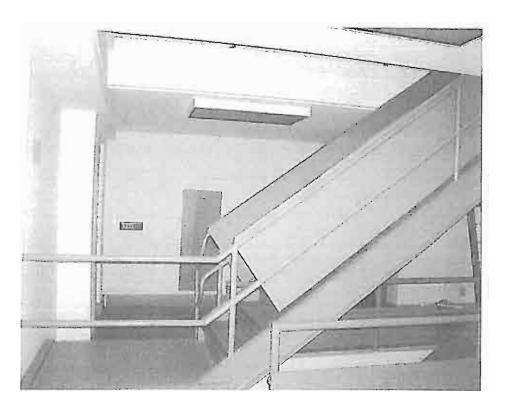
View of Southwest Stairs to Mezzanine Level (Metal Stair Components Coated With Lead-Based Paint)

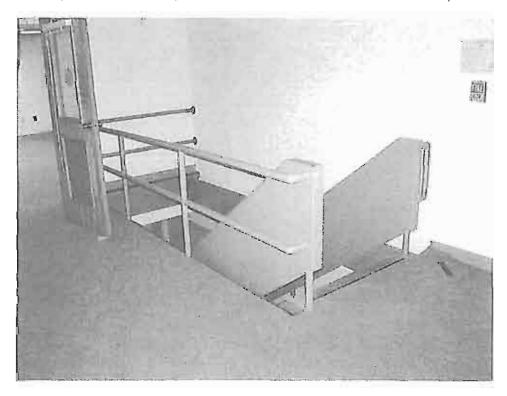
View of East Stairs from Lobby to Mezzanine Level (Metal Stair Components Coated With Lead-Based Paint)

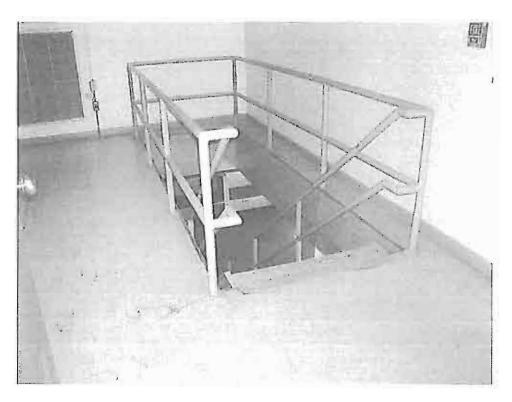
View of Northwest Stairs to Mezzanine Level (Metal Stair Components Coated With Lead-Based Paint) (Note Asbestos-Containing White 9"x9" Floor Tile)

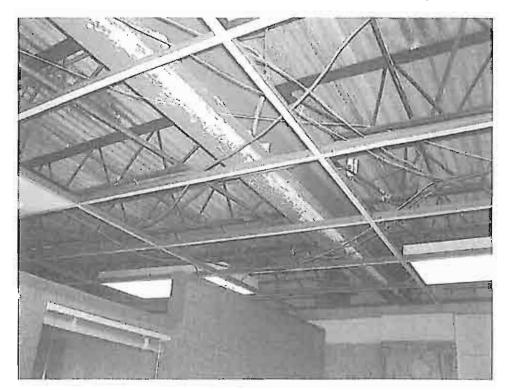
View of Orange Structural I-Beam Under Mezzanine Floor Decking (Beam is coated with lead-based paint but reddish-brown joists are not)

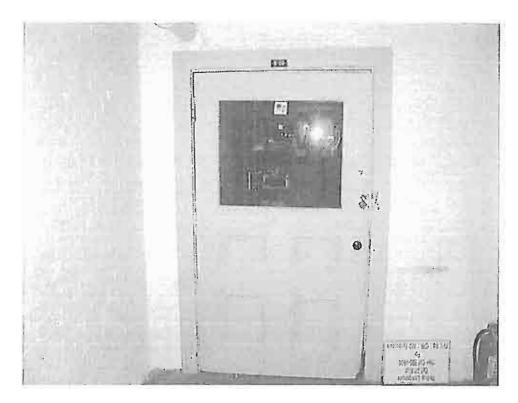
Door Assembly at Entrance to Room B-09 in Basement (Wood Door and Frame are Coated With Lead-Based Paint)

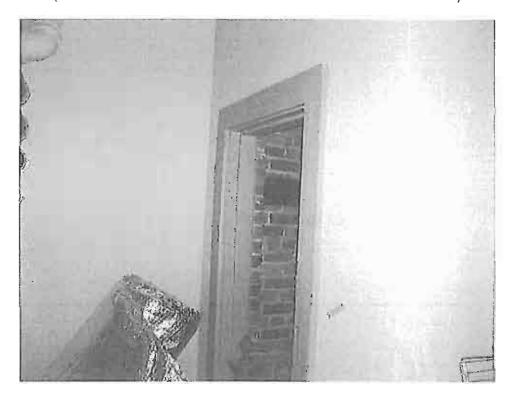
Wood Door Frame Under Stairs in Room B-09 (Door Frame is Coated With Lead-Based Paint)

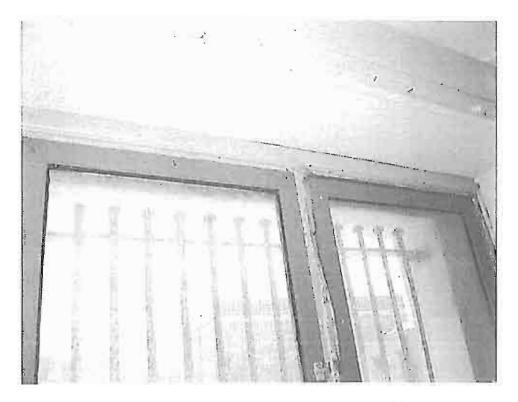
Tan Window Casing Coated With Lead-Based Paint (Located in Rooms B-08 and B-09)

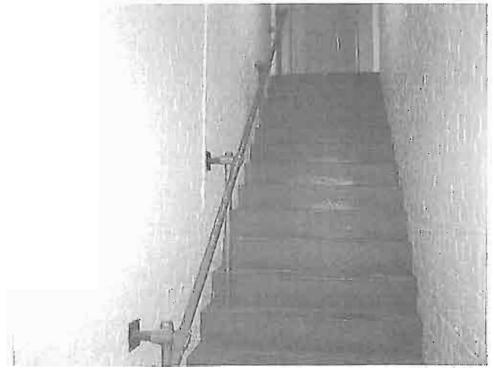
Red Handrail Coated With Lead-Based Paint in Basement Stairwell Between Rooms B-06 and B-09

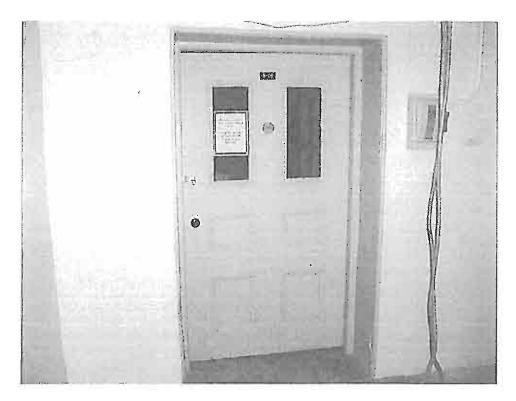
Door Assembly at Entrance to Room B-06 in Basement (Wood Door and Frame are Coated With Lead-Based Paint)

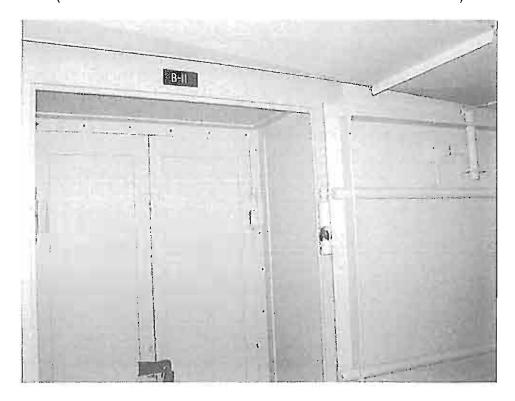
Door Assembly at Entrance to Room B-11 in Basement (Metal Doors and Frame are Coated With Lead-Based Paint)

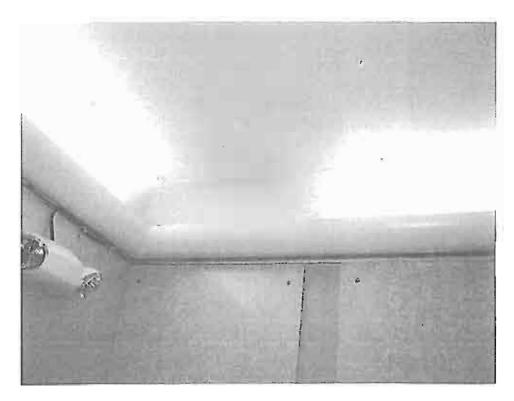
White, Metal Ceiling Inside Elevator Cab Coated With Lead-Based Paint

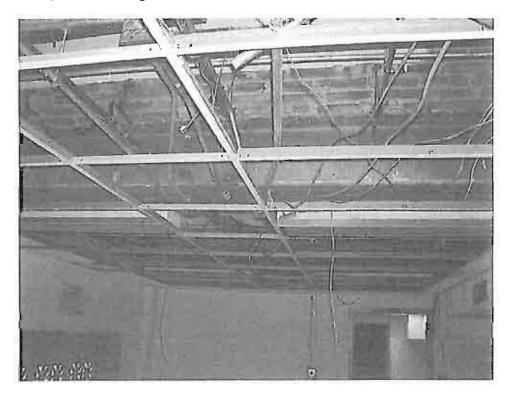
View of Orange Structural I-Beam Coated With Lead-Based Paint Located in Room 202 of Mezzanine Level, Under 2<sup>nd</sup> Floor

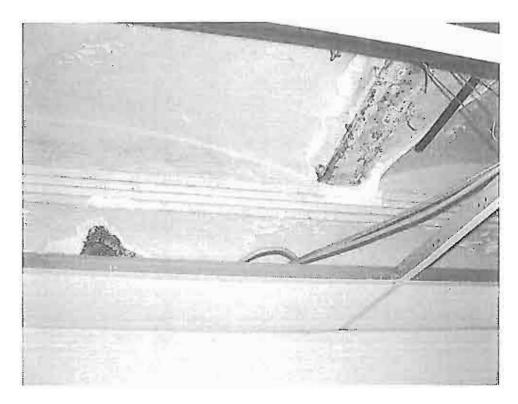
Plaster Ceiling and Decorative Molding Coated With Lead-Based Paint (Above Drop Ceiling on Mezzanine Level – Original 1<sup>st</sup> Floor Ceiling)

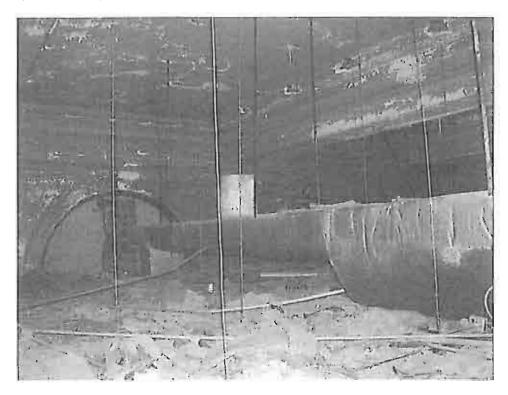
View of Original Ceiling and Decorative Molding Above Existing Ceiling in Courtroom (Room 307 on 2<sup>nd</sup> Floor) – Assumed to be Coated With Same Lead-Based Paint as the Original 1<sup>st</sup> Floor Ceiling

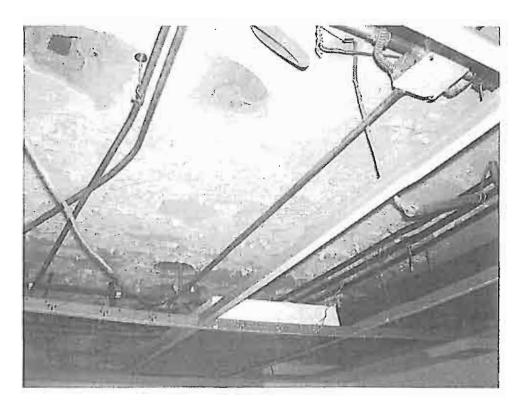
Lead-Based Paint in Poor Condition on the Original Plaster Ceiling of the 1<sup>st</sup> Floor (Above Mezzanine Drop Ceiling)

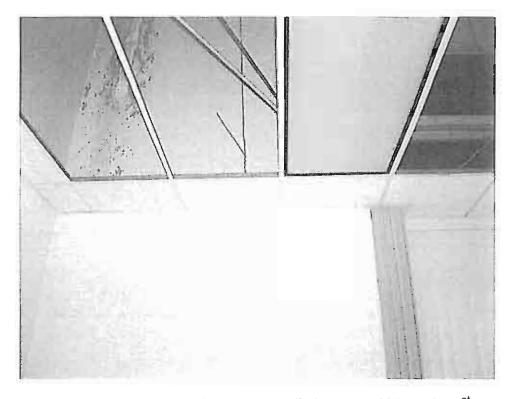
Green and White Lead-Based Paint on Walls in Room 105 on the 1st Floor
