ADDENDUM No. 2

Grant County Airport Terminal Renovation
Grant County IFB No. B-20-02
AIP Project No. 3-35-0039-021-2019
NMDOT – Aviation Division Grant No. SVC-19-03

**LIMITED ASBESTOS SURVEY REVISION #1
ADDITIONAL SAMPLING**

Project: Grant County Airport Revision #1 (Additional Sampling)

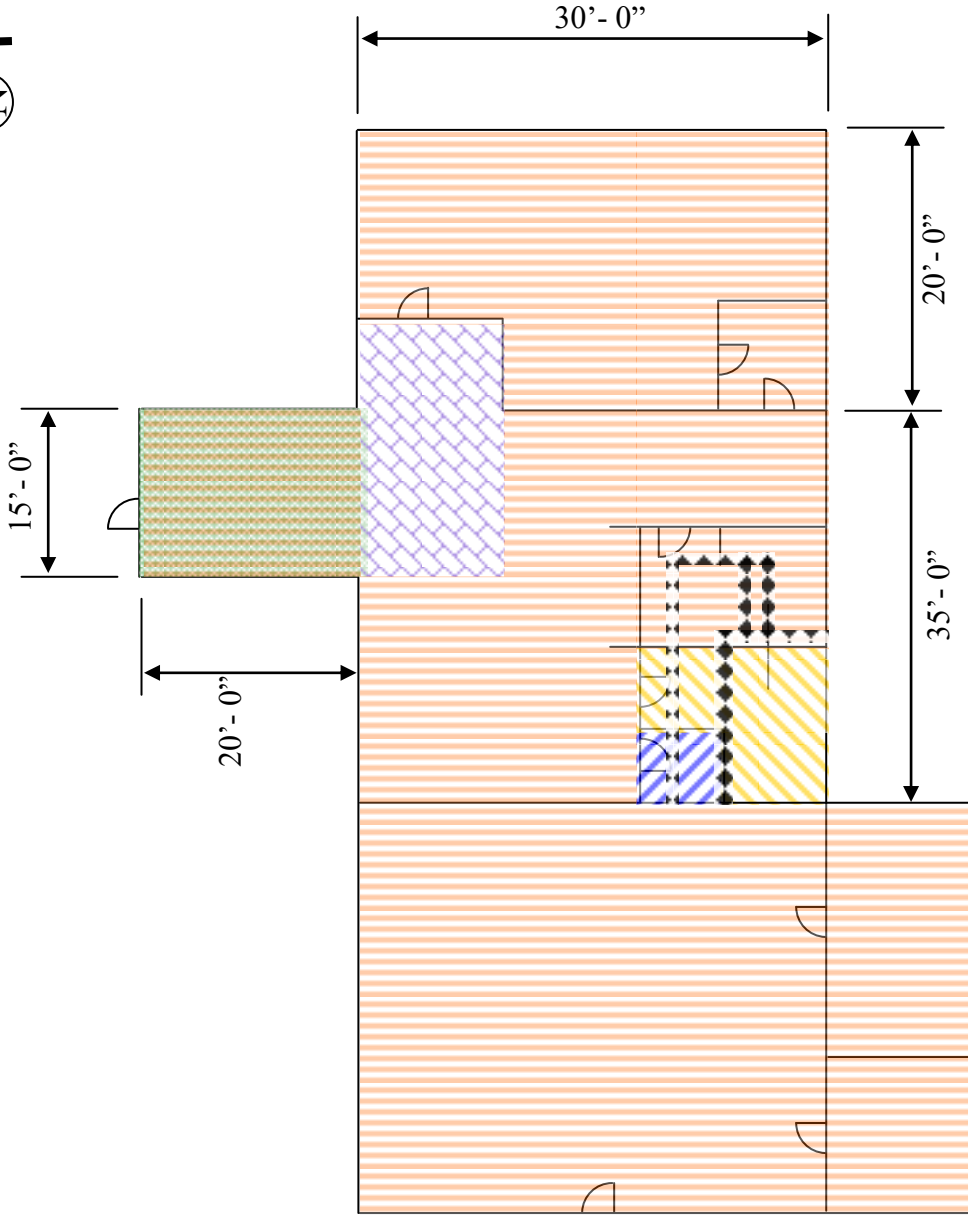
Homogeneous Areas Floor Plan

-   Pipe Insulation
-   Tan Marbled 9"x9" Floor Tile/Black Mastic
-   Tan Speckled 12"x12" Floor Tile
-   Assumed Black Mastic
-   White Popcorn Acoustical Ceiling Texture
-   Black Carpet/Yellow-Black Mastic
