# Lead-Based Paint Inspection Report

## **Northgate Terrace**

4301 Whittle Springs Road  
Knoxville, Tennessee 37917

**Inspection Dates:** June 14-16, 2021

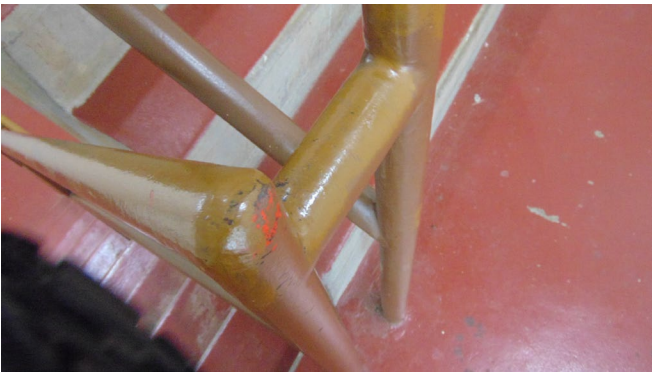
As of the date of the evaluation, paints throughout the interior and exterior of the structure were primarily intact, however, deteriorated lead-based paint was identified on building exterior and stairwell areas. Deteriorated lead-based paint should be stabilized in accordance with State of Tennessee Lead-Based Paint Regulations.

**Stairwell Handrail – Deteriorated LBP**

One Source Environmental, LLC recommends stabilization of deteriorated lead-based paint and ongoing monitoring and maintenance of components identified as containing lead-based paint to prevent deterioration of these components and possible development of lead-based paint hazards in the future.

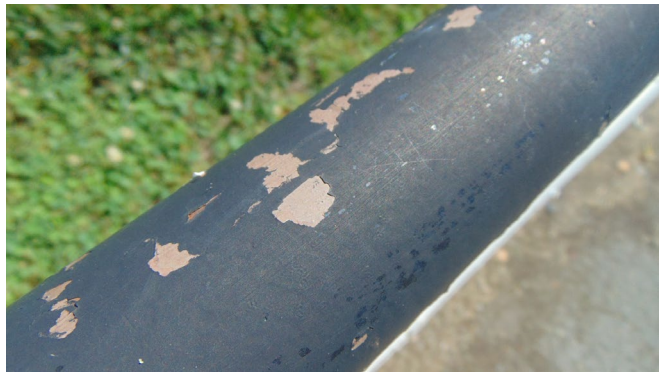
**Exterior Handrail – Deteriorated LBP**
