October 22, 2014

City of Knoxville
Office of Redevelopment
400 Main Street, Suite 655
Knoxville, Tennessee 37902

Subject: **Report of Limited Asbestos and Lead-Based Paint Survey**
625 North Broadway Former Sanitary Laundry Facility
750 Stone Street – Auto Repair Building
760 Stone Street – Boiler House
Knoxville, Tennessee
EPA Cooperative Agreement Number BF-95443509-1
S&ME Project No. 1434-11-392-007

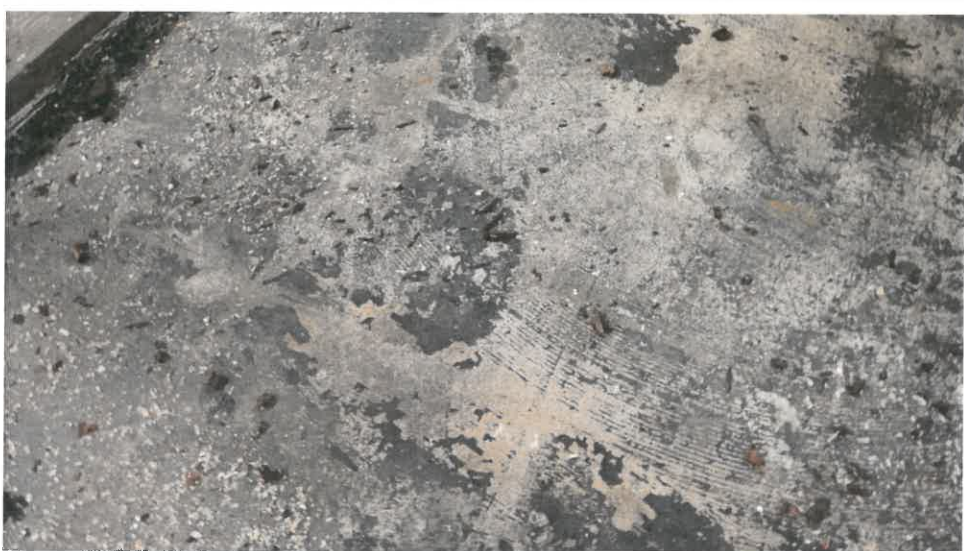
Photo 2

Date: 2/17/2014 Photographer: Emily Buckingham
Sample # / Location	SL-005 A/B / Sanitary laundry building - Ground floor room 101	
Remarks	Black mastic on concrete floor 7% Chrysotile

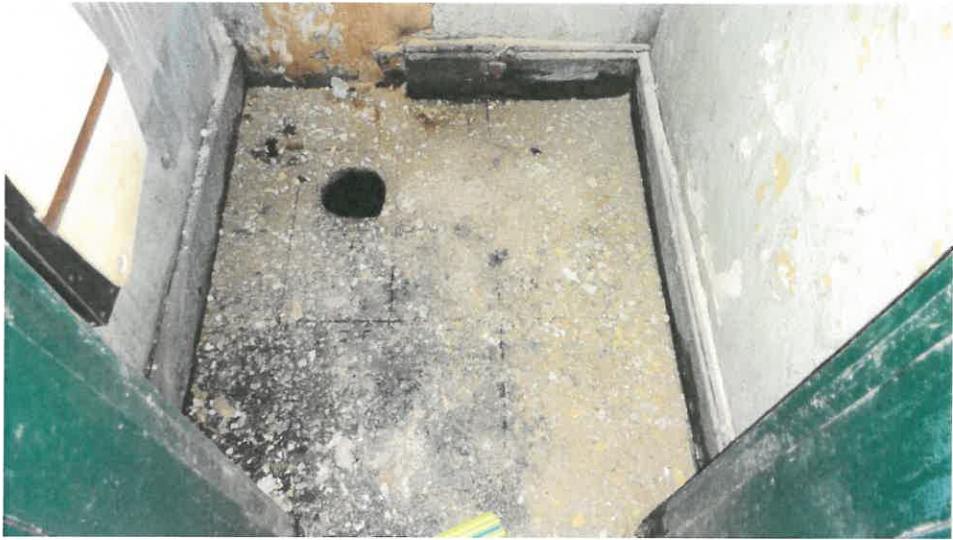
Photo 3

Date: 2/17/2014 Photographer: Emily Buckingham
Sample # / Location	SL-008 A/B/ Sanitary laundry building - Ground floor bathroom 102	
Remarks	Beige 9" x 9" floor tile with black mastic Tile: 5% Chrysotile, Mastic: 3% Chrysotile

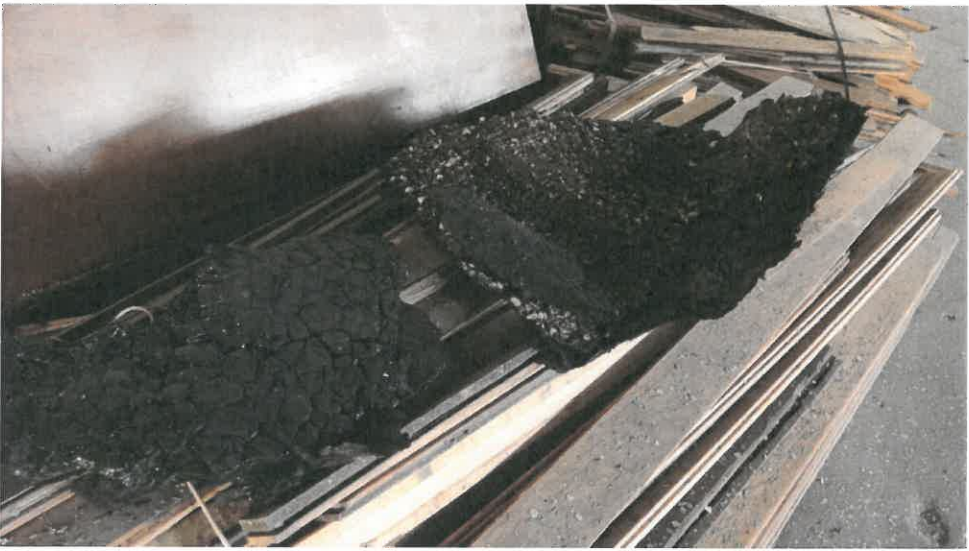
Photo 4

Date: 2/17/2014 Photographer: Emily Buckingham
Sample # / Location	SL-011 A/B & SL-012 A/B / Sanitary laundry building - Roof	
Remarks	Rocks over tar paper over roofing felt Tar paper: 4% Chrysotile

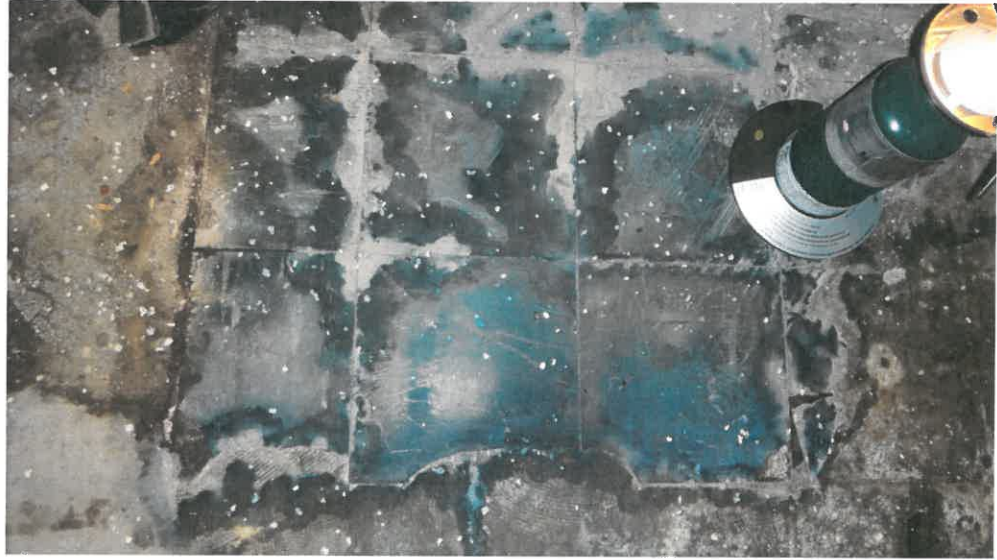
Photo 5

<p>Date: 2/19/2014</p> <p>Photographer: Emily Buckingham</p>
Sample # / Location	SL-018 A/B/ Sanitary laundry building - Basement room 010	
Remarks	Blue 9" x 9" floor tile with black mastic Floor tile: 4% Chrysotile, Mastic 3% Chrysotile

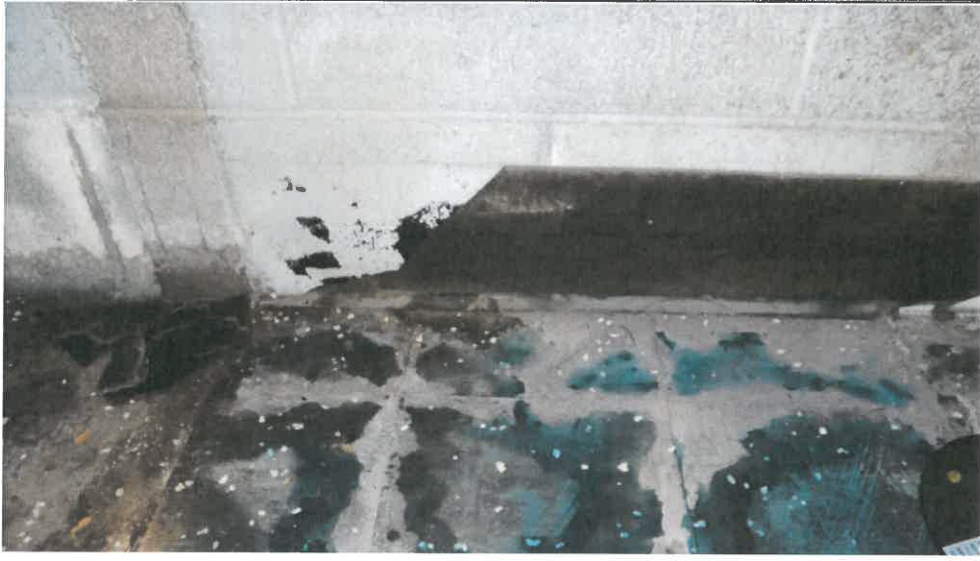
Photo 6

<p>Date: 2/19/2014</p> <p>Photographer: Emily Buckingham</p>
Sample # / Location	SL-019 A/B/ Sanitary laundry building - Basement room 010	
Remarks	Black covebase with black mastic Covebase: 4% Chrysotile, Mastic: ND

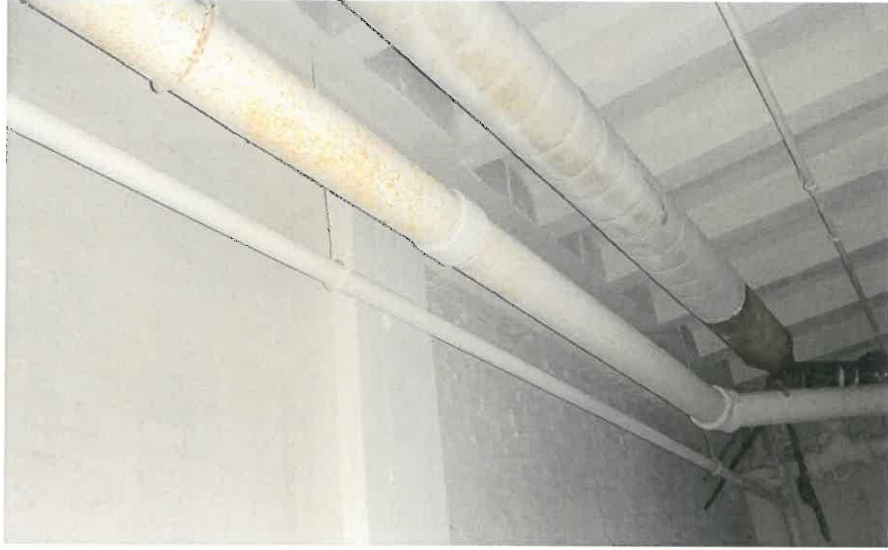
Photo 7

Date: 2/19/2014 Photographer: Emily Buckingham
Sample # / Location	SL-020 A/B/C/ Sanitary laundry building - Basement rooms 009 and 010	
Remarks	Brown paper and black tar layered thermal system insulation with paper wrap on water pipes Brown paper: 20% Chrysotile

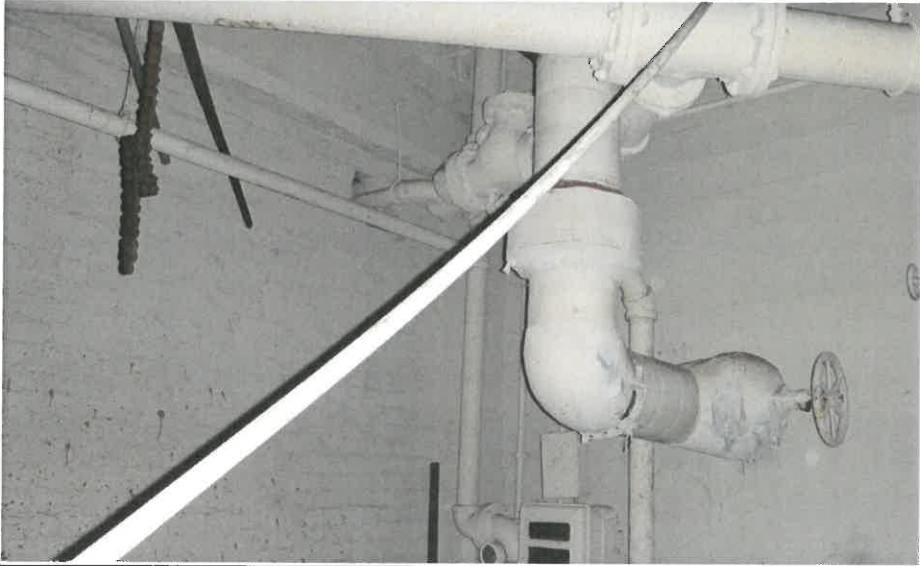
Photo 8

Date: 2/19/2014 Photographer: Emily Buckingham
Sample # / Location	SL-021 A/B/C/Sanitary laundry building - Basement room 010	
Remarks	Hard, White mud on elbows of water pipes 30% Chrysotile

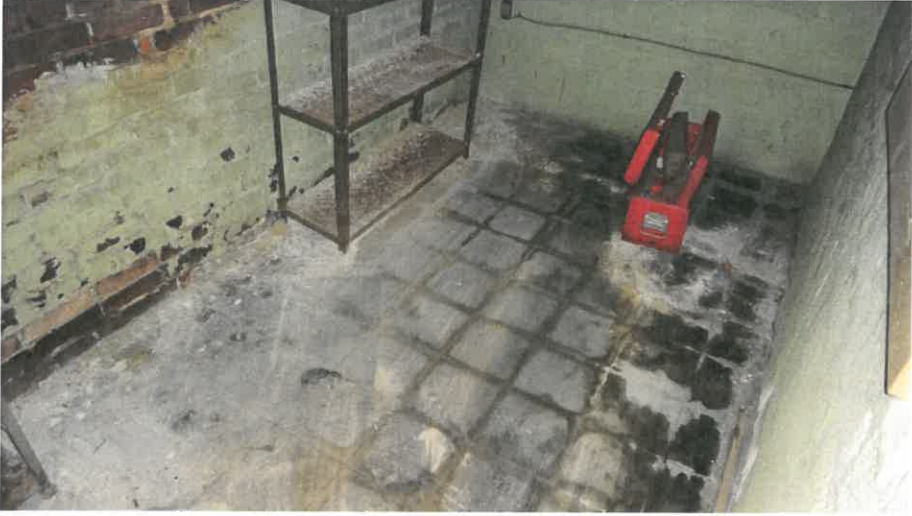
Photo 9

Date: 2/19/2014 Photographer: Emily Buckingham
Sample # / Location	SL-022 A/B/Sanitary laundry building - Basement room 007	
Remarks	Green 9" x 9" floor tile with black mastic Floor tile: 4% Chrysotile, Mastic 5% Chrysotile

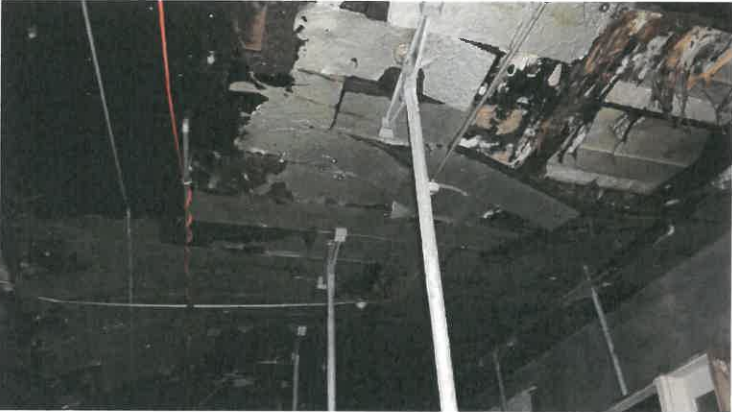
Photo 10

Date: 2/19/2014 Photographer: Emily Buckingham
Sample # / Location	SL-024 A/B/ Saniary laundry building - Basement room 015	
Remarks	Silver paint over black mastic on corkboard on ceiling Black mastic: 2% Chrysotile
