LIMITED HAZARDOUS MATERIALS SURVEY

ROOFS AND EXTERIOR AREAS OF VIRGINIA HOSPITAL CENTER

601 S. CARLIN SPRINGS ROAD
ARLINGTON, VIRGINIA 22204

NOVEMBER 22, 2019

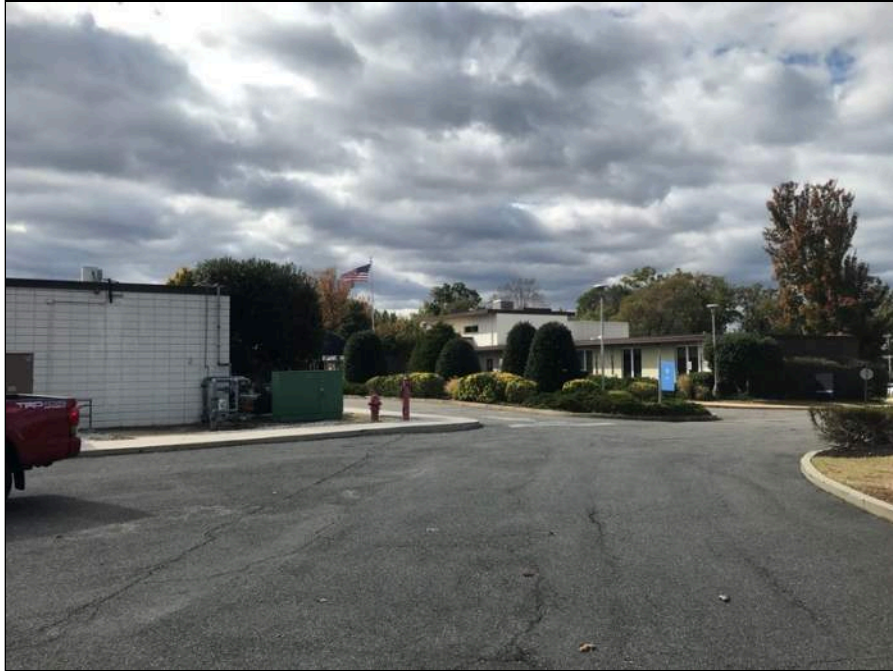
1 - View of the Northern One-Story and Two-Story Sections of the Building.

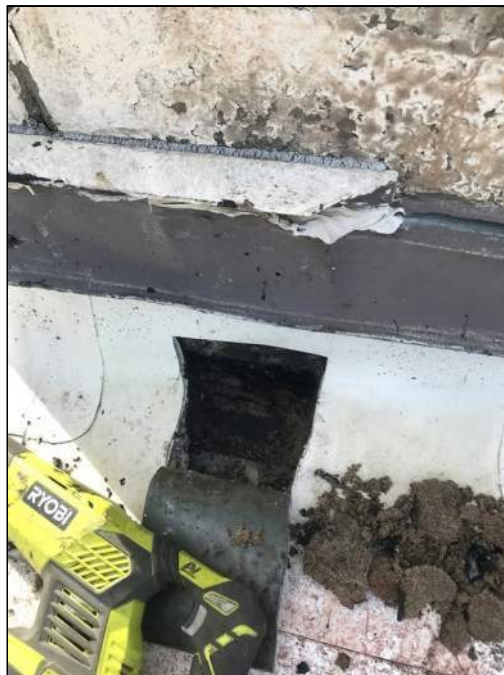
Asbestos-containing multiple layered flashing caulk was observed on the parapet wall adjacent to the southern multiple story section of the building. The asbestos-containing multiple layered flashing caulk appeared to be isolated to the connecting building parapet wall. Including a 20% contingency factor, approximately 50 linear feet of asbestos-containing multiple layered flashing caulk is associated with the parapet wall.

2 - View of Asbestos-Containing Multiple Layered Flashing Caulk on the Connecting Building Parapet Wall. Sample No. 61.

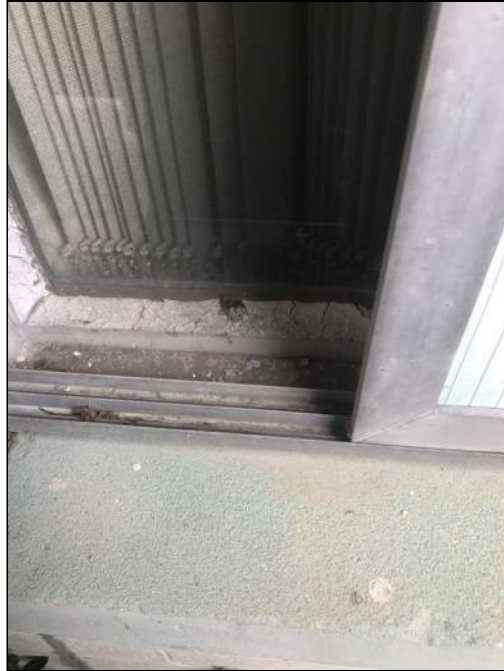
The asbestos-containing exterior gray window glazing was observed on the majority of exterior windows. Including a 20% contingency factor, approximately 6,000 linear feet of asbestos-containing exterior gray window glazing is located on exterior windows of the northern one-story and two-story sections of the building.

3 - View of Asbestos-Containing Gray Window Glaze on Exterior Windows. Sample No. 125.

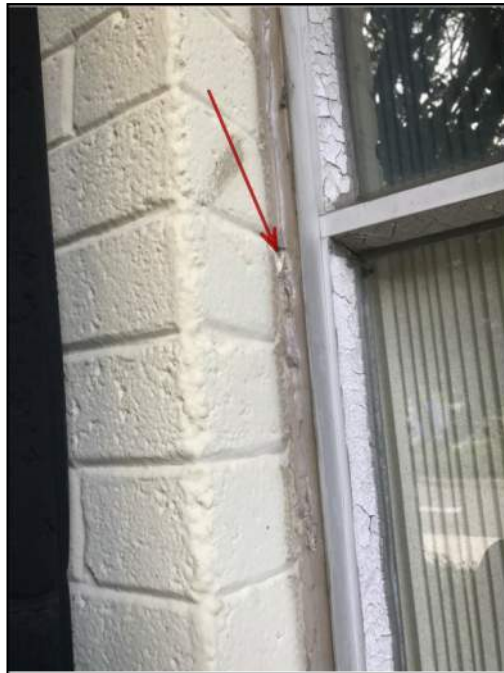
The asbestos-containing exterior white window caulk was observed on the majority of exterior windows. Including a 20% contingency factor, approximately 3,000 linear feet of asbestos-containing exterior white window caulk is located on exterior windows of the northern one-story and two-story sections of the building.

4 - View of Asbestos-Containing White Window Caulk on Exterior Windows. Sample No. 127-B.

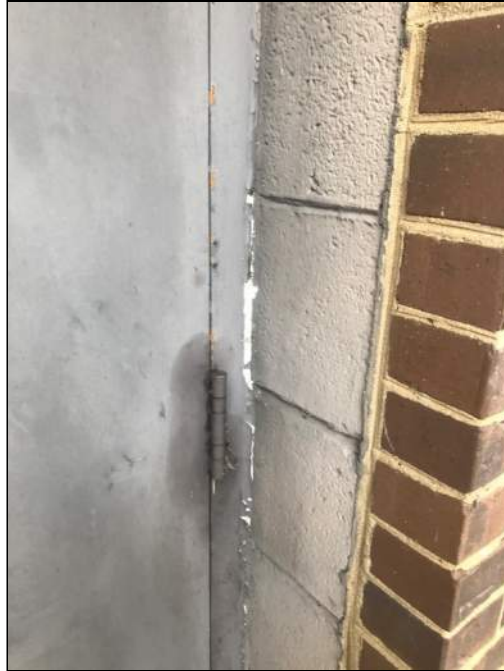
The asbestos-containing exterior tan door caulk was observed on several exterior doors. Including a 20% contingency factor, approximately 500 linear feet of asbestos-containing exterior tan door caulk is located on exterior doors around the northern one-story and two-story sections of the building.

5 - View of Asbestos-Containing Tan Door Caulk on Exterior Doors. Sample No. 149.

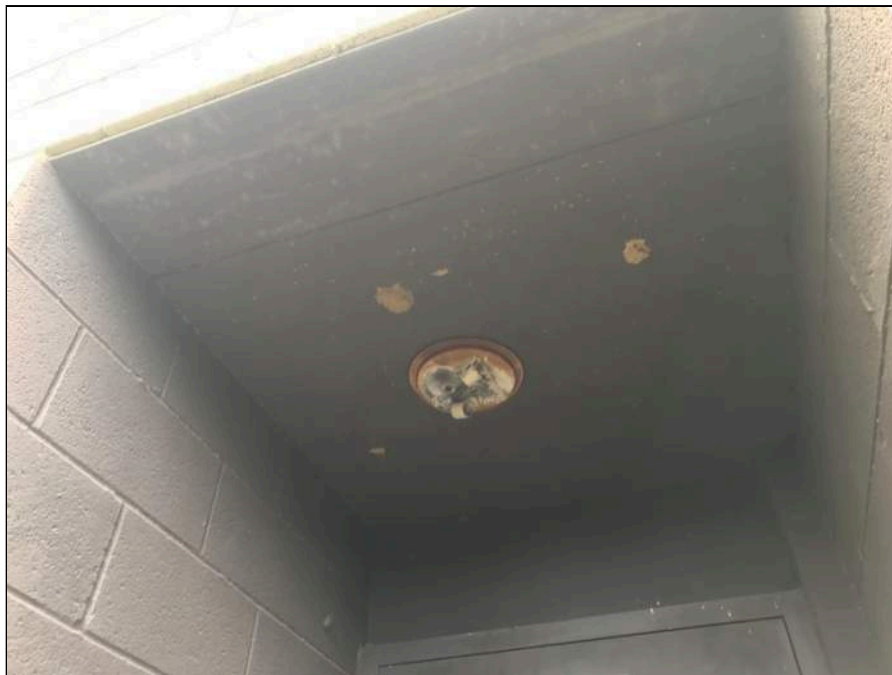
An asbestos-containing light shield insulation was observed underneath the several exterior soffits of the building. The asbestos-containing light shield insulation on one of the southeast soffits was observed in a damaged condition. Approximately 6 pieces of light shield insulation were observed on exterior soffits.

6 - View of Damaged Asbestos-Containing Light Shield Insulation on Exterior Soffits. Sample No. 164.

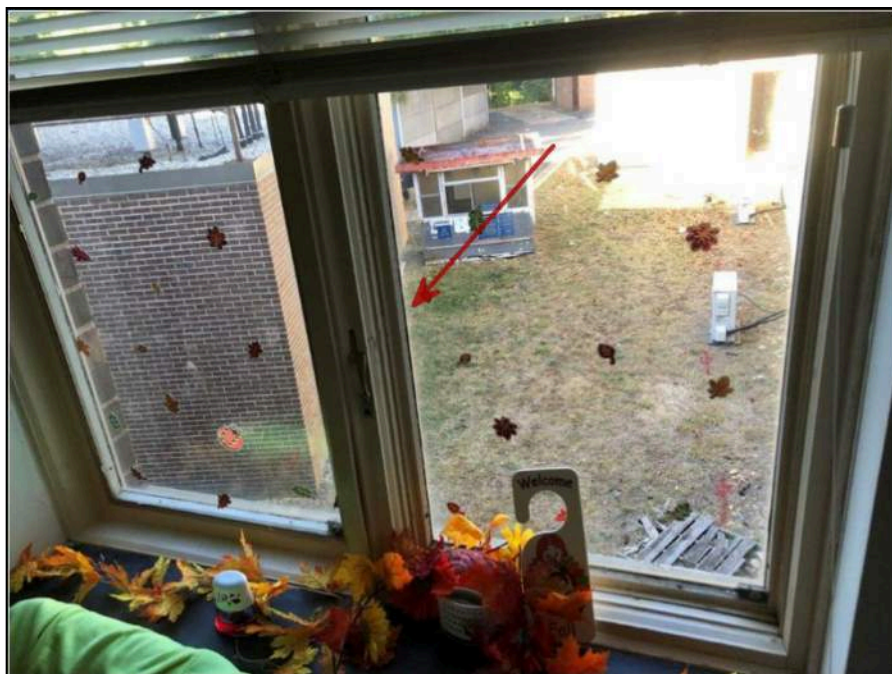
The section of building which connects the northern one-story and two-story sections with the southern multiple story section of the building appeared to have a distinct window system which is unique to the connecting building. The interior black window glaze on the connecting building windows was reported to contain asbestos. The windows are approximately four feet wide by six feet tall. Including a 20% contingency factor, approximately 275 linear feet of interior black window glazing was observed.

7 - View of Asbestos-Containing Interior Black Window Glazing on Connecting Building Windows. Sample No. 179.

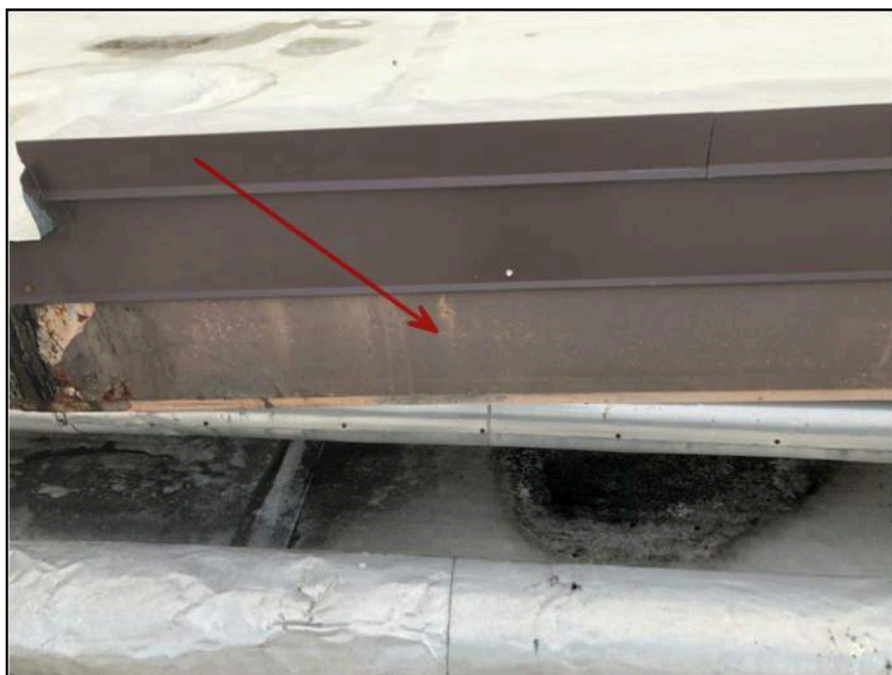
8 - View of Lead Based Paint on a Red Metal Beam on the Roof. XRF Reading No. 1031.

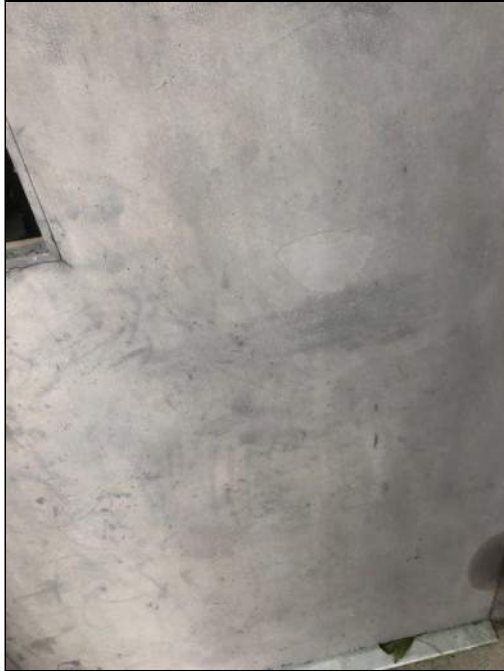
9 - View of Lead Based Paint on a Dark Gray Metal Door. XRF Reading Nos. 1050 and 1051.

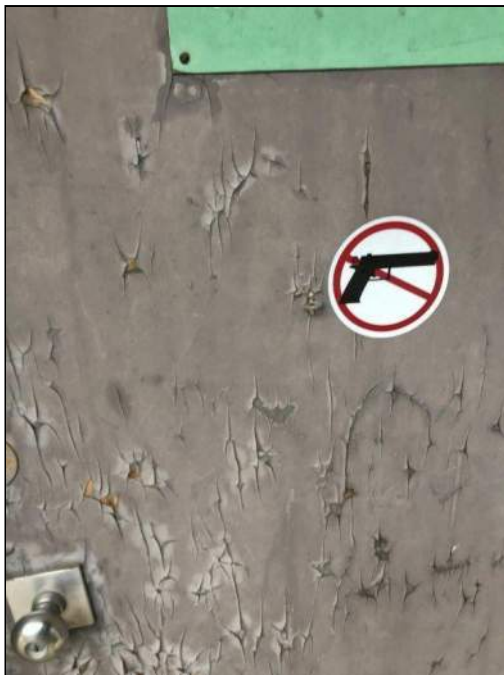
10 - View of Lead Based Paint on a Brown Metal Door. XRF Reading No. 1056.

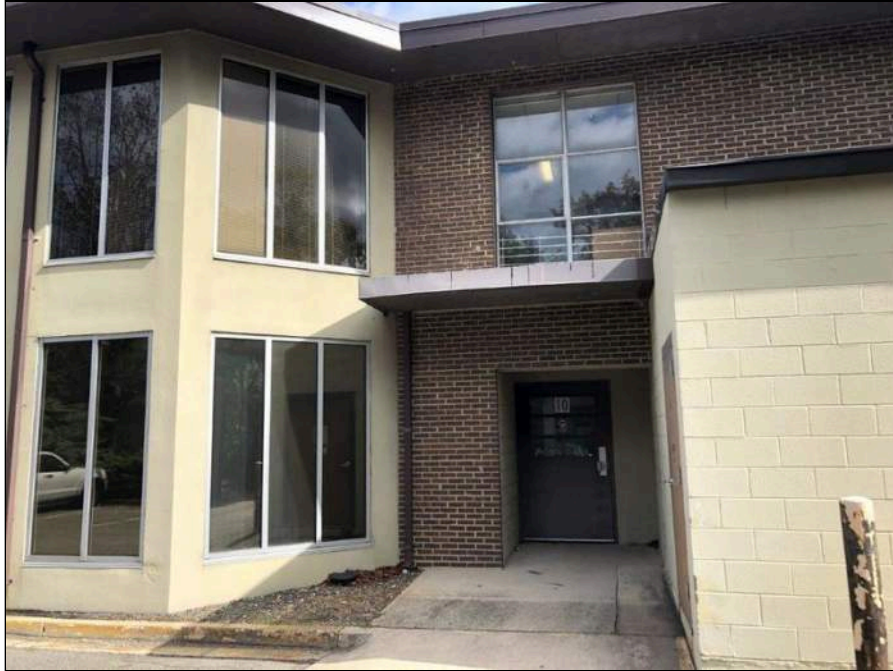
11 - View of Lead Based Paint on a Brown Metal Door. XRF Reading No. 1077.
