**HAZARDOUS MATERIALS INSPECTION REPORT
OF THE
VIRGINIA HOSPITAL CENTER FACILITY
LOCATED AT
601 S. CARLIN SPRINGS ROAD
ARLINGTON, VIRGINIA**

AMA Job#: 19415
Contract #: 678-12
PO #: 273316

November 4, 2019

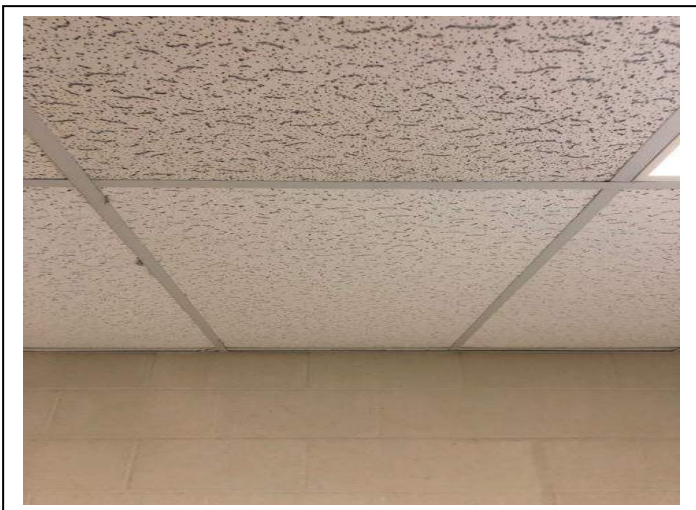
Photo #3

**Material: Fissure Pinhole Ceiling Tile
Sample Result: No Asbestos Detected**

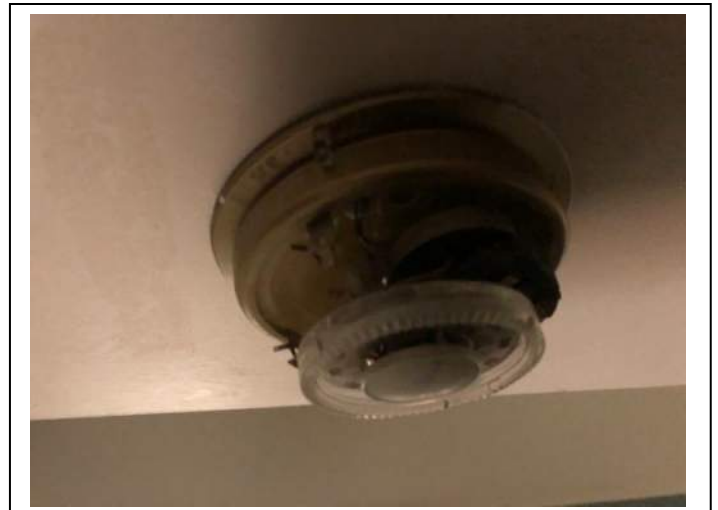
Photo #4

**Material: Mercury Thermostat
Sample Result: Not Sampled**

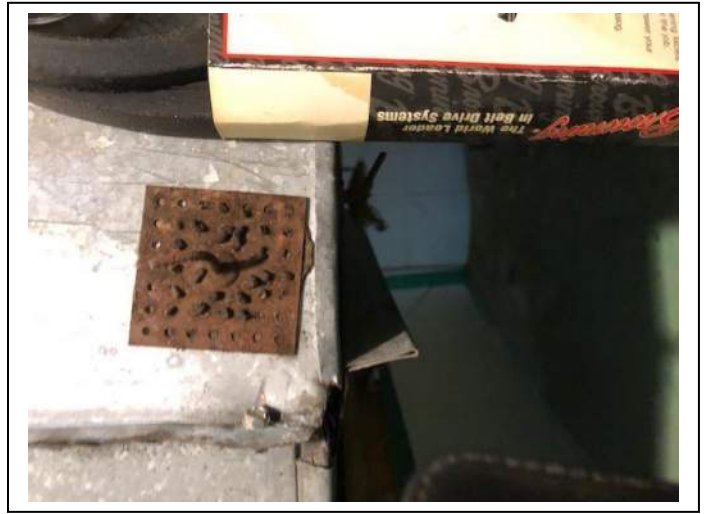
**Photo #12
Material: Brown Pin Mastic
Sample Result: 40% Chrysotile**

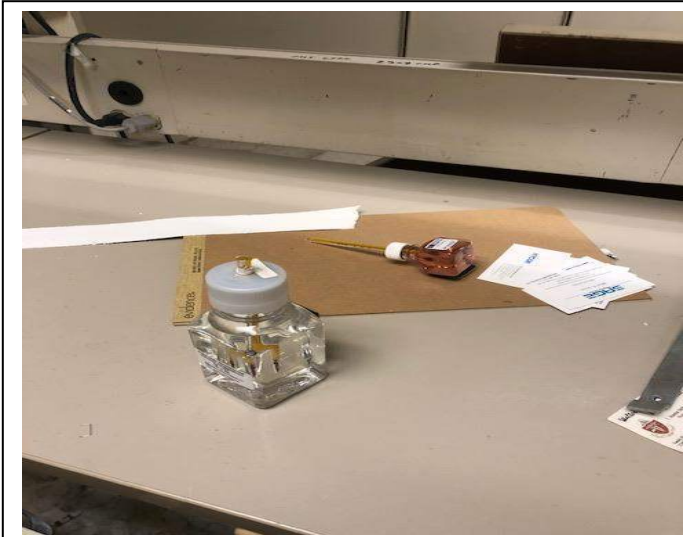
**Photo #13
Material: Mercury Thermometers
Sample Result: Not Sampled**

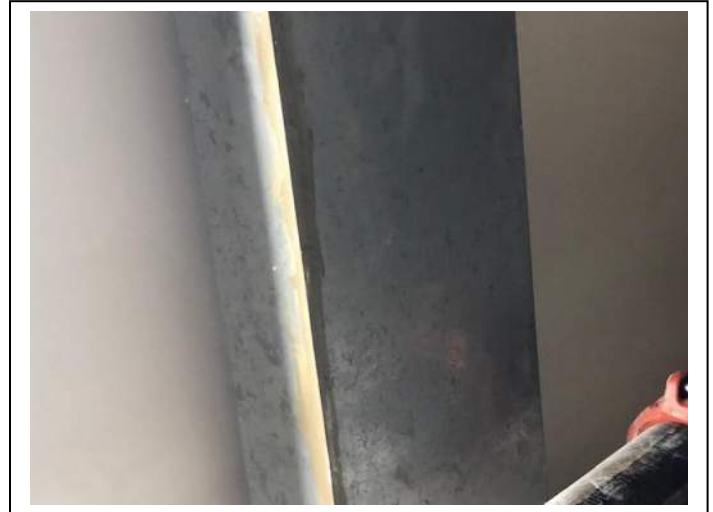
**Photo #14
Material: Brown Metal Duct Seam Sealant On
Metal
Sample Result: No Asbestos Detected**

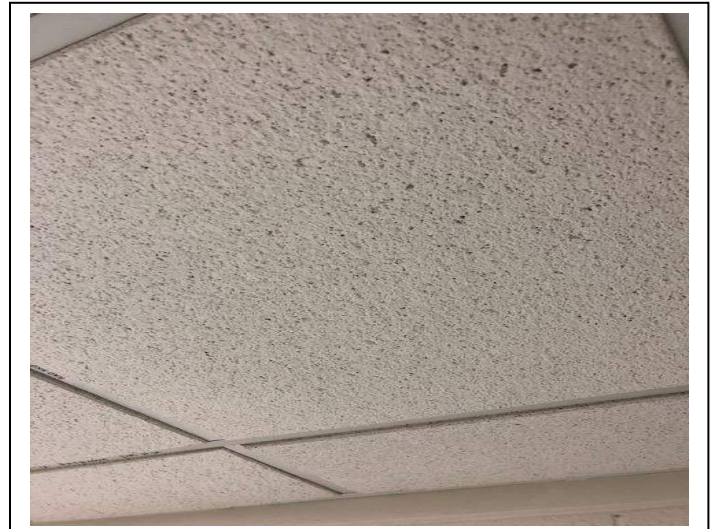
**Photo #16
Material: 2'x2' Rough Ceiling tile
Sample Result: No Asbestos Detected**

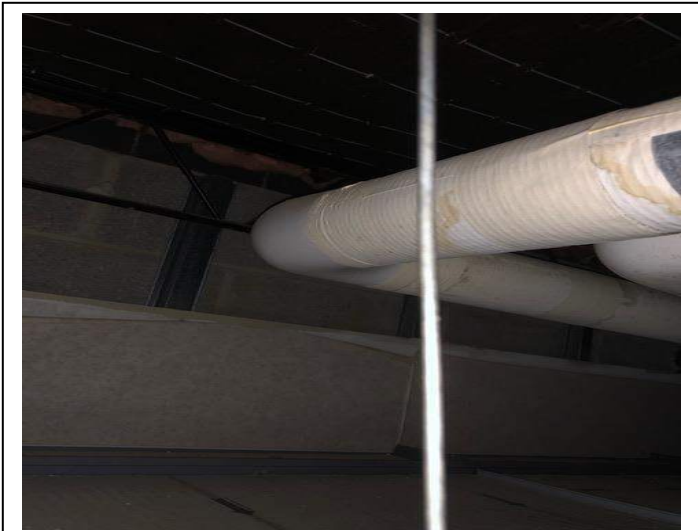
**Photo #19
Material: White Pipe Seam Sealant (New)
Sample Result: No Asbestos Detected**

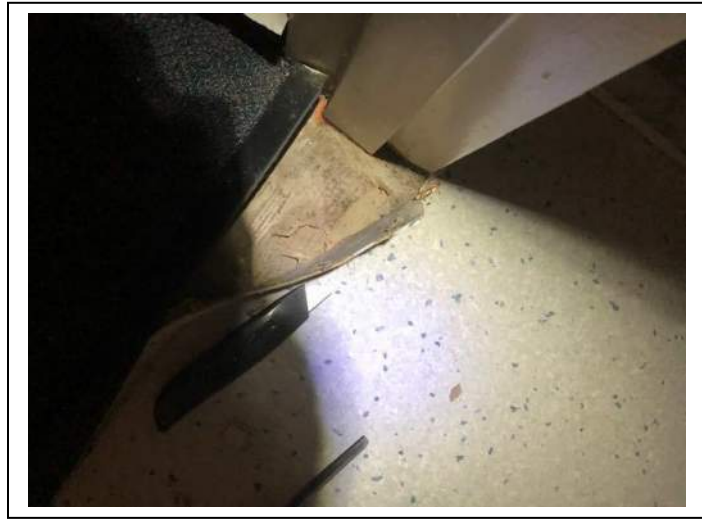
**Photo #20
Material: Linoleum Sheetting With Gray Mastic
Sample Result: No Asbestos Detected**

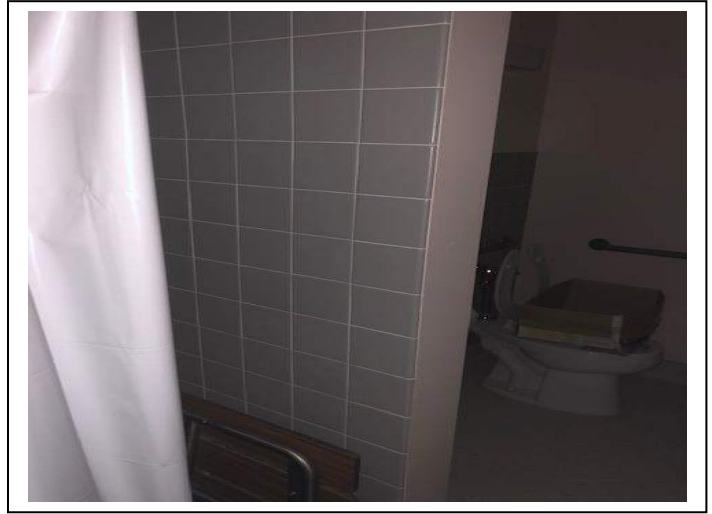
**Photo #22
Material: Ceramic Tile Grout
Sample Result: No Asbestos Detected**

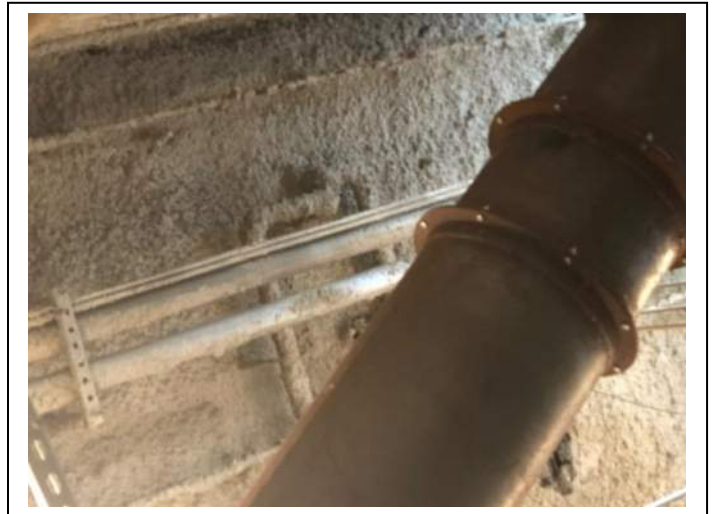
**Photo #24
Material: Spray Applied Fire Proofing
Sample Result: No Asbestos Detected**

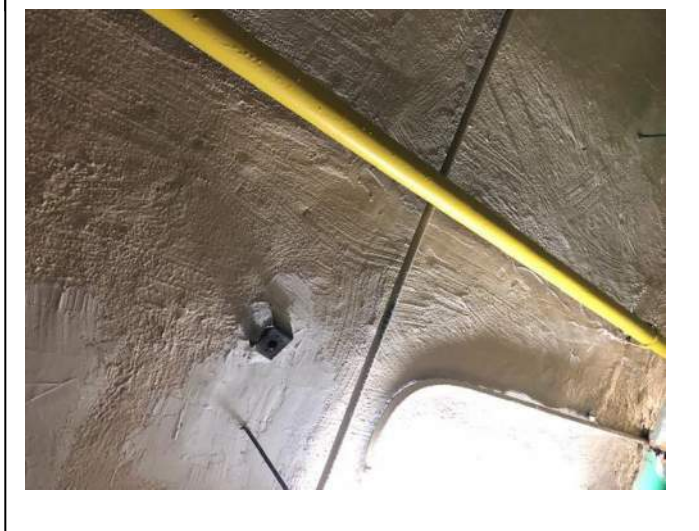
**Photo #30
Material: Tan Duct Seam Sealant on Metal
Sample Result: No Asbestos Detected**

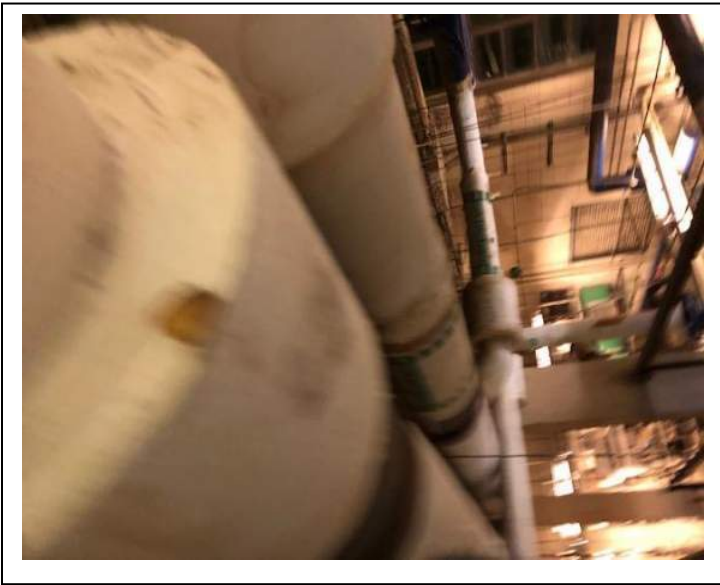
**Photo #33
Material: End Cap Sealant (New)
Sample Result: No Asbestos Detected**

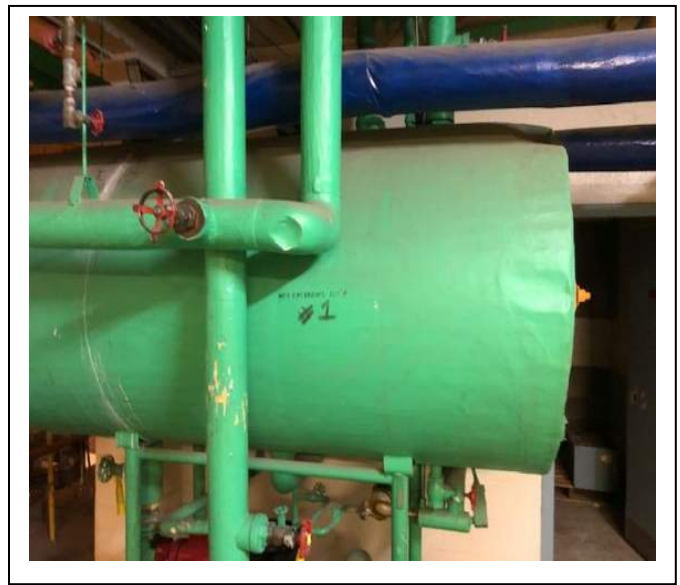
**Photo #34
Material: Green Canvas Tank
Sample Result: No Asbestos Detected**

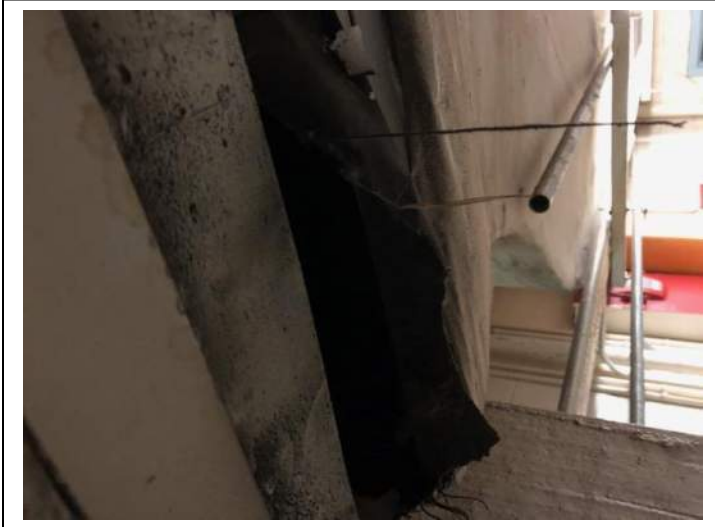
**Photo #37
Material: Cloth Vibration Dampner
Sample Result: No Asbestos Detected**

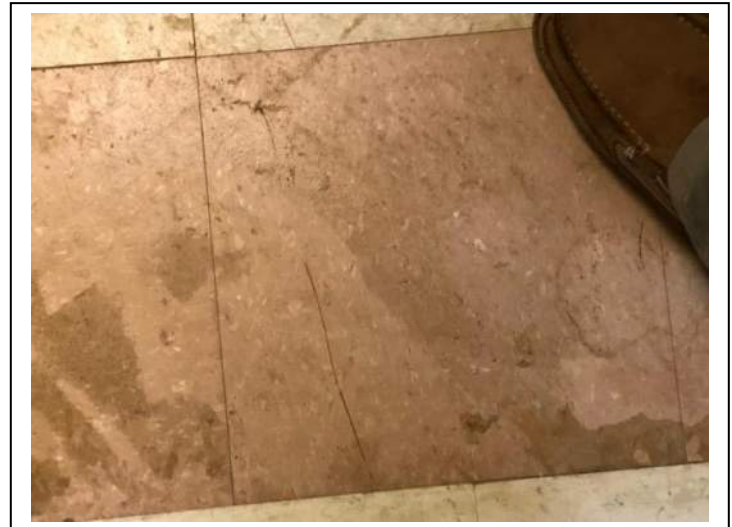
**Photo #38
Material: 12"x12" Pink Floor Tile
Sample location:**

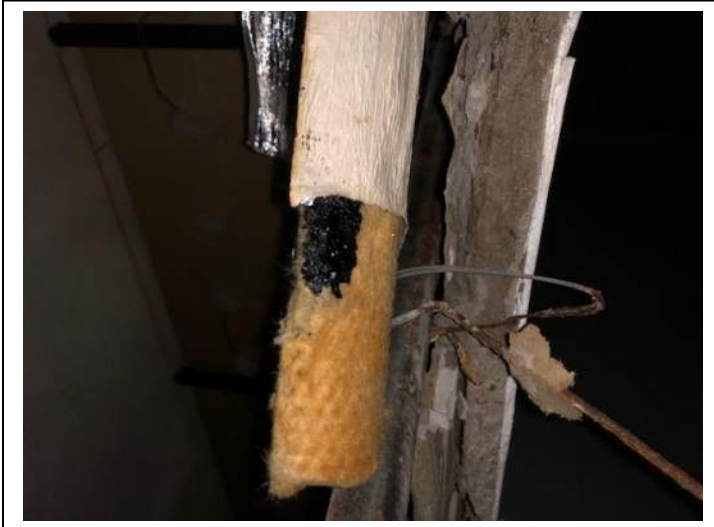
**Photo #39
Material: Black Mastic On Fiberglass Insulation
Sample Result: 5% Chrysotile**

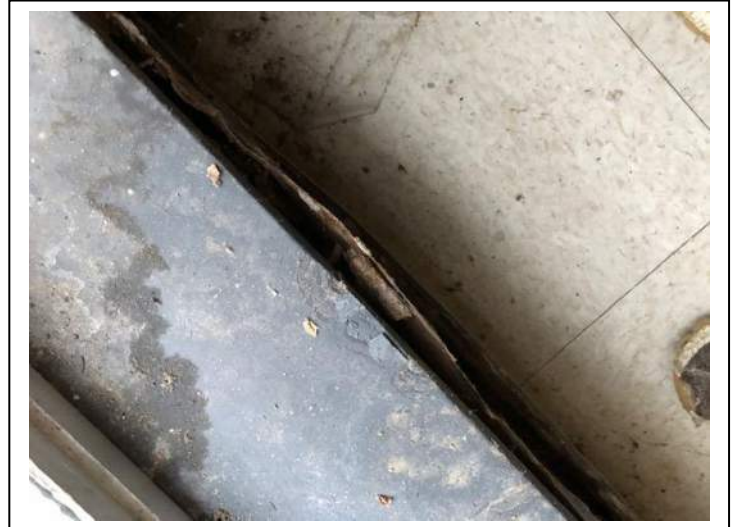
**Photo #40
Material: Transite Window Sill
Sample Result: No Asbestos Detected**

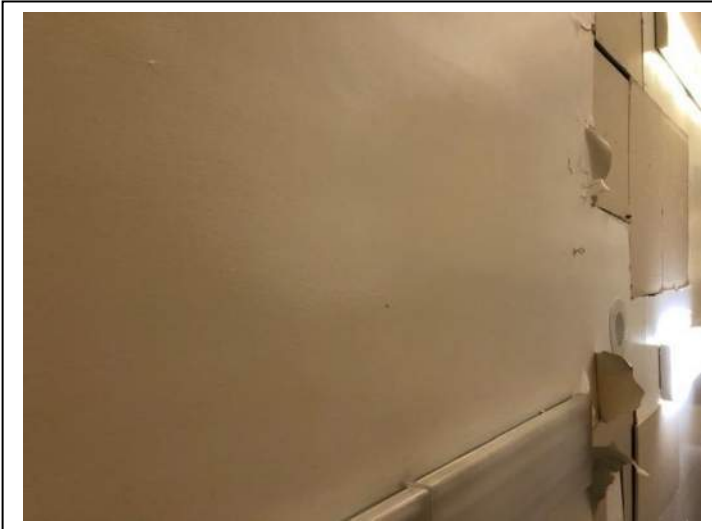
**Photo #41
Material: Smooth Plaster
Sample Result: No Asbestos Detected**

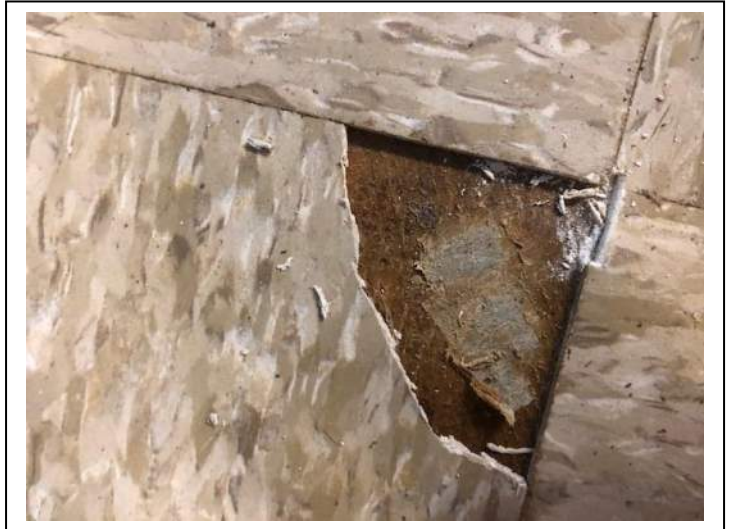
**Photo #42
Material: Tan Floor Tile Mastic
Sample Result: No Asbestos Detected**

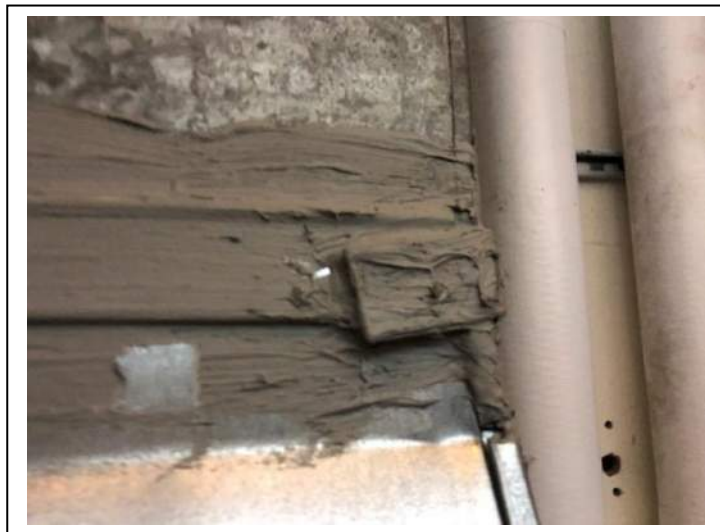
**Photo #43
Material: Gray Metal Duct Seam Sealant
Sample Result: No Asbestos Detected**

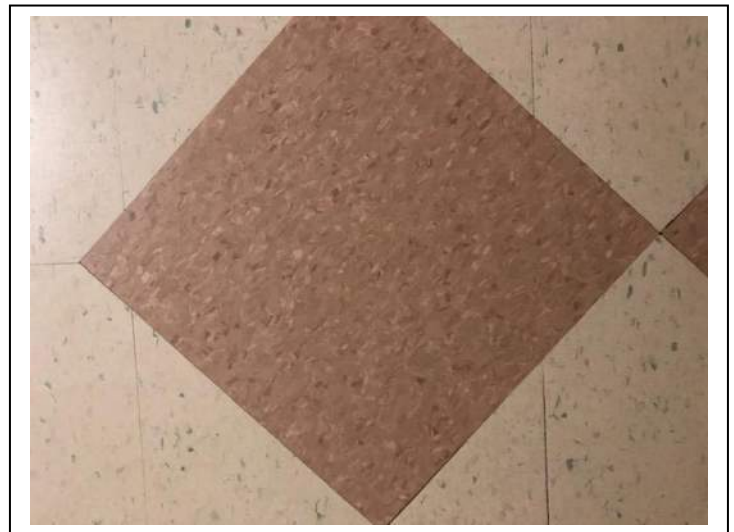
**Photo #44
Material: 12"x12" Pink Mottled Floor Tile
Sample Result: No Asbestos Detected**

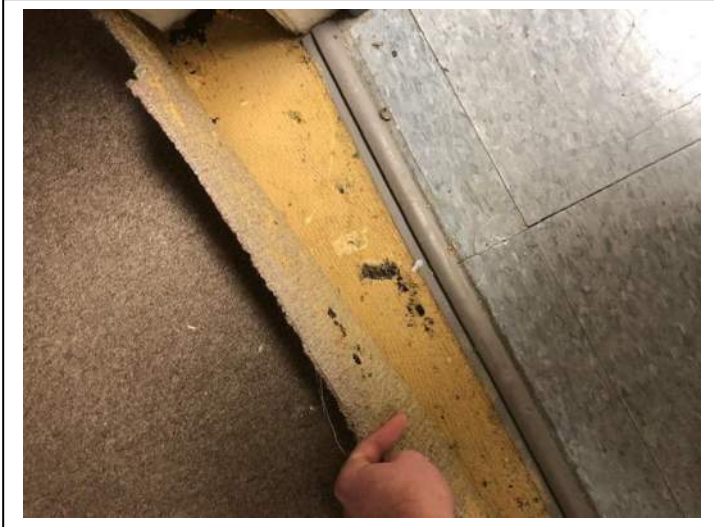
**Photo #45
Material: Black Mastic Underneath Yellow
Carpet Mastic
Sample Result: 2% Chrysotile**

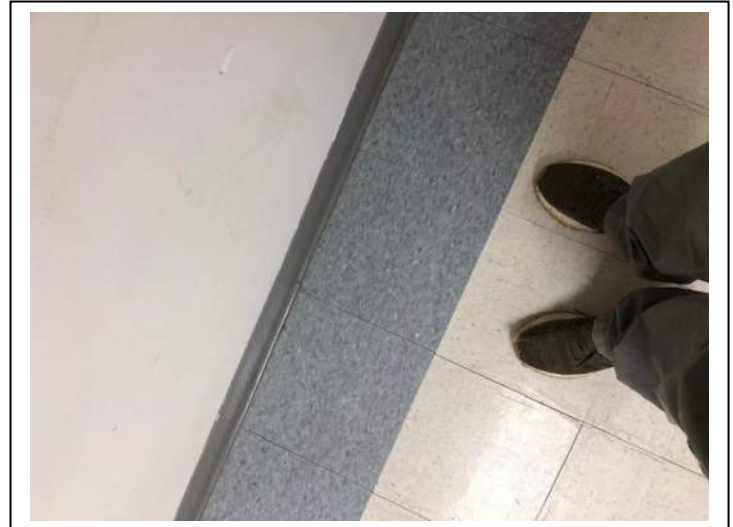
**Photo #46
Material: 12"x12" Blue Mottled Floor Tile
Sample Result: No Asbestos Detected**

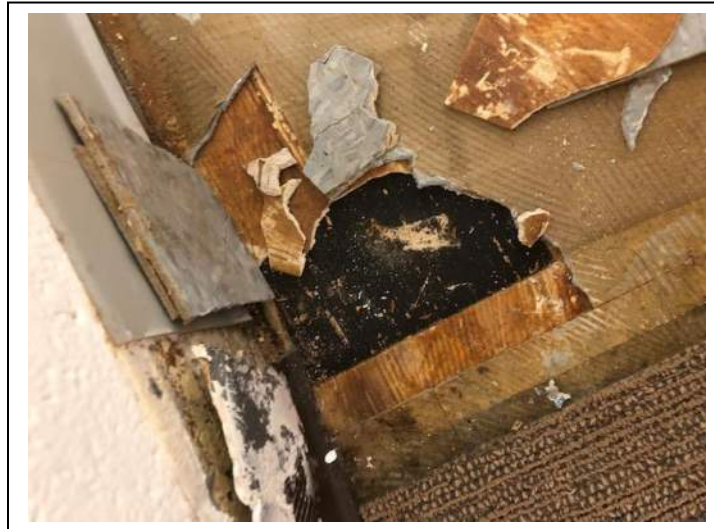
**Photo #47
Material: 12"x12" Tan Floor Tile
Sample Result: No Asbestos Detected**

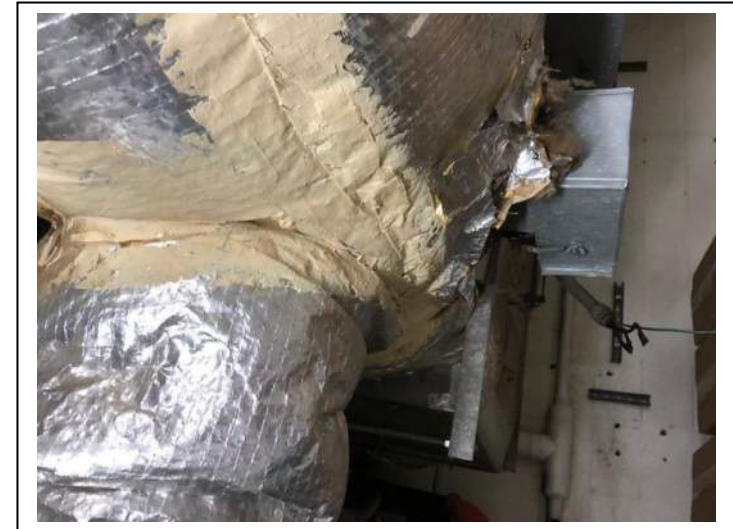
**Photo #48
Material: Tan Duct Seam Sealant on foil
Sample Result: No Asbestos Detected**

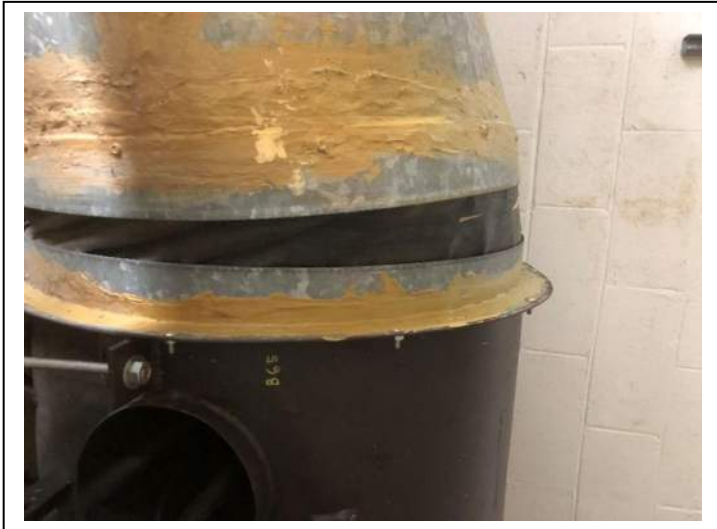
**Photo #49
Material: Tan Duct Seam Sealant On Metal
Sample Result: No Asbestos Detected**

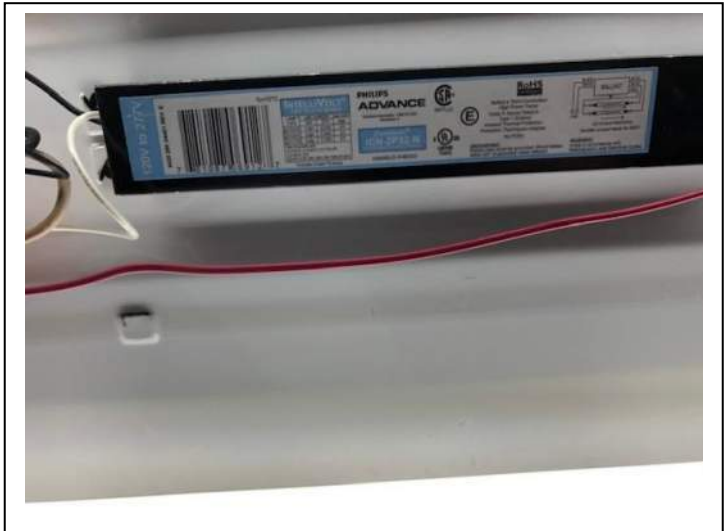
**Photo #50
Material: Non-PCB Ballast
Sample Result: Not sampled**

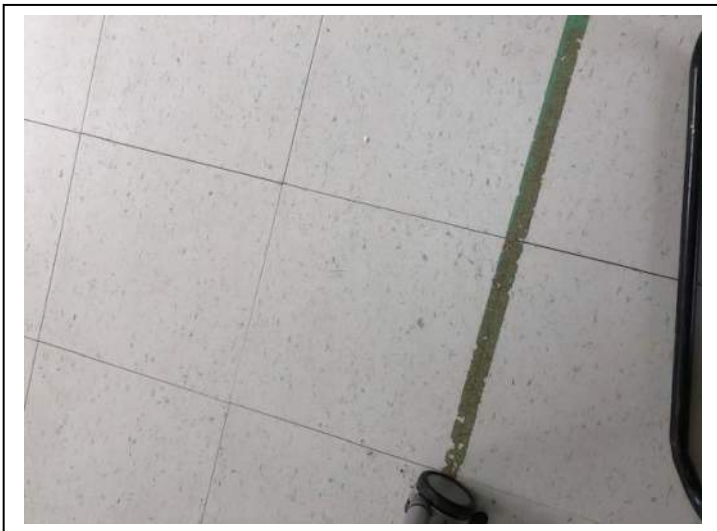
**Photo #51
Material: 12"x12" White With Green Specks
Floor Tile
Sample Result: No Asbestos Detected**

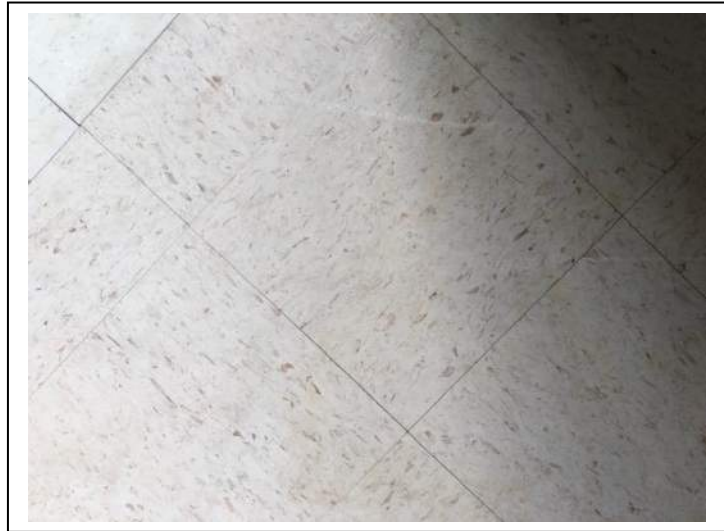
**Photo #52
Material: 12"x12" White With Pink Specks
Floor Tile
Sample Result: No Asbestos Detected**

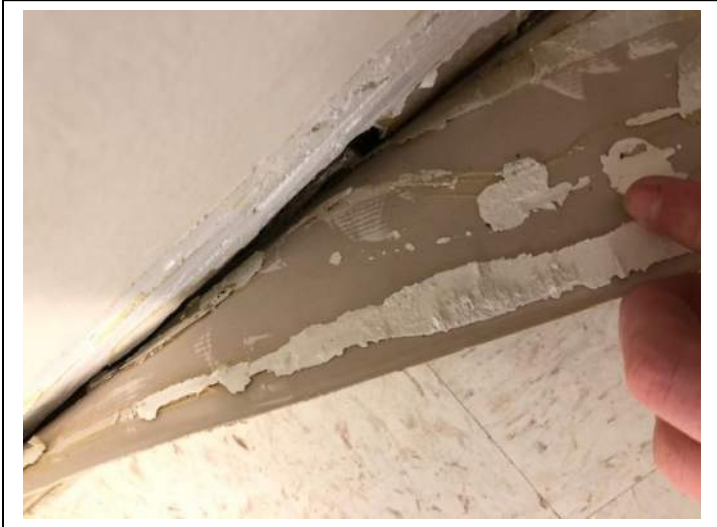
**Photo #53
Material: White Baseboard Mastic
Sample Result: No Asbestos Detected**

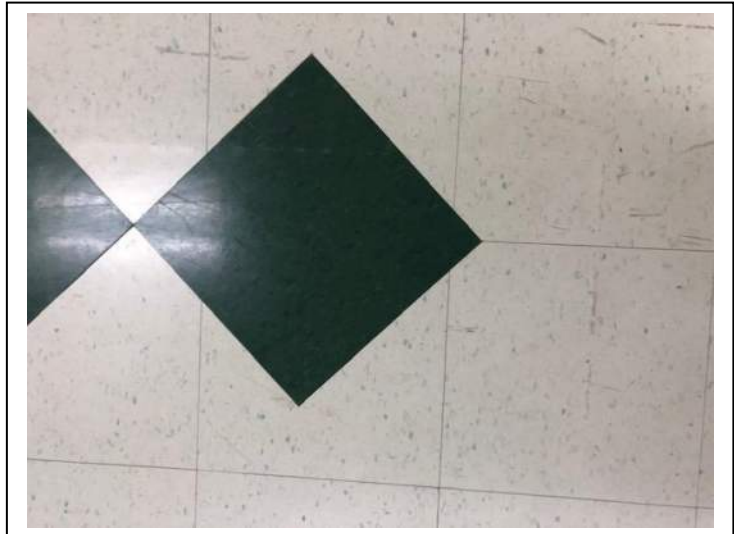
**Photo #54
Material: 12"x12" Green Mottled Floor Tile
Sample Result: No Asbestos Detected**

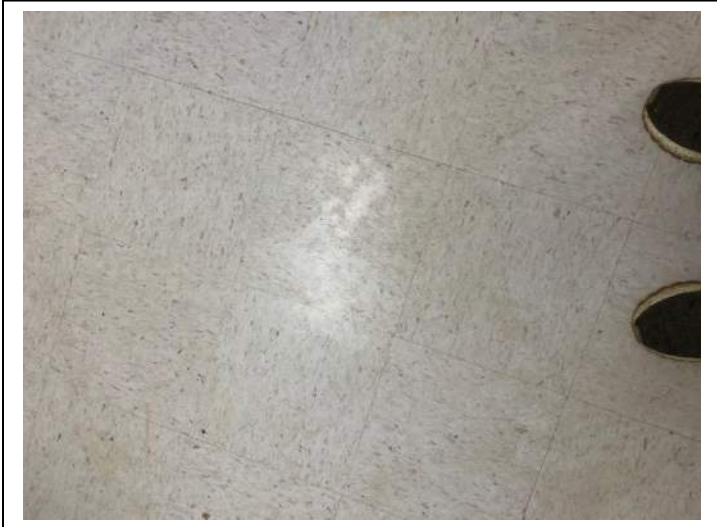
**Photo #55
Material: 12"x12" White With Gray Specks
Floor Tile
Sample Result: No Asbestos Detected**

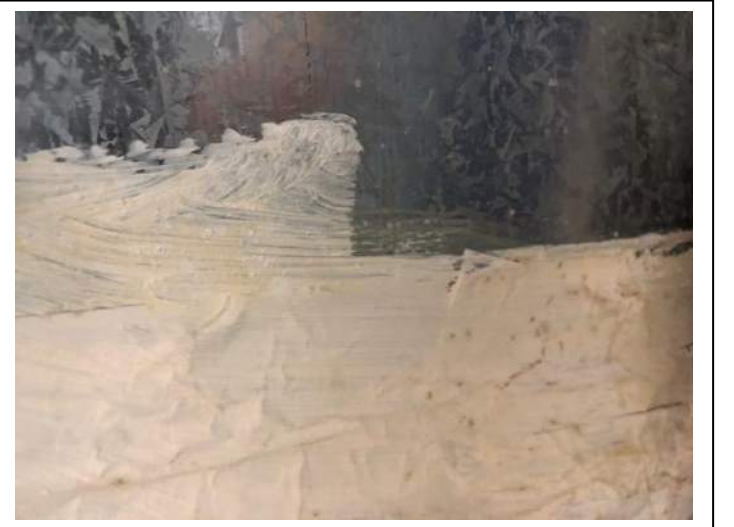
**Photo #56
Material: White Duct Seam Sealant On Metal
Sample Result: No Asbestos Detected**

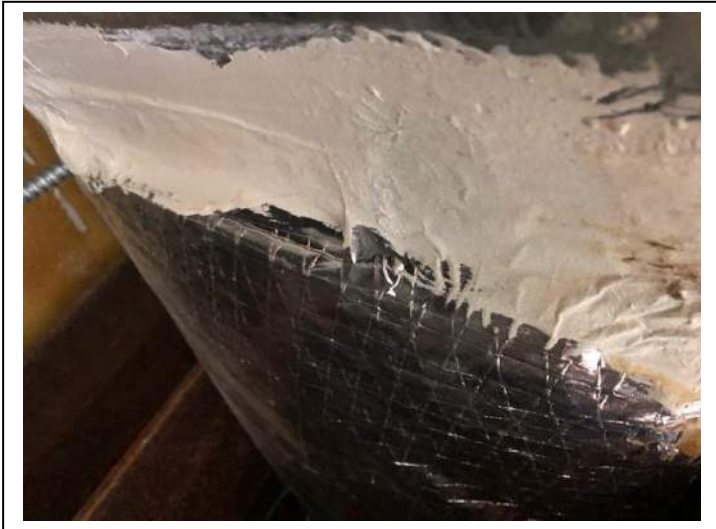
Photo #57

**Material: White Duct Seam Sealant on Foil
Sample Result: No Asbestos Detected**

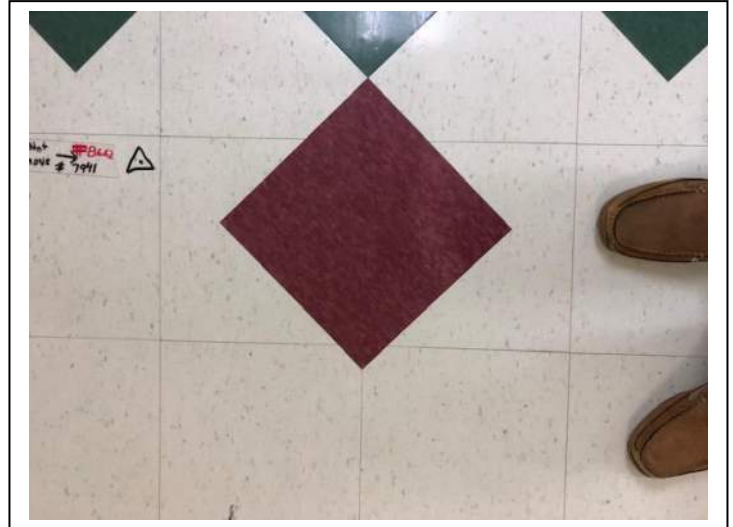
Photo #58

**Material: 12"x12" Red Mottled Floor Tile
Sample Result: No Asbestos Detected**

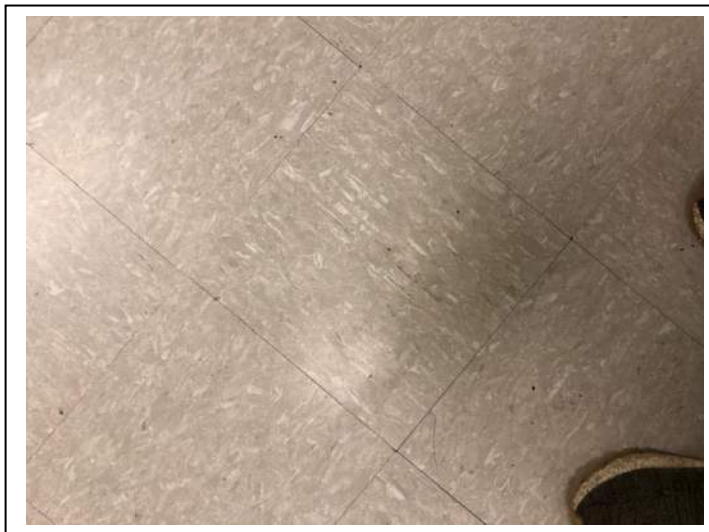
Photo #59

**Material: 12"x12" Cream Mottled Floor Tile
Sample Result: No Asbestos Detected**

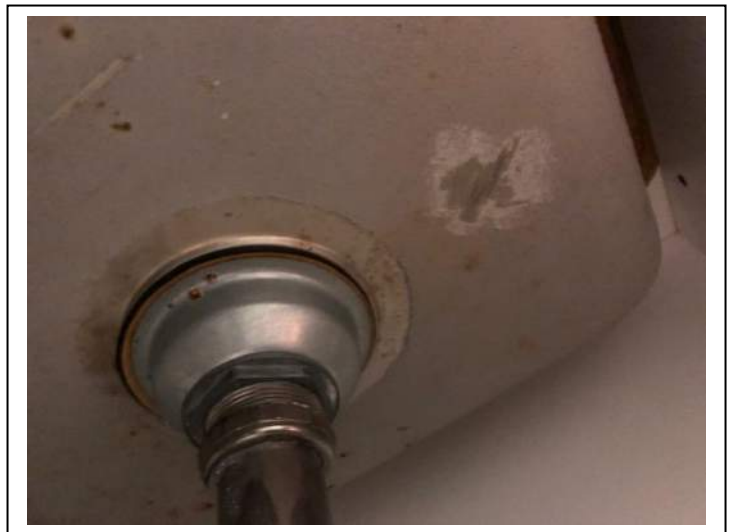
Photo #60

**Material: Gray Sink Mastic
Sample Result: No Asbestos Detected**

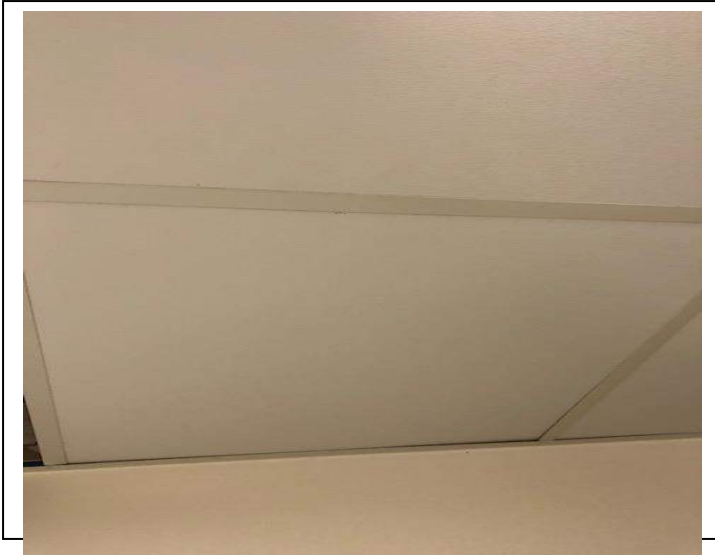
Photo #61
Material: Smooth Pinhole Ceiling Tile
Sample Result: No Asbestos Detected

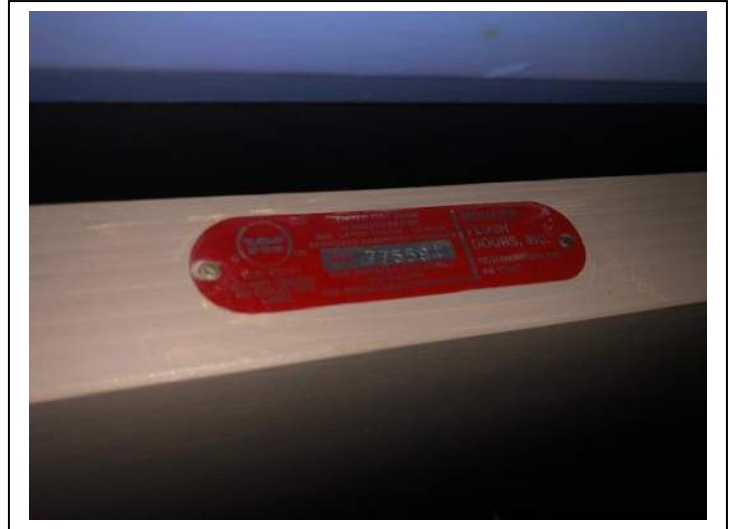
Photo #62
Material: Labeled Metal Fire Door
Sample Result: Assumed ACM

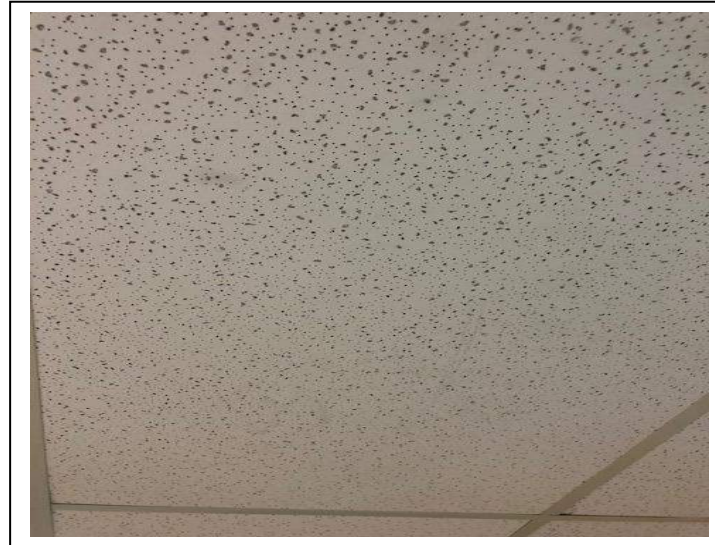
Photo #63
Material: Cratered Pinhole Ceiling Tile
Sample Result: No Asbestos Detected

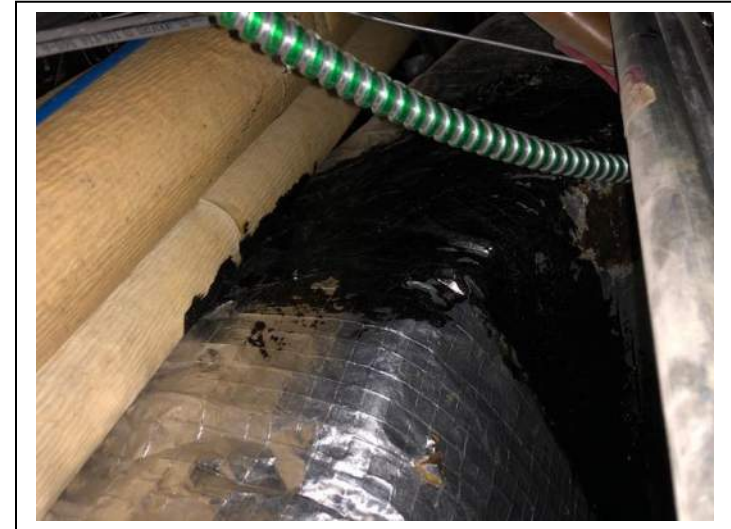
Photo #64
Material: Black Mastic On Foil Duct
Sample Result: 5% Chrysotile

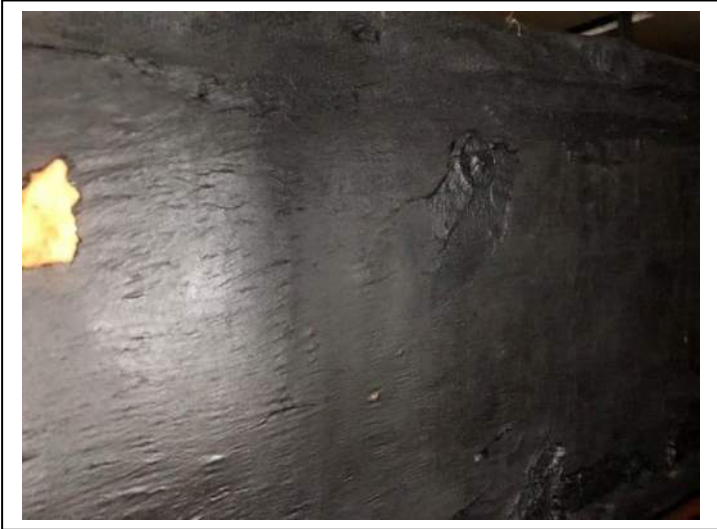
Photo #65
Material: Black Mastic On Canvas Duct
Sample Result: 5% Chrysotile

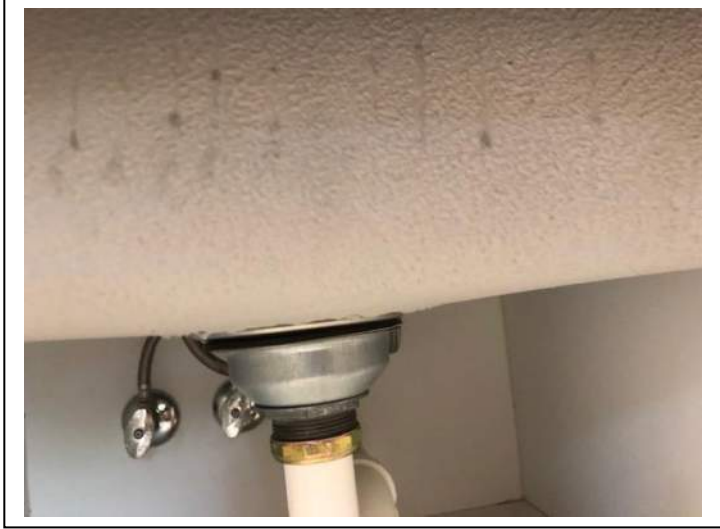
Photo #66
Material: Sink Trap
Sample Result: Potential Mercury

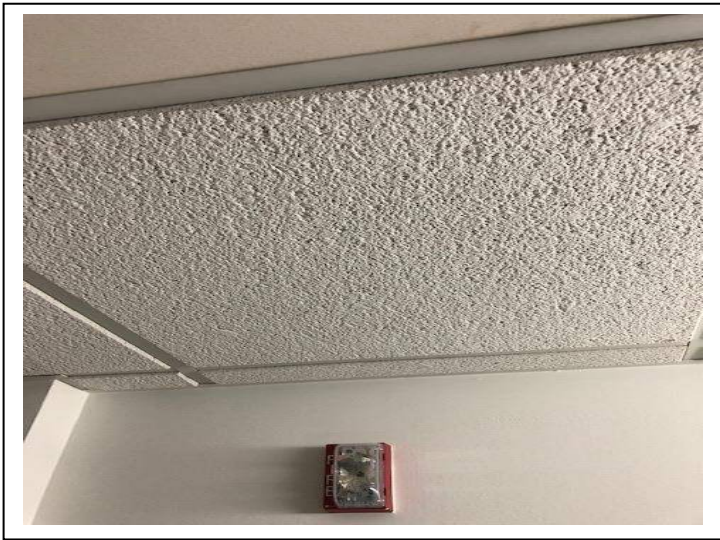
Photo #67
Material: Textured Ceiling Tile
Sample Result: No Asbestos Detected

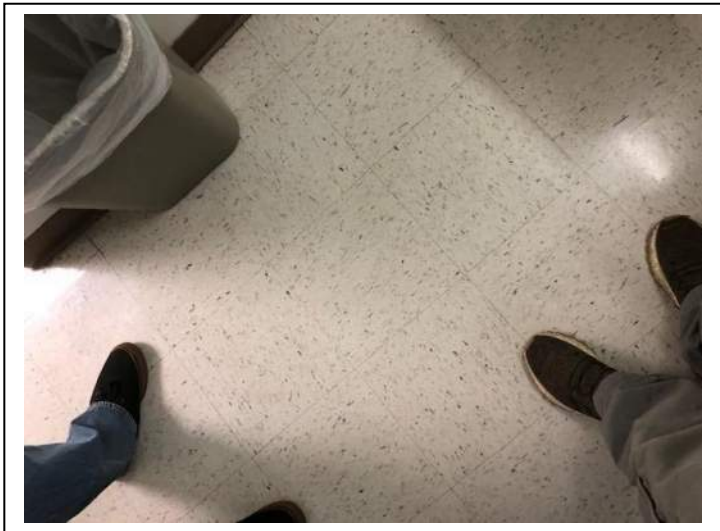
Photo #68
Material: 12"x12" White with Black Specks
Sample Result: No Asbestos Detected

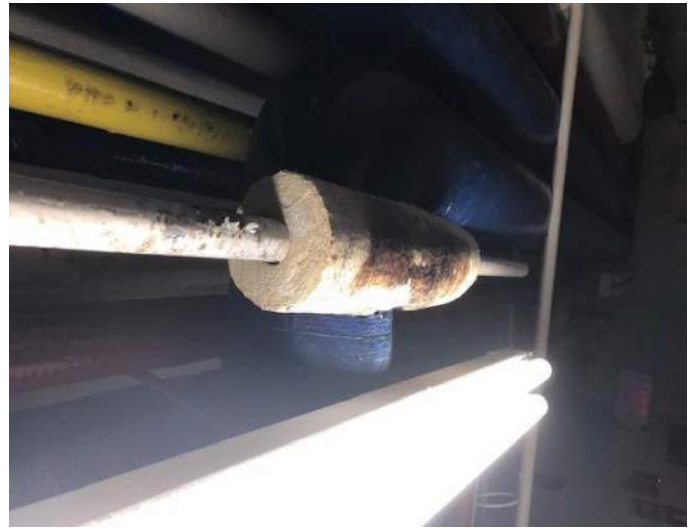
**Photo #72
Material: End Cap Sealant (Old)
Sample Result: No Asbestos Detected**

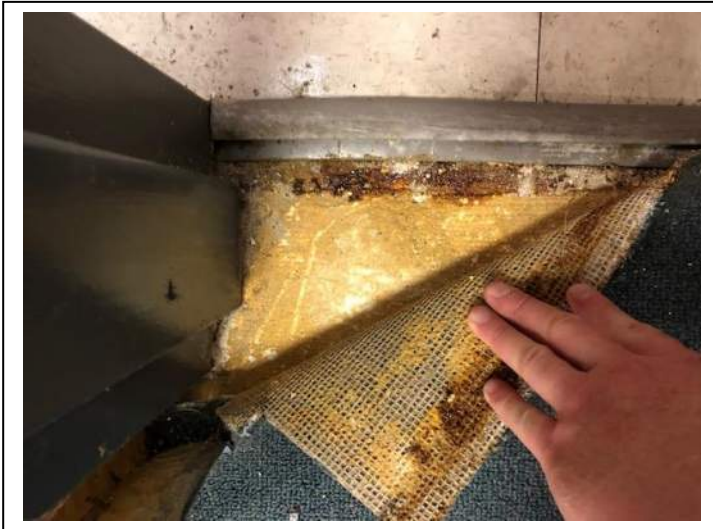
**Photo #73
Material: Yellow Carpet Mastic
Sample loc Sample Result: No Asbestos Detected**

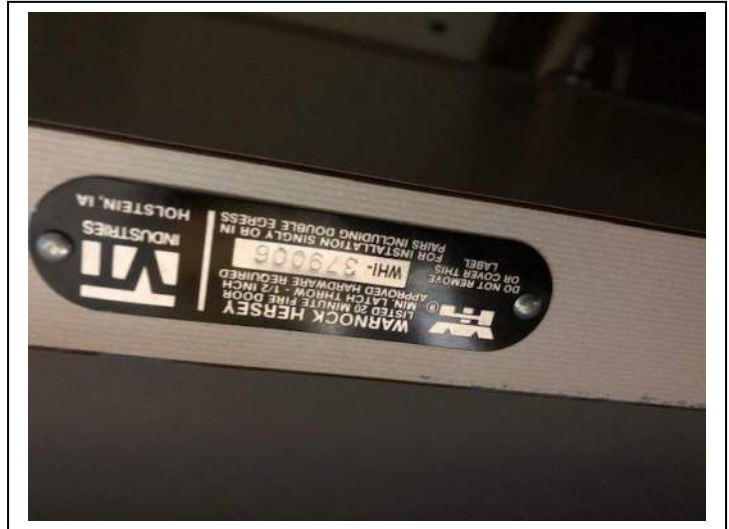
**Photo #74
Material: Labeled Wooden Fire Door
Sample Result: Assumed ACM**

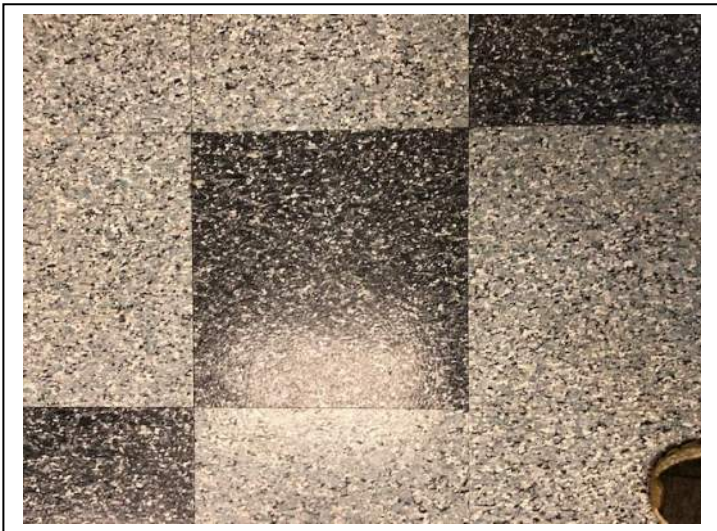
**Photo #75
Material: 12"x12" Black With White Specks
Floor Tile
Sample Result: No Asbestos Detected**

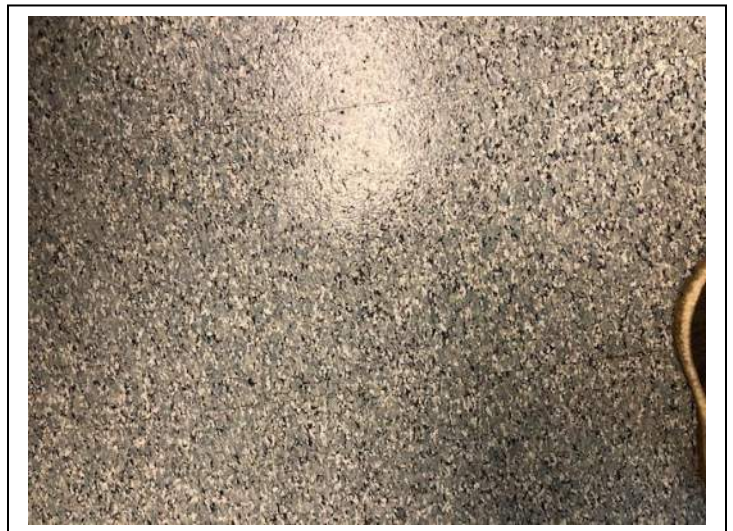
**Photo #76
Material: 12"x12" Blue Multi-Speck Floor Tile
Sample Result: No Asbestos Detected**

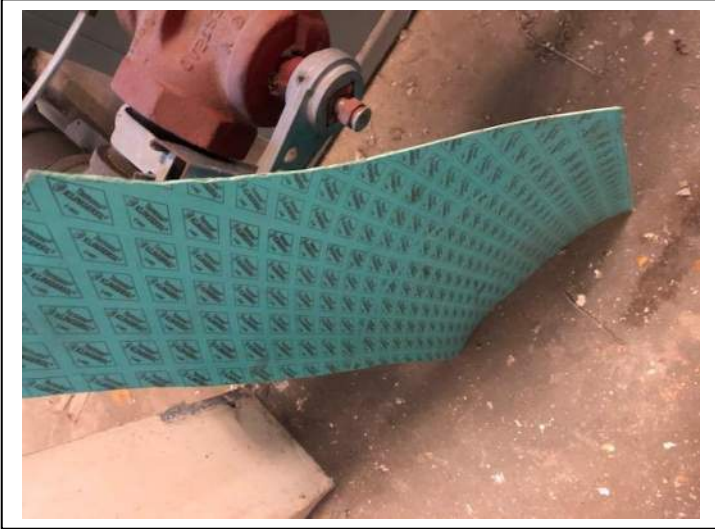
Photo #77
Material: Flange Gasket Material
Sample Result: No Asbestos Detected

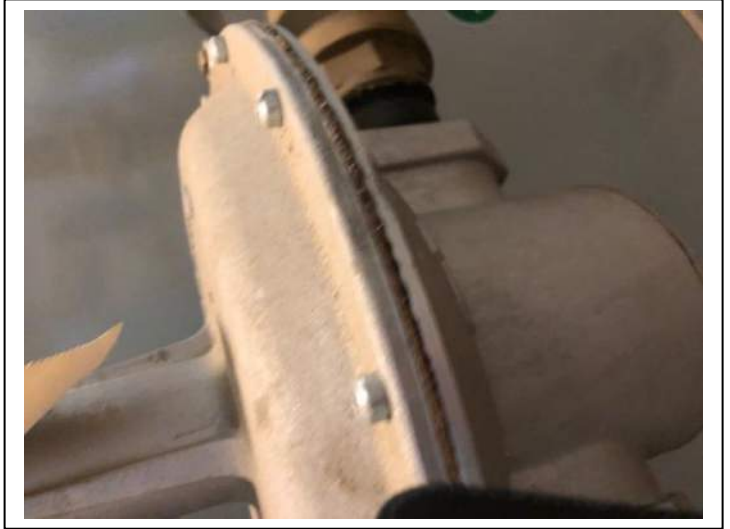
Photo #78
Material: Flange Gasket
Sample Result: No Asbestos Detected

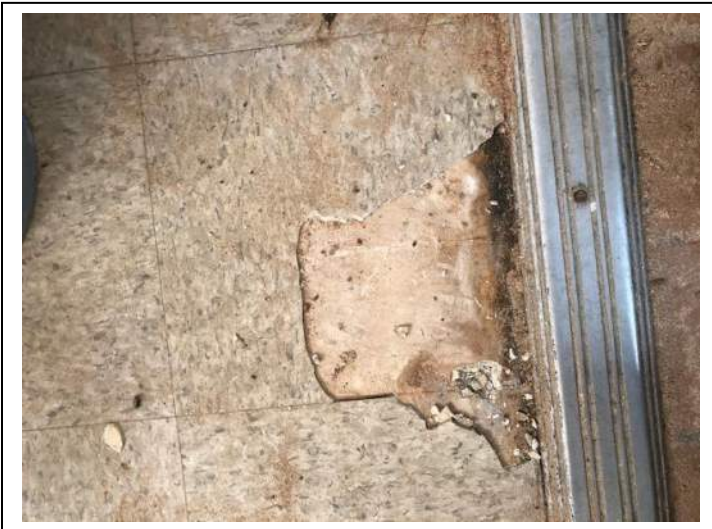
Photo #79
Material: 12"x12" Pink Floor Tile
Sample Result: No Asbestos Detected

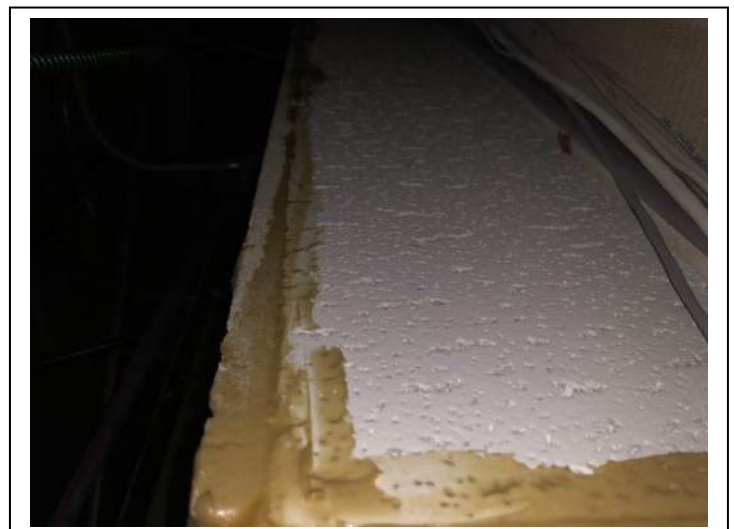
Photo #80
Material: Tan Light Mastic
Sample Result: No Asbestos Detected

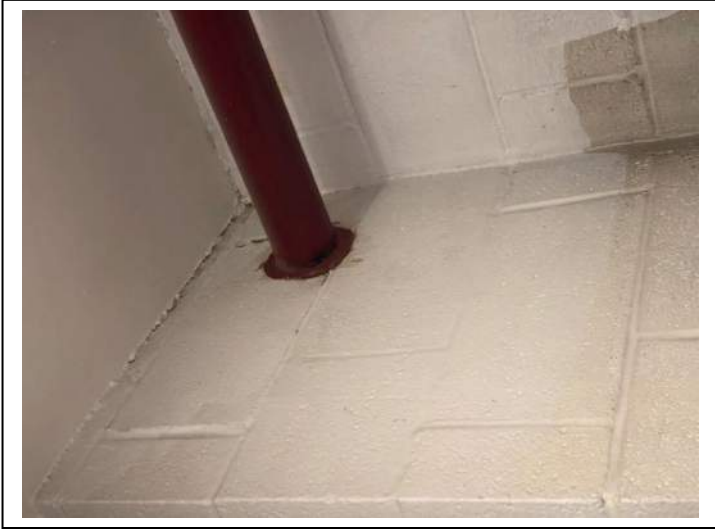
Photo #81
Material: Red Fire Stop
Sample Result: No Asbestos Detected

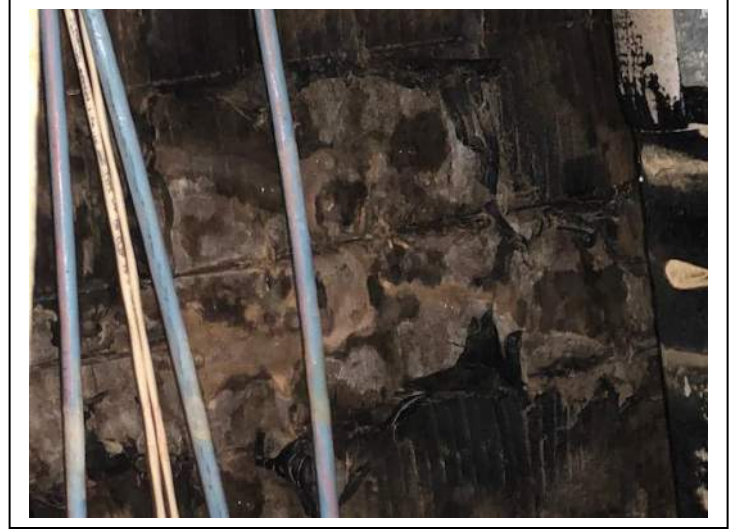
Photo #82
Material: Cement Paper Support
Sample Result: No Asbestos Detected

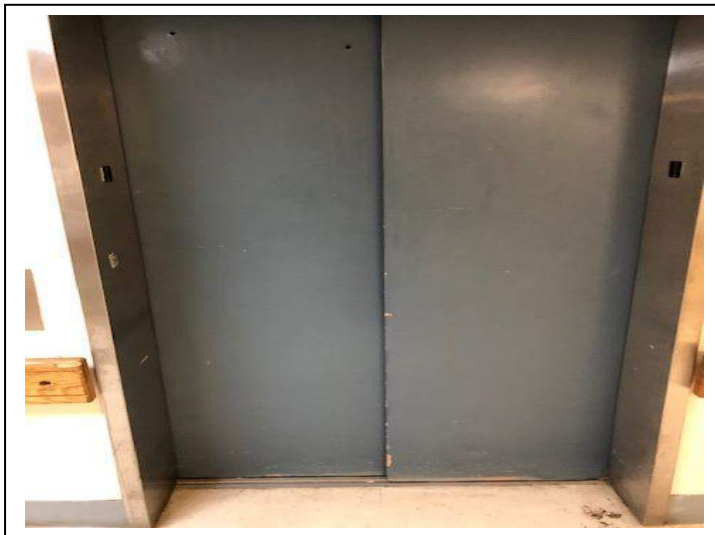
Photo #83
Material: Elevator Door Insulation
Sample Result: Assumed ACM
