**HAZARDOUS MATERIALS INSPECTION REPORT
OF THE
VIRGINIA HOSPITAL CENTER FACILITY
LOCATED AT
601 S. CARLIN SPRINGS ROAD
ARLINGTON, VIRGINIA**

AMA Job#: 19415
Contract #: 678-12
PO #: 273316

November 4, 2019

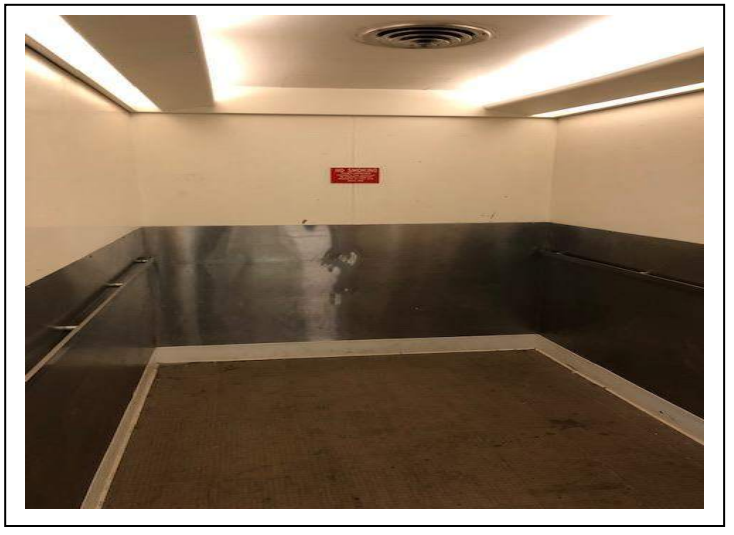
Photo #84
Material: Elevator Cab Insulation
Sample Result: Assumed ACM

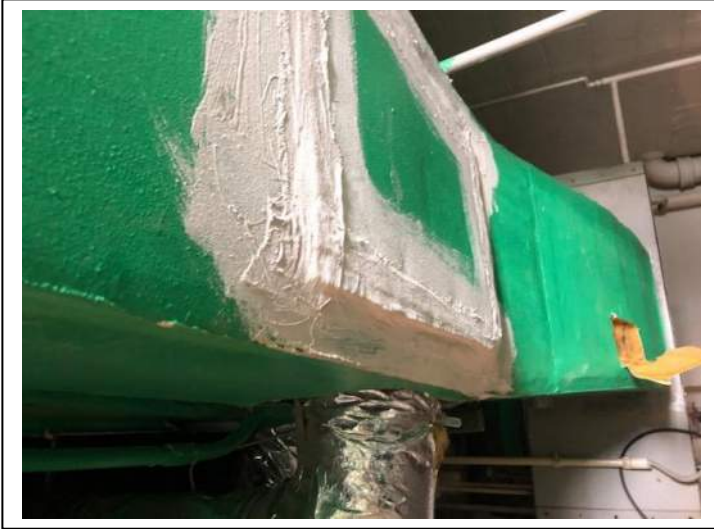
Photo #85

**Material: White Duct Seam Sealant On Canvas
Sample Result: No Asbestos Detected**

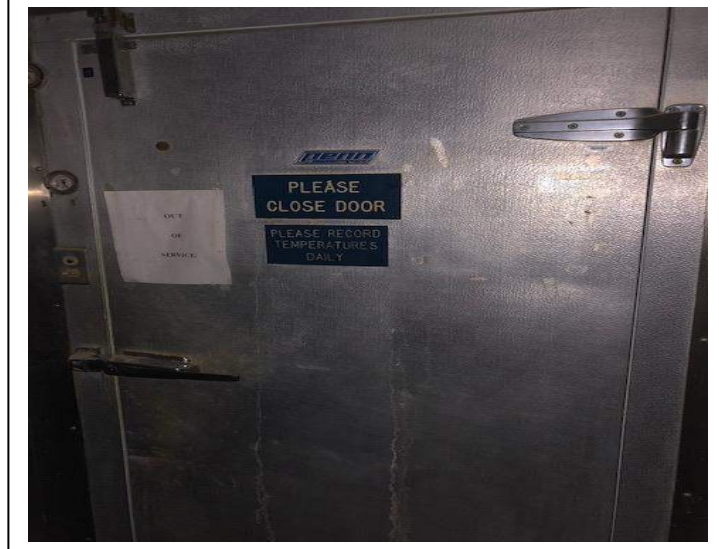
Photo #86

**Material: Freezer Insulation
Sample Result: Assumed ACM**

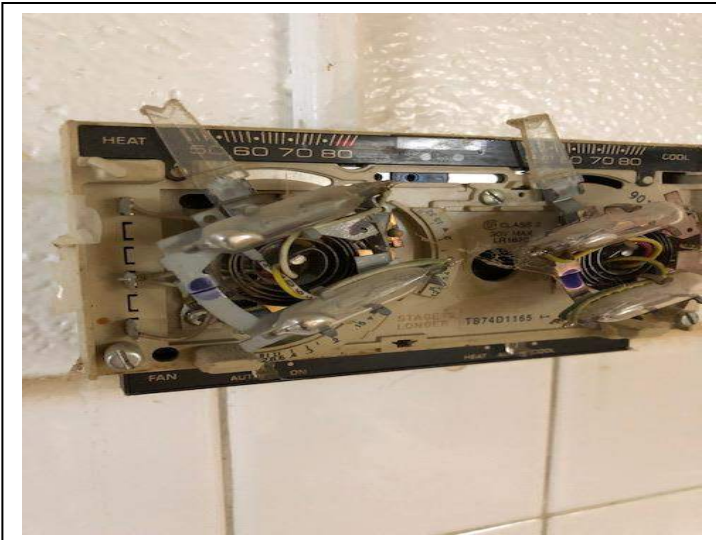
Photo #87

**Material: Mercury Tubes
Sample Result: Potential Mercury**
