## **Asbestos & Lead Based Paint Assessment**

City of Spartanburg  
321 Caulder Avenue  
Spartanburg, South Carolina 29306

Project Number: 0120-17

February 10, 2020

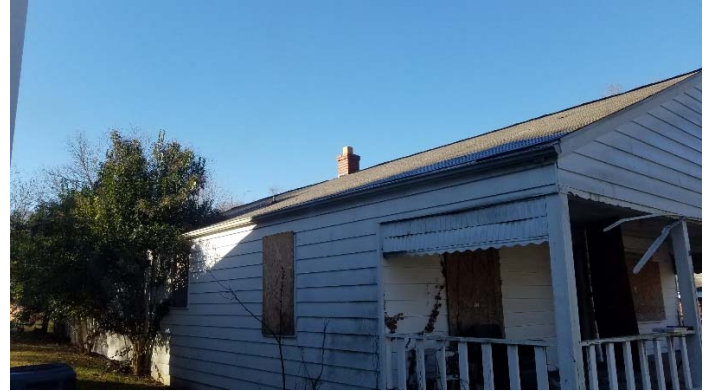
Photo 2 – Assumed asbestos chimney tar.

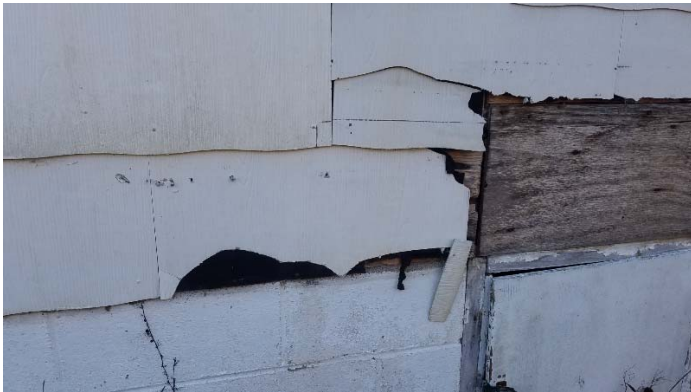
Photo 3 – Transite exterior siding with black felt.

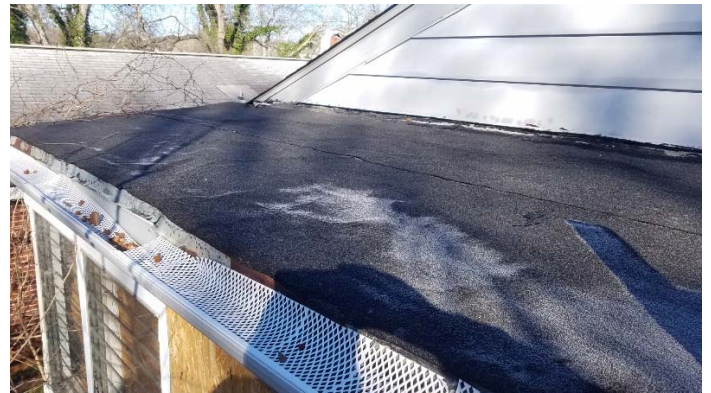
Photo 4 – Back porch roof.

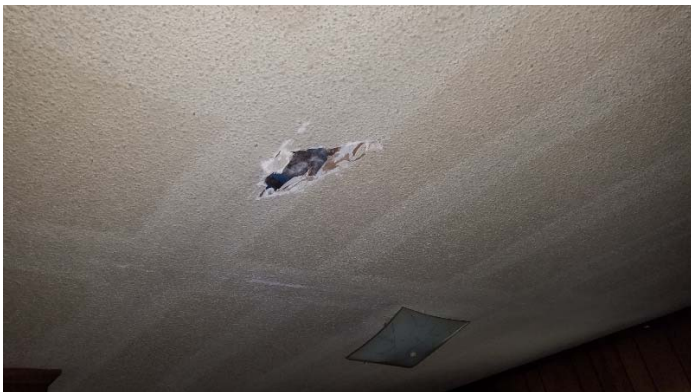
Photo 5 – Popcorn ceiling texture in left rear bedroom.

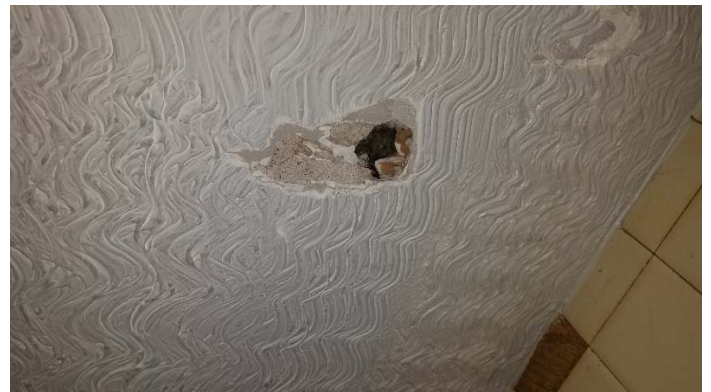
Photo 6 – Kitchen swirl ceiling texture.

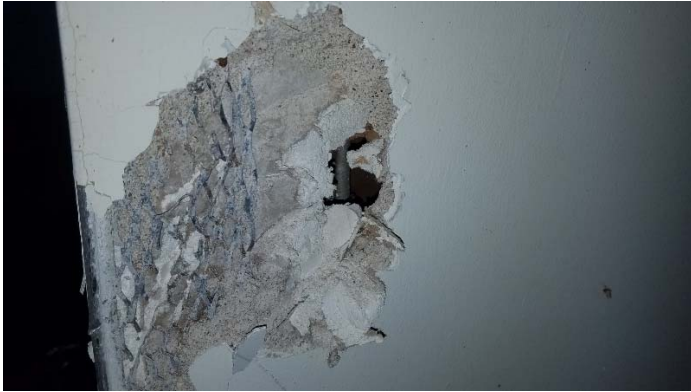
Photo 7 – Plaster over unfinished drywall.

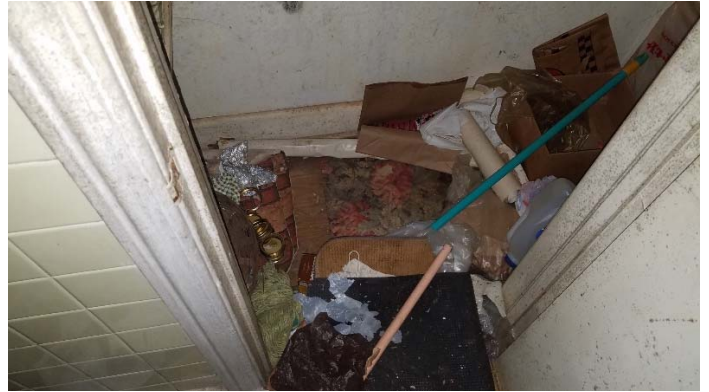
Photo 8 – Kitchen closet floral felt flooring.

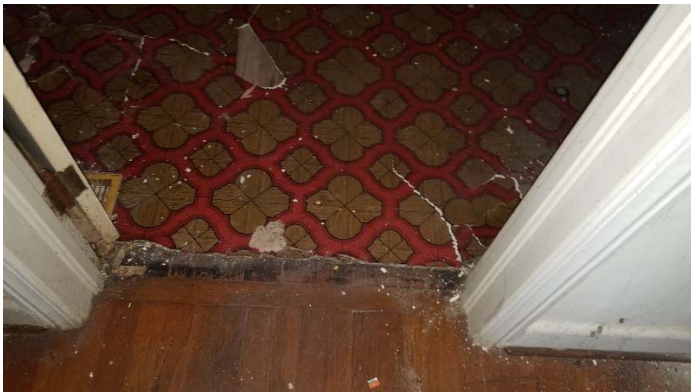
Photo 9 – Front left bedroom flooring.

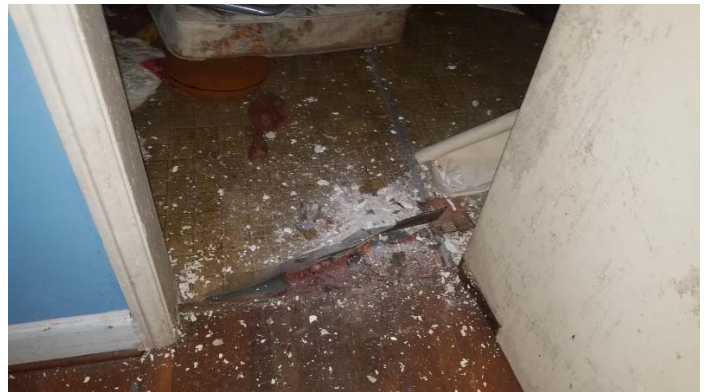
Photo 10 – Kitchen flooring layers.

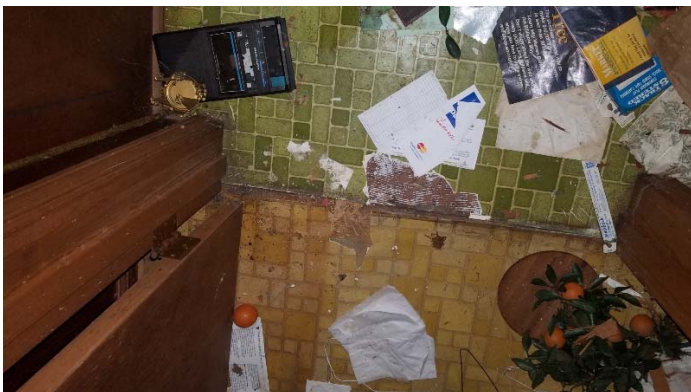
Photo 11 – 3<sup>rd</sup> and 4<sup>th</sup> bedroom roll flooring.
