**HIGHLANDS COUNTY
BOARD OF COUNTY COMMISSIONERS
(HCBCC)
PURCHASING DIVISION**

BID NO. ITB 18-011 ADDENDUM No. 1

PROJECT: Construction of Highlands Park Estate Clubhouse

**SUBJECT: ASBESTOS SURVEY REPORT
HIGHLAND PARK ESTATES CLUBHOUSE
91 DEERGLLEN BOULEVARD, LAKE PLACID, FLORIDA
A-C-T PROJECT NO. 16762**

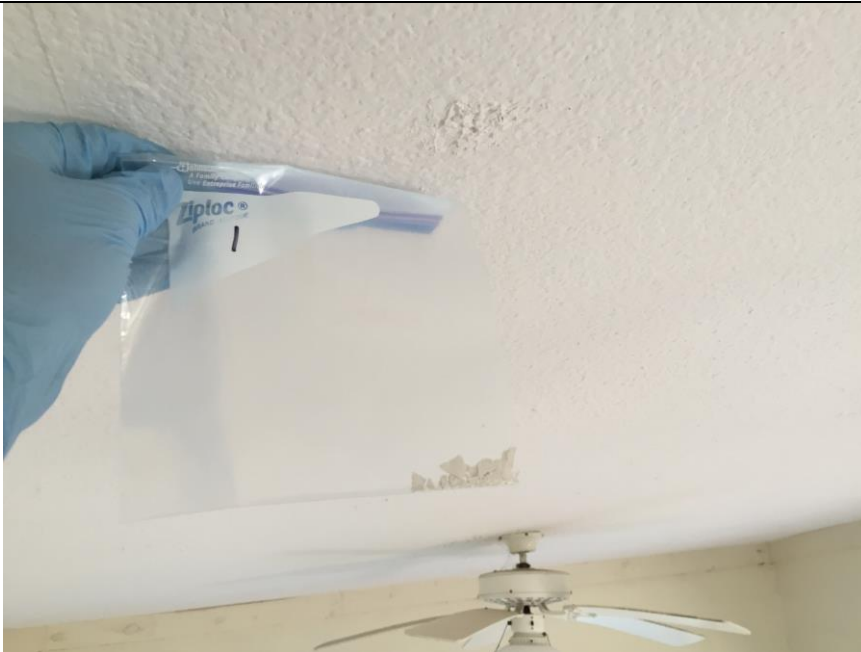
PHOTO # 2: VIEW OF SAMPLED CEILING SURFACING MATERIAL.

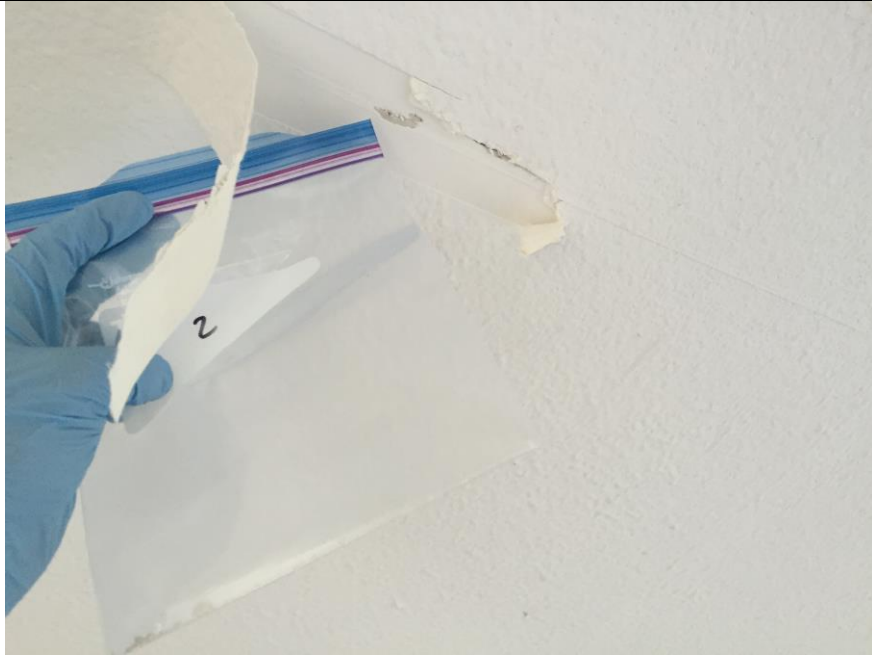
PHOTO # 3: VIEW OF SAMPLED CEILING JOINT COMPOUND.

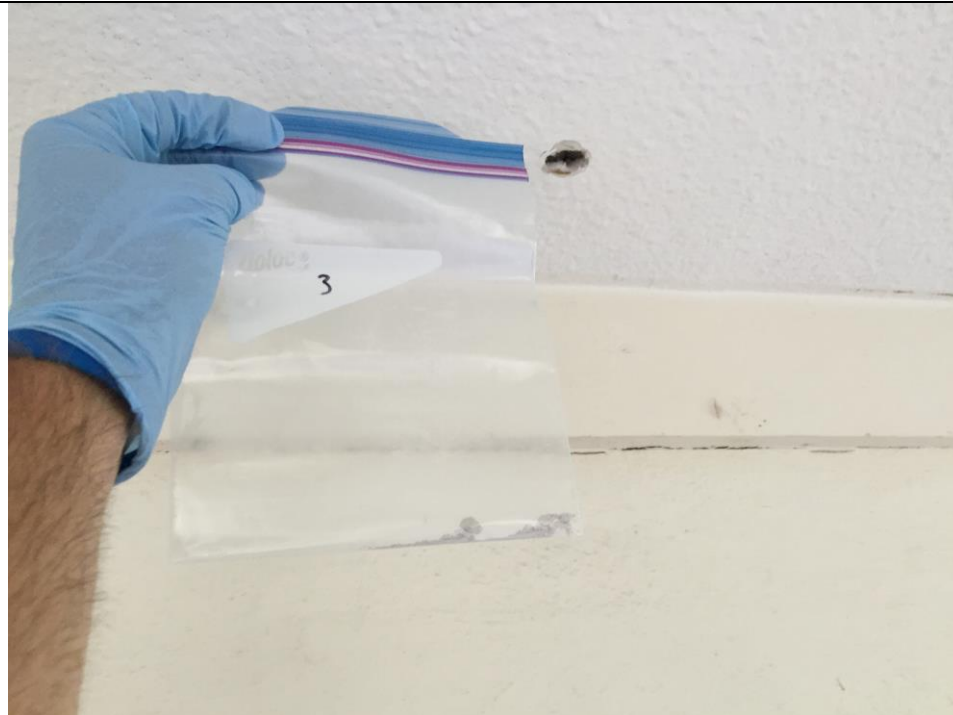
PHOTO # 4: VIEW OF SAMPLED CEILING DRYWALL.

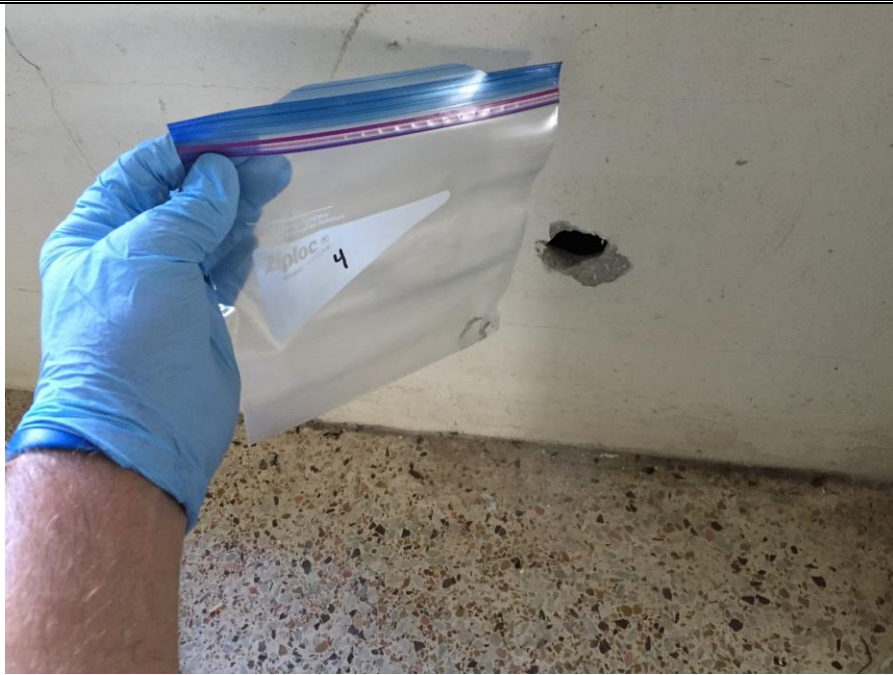
PHOTO # 5: VIEW OF SAMPLED CONCRETE BLOCK.

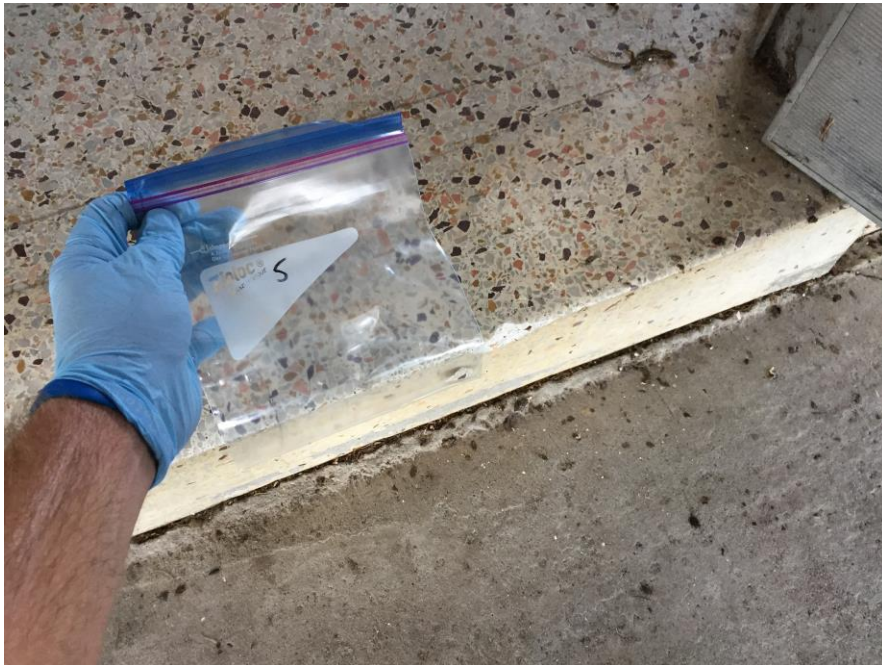
PHOTO # 6: VIEW OF SAMPLED TERRAZZO FLOOR.

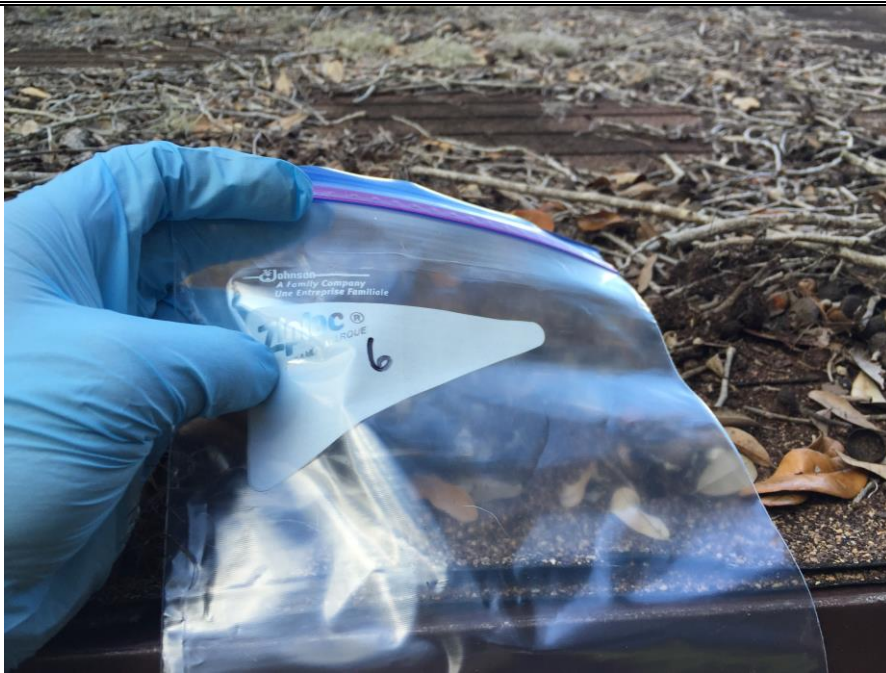
PHOTO # 7: VIEW OF SAMPLED ROOF MATERIAL.

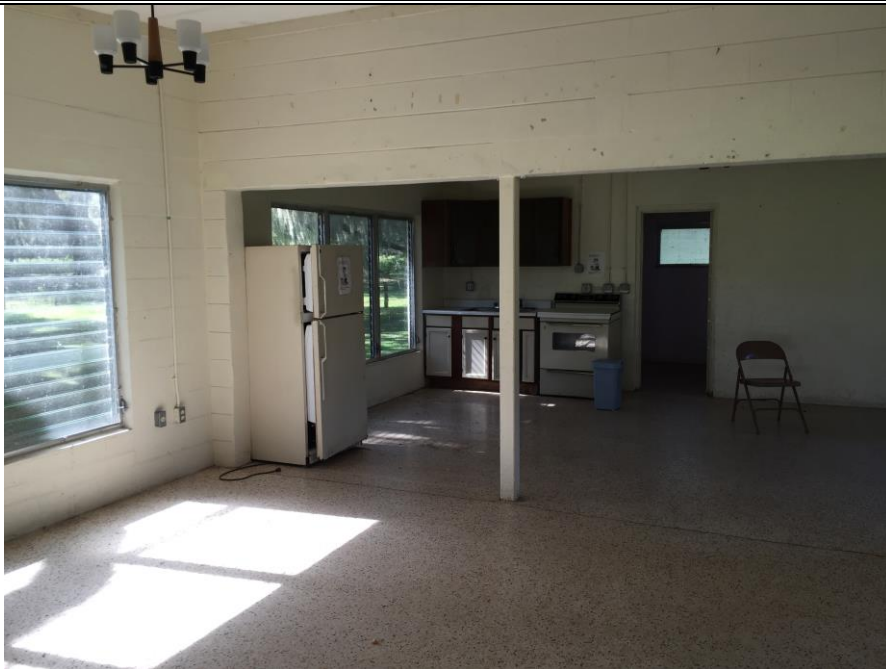
PHOTO # 8: VIEW OF GENERAL INTERIOR CONDITIONS.

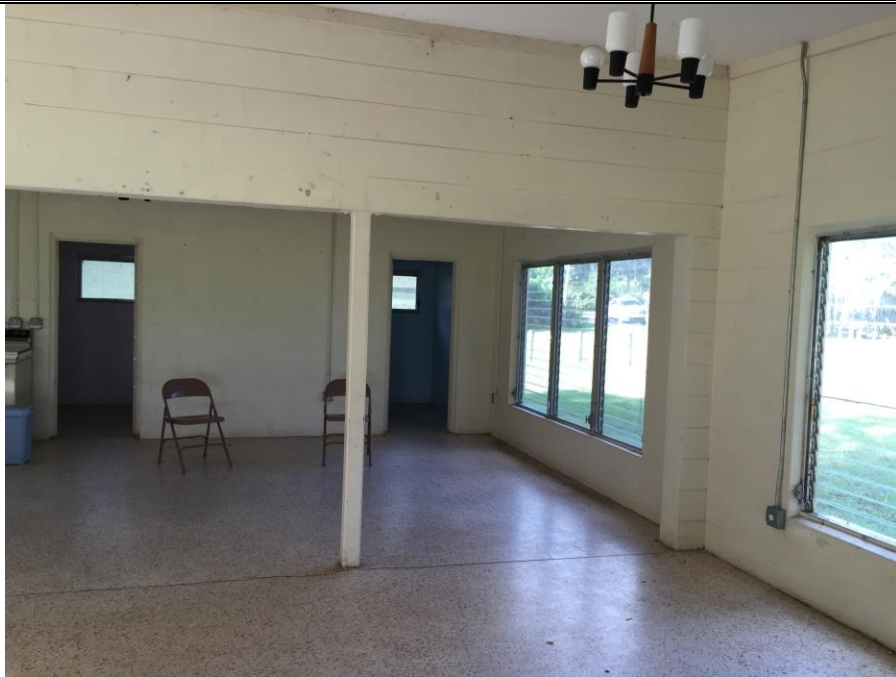
PHOTO # 9: VIEW OF GENERAL INTERIOR CONDITIONS.

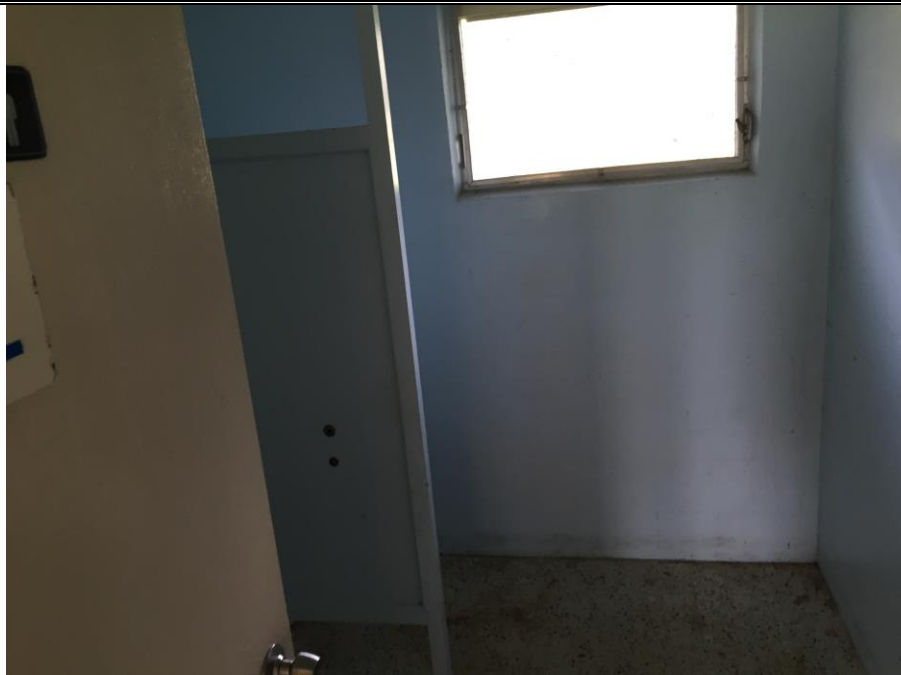
PHOTO # 10: VIEW OF GENERAL INTERIOR CONDITIONS.
