## Apex Project Number 0617-111

Reference: Asbestos Assessment Services  
Cammie Clagett Courts  
Phase 2 - 9 Buildings (42 Units)  
Highland Street Area  
Spartanburg, South Carolina

**APPENDIX I**  
**PHOTOGRAPHIC LOG**

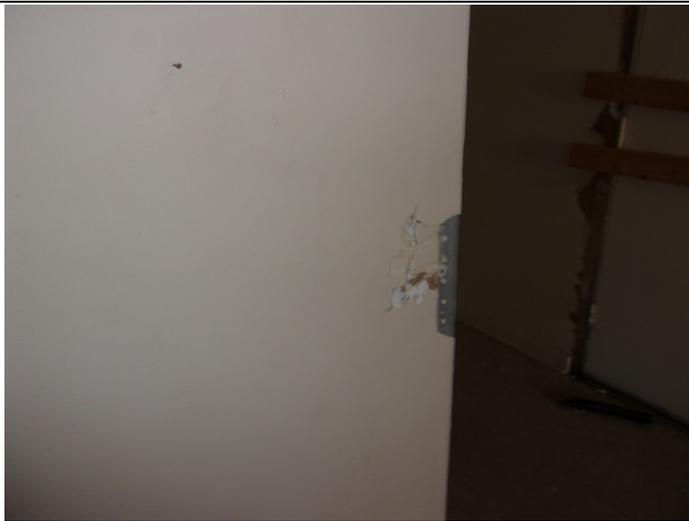
Photo 1 – Typical view of drywall with joint compound and tape throughout buildings 1-6 & 36-38.

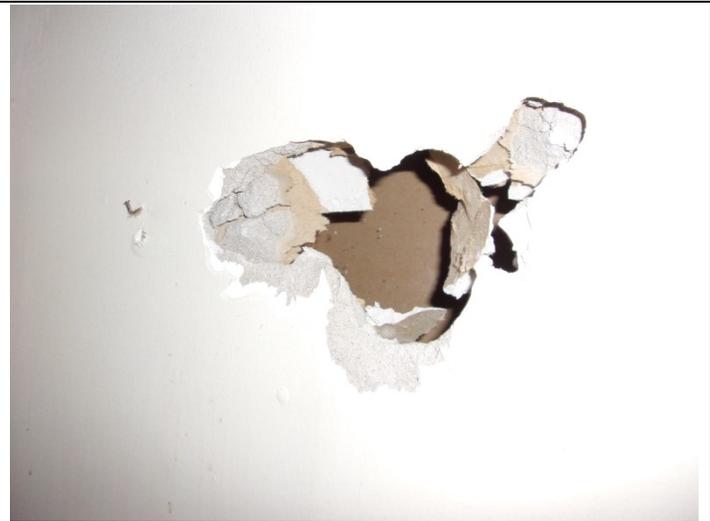
Photo 2 – Typical view of drywall with joint compound and tape throughout buildings 1-6 & 36-38.

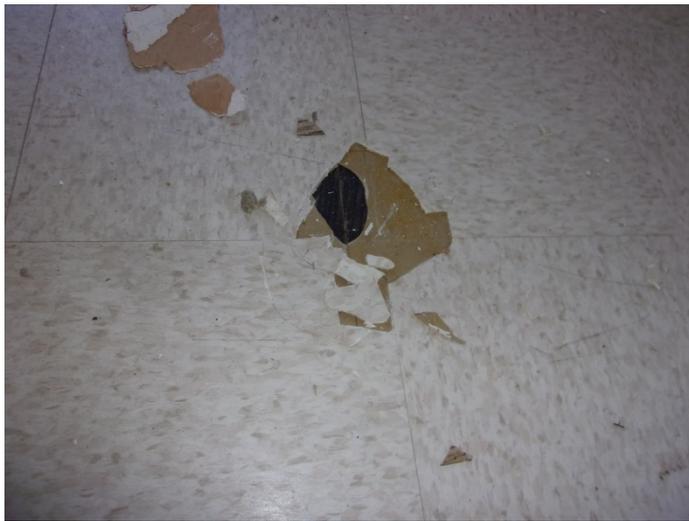
Photo 3 – Typical view of 12" x 12" tan speckled floor tile & mastic over 2<sup>nd</sup> layer of floor tile & mastic over concrete throughout buildings 1-6 & 36-38.

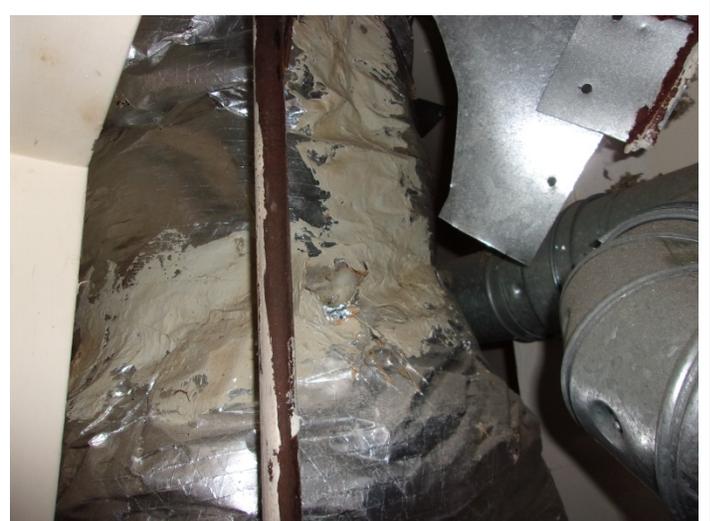
Photo 4 – Beige HVAC mastic above the ceiling and in HVAC closet in building 37.

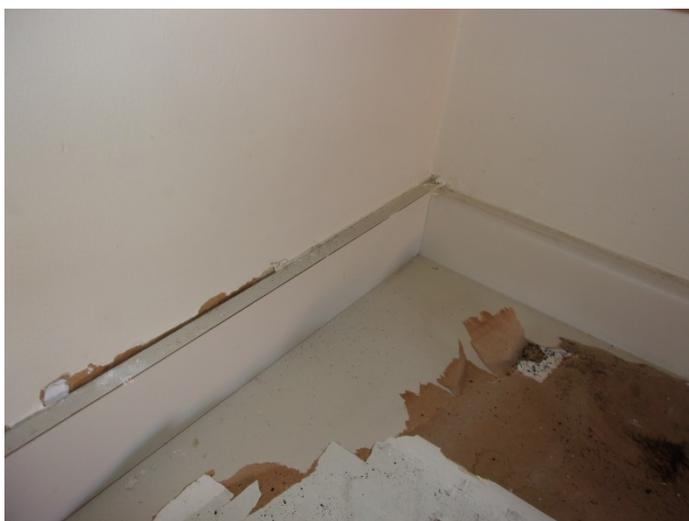
Photo 5 – Typical view of kitchen counter caulk throughout buildings 1-6 & 36-38.

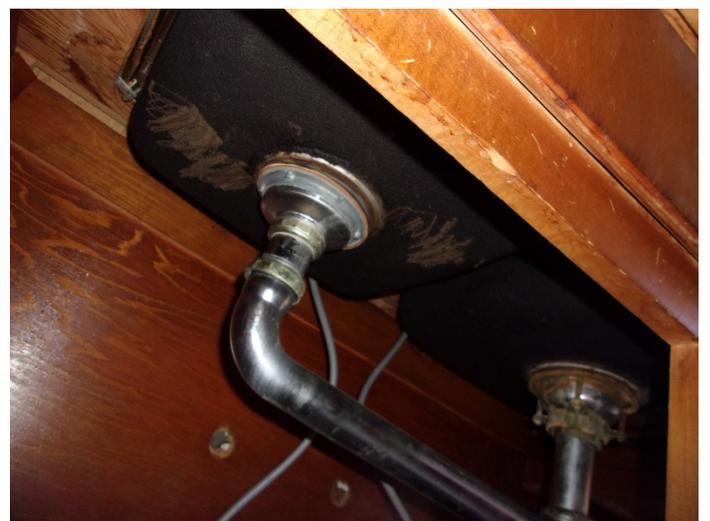
Photo 6 – Typical view of the black kitchen sink coating in buildings 1-6 & 36-38.

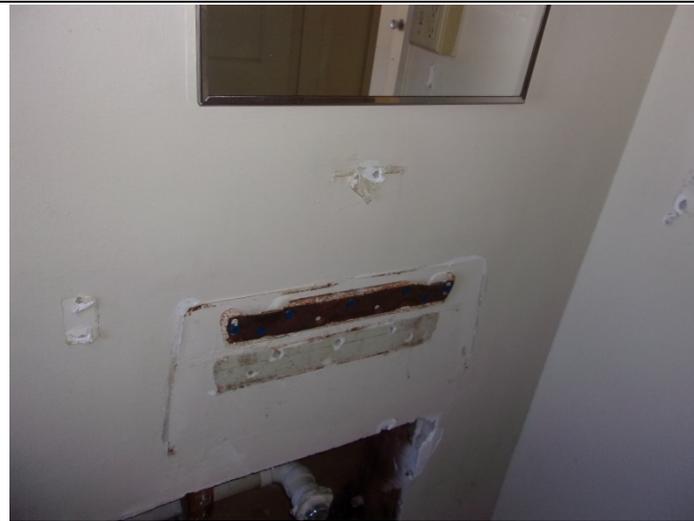
Photo 7 – Typical view of the bathroom sink caulk in buildings 1-6 & 36-38.

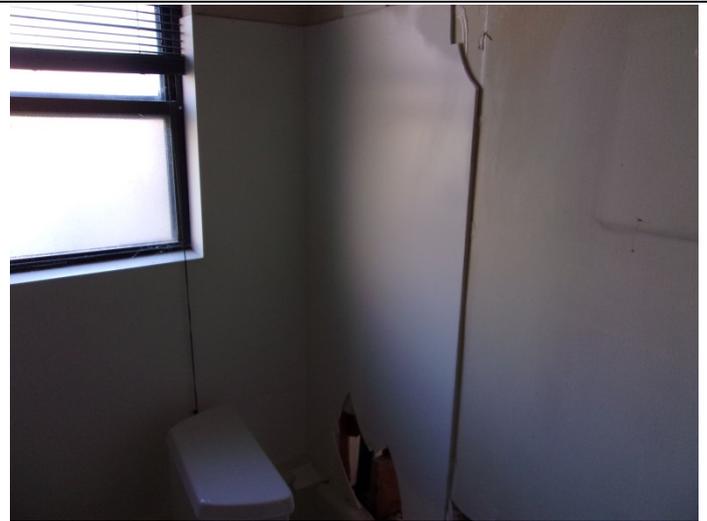
Photo 8 – Typical view of the shower stall caulk in buildings 1-6 & 36-38.

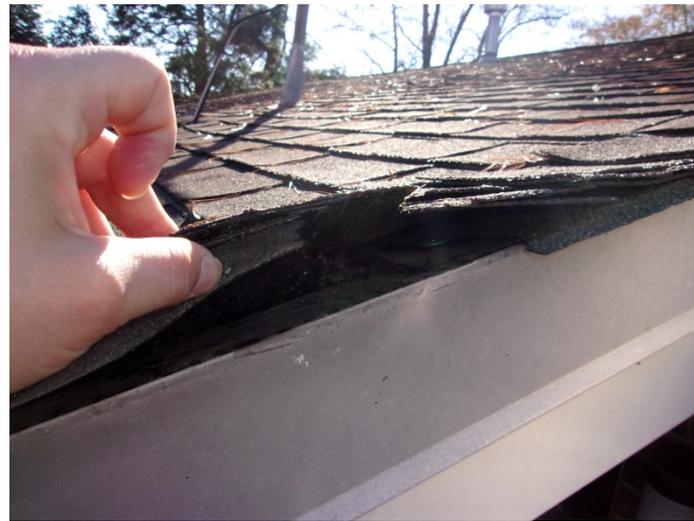
Photo 9 – Typical view of the roof shingles & felt on the main roof and awning roofs on buildings 1-6 & 36-38.

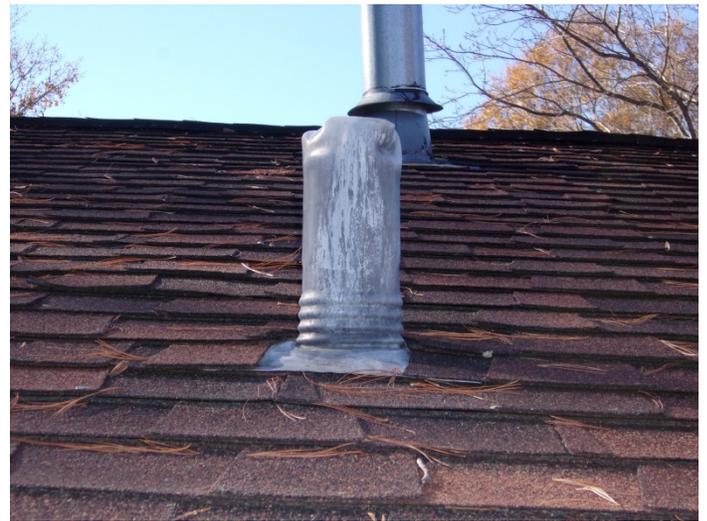
Photo 10 – Typical view of the paint coated roof vents on buildings 1-6 & 36-38.

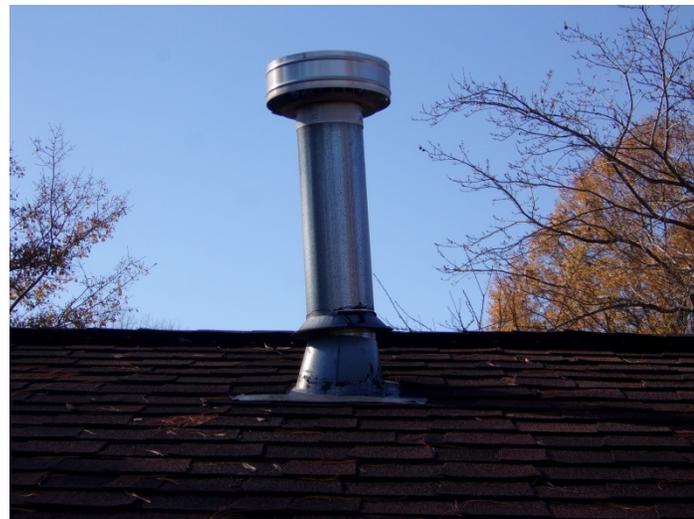
Photo 11 – Typical view of black & black/gray mastic/tar on roof penetrations on buildings 1-6 & 36-38.

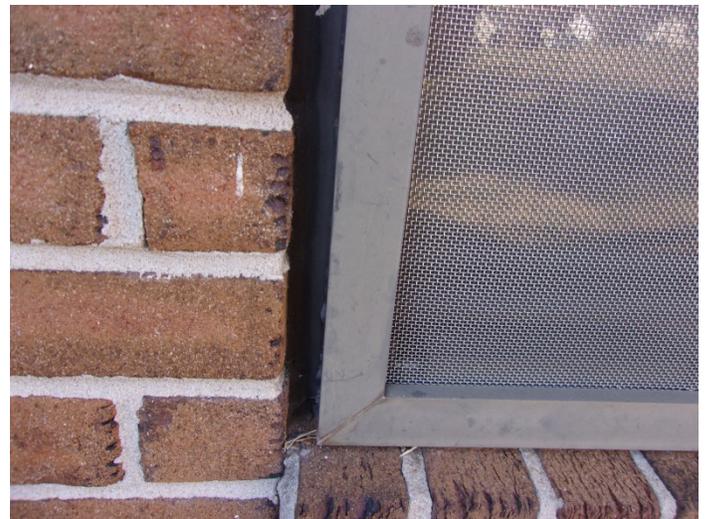
Photo 12 – Typical view of the black and brown interior and exterior window caulk in buildings 1-6 & 36-38.

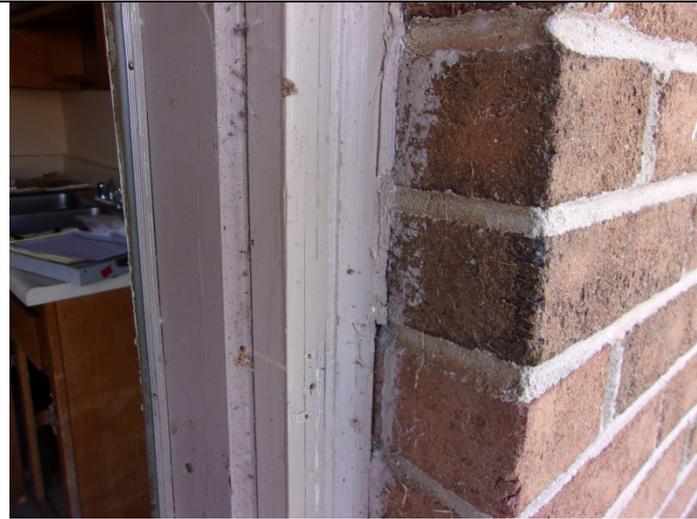
Photo 13 – Typical view of the door caulk in buildings 1-6 & 36-38.

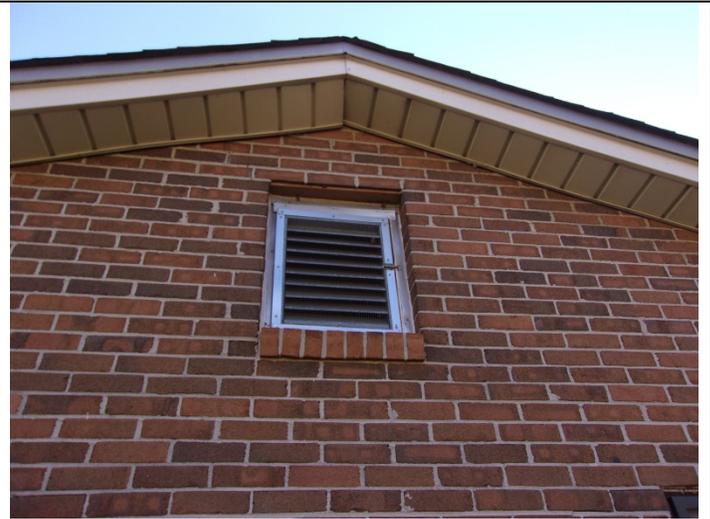
Photo 14 – Typical view of roof gable vents with caulk on buildings 1-6 & 36-38.

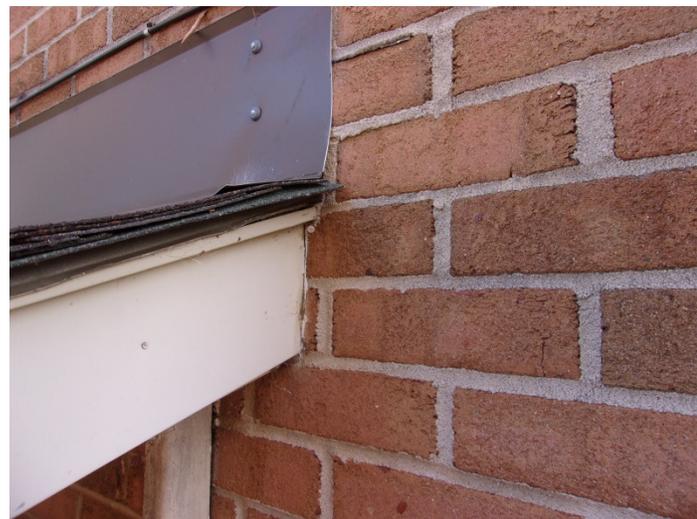
Photo 15 – Typical view of the caulk on the awning & flashing on buildings 1-6 & 36-38.

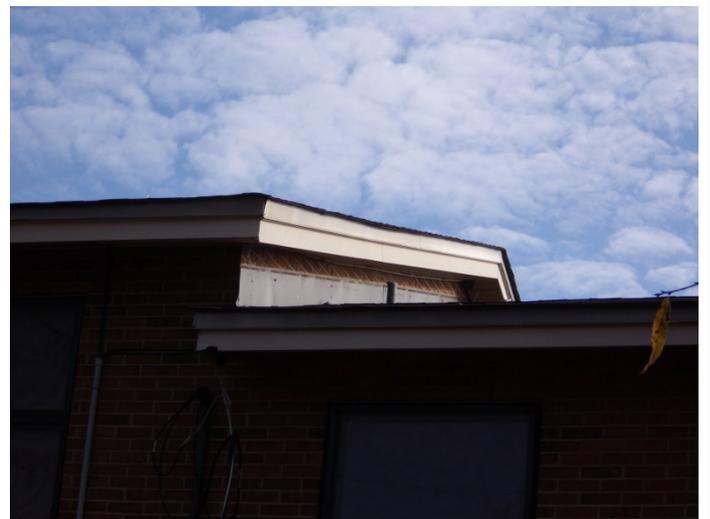
Photo 16 – Typical view of the caulk on the main roof flashing on buildings 1-6 & 36 & 38.

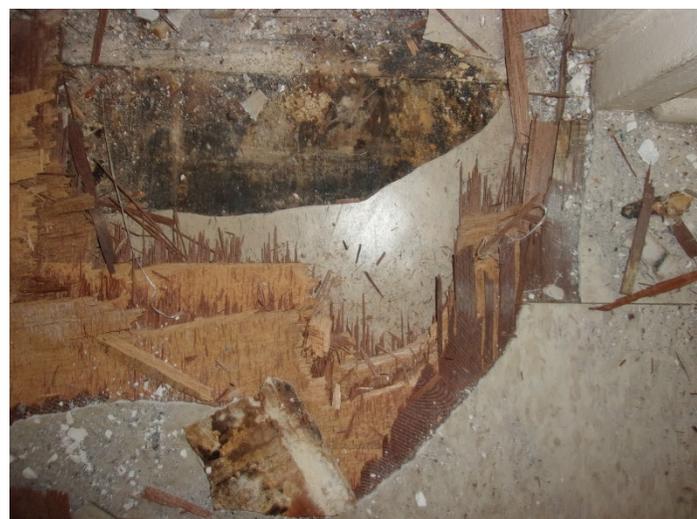
Photo 17 – Typical view of 12" x 12" tan speckled floor tile & mastic over 2<sup>nd</sup> layer of floor tile & mastic under wood throughout buildings 1-6 & 36-38.

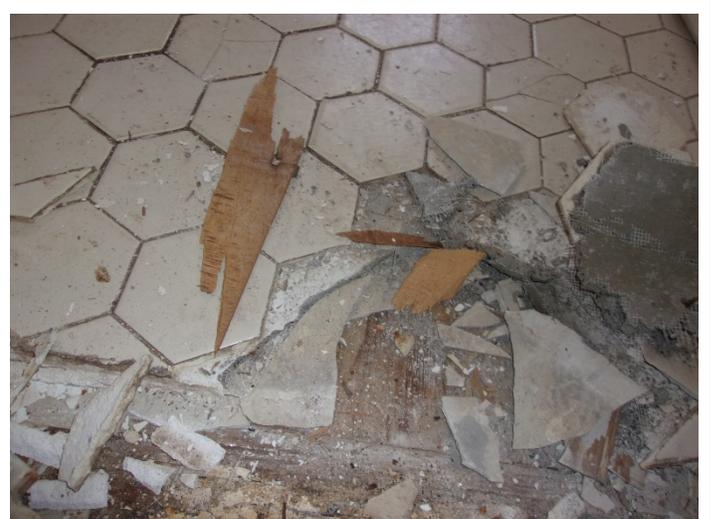
Photo 18 – Typical view of ceramic tile with wood & vinyl flooring beneath throughout buildings 1-6 & 36-38.

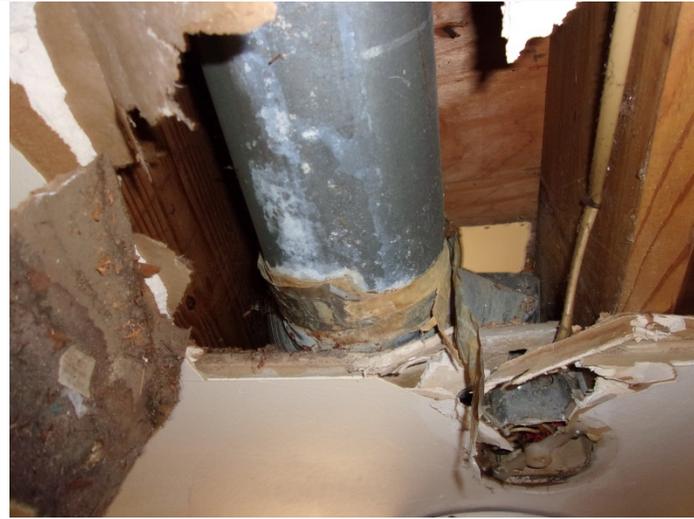
Photo 19 – Typical view of HVAC tape & mastic above the ceilings throughout buildings 1-6 & 36 & 38.

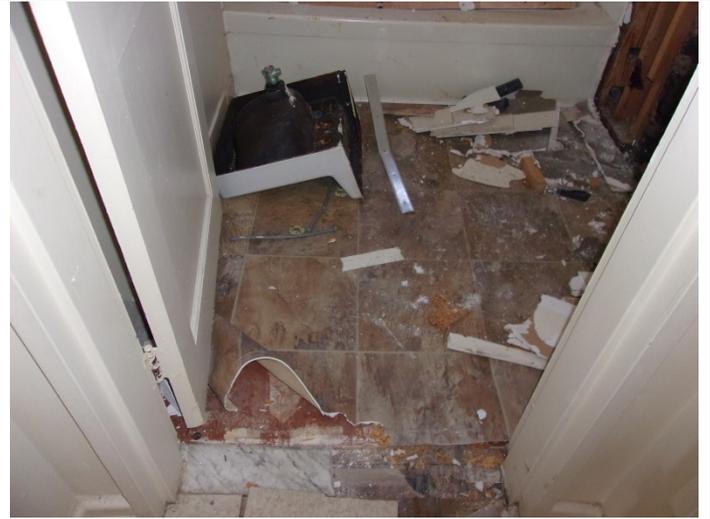
Photo 20 – Typical view of vinyl flooring & mastic in portions of the buildings (no ceramic tile exists).

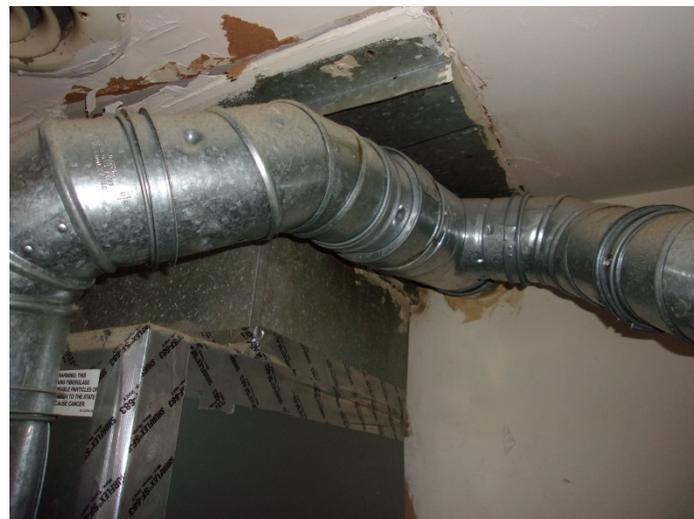
Photo 21 – Typical view of caulk on the HVAC units throughout the HVAC closets in buildings 1-6 & 36-38.

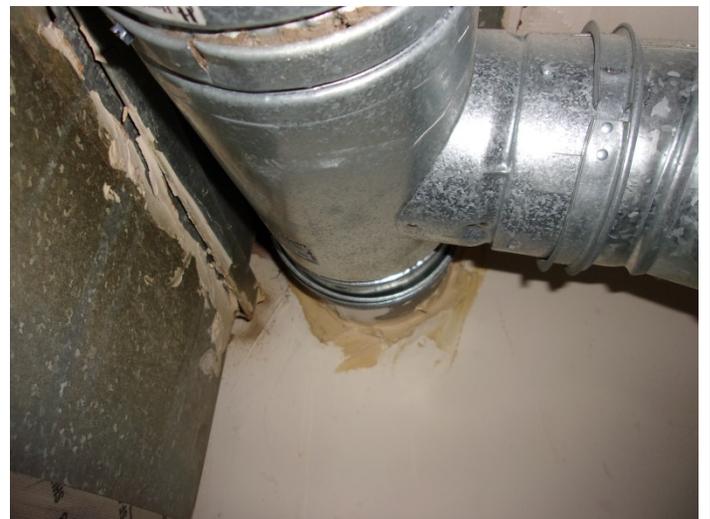
Photo 22 – Typical view of caulk on the HVAC units throughout the HVAC closets in buildings 1-6 & 36-38.

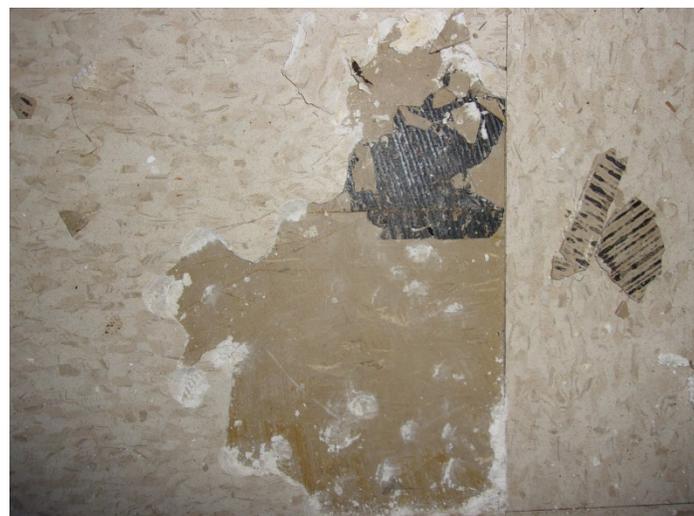
Photo 23 – Typical view of 12"x12" brown streaked floor tile and mastic (bottom layer) assumed positive in Buildings 7 to 35.
