Asbestos & Lead Based Paint Assessment

City of Spartanburg
197 Bon Air Avenue
Spartanburg, South Carolina

Project Number: 0815-163

December 15, 2015

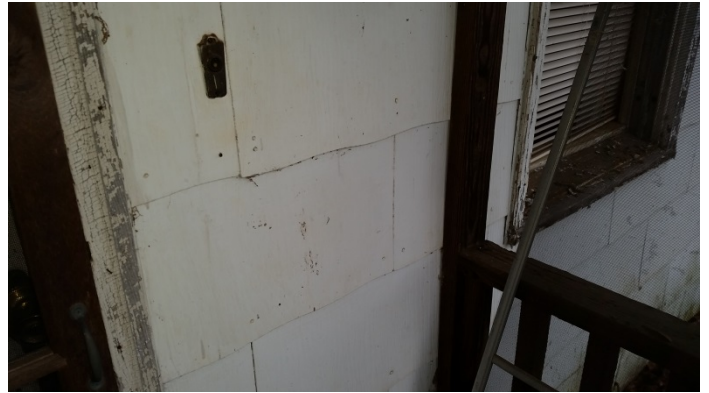
Photo 2 – Transite siding on building exterior.

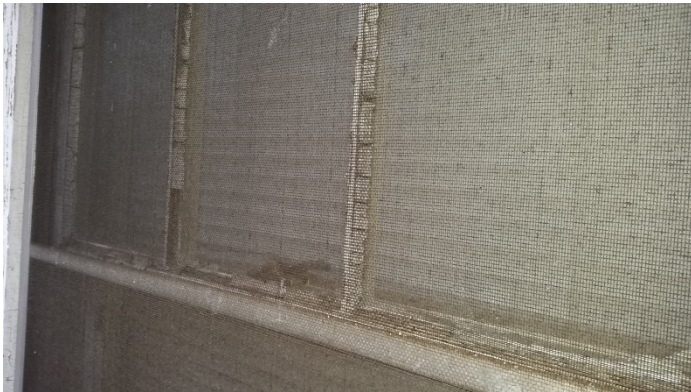
- Linoleum floor beneath the sub-flooring in both kitchens, 525 SF.
- Window glazing on exterior windows, 3 window units.
- Pattern linoleum floor & mastic & 2 layers of floor tile beneath in right bathroom, 41 SF.
- Exterior transite siding, 1,000 SF.
- Roof/chimney mastic assumed positive on 2 chimneys, 12 LF.

Photo 3 – Window glazing.

1. Abate the asbestos containing materials in the structure prior to renovation or demolition.
2. Follow applicable asbestos regulations during renovation or demolition of the structure. You should be aware that stringent requirements are imposed upon anyone renovating or demolishing a structure in which ACM will be disturbed. This work must be performed in accordance with OSHA asbestos regulations, 29 CFR 1910 & 1926, and NESHAP asbestos regulations 40 CFR 61, subpart M. South Carolina regulations require the accreditation of personnel who work in the asbestos field and notification and permitting fees for asbestos removal projects. There is a 10 working day notification period required prior to abatement of asbestos in a facility. Failure to take proper precautions and actions to protect human health and the environment can result in penalties, danger to personnel, and construction delays.

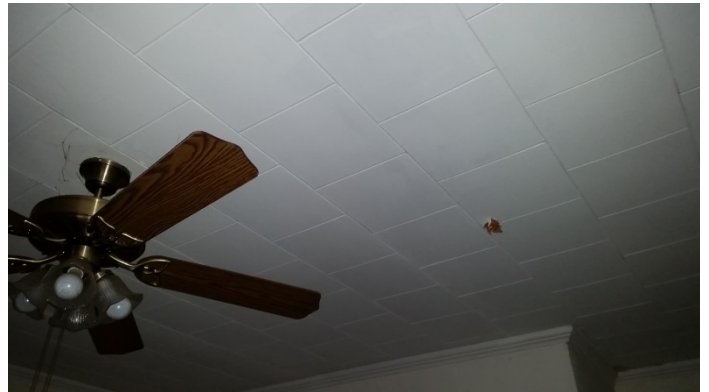
Photo 4 – Ceiling tile.

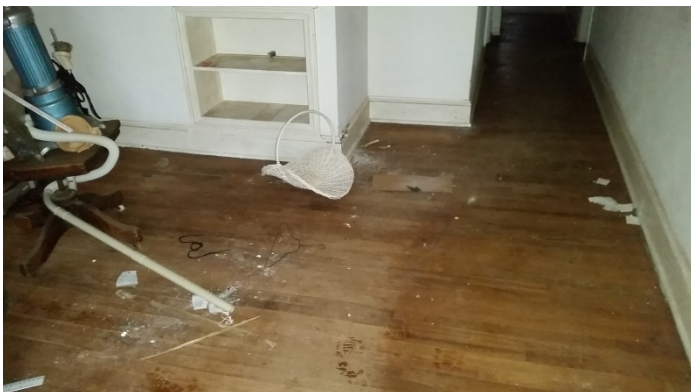
Photo 5 – Plaster with finish & hard wood floors.

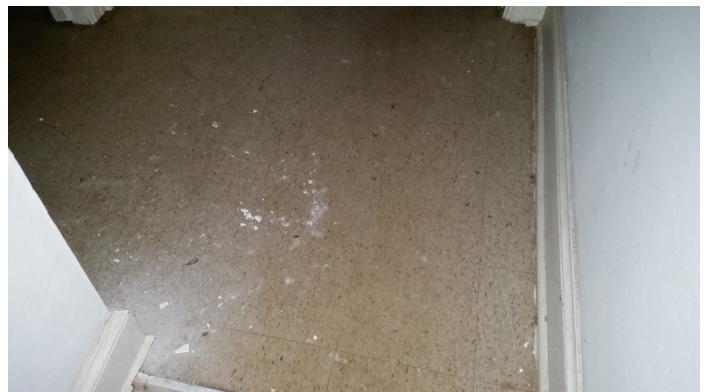
- 12" x 12" tan floor tile in both kitchens, 525 SF.

Photo 6 – 12" x 12" tan floor tile & mastic in both kitchens.

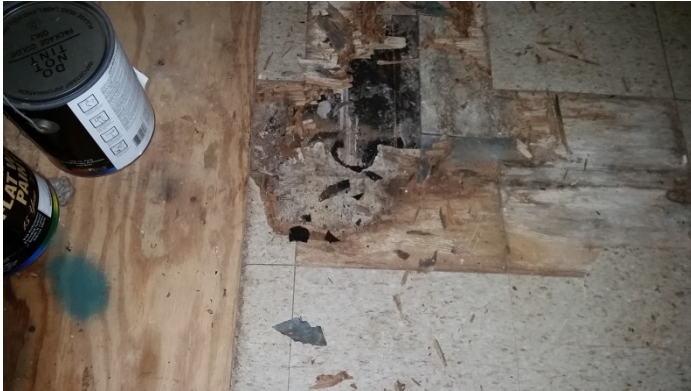
Photo 7 -- Linoleum flooring beneath sub-floor with no mastic in both kitchens.

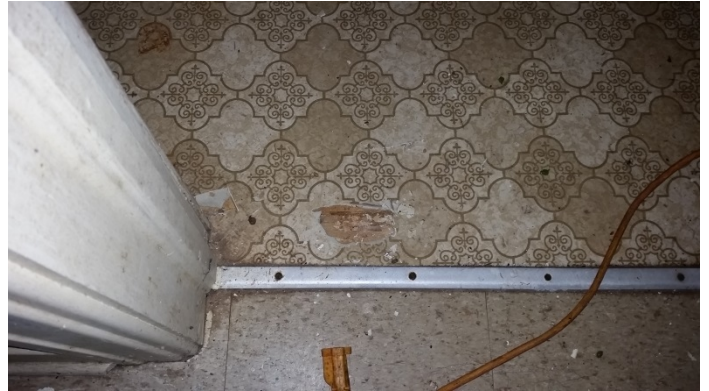
Photo 8 – Patterned linoleum flooring & mastic with 2 layers of floor tile & mastic beneath in the right bathroom.
