## **Asbestos & Lead Based Paint Assessment**

City of Spartanburg  
278 Arch Street  
Spartanburg, South Carolina

Project Number: 0815-163

February 3, 2017

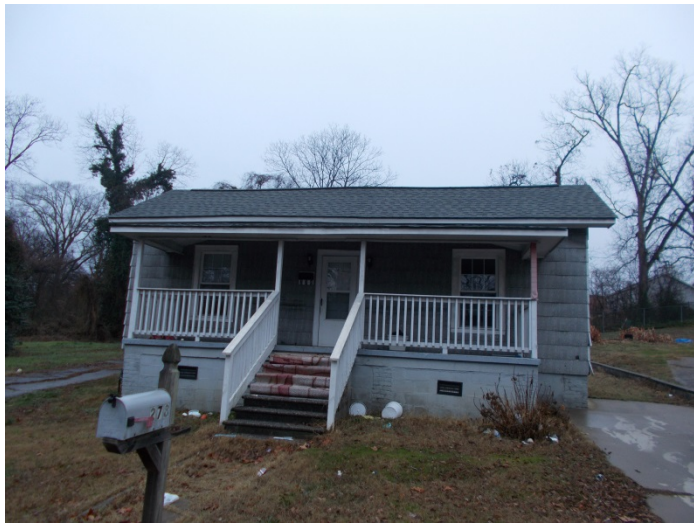
Photo 1 -- 278 Arch Street in Spartanburg, SC.

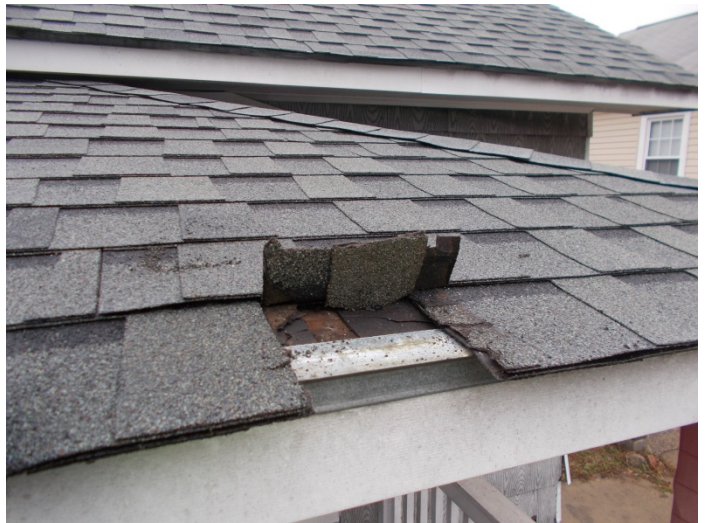
Photo 2 – Roll shingle roof (4) & felt (3).

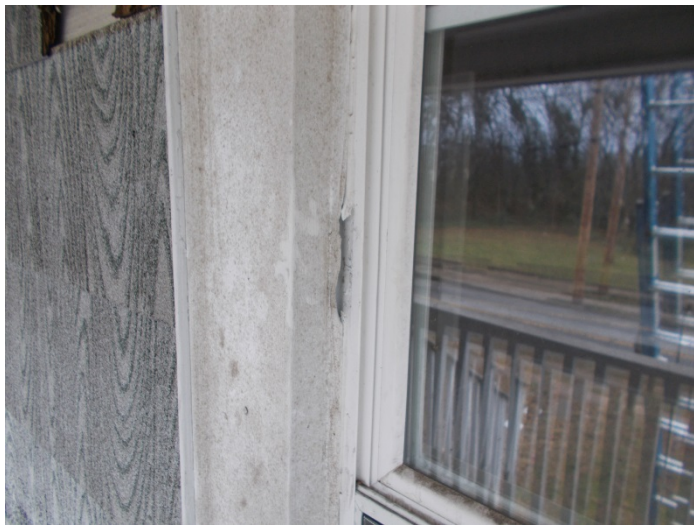
Photo 3 – Window caulk.

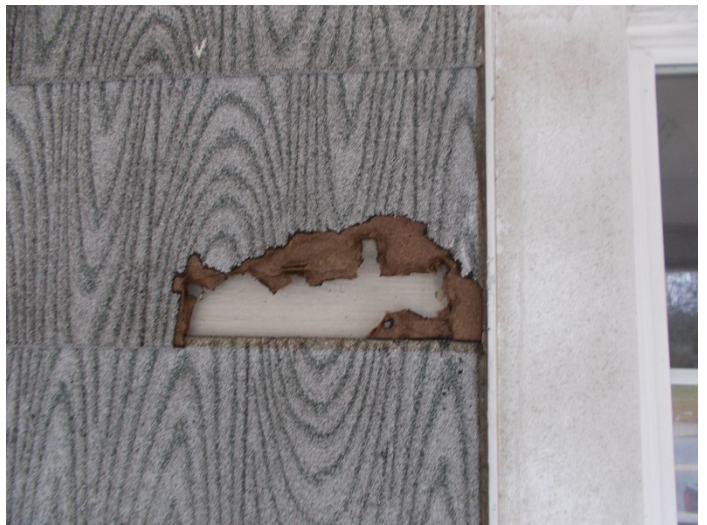
Photo 4 – Composite siding with shingle and felt.

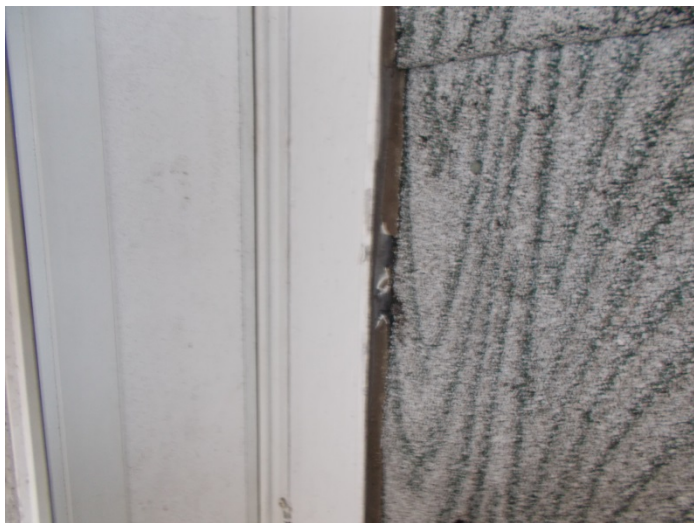
Photo 5 – Door caulk.

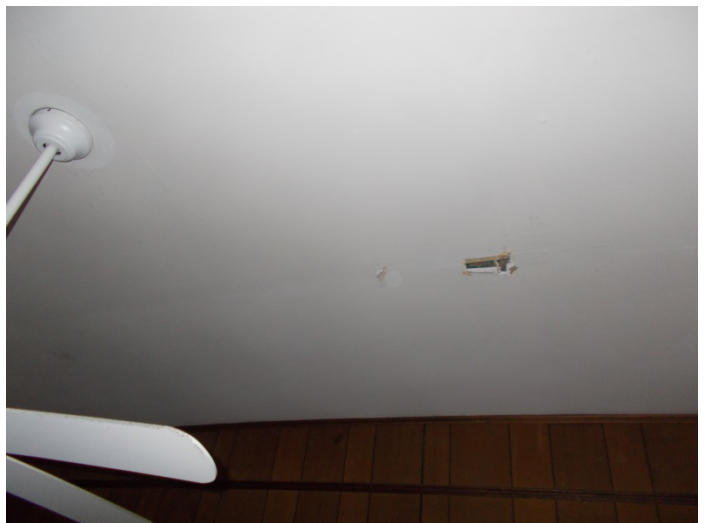
- Approximately 1,500 SF of drywall system throughout.
- Approximately 115 SF of vinyl floor (5<sup>th</sup> layer) with mastic (4<sup>th</sup> layer) in the kitchen.
- Approximately 105 SF of gold and brown pattern vinyl floor in the laundry room and bathroom (2<sup>nd</sup> layer).

Photo 6 – Drywall with joint compound and tape.

1. Abate the asbestos containing materials in the structure prior to renovation or demolition.

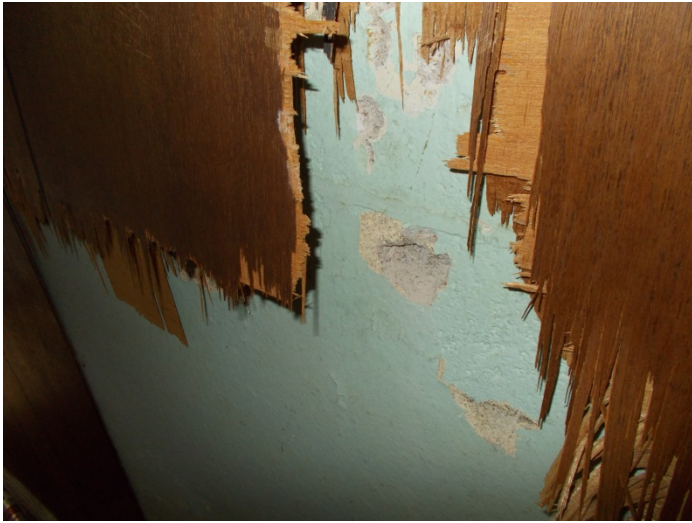
Photo 7 – Plaster with finish.

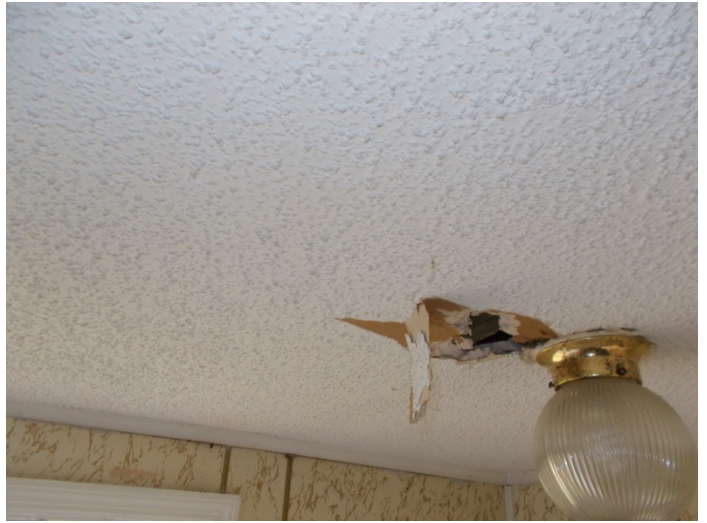
Photo 8 – Ceiling texture.

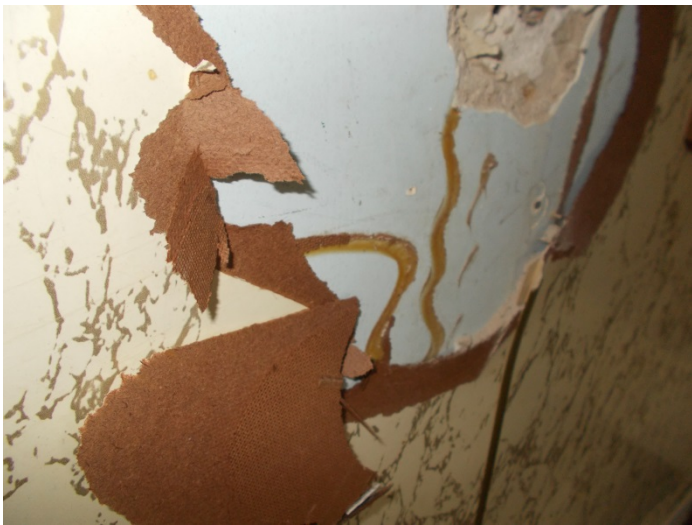
Photo 9 – Wall panel mastic.

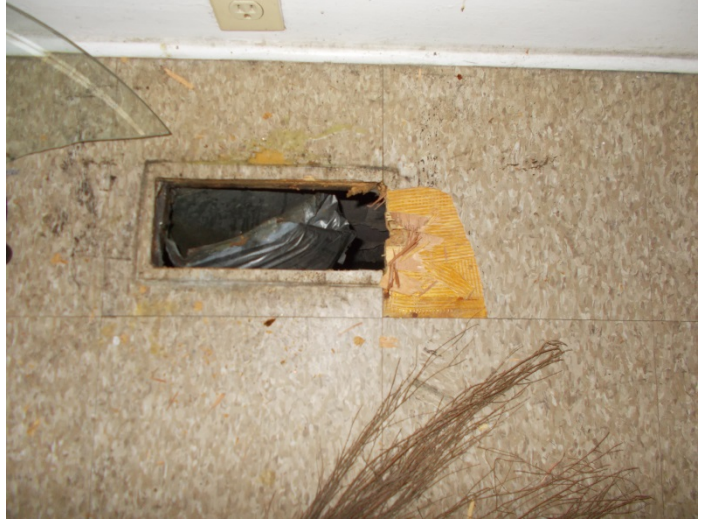
Photo 10 – 12"x12" beige speckled floor tile with mastic.

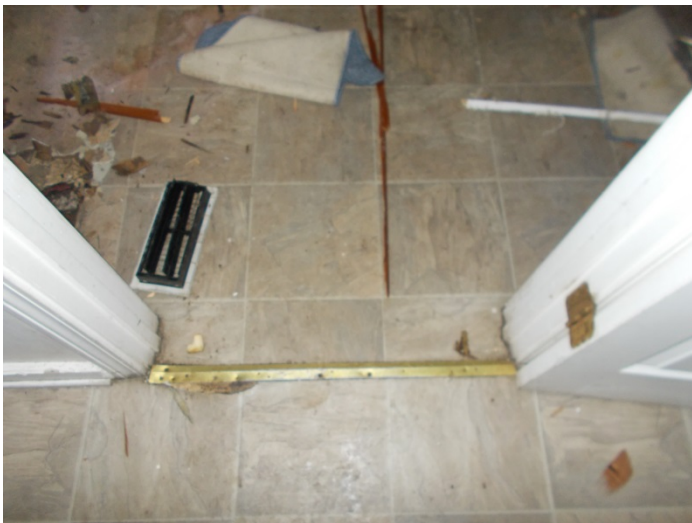
Photo 11 – Tan slate pattern vinyl floor with mastic

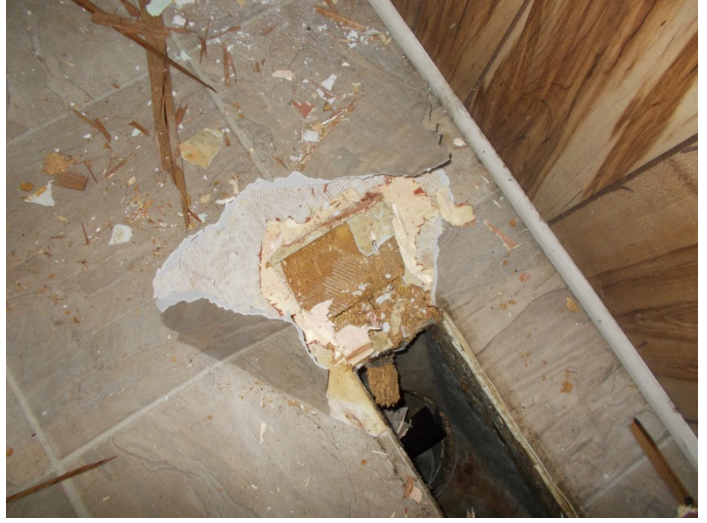
Photo 12 – White floor tile and mastic under wood.

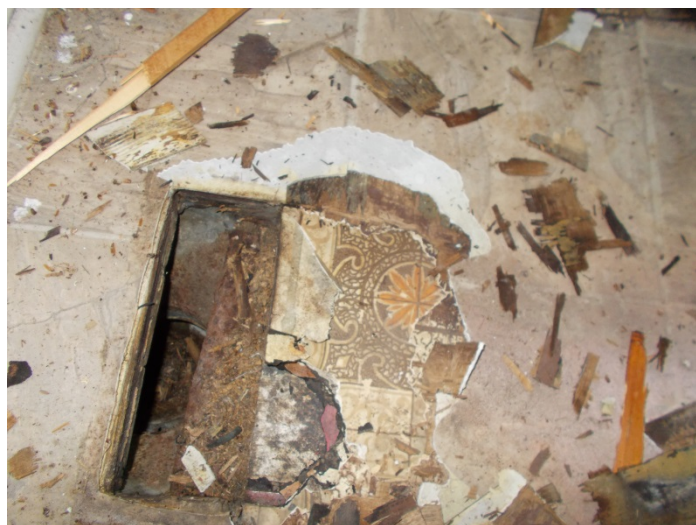
Photo 13 – Multiple layers of vinyl floor with no mastic, floor tile with mastic and felt backing in the kitchen

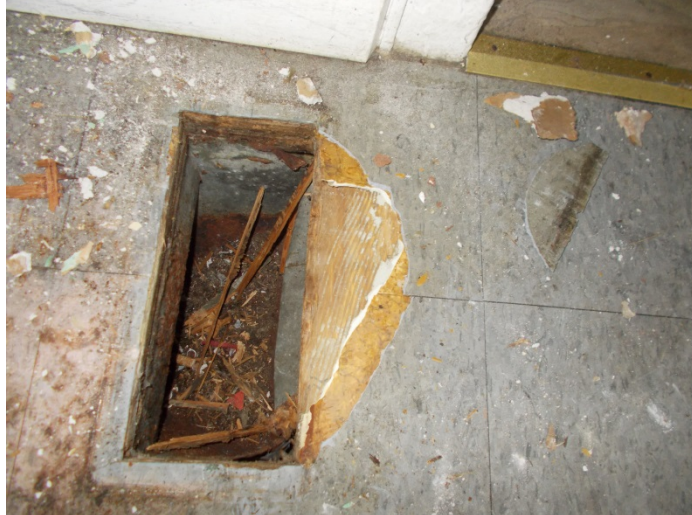
Photo 14 – 12"x12" blue streaked floor tile with mastic over gold / brown pattern vinyl floor with mastic in the laundry room and bathroom.
