Asbestos & Lead Based Paint Assessment

City of Spartanburg
270 Arch Street
Spartanburg, South Carolina

Project Number: 0815-163

February 3, 2017

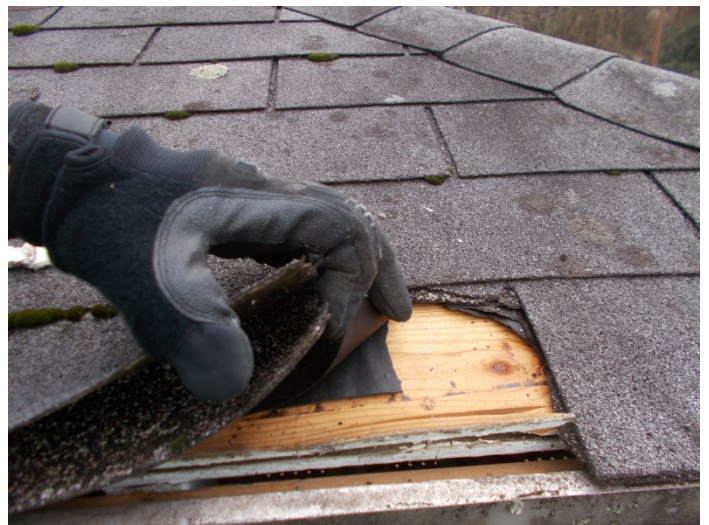
Photo 2 – Roll shingle roof (2) & felt (2).

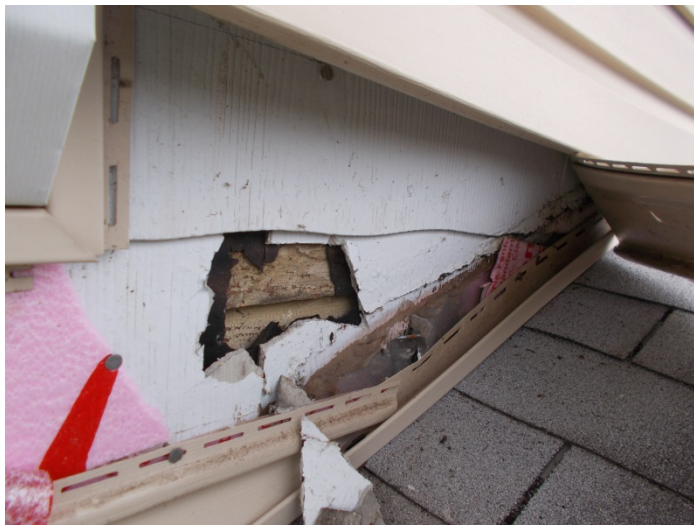
- Approximately 1,475 SF of cement board siding.
- Approximately 4 wooden windows with glazing.

Photo 3 – Cement board siding and felt.

1. Abate the asbestos containing materials in the structure prior to renovation or demolition.

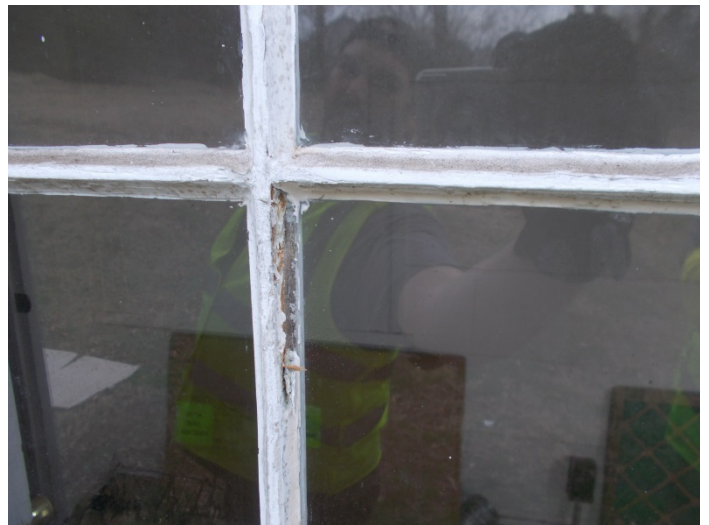
Photo 4 – Window glazing.

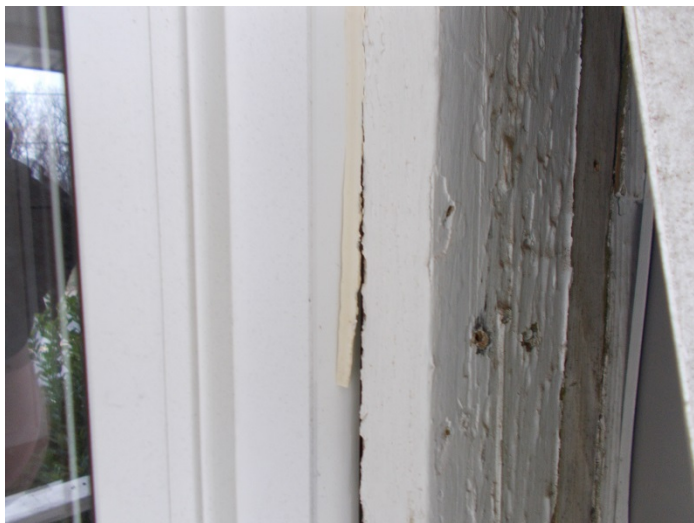
Photo 5 – Window casing caulk.

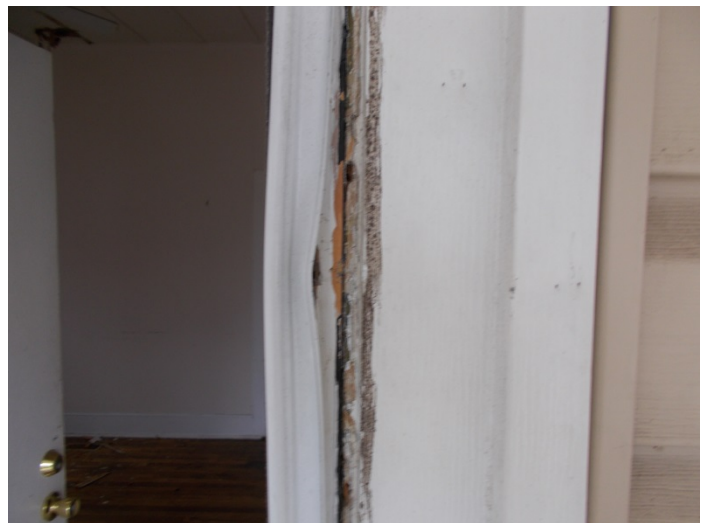
Photo 6 – Door caulk.

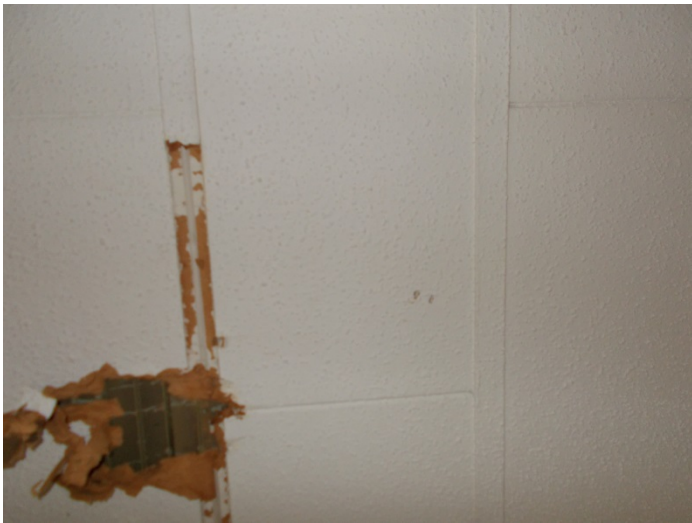
Photo 7 – Ceiling texture over wooden composite ceiling tiles.

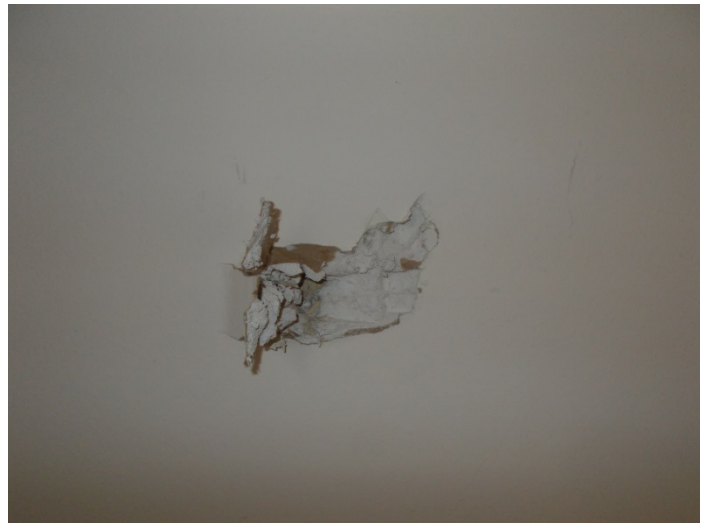
Photo 8 – Drywall with joint compound and tape.

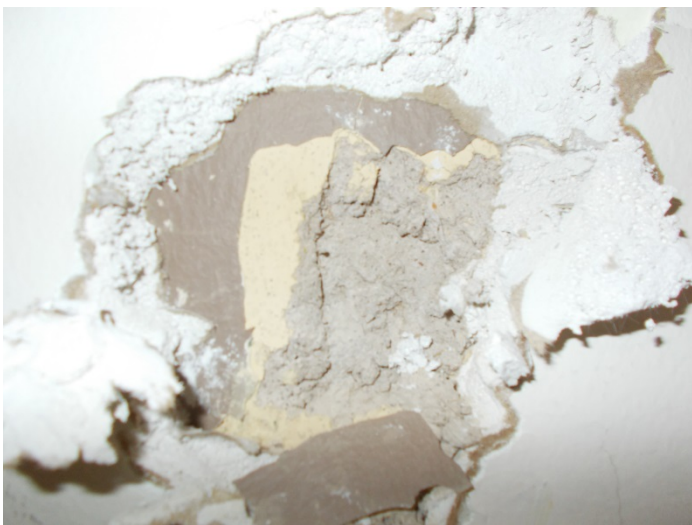
Photo 9 – Plaster with finish.

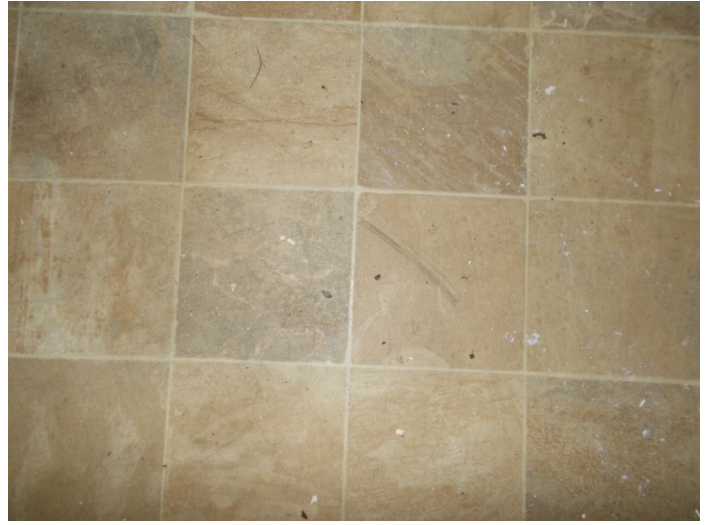
Photo 10 – Slate square pattern vinyl floor with mastic (top layer).

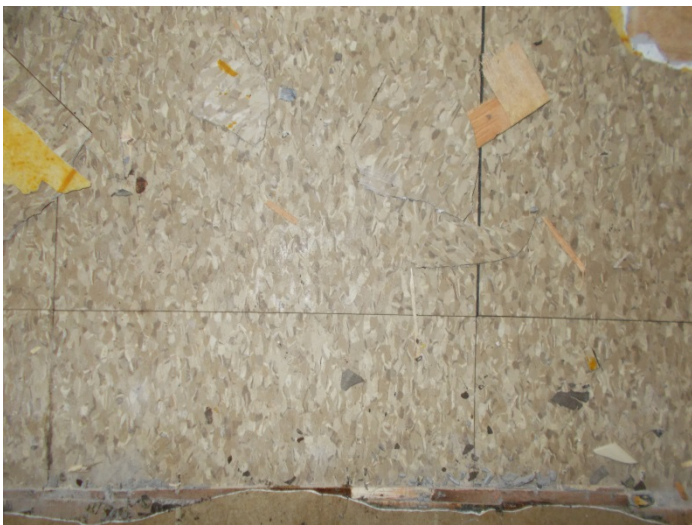
Photo 11 – 12"x12" tan speckled floor tile with mastic (2nd layer).

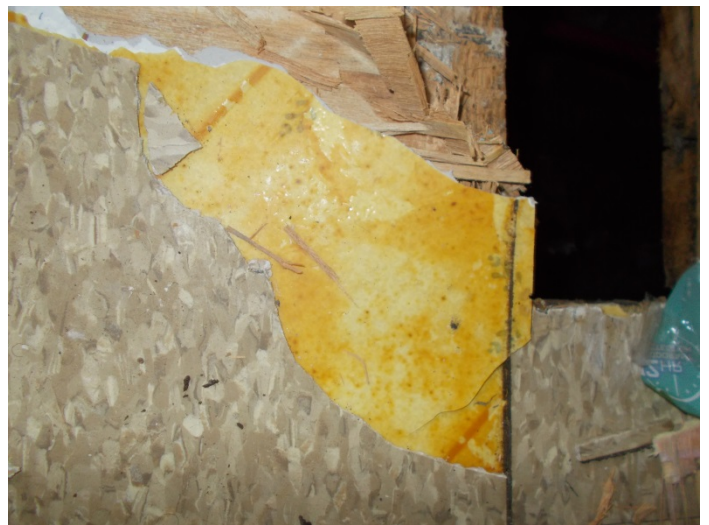
Photo 12 – Yellow pattern vinyl floor with no mastic (3rd layer).

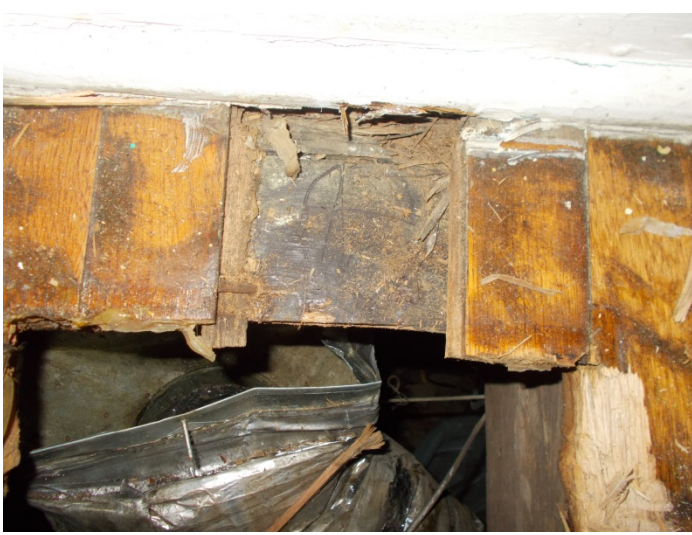
Photo 13 – Flooring paper throughout under wood.

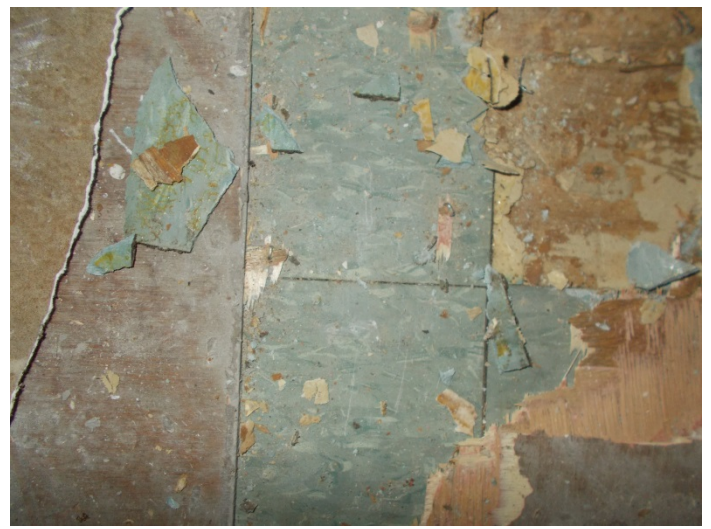
Photo 14 – Green streaked floor tile with mastic over cream vinyl floor with mastic .
