## **Asbestos & Lead Based Paint Assessment**

City of Spartanburg  
261 Arch Street  
Spartanburg, South Carolina

Project Number: 0815-163

February 8, 2017

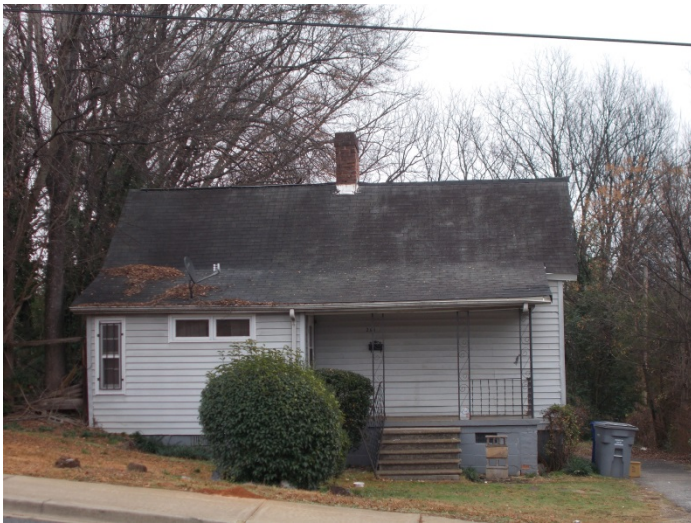
Photo 1 -- 261 Arch Street in Spartanburg, SC.

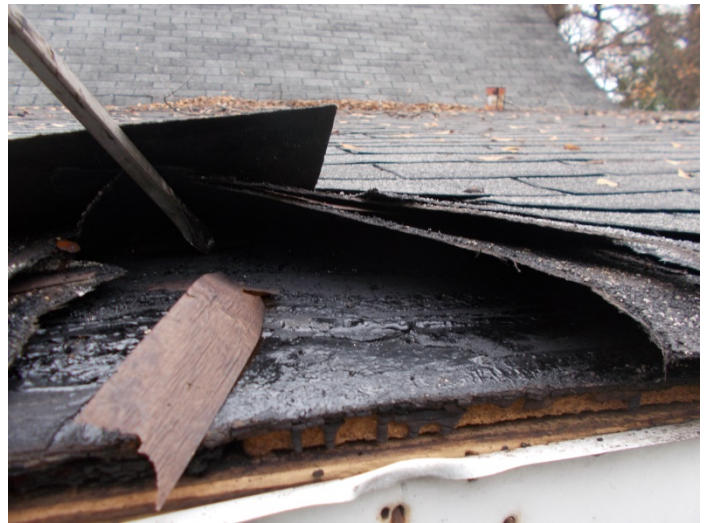
Photo 2 – Roof shingles (2 layers) with tar and no felt.

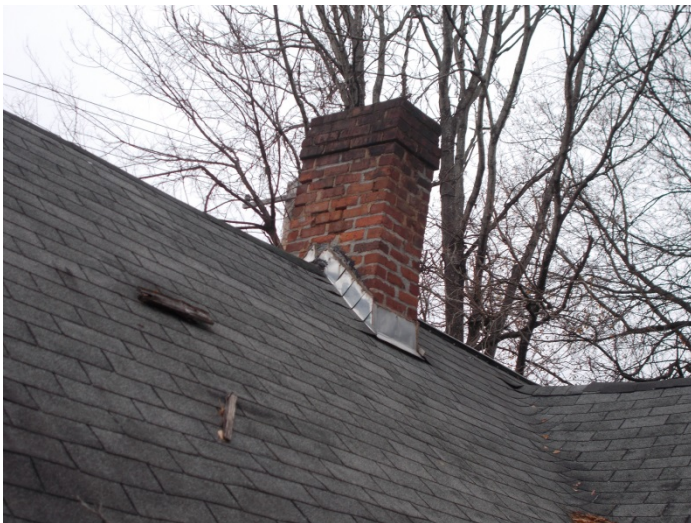
- Approximately 1,475 SF of drywall system throughout the interior walls.
- Approximately 55 SF of wall panel mastic in the front right bathroom.
- Approximately 6 LF of chimney mastic on 1 chimney - assumed.

Photo 3 – One chimney with tar assumed positive.

1. Abate the asbestos containing materials in the structure prior to renovation or demolition.
2. Follow applicable asbestos regulations during renovation or demolition of the structure. You should be aware that stringent requirements are imposed upon anyone renovating or demolishing a structure in which ACM will be disturbed. This work must be performed in accordance with OSHA asbestos regulations, 29 CFR 1910 & 1926, and NESHAP asbestos regulations 40 CFR 61, subpart M. South Carolina regulations require the accreditation of personnel who work in the asbestos field and notification and permitting fees for asbestos removal projects. There is a 10 working day notification period required prior to abatement of asbestos in a facility. Failure to take proper precautions and actions to protect human health and the environment can result in penalties, danger to personnel, and construction delays.

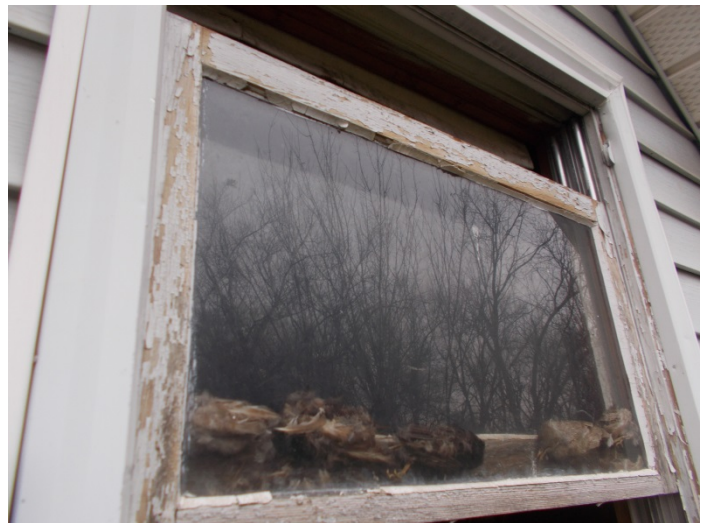
Photo 4 – Wooden window glazing.

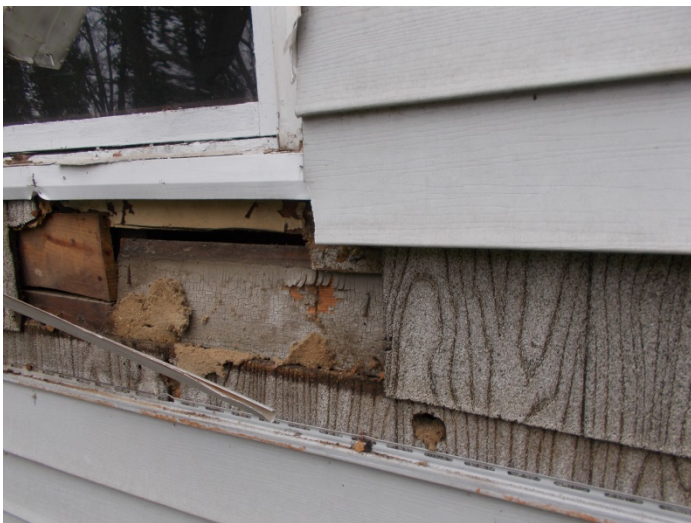
Photo 5 – Shingle siding with felt backing.

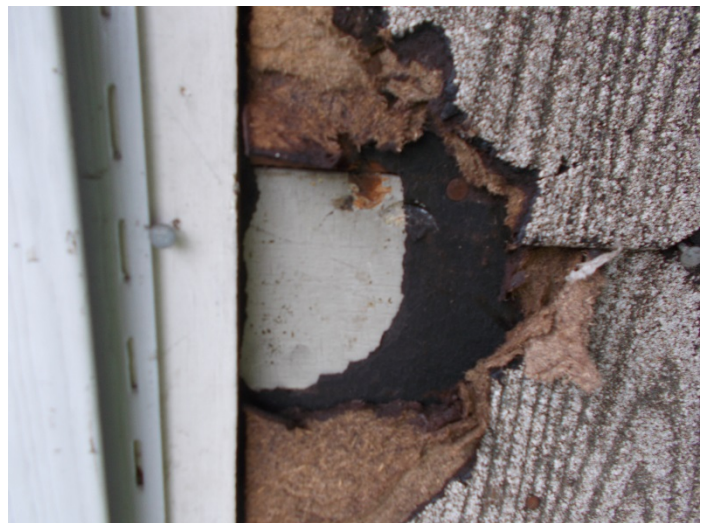
Photo 6 – Siding felt over wood.

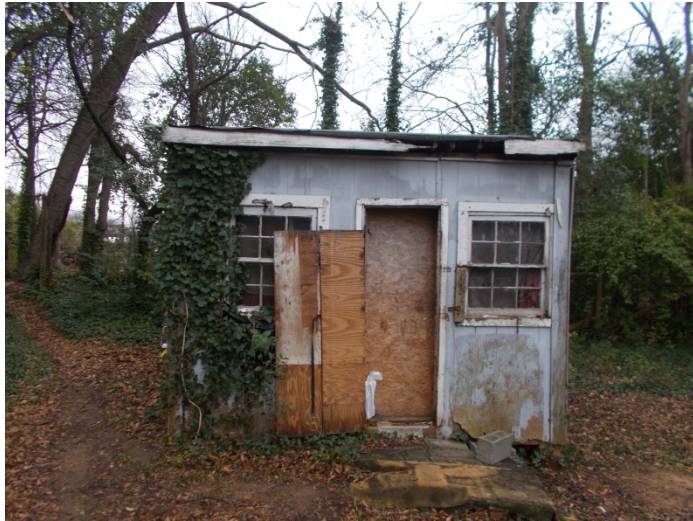
Photo 7 – Exterior shed.

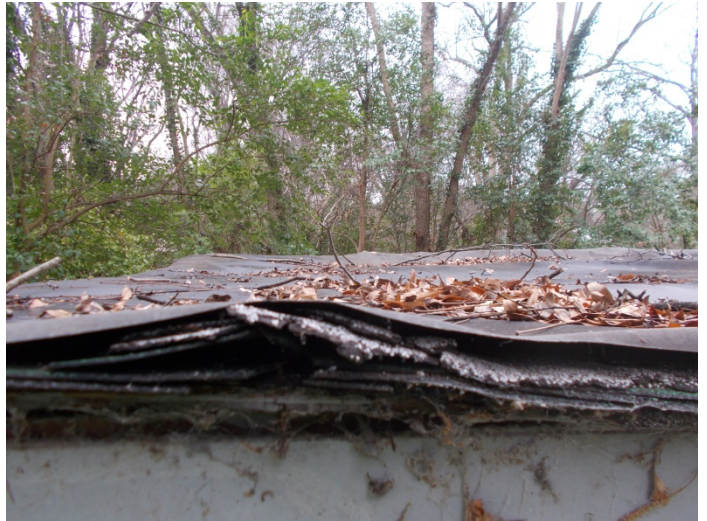
Photo 8 – Roofing shingles (7 layers) and no felt on shed roof.

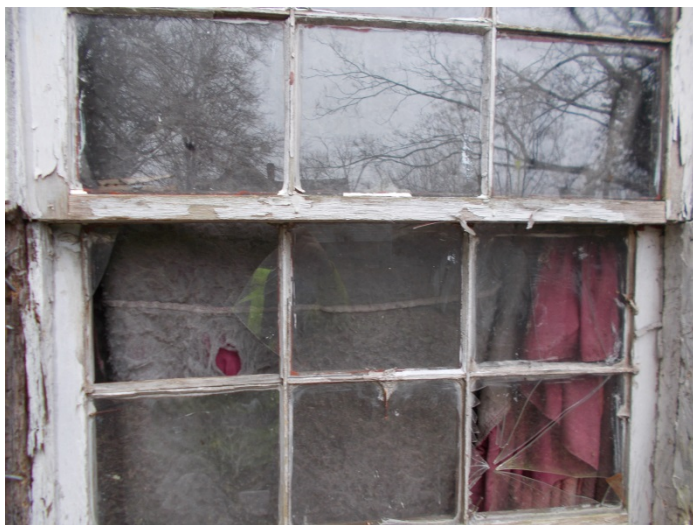
Photo 9 – Window glazing on shed windows.

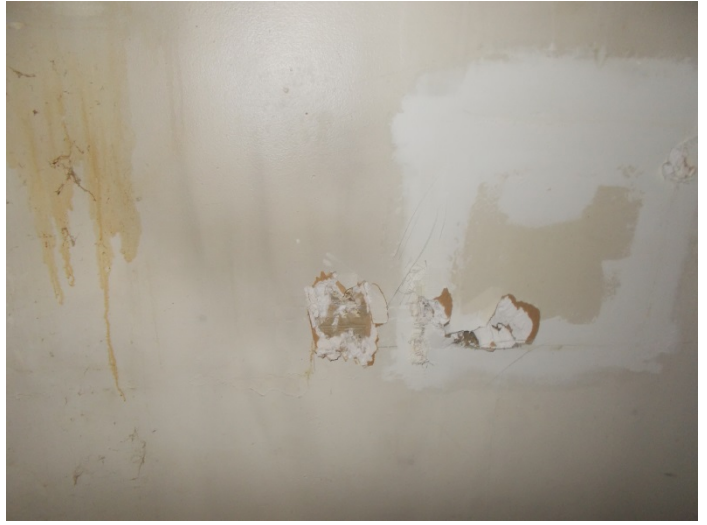
Photo 10 – Drywall with joint compound and tape throughout walls.

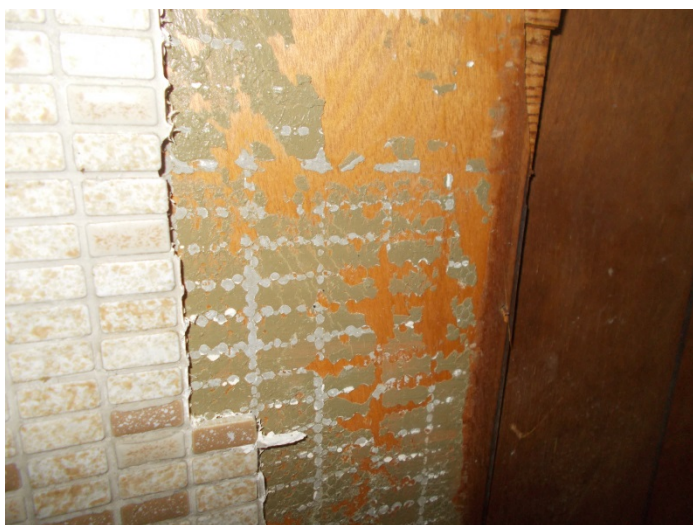
Photo 11 – Wall panel mastic in front right bathroom.

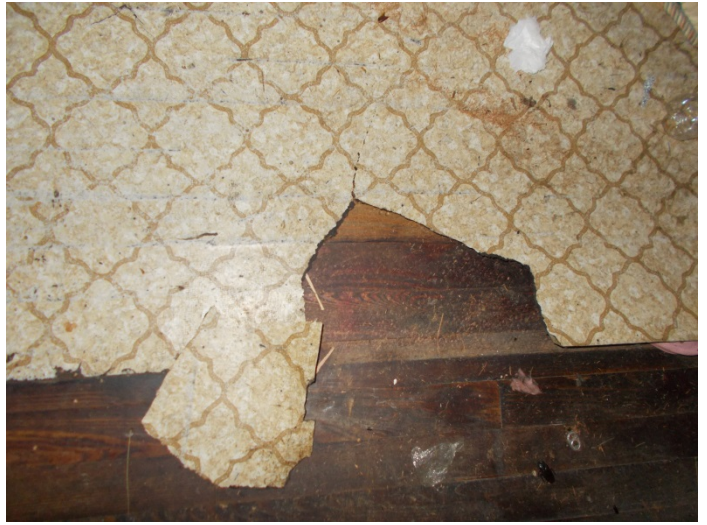
Photo 12 – Brown pattern vinyl floor with no mastic over wood in front right bedroom.

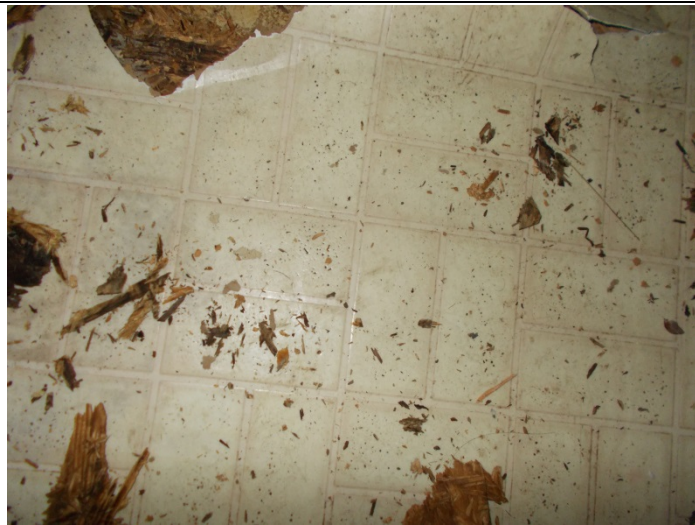
Photo 13 – Tan square pattern vinyl floor with mastic in front right bathroom (top layer).

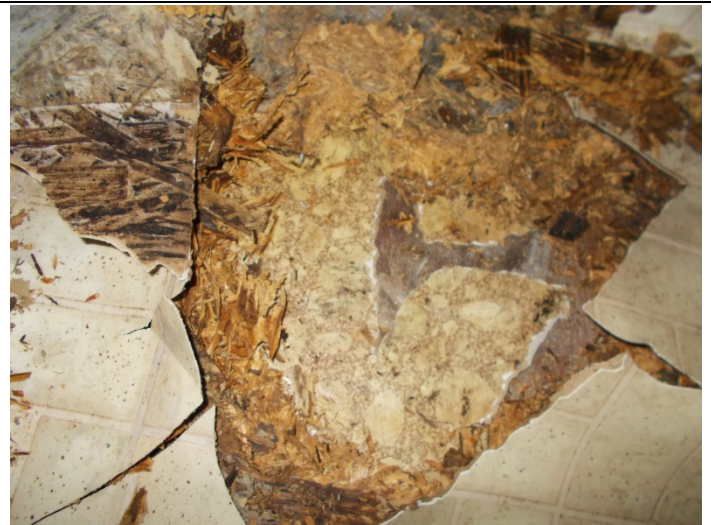
Photo 14 – Yellow pattern vinyl floor with mastic under wood (2<sup>nd</sup> layer).

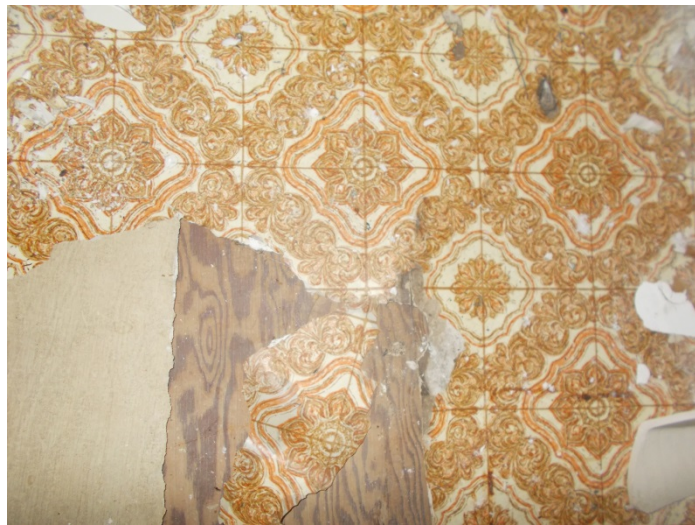
Photo 15 – Brown and orange pattern vinyl floor with mastic in rear bathroom.

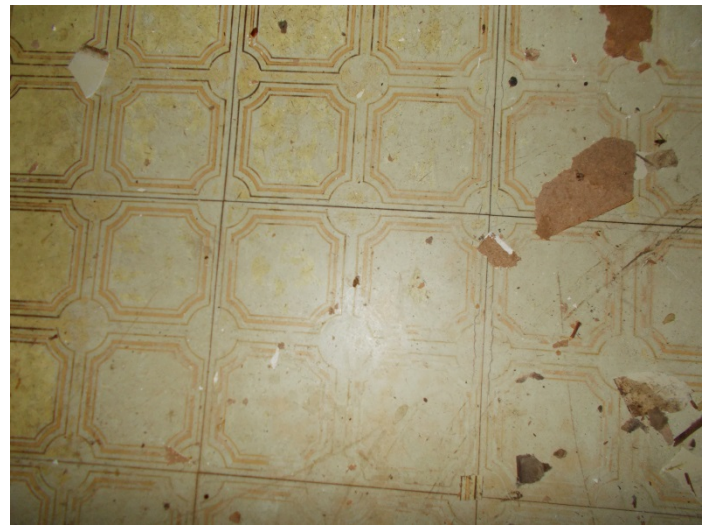
Photo 16 – 12"x12" yellow pattern floor tile with mastic in kitchen (top layer).

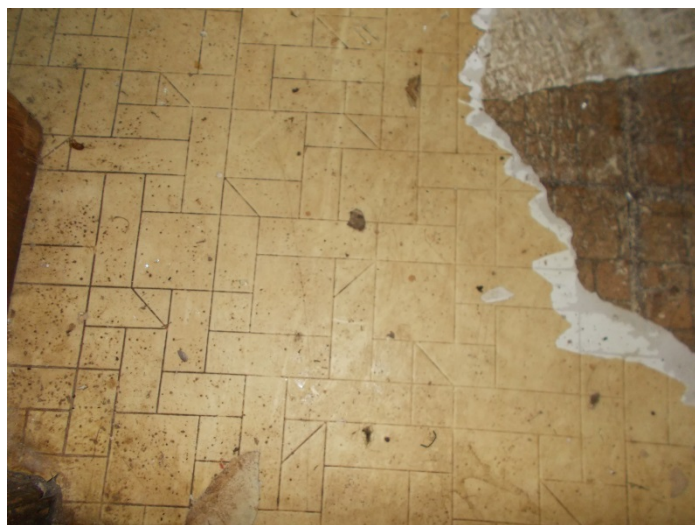
Photo 17 – Cream rectangle pattern vinyl floor with mastic in mud porch (top layer).

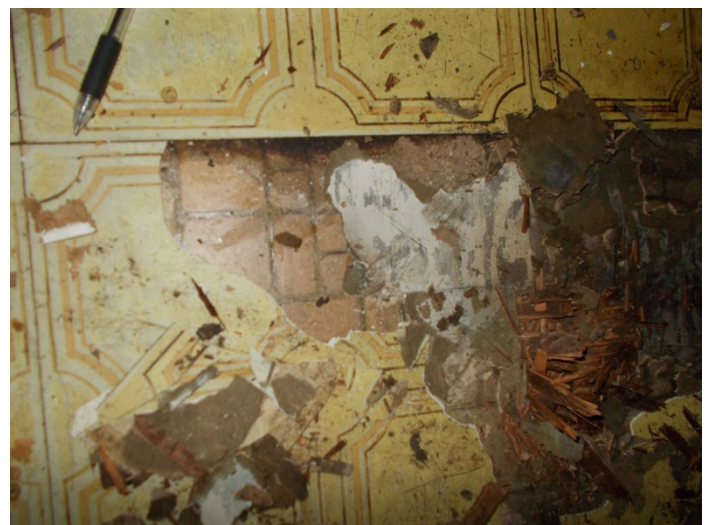
Photo 18 – Brown small square pattern vinyl floor with mastic in kitchen and mud porch (bottom layer).
