## **Asbestos & Lead Based Paint Assessment**

City of Spartanburg  
342 Ridgewood Avenue  
Spartanburg, South Carolina 29306

Project Number: 0119-09

May 20, 2019

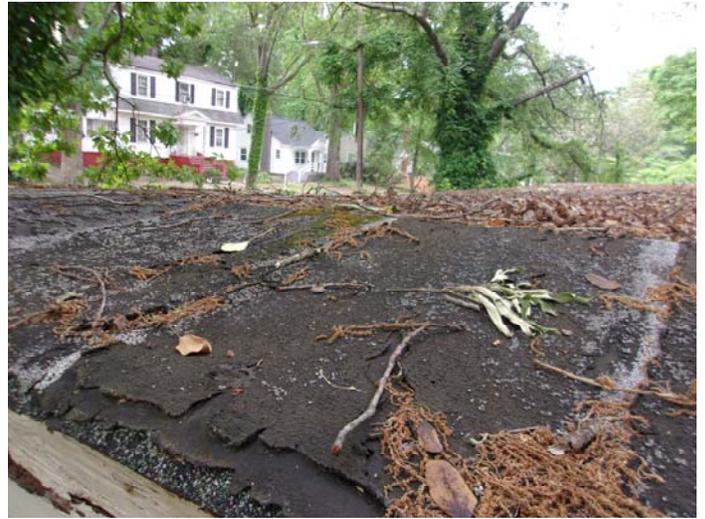
| Sample No. | Location | Sample Description | Analytical Results | Friable/Non Friable | Condition | Quantity |
|---|--|--|--|---|---|---|
| 1 | Front porch roof | Roof shingles (2 layers) with tar & felt | PLM - 3% chry (tar)<br>NAD (shingles & felt) | Non-Friable | Good | 400 SF |

Photo 2 – Roof shingles with tar & felt on the front porch roof

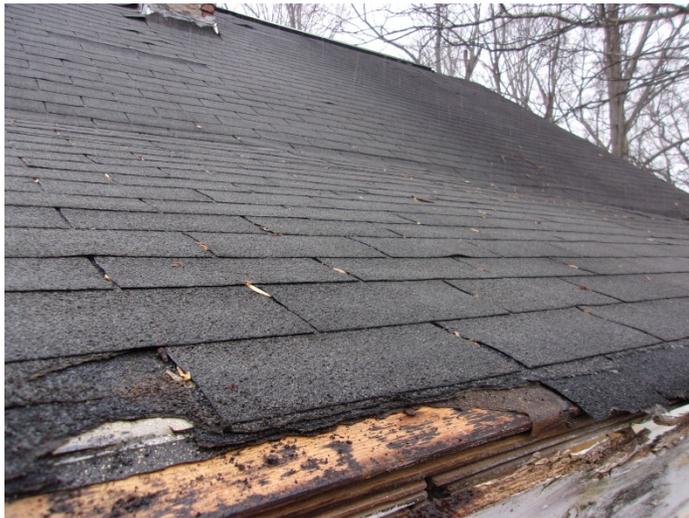
| Sample No. | Location | Sample Description | Analytical Results | Friable/Non Friable | Condition | Quantity |
|---|--|--|--|---|---|---|
| 4 | Main house roof | Roof shingles (1 layer) with tar & no felt | PLM - NAD | Non-Friable | Good | 2,100 SF |

Photo 3 – Roof shingles with tar & no felt on the main house roof

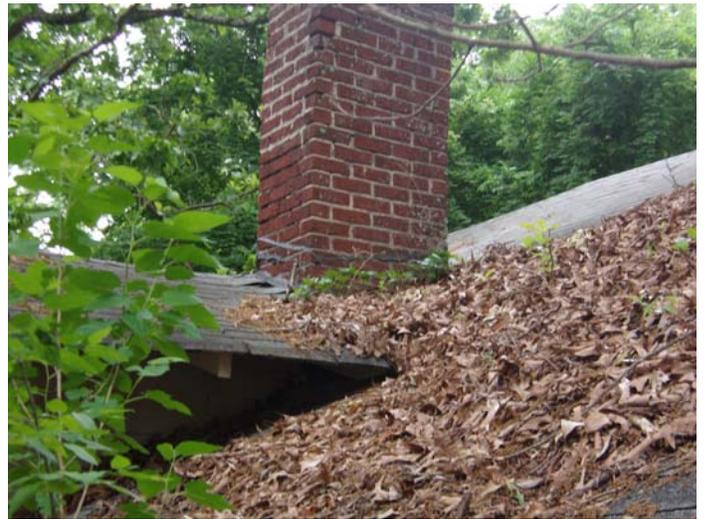
| Sample No. | Location | Sample Description | Analytical Results | Friable/Non Friable | Condition | Quantity |
|---|--|--|--|---|---|---|
| 7 | Tar on brick wall on left side of house on previous roof & chimney | Tar on previous roof flashing & chimney | 4% chrysotile | Non-Friable | Good | 30 LF |

Photo 4 – Tar on chimney

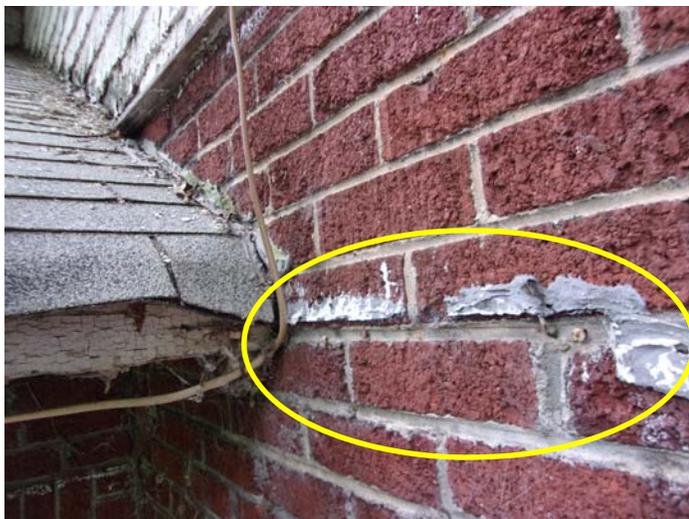
Photo 5 – Tar on brick wall on left side of house on previous roof flashing

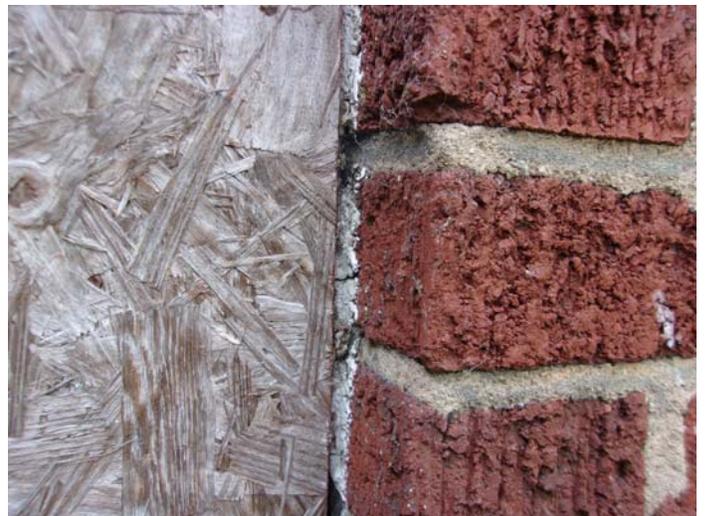
| Sample No. | Location | Sample Description | Analytical Results | Friable/Non Friable | Condition | Quantity |
|---|--|--|--|---|---|---|
| 10 | Wooden/brick window casings | Window casing glazing | 2% chrysotile | Non-Friable | Good | 21 EA |

Photo 6 – Wooden/brick window casings with glazing

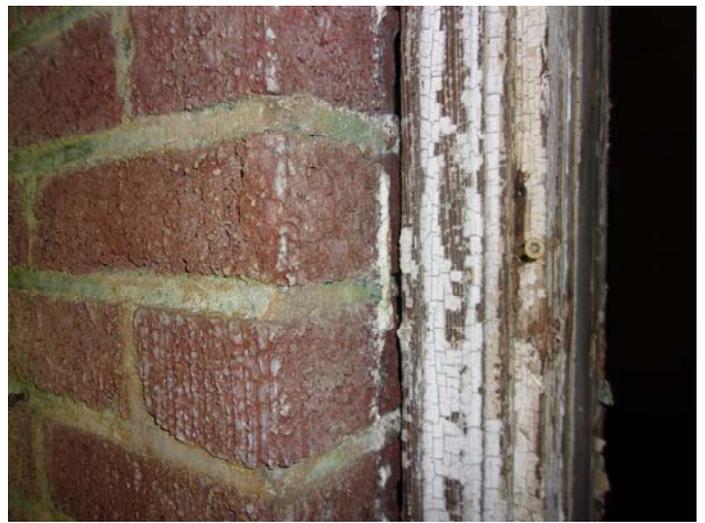
| Sample No. | Location | Sample Description | Analytical Results | Friable/Non Friable | Condition | Quantity |
|---|--|--|--|---|---|---|
| 16 | Wooden/brick door casings | Door casing caulk | 2% chrysotile | Non-Friable | Good | 4 EA |

Photo 8 – Wooden/brick door casings with caulk

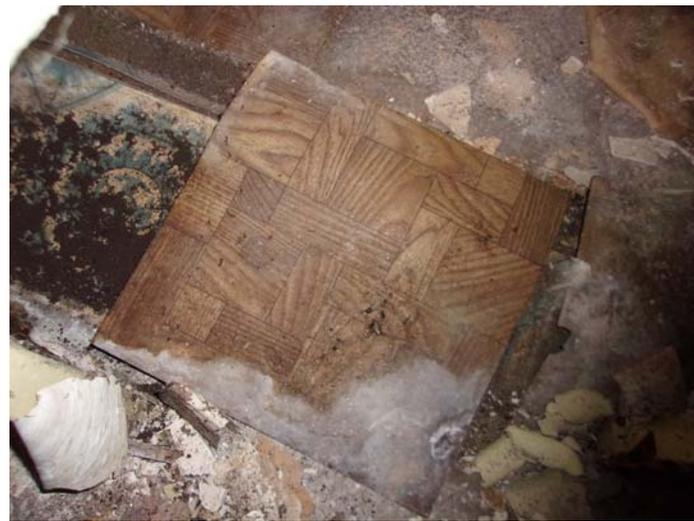
| Sample No. | Location | Sample Description | Analytical Results | Friable/Non Friable | Condition | Quantity |
|---|--|--|--|---|---|---|
| 24 | Dining room & kitchen patches (top layer) | 12" x 12" wooden pattern self-stick floor tile | PLM - NAD | Non-Friable | Good | 75 SF |

Photo 9 – 12" x 12" wooden pattern self-stick floor tile in the dining room & kitchen patches (top layer)

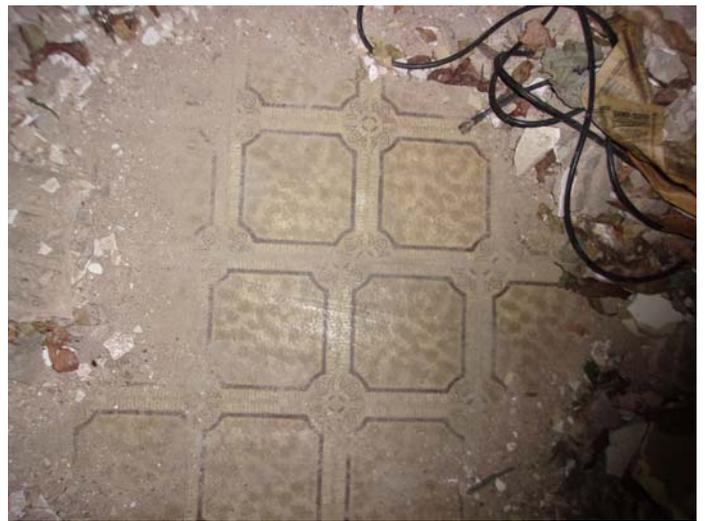
| Sample No. | Location | Sample Description | Analytical Results | Friable/Non Friable | Condition | Quantity |
|---|---|---|---|---|---|---|
| 27 | Kitchen - top layer | 12" x 12" beige multi-square pattern self-stick floor tile | PLM - NAD | Non-Friable | Good | 145 SF |

Photo 10 – 12" x 12" beige multi-square pattern self-stick floor tile in the kitchen (top layer)

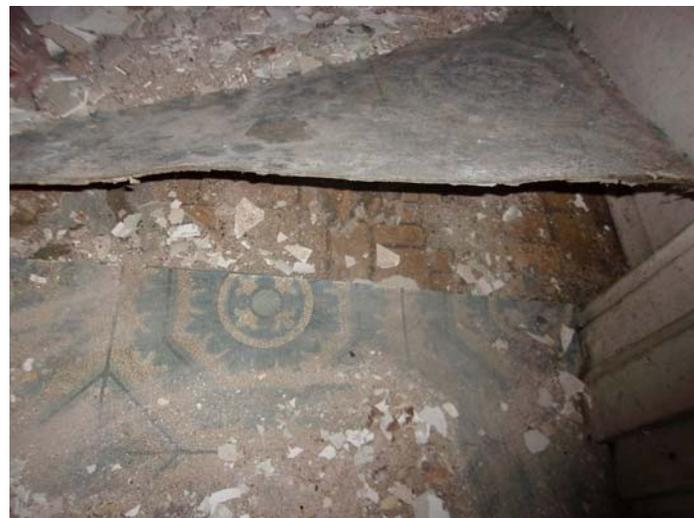
Photo 11 – Tan & blue pattern vinyl floor with no mastic in the dining room & kitchen (2<sup>nd</sup> layer) & pantry (top layer)

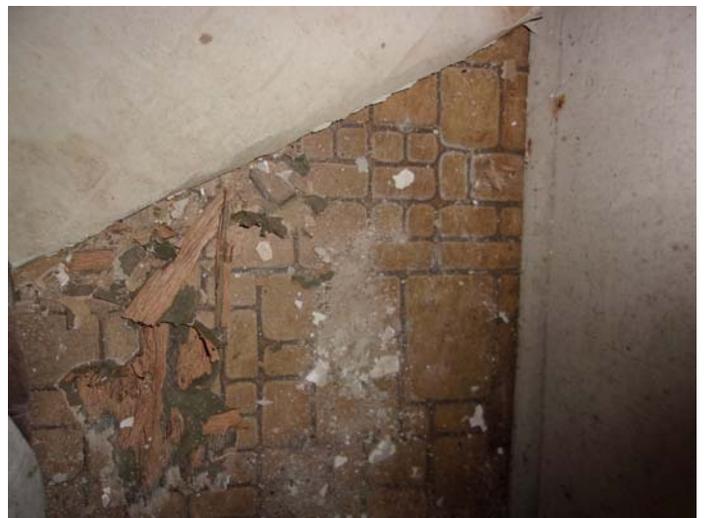
Photo 12 – Brown rectangle pattern vinyl floor with no mastic in the dining room & kitchen (3<sup>rd</sup> layer) & pantry (2<sup>nd</sup> layer)

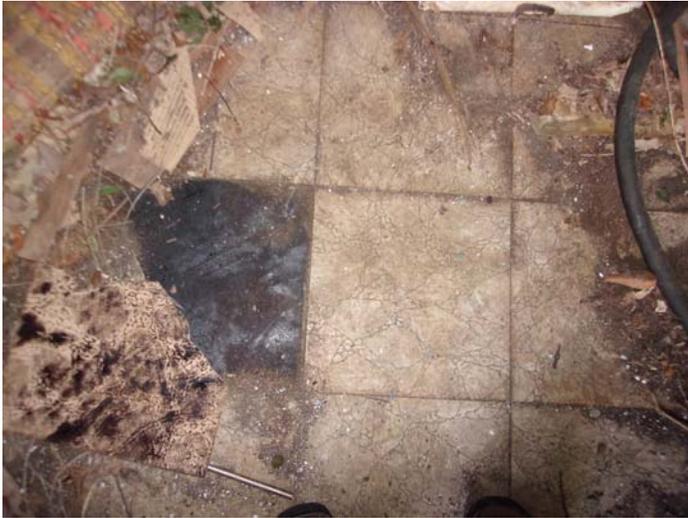
| Sample No. | Location | Sample Description | Analytical Results | Friable/Non Friable | Condition | Quantity |
|---|---|---|---|---|---|---|
| 36 | Throughout the finished portion of the basement | 12" x 12" tan rock fissure pattern floor tile & black mastic | PLM - 3% chry (floor tile) 6% (black mastic) | Non-Friable | Good | 425 SF |

Photo 13 – 12" x 12" tan rock fissure pattern floor tile & black mastic throughout the finished portion of the basement

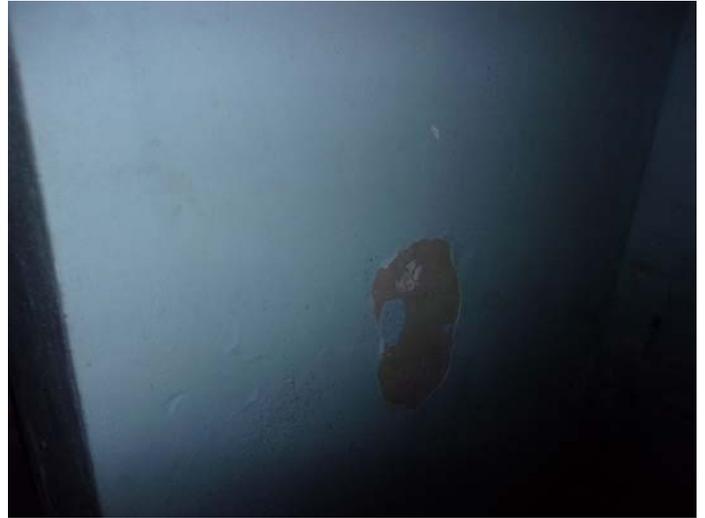
| Sample No. | Location | Sample Description | Analytical Results | Friable/Non Friable | Condition | Quantity |
|---|---|---|---|---|---|---|
| 39 | Throughout the finished portion of the basement | Skim coat over concrete walls | PLM - NAD | Friable | Good | 650 SF |

Photo 14 – Skim coat over concrete walls throughout the finished portion of the basement

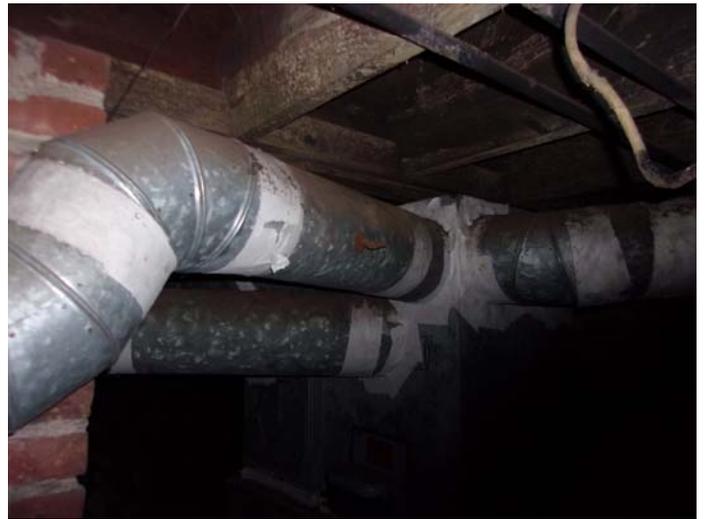
| Sample No. | Location | Sample Description | Analytical Results | Friable/Non Friable | Condition | Quantity |
|---|---|---|---|---|---|---|
| 45 | Throughout the finished portion of the basement & crawlspace | HVAC "A" tape on metal ducts | 60% chrysotile | Friable | Good | 50 SF |

Photo 16 – HVAC "A" tape on metal ducts throughout the finished & unfinished basement
