Asbestos & Lead Based Paint Assessment

City of Spartanburg
575 Farley Avenue
Spartanburg, South Carolina 29301

Project Number: 0119-09

May 19, 2019

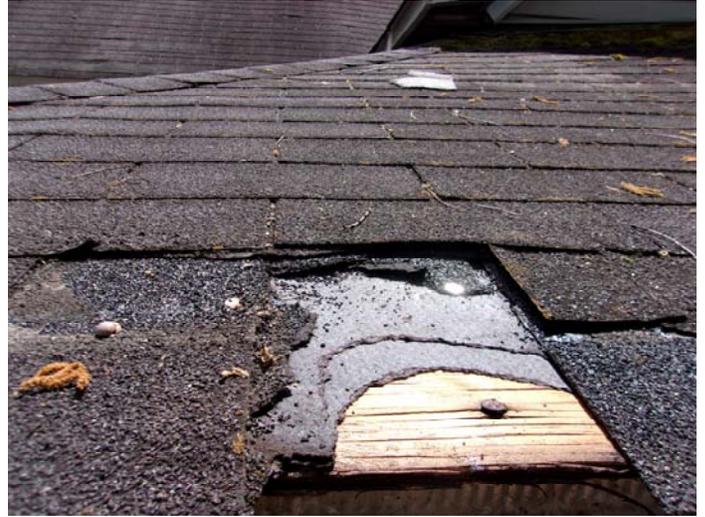
Photo 2 – Roof shingles with tar & felt on the roof

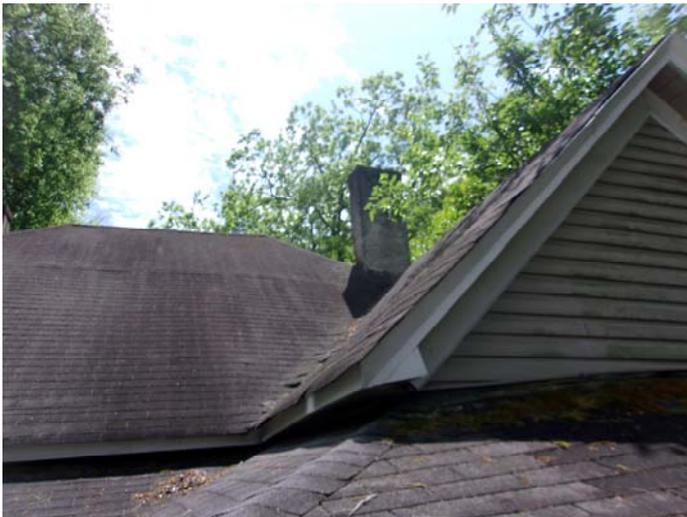
- Pitched wooden with roof shingles, tar & felt.
- Vinyl siding over styrofoam and wooden siding.
- Wooden windows with glazing.
- Wooden doors with no caulk.
- Portions of the roof and front porch are unstable, leaning and collapsing.
- 2 chimney's with tar – assumed positive as ACM.

Photo 3 – 1 chimney with tar – assumed positive

1. Abate the asbestos containing materials in the structure prior to renovation or demolition.
2. Follow applicable asbestos regulations during renovation or demolition of the structure. You should be aware that stringent requirements are imposed upon anyone renovating or demolishing a structure in which ACM will be disturbed. This work must be performed in accordance with OSHA asbestos regulations, 29 CFR 1910 & 1926, and NESHAP asbestos regulations 40 CFR 61, subpart M. South Carolina regulations require the accreditation of personnel who work in the asbestos field and notification and permitting fees for asbestos removal projects. There is a 10 working day notification period required prior to abatement of asbestos in a facility. Failure to take proper precautions and actions to protect human health and the environment can result in penalties, danger to personnel, and construction delays.

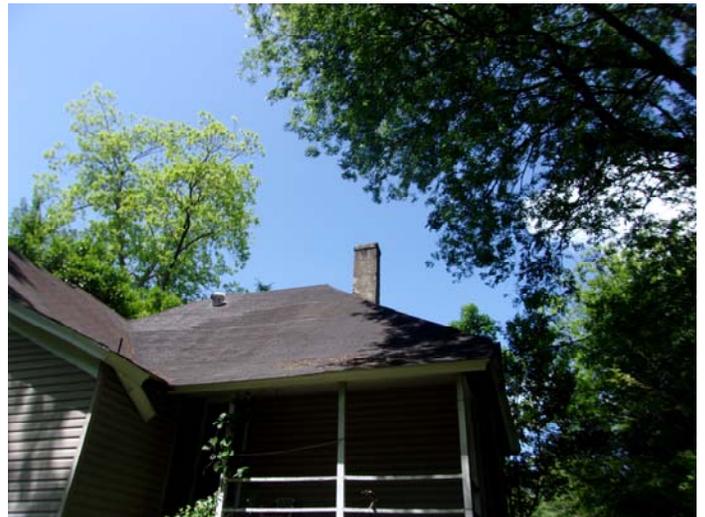
Photo 4 – 2nd chimney with tar – assumed positive

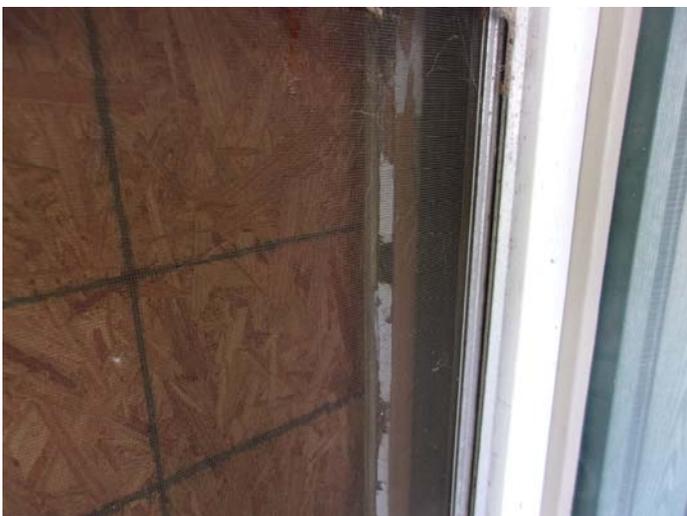
Photo 5 – Wooden window glazing

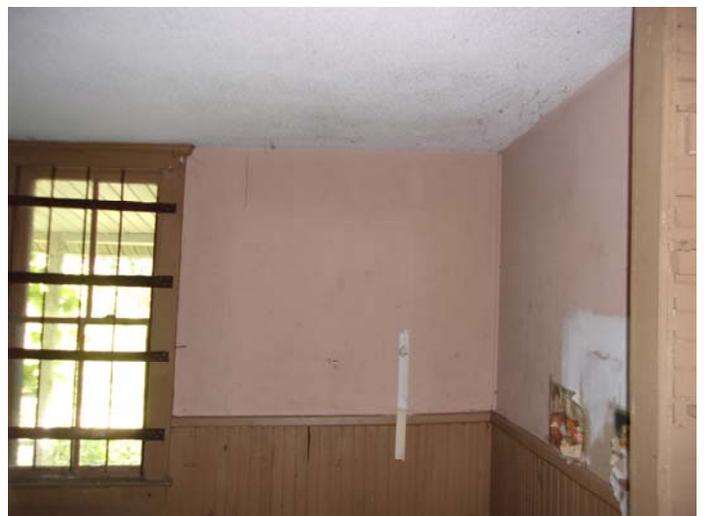
Photo 6 – Drywall with joint compound & tape throughout

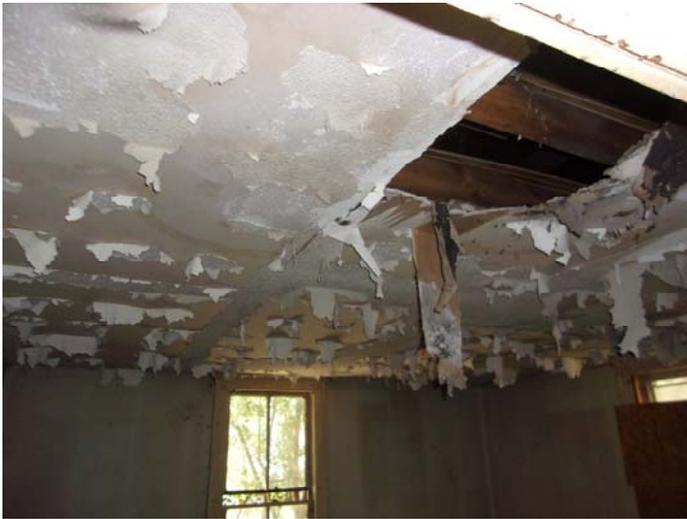
Photo 7 – Popcorn ceiling texture throughout

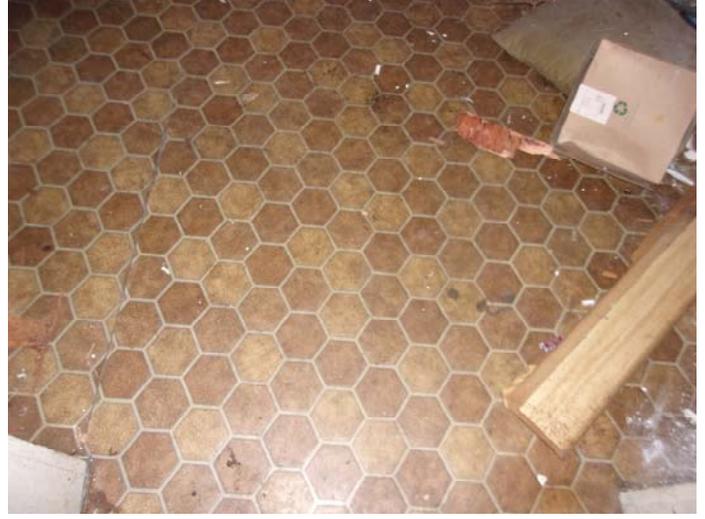
- Approximately 400 SF of brown hexagon pattern vinyl flooring in the front hallway, back right bedroom, kitchen & laundry room.
- Approximately 50 SF of tan paisley pattern vinyl floor in the bathroom.
- Approximately 12 LF of tar on 2 chimneys – assumed positive.
- The square footages referenced above should be field verified prior to bidding.

Photo 8 – Brown hexagon pattern vinyl floor & brown mastic in the front hallway, back right bedroom, kitchen & laundry room

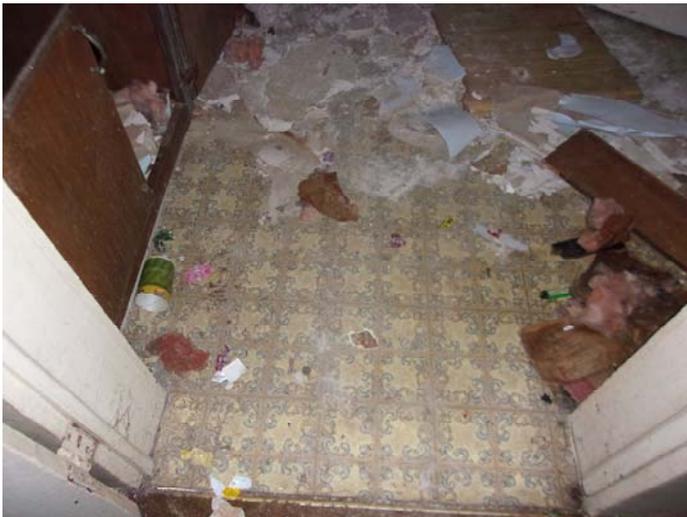
Photo 9 – Tan paisley pattern vinyl floor with adhesive in the bathroom

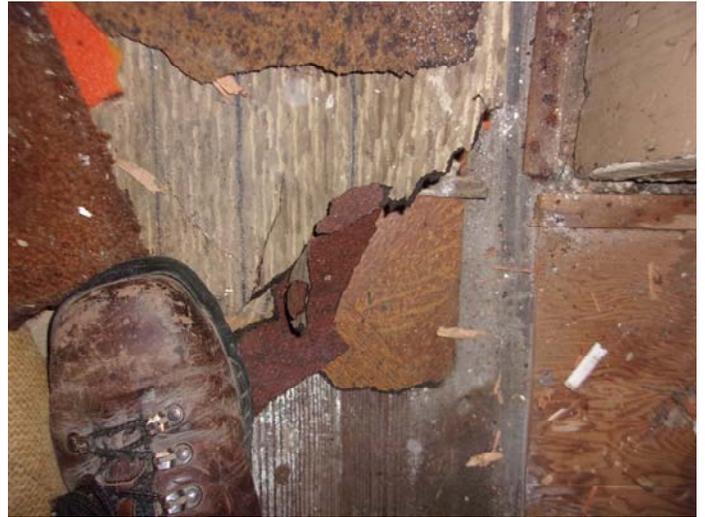
Photo 10 – Green streaked pattern over brown pattern vinyl floors with no mastics (2 layers) in the middle back room at the end of the front hallway (under carpet)

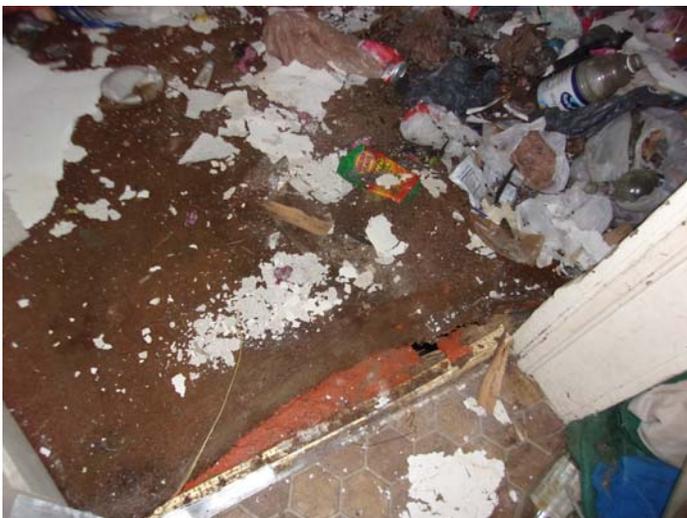
- Drywall with joint compound & tape throughout.
- Popcorn ceiling texture throughout.
- Multiple types & layers of vinyl flooring with & without mastics.
- Carpet over wooden floors.
- A portion of the floors in the front right bedroom are unstable and collapsing.

Photo 11 – Unstable & collapsing flooring in the front right bedroom
