## **Asbestos & Lead Based Paint Assessment**

City of Spartanburg  
686 Saxon Avenue  
Spartanburg, South Carolina 29301

Project Number: 0118-14

December 28, 2018

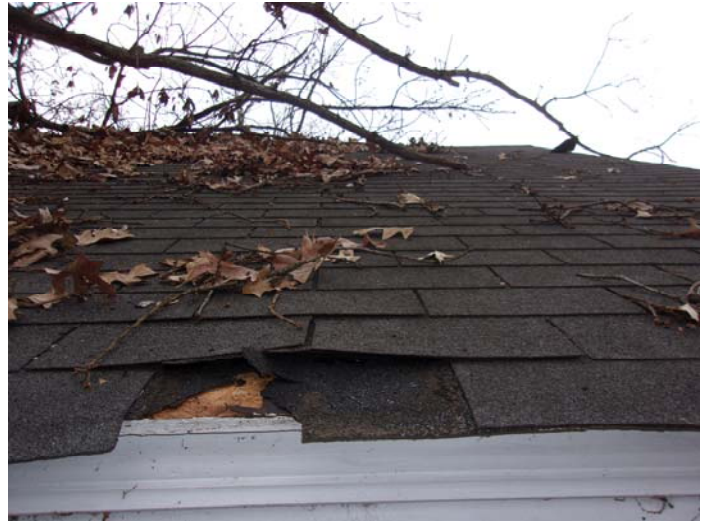
Photo 2 – Roof shingles & felt

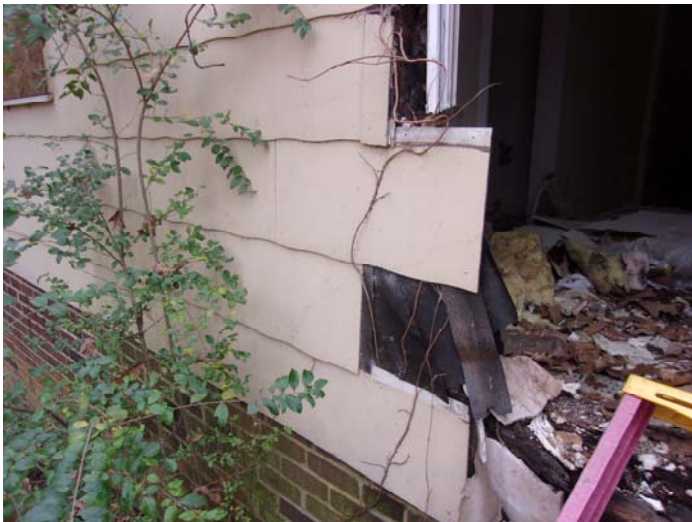
Photo 3 – Cement board siding with felt paper over wood

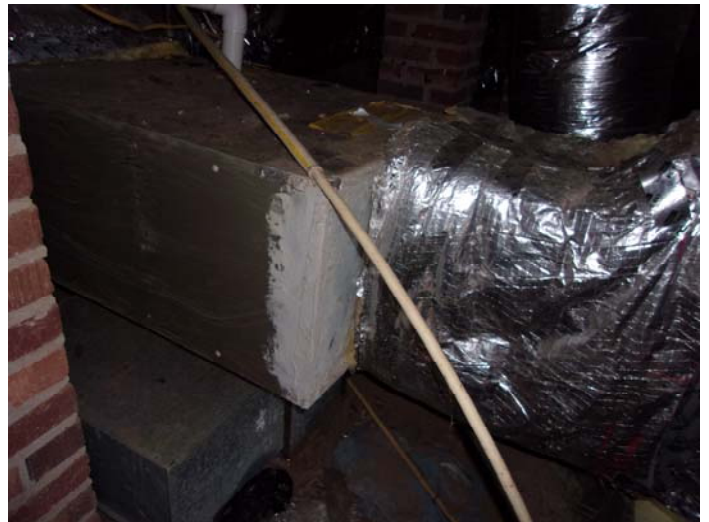
Photo 4 – Beige HVAC mastic in crawlspace & on HVAC

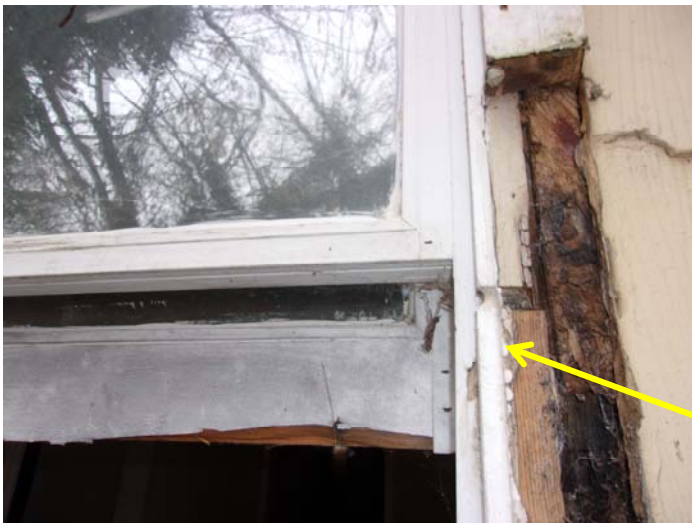
Photo 5 – Bid wooden windows with caulk

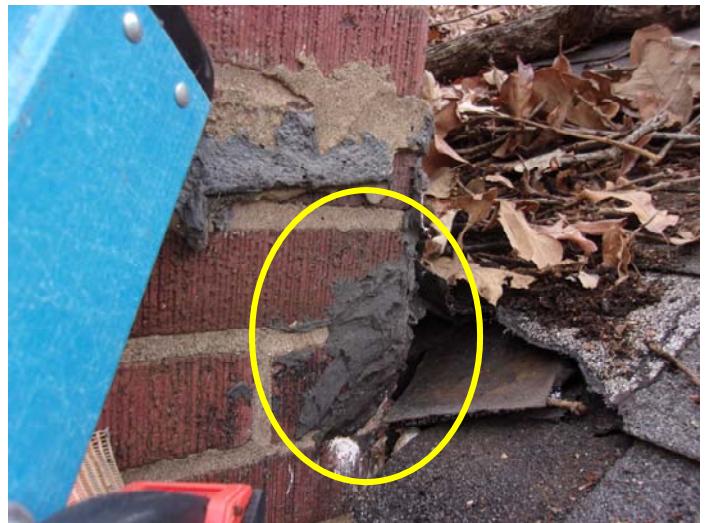
Photo 6 – Tar on 2 chimneys

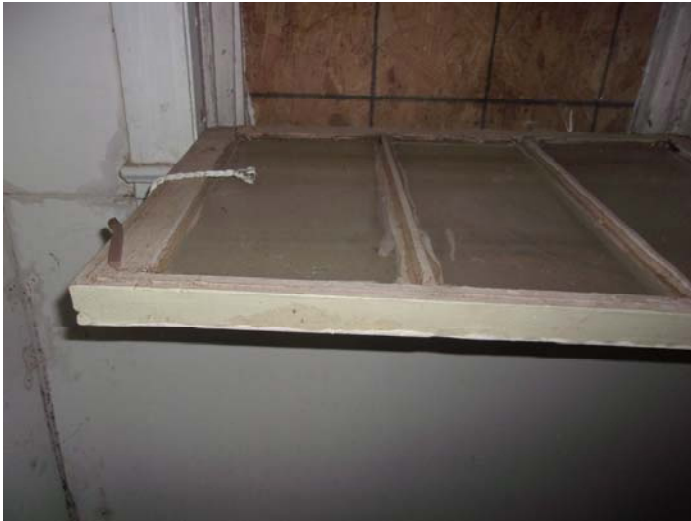
Photo 7 – Window glazing on small wooden bathroom window

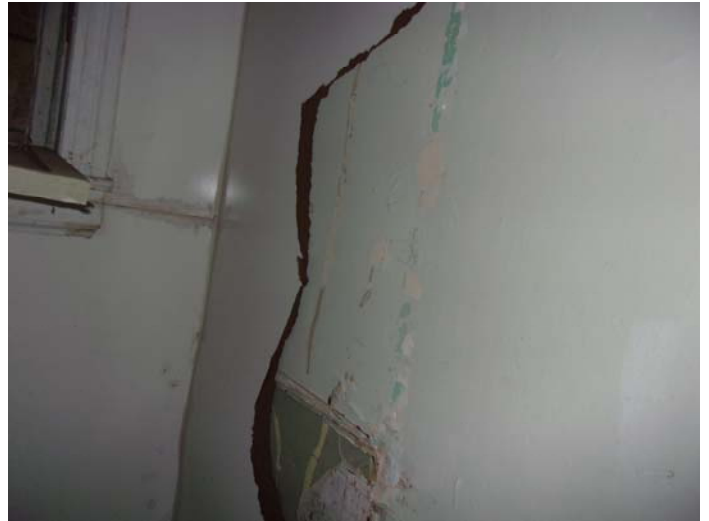
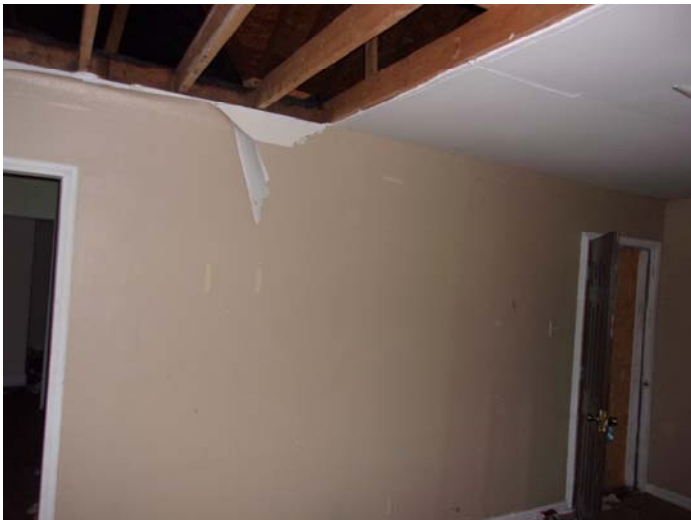
Photo 8 – Drywall with joint compound & tape throughout

Photo 9 – Drywall with joint compound & tape throughout

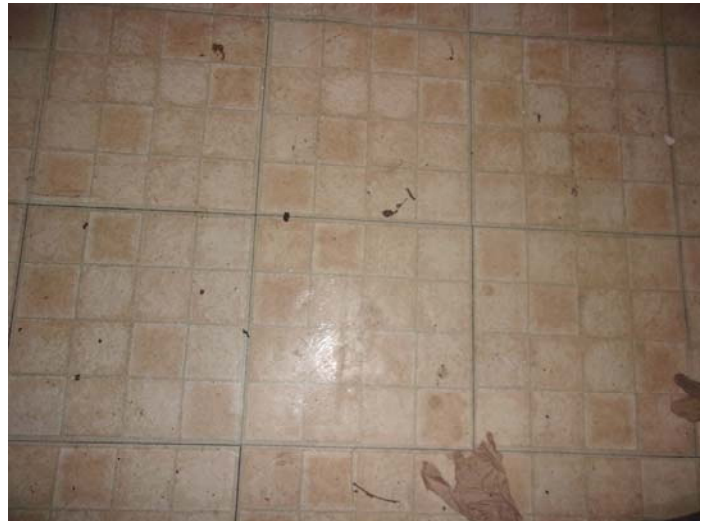
Photo 10 – Tan multi-square pattern self-stick floor tile & tan adhesive in the kitchen (top layer) & bathroom (2<sup>nd</sup> layer)

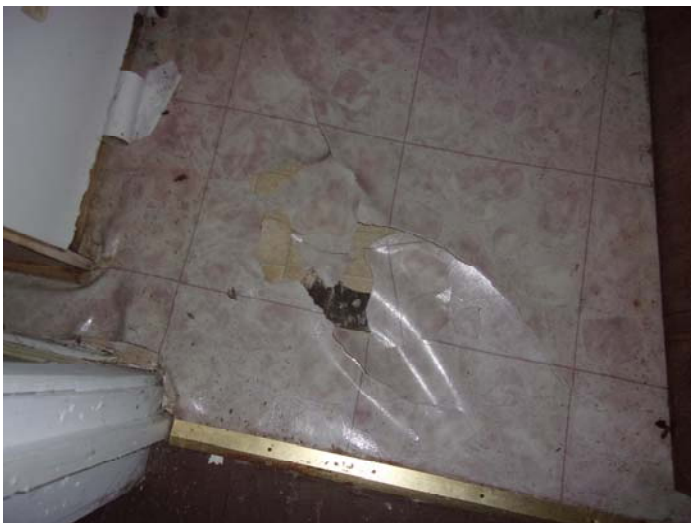
Photo 11 – Grey stone pattern vinyl floor with no mastic in the bathroom (top layer)

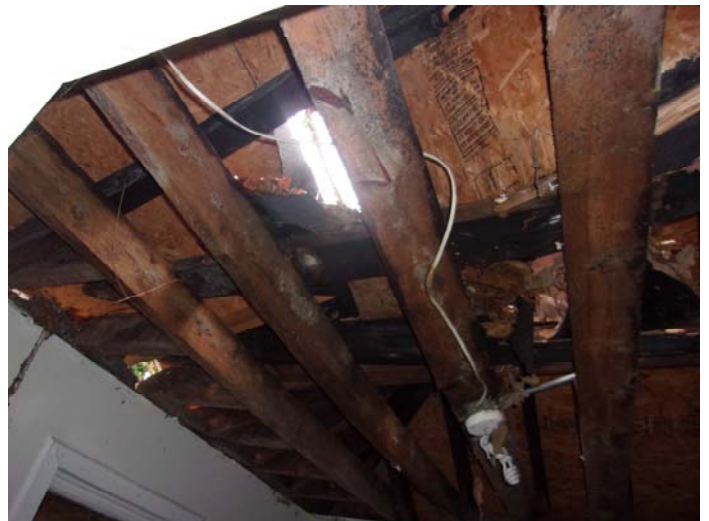
Photo 12 – View of collapsed roof and ceiling

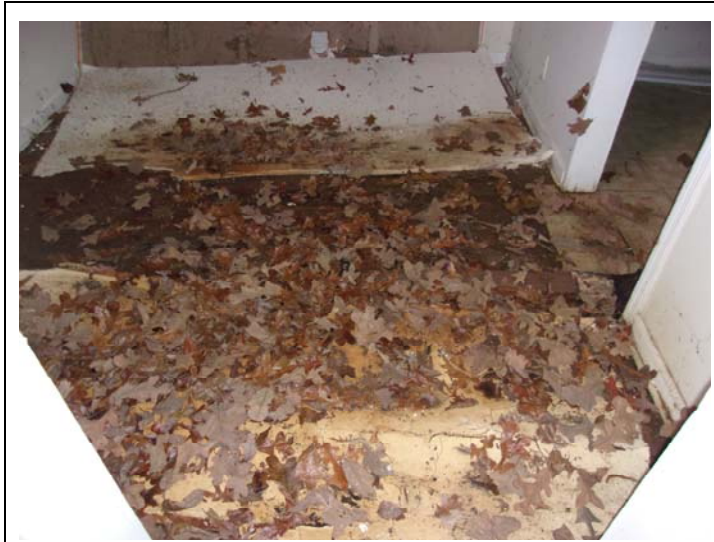
Photo 13 – View of unstable flooring
