Asbestos & Lead Based Paint Assessment

City of Spartanburg
583 Carpenter Street
Spartanburg, South Carolina 29301

Project Number: 0119-09

May 8, 2019

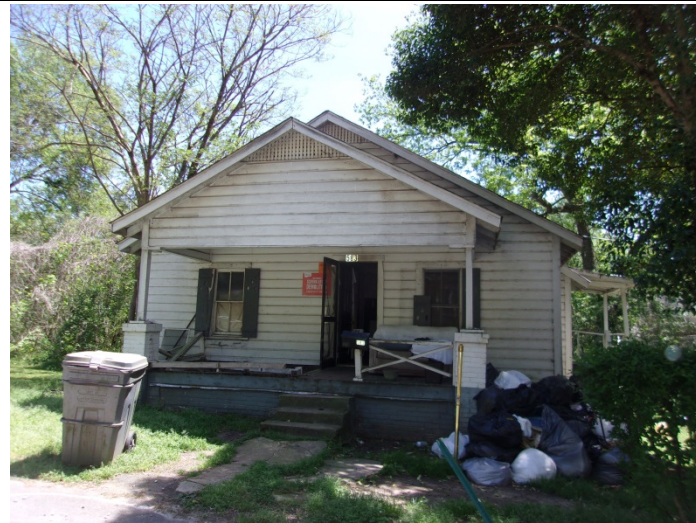
Photo 1 – 583 Carpenter Street in Spartanburg, South Carolina

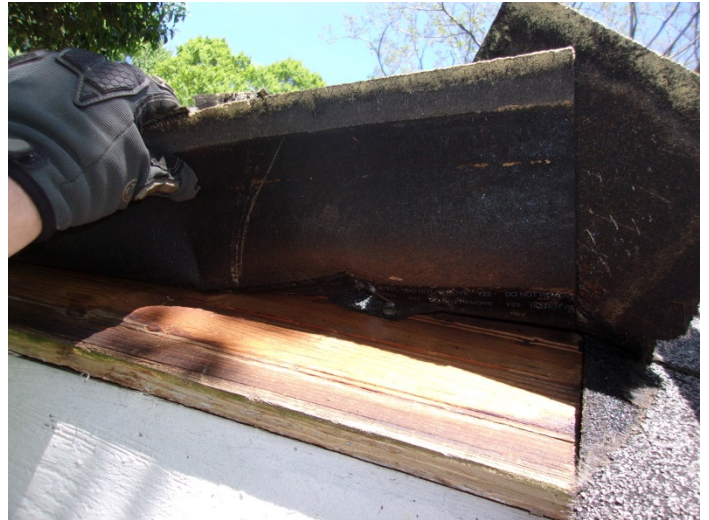
Photo 2 – Roof shingles with tar and no felt

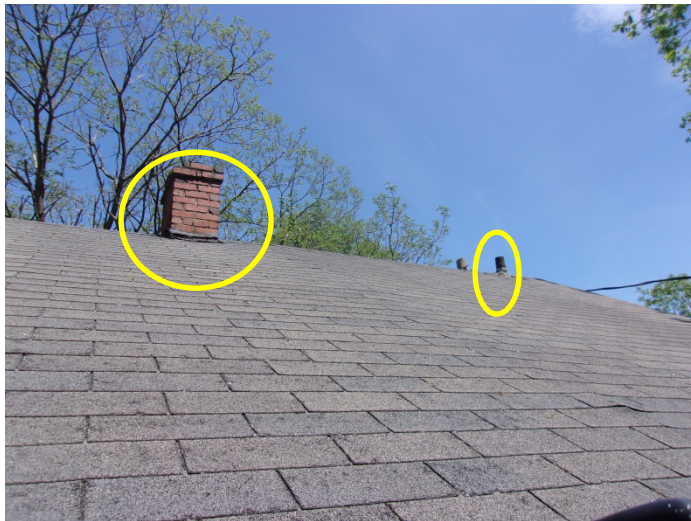
- Approximately 500 SF drywall walls and ceiling in the back right bedroom.
- Approximately 6 LF of tar on 1 chimney and 6 LF of tar along the roof line at the side porch – assumed positive.
- Approximately 1 SF of tar on 1 vent pipe on the roof – assumed positive.

Photo 3 – Tar on chimney & vent pipe – assumed positive

1. Abate the asbestos containing materials in the structure prior to renovation or demolition.

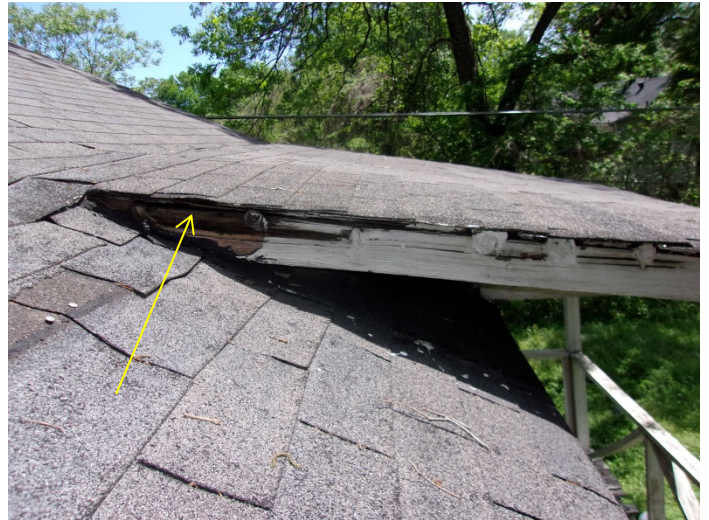
Photo 4 – Tar on roof line at the side porch – assumed positive

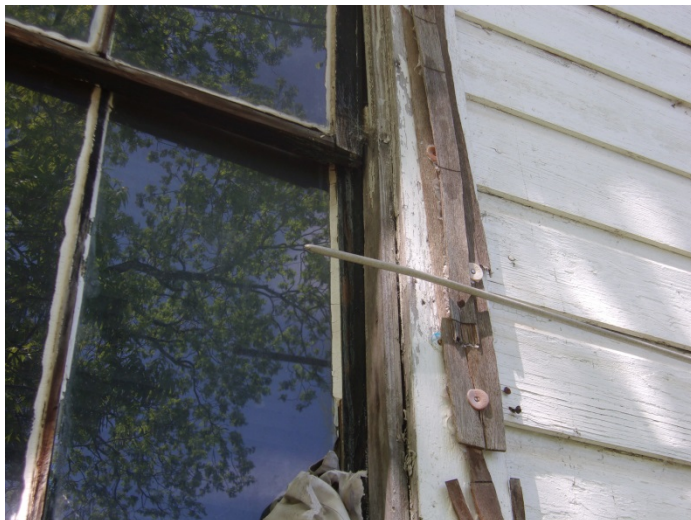
Photo 5 – Wooden window glazing

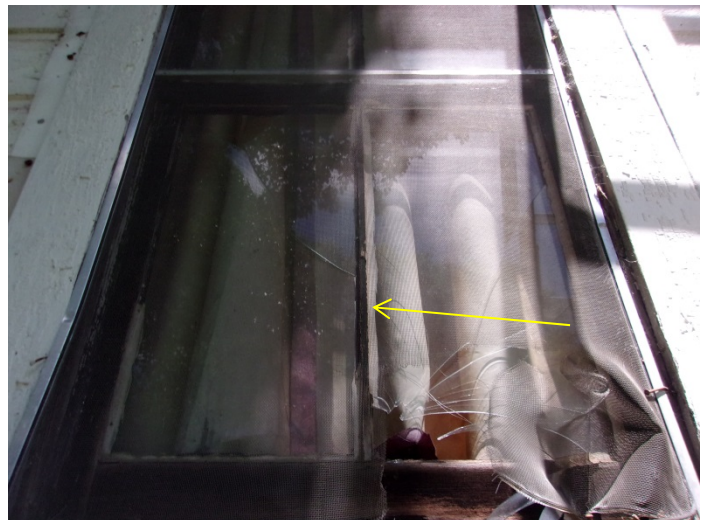
Photo 6 – Wooden window caulk

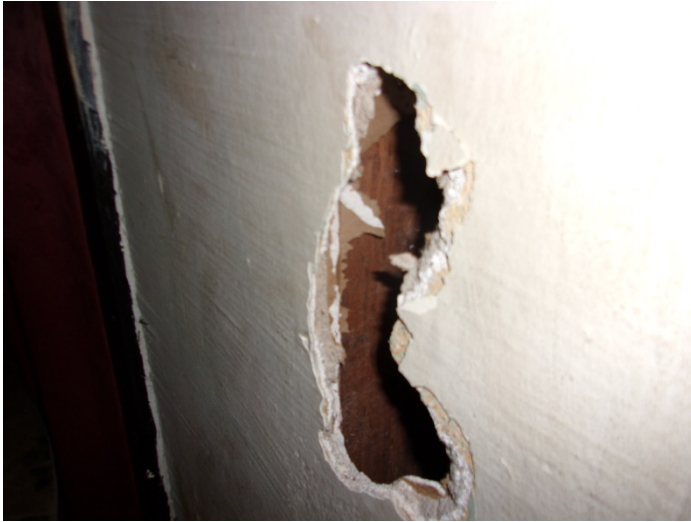
Photo 7 – Plaster with finish over unfinished drywall in the living room & front left bedroom walls

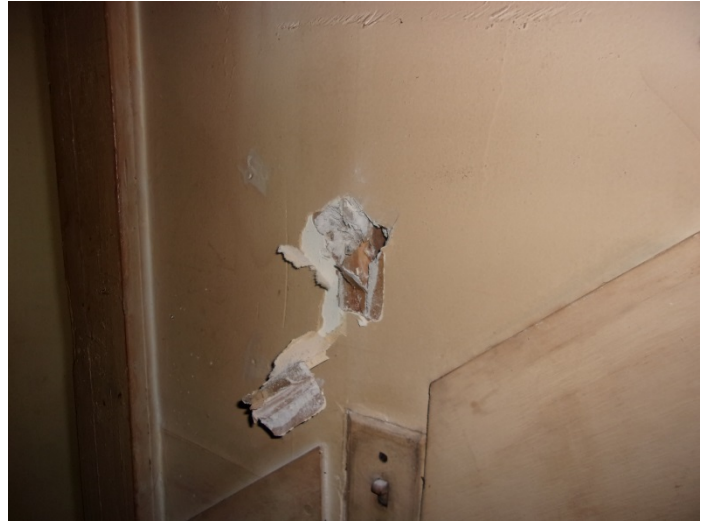
Photo 8 – Drywall with joint compound & tape in the back right bedroom walls & ceiling

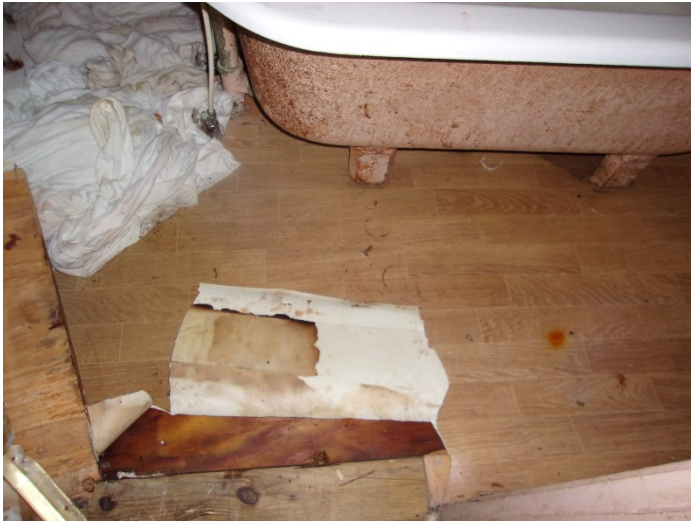
Photo 9 – Brown wooden plank pattern vinyl floor with no mastic in the bathroom

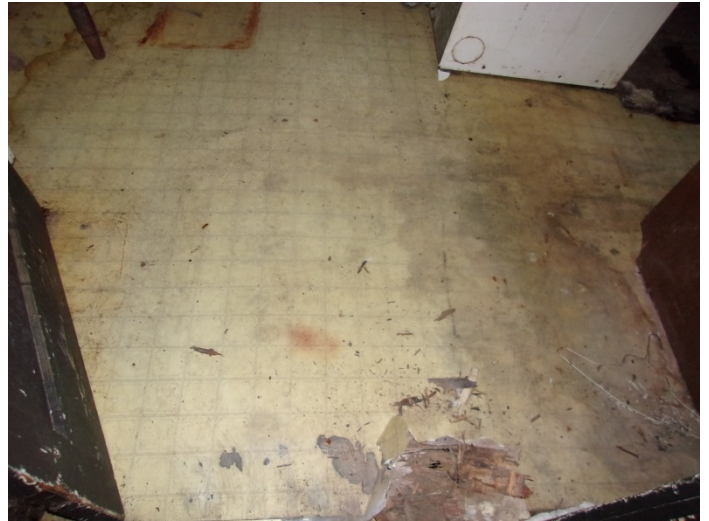
Photo 10 – Tan small square pattern vinyl floor with no mastic in the kitchen

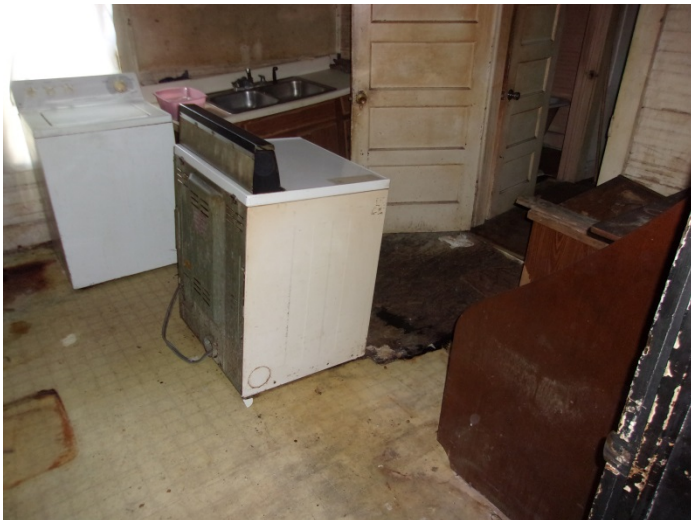
Photo 11 – The flooring is unstable and collapsed in some areas of the kitchen

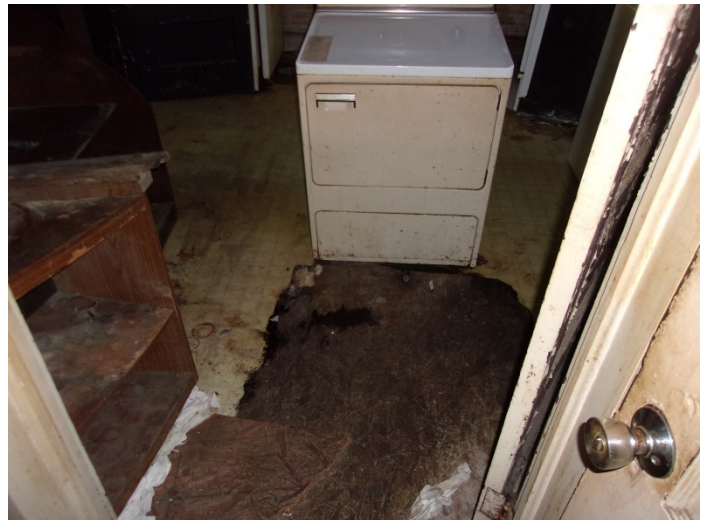
Photo 12 – The flooring is unstable and collapsed in some areas of the kitchen
