Asbestos & Lead Based Paint Assessment

City of Spartanburg
276 Fremont Avenue
Spartanburg, South Carolina 29303

Project Number: 0119-09

March 15, 2019

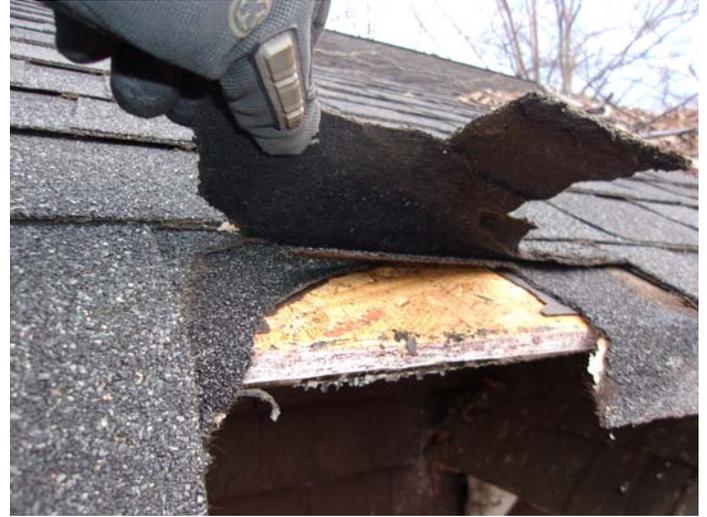
Photo 2 – Roof shingles & felt on the main roof

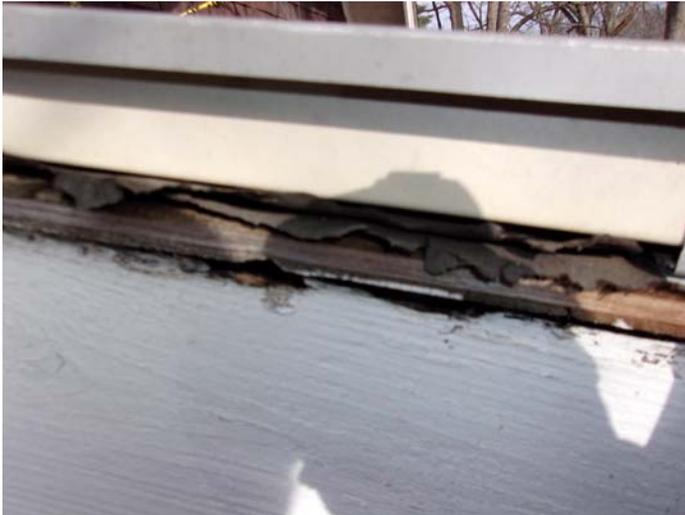
Photo 3 – Felt under metal side porch roof

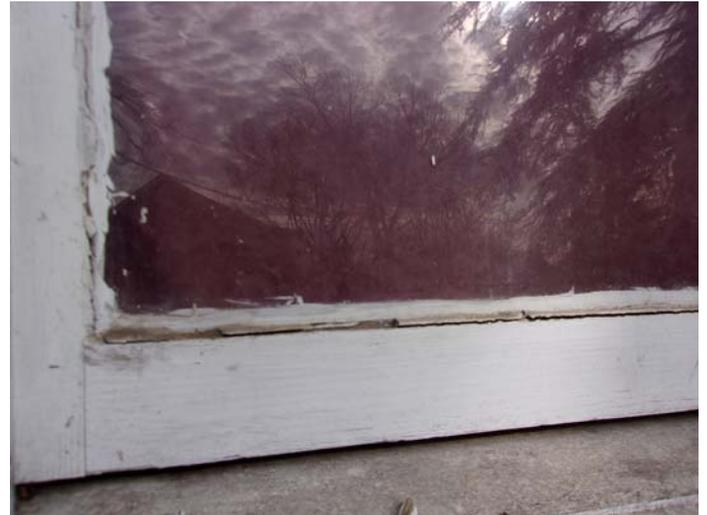
Photo 4 – Wooden window glazing

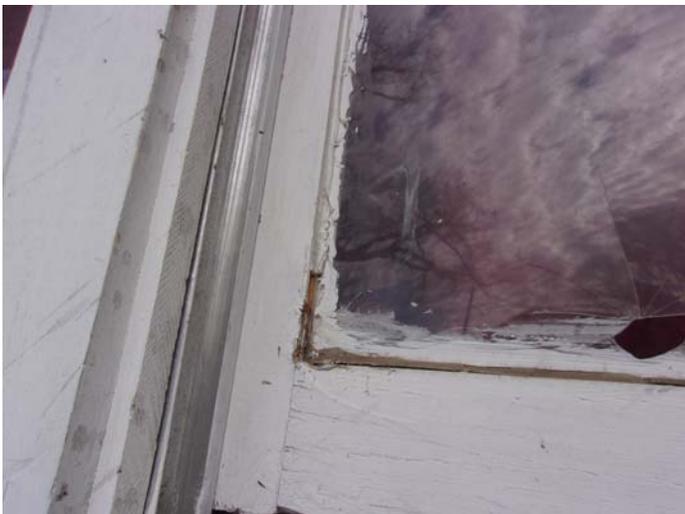
Photo 5 – Wooden window caulk

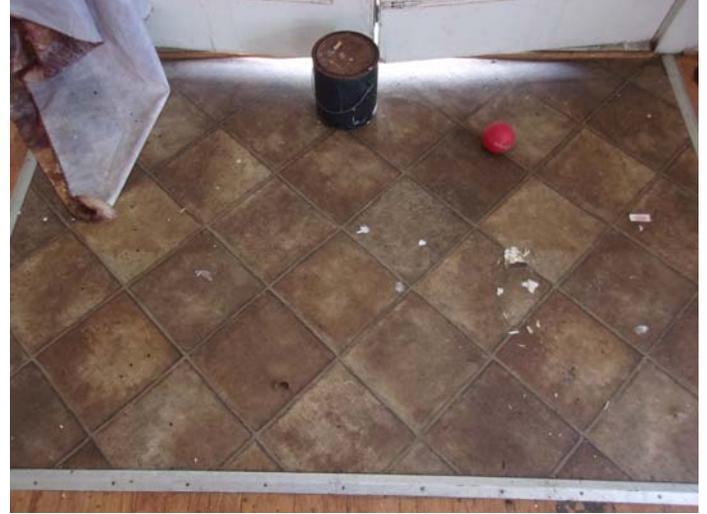
Photo 6 – Brown square vinyl floor & mastic in the Living room entries, kitchen & bathroom – top layer

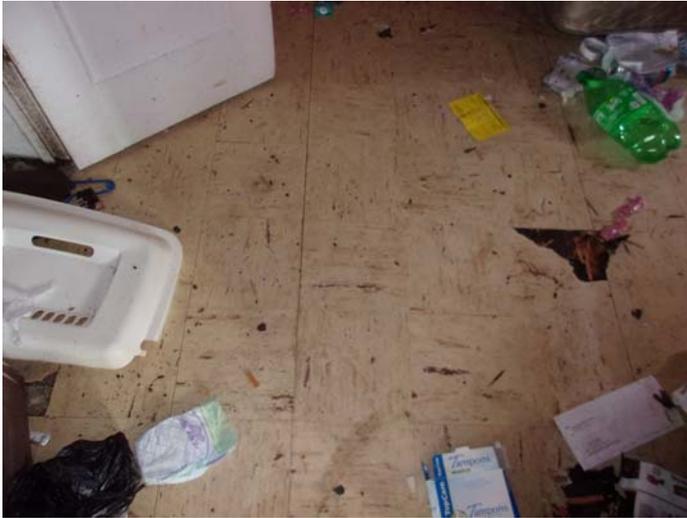
Photo 7 – Beige streaked 9" x 9" floor tile with mastic & felt in the right bedroom (single layer); living room & dining room under wood – 2nd layer

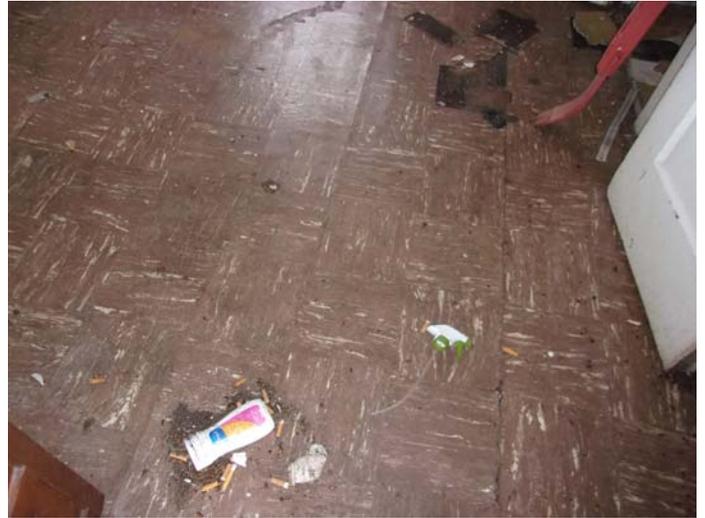
Photo 8 – Brown 9" x 9" floor tile with mastic & felt in the left bedroom (single layer); living room & dining room under wood – 2nd layer

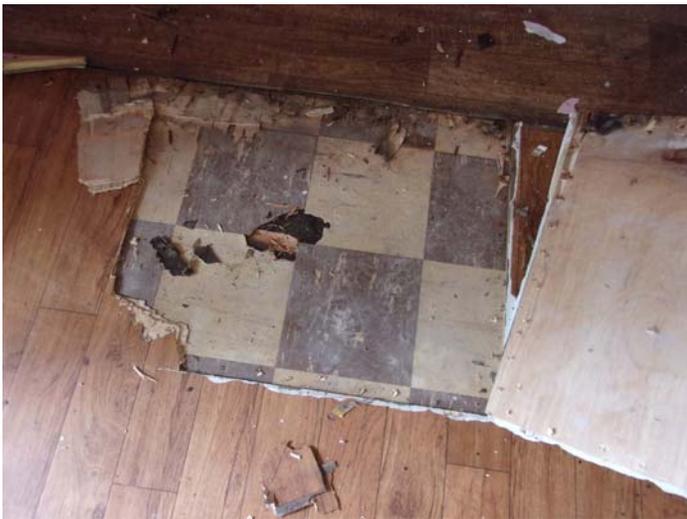
Photo 9 – Beige streaked & brown 9" x 9" floor tile in the living room & dining room under wood – 2nd layer

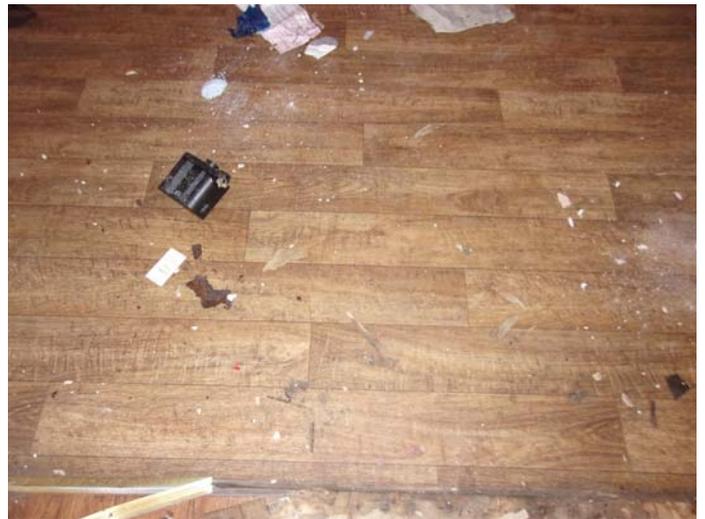
Photo 10 – Wood grain vinyl floor & no mastic in the dining room – top layer

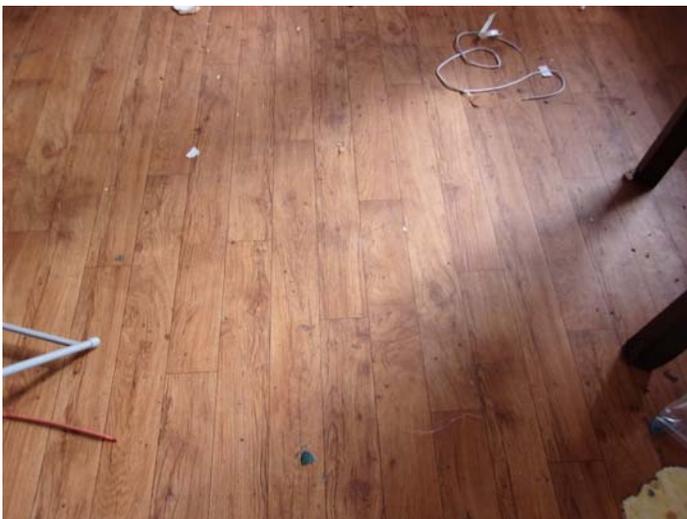
Photo 11 – Light wood grain vinyl floor & mastic in the living room – top layer

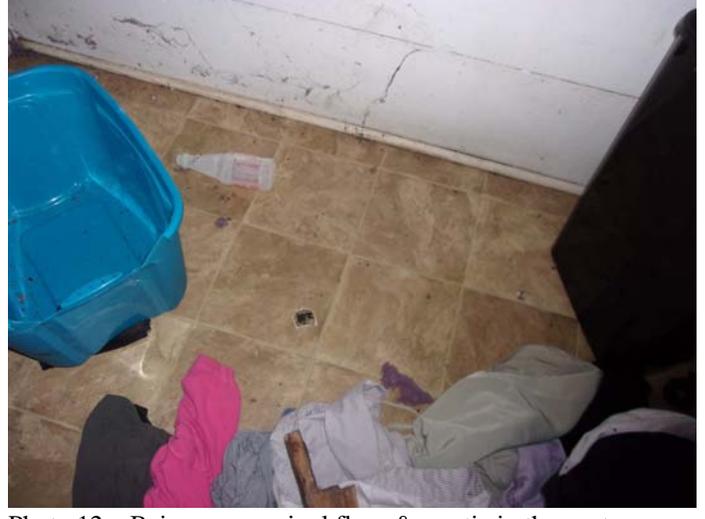
Photo 12 – Beige square vinyl floor & mastic in the pantry over 12" x 12" wood grain pattern self-stick floor tile with mastic over 3rd layer of vinyl floor with no mastic in the pantry

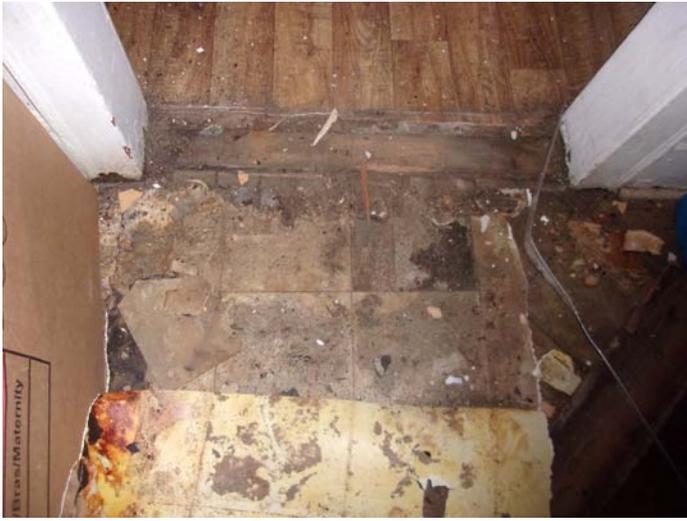
Photo 13 – 9" x 9" floor tile with backing, felt & mastics in the kitchen – 2nd layer

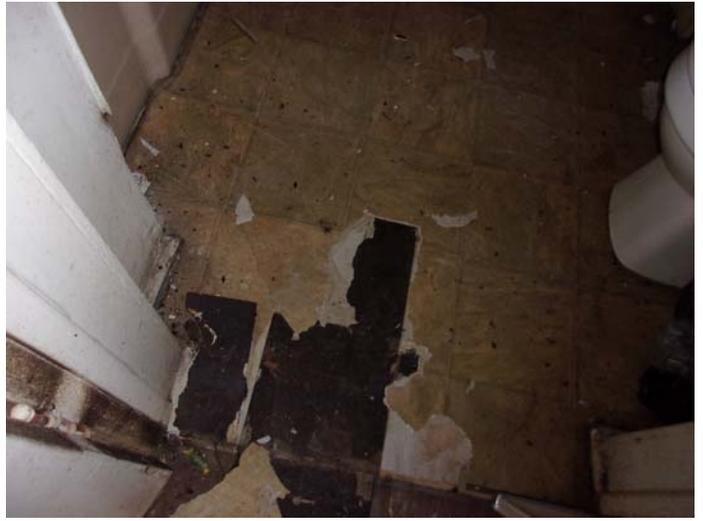
Photo 14 – 9" x 9" floor tile with backing, felt & mastics in the bathroom – 2nd layer

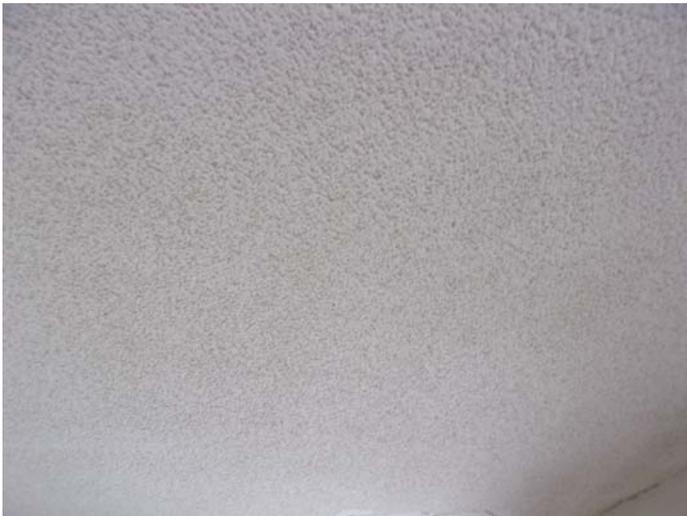
Photo 15 – Ceiling texture in the living room, dining room & left bedroom

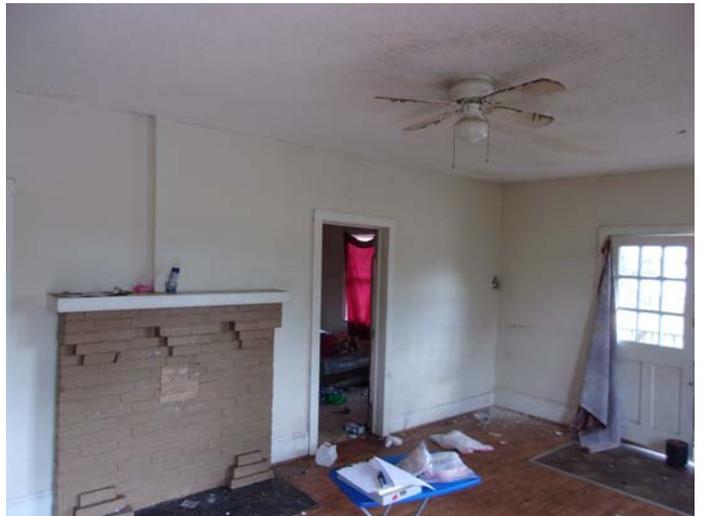
Photo 16 – Drywall with joint compound & tape in the living room walls & ceiling

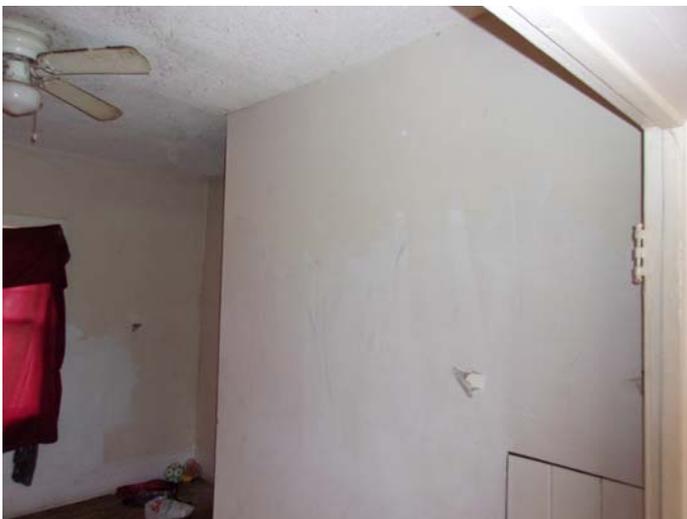
Photo 17 – Drywall with joint compound & tape in the dining room stairway wall & ceiling

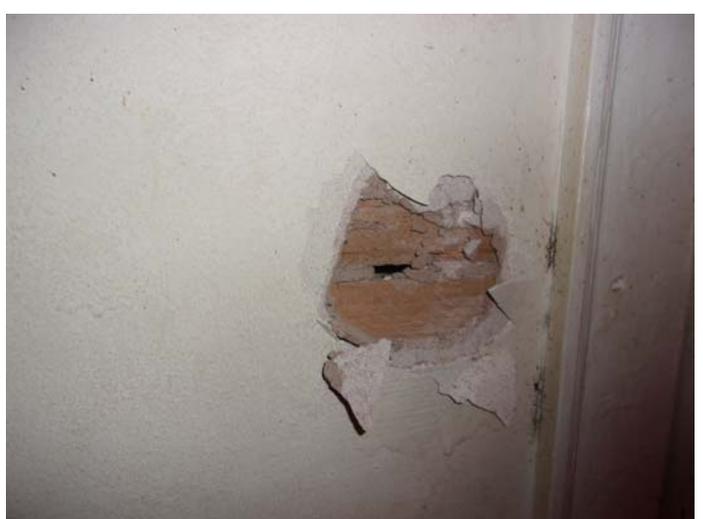
Photo 18 – Plaster with finish throughout
