## **LEAD-BASED PAINT INSPECTION REPORT**

**108 Hudson Street  
Spartanburg, South Carolina**

**ASSESSMENT DATE: June 25, 2020**

**Crossroads Environmental, LLC  
1258 Boiling Springs Road  
Spartanburg, South Carolina 29303  
(864) 541-8736  
CRE Project # 19113-IL**

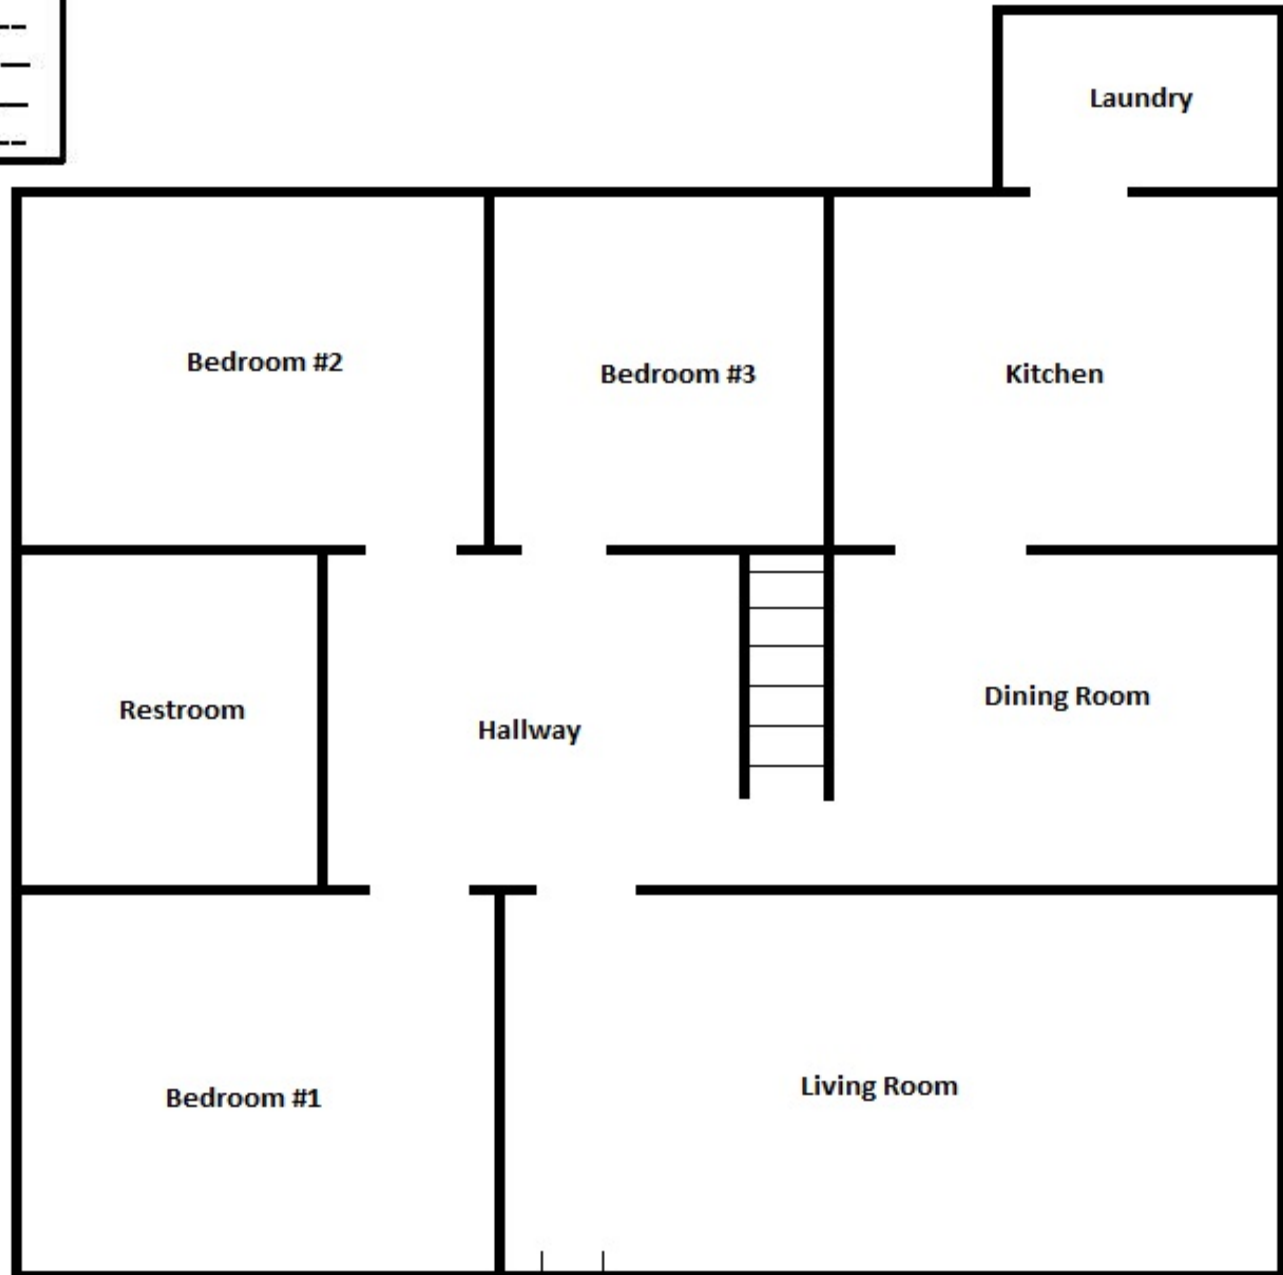
**SAMPLE LOCATION SKETCH**

**Lead-based paint was detected on off-white wood door components within the kitchen and bedroom #2; white wood door components of the laundry room; off-white wood window components of the dining room, restroom, and kitchen; navy wood window sash of the restroom; the green wood column of the laundry room; green wood ceiling of the laundry room; white wood window components of the porch; yellow wood porch header; white wood porch support beams; and white wood porch overhang.**

Of the lead components identified within the structure only the wood door of the kitchen, wood windows of the dining room, and various wood components within the laundry room are in poor condition (peeling/cracking).

Lead-based paint on exterior window components, columns, and overhangs have minor cracking and peeling. The paint on exterior is in overall good condition, but does have minor peeling.

- 1) Paint stabilization of all wooden components that cannot be feasibly wrapped (roof overhang, supports, columns, rails, etc.).
- 2) Replacement of doors painted with lead-based paint.
- 3) Replacement of windows. Note: If it is not financially feasible to replace the windows, they should remain closed since, with the exception of the bathroom window and kitchen window, the lead is on the exterior and window troughs.
- 4) Professional wrapping of all window casing by means of vinyl, aluminum, etc. if entire components cannot feasibly be replaced.
