EXHIBIT "C"

COMPREHENSIVE ASBESTOS SURVEYS

COMPREHENSIVE ASBESTOS SURVEY

**COMMERCIAL BUILDING
1240 YEAMANS HALL ROAD
HANAHAN, SC 29410**

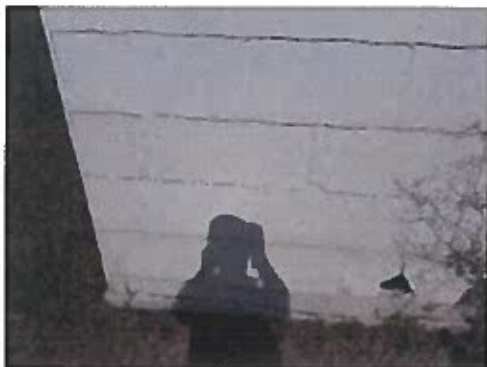
HOMOGENEOUS AREA 01
TRANSITE PANEL

Asbestos fibers were identified in the Transite Siding. Approximately 1,440 square feet is present and in good condition. This material is considered Category II – Non Friable Asbestos and is located on the exterior walls.

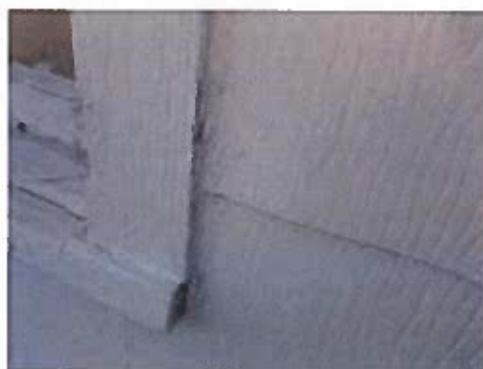
HOMOGENEOUS AREA 04
EXTERIOR CAULK

Asbestos fibers were identified in the Exterior Caulk. Approximately 80 square feet is present and in good condition. This material is considered Category I – Non Friable Asbestos and is located around exterior windows and doors.

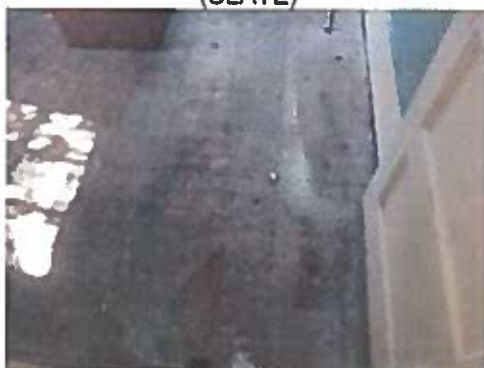
**HOMOGENEOUS AREAS 13, 14
9" FLOOR TILE (BEIGE)
MASTIC (BLACK)**

Asbestos fibers were identified in the 9” Floor Tile (beige) and the associated Floor Tile Mastic (black). Approximately 236 square feet of each is present and is significantly damaged condition. These materials are considered RACM – Friable Asbestos and are located in Bedroom B (layer 2) and Bedroom A (layer 1). **Note: Floor Tiles may be located under cabinets, appliance and non-load bearing walls.**

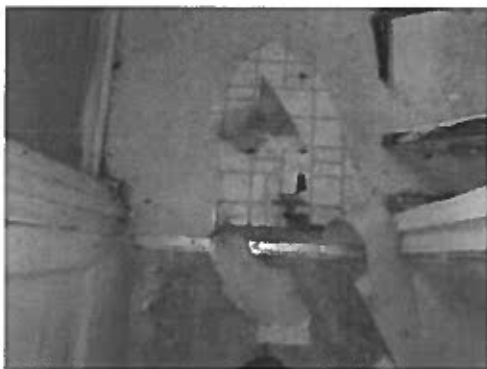
**HOMOGENEOUS AREAS 15, 16
VINYL SHEET FLOORING
(YELLOW SQUARES)
MASTIC (BLACK)**

Asbestos fibers were identified in the Vinyl Sheet Flooring (yellow squares) and the associated Floor Tile Mastic (black). Approximately 50 square feet is present and in good condition. The materials are considered RACM – Friable Asbestos and is located in Bathroom A. (layer 2) **Note: Floor Tiles may be located under cabinets, appliance and non-load bearing walls.**

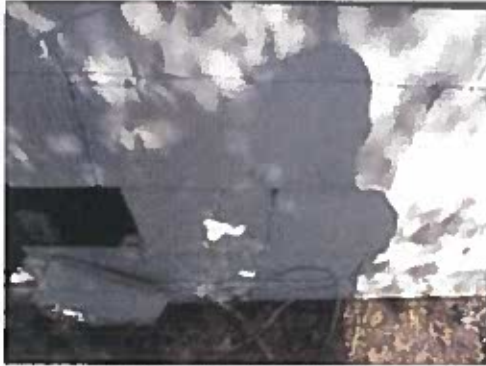
**HOMOGENEOUS AREA 01
TRANSITE SIDING**

Asbestos fibers were identified in the Transite Siding. Approximately 1,788 square feet is present and in good condition. This material is considered Category II – Non Friable Asbestos and is located on the exterior.
