## **Asbestos & Lead Based Paint Assessment**

City of Spartanburg  
620 Humphrey Street  
Spartanburg, South Carolina

Project Number: 0815-163

January 24, 2018

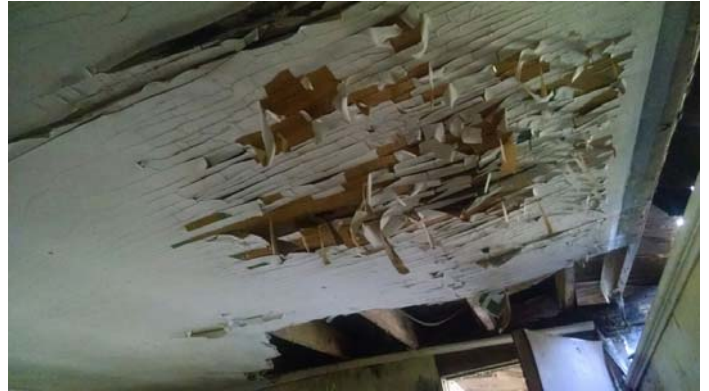
Photo 2 – Drywall, joint compound and tape throughout the ceilings and a quarter of the walls.

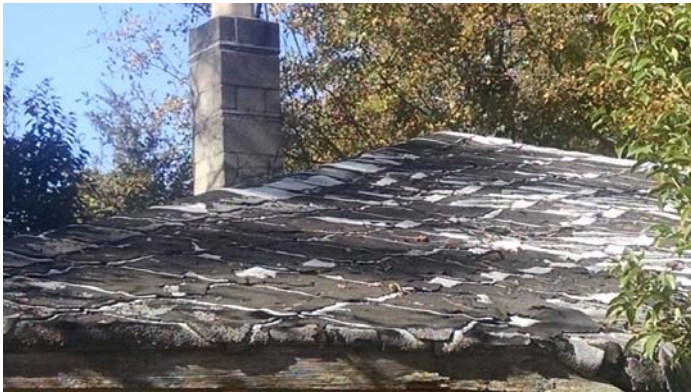
Photo 3 – Roofing shingles and felt on the roof and chimney mastic assumed positive.

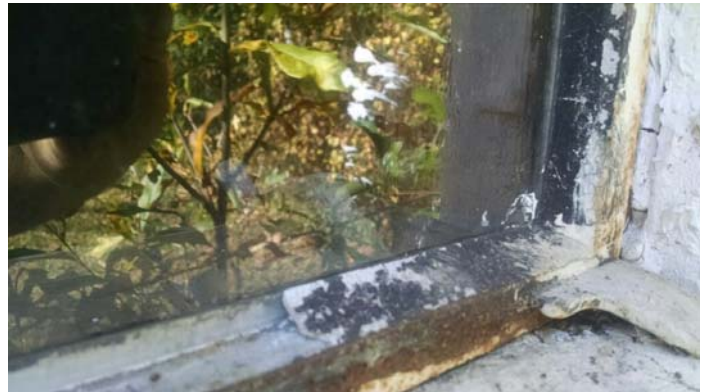
Photo 4 – Exterior windows with glazing.

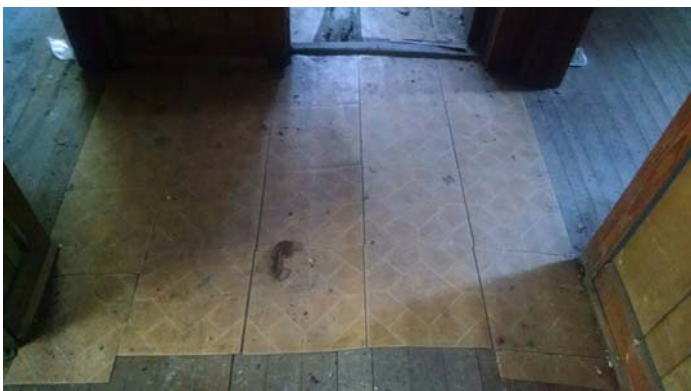
Photo 5 – 12"x12" tan pattern self-stick flooring in the bathroom.

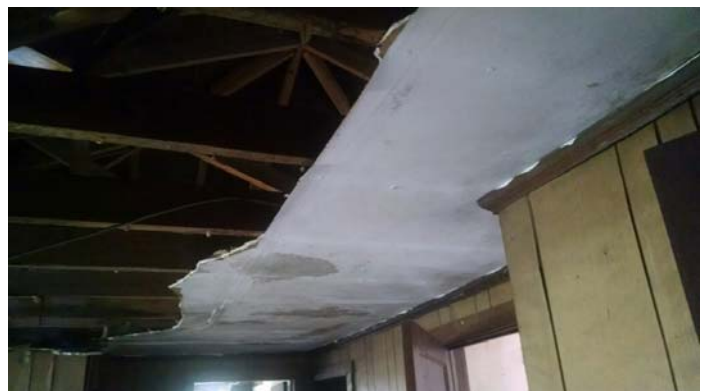
Apex performed a full assessment within the residence at the time of the survey. During the assessment, a portion of the floors and ceilings were observed to be collapsed. Due to safety concerns during abatement activities and the feasibility of building a full containment due to the

condition of the residence, Apex recommends that the building be demolished in place and materials be treated and disposed of as friable ACM.

Photo 6 – Typical view of collapsed drywall, joint compound and tape ceiling.

1. Demolish the residence with ACM in place and dispose of the waste stream as friable Regulated Asbestos Containing Materials (RACM) and delivered to an asbestos approved hazardous waste landfill for disposal.

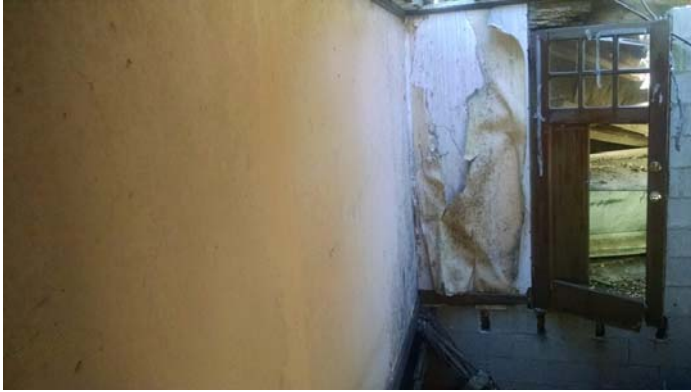
Photo 7 – Drywall with joint compound and tape throughout the ceilings and a quarter of the walls.

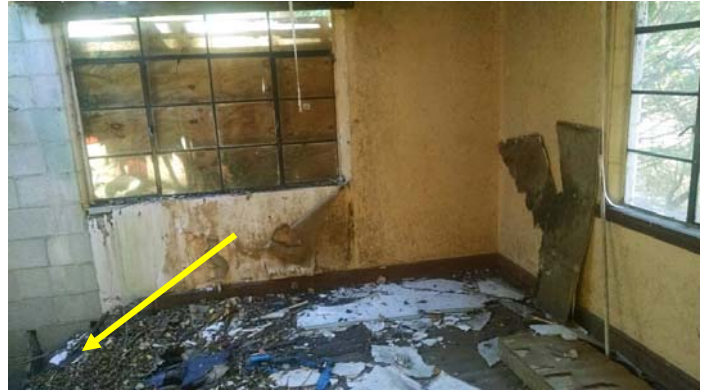
Photo 8 – Typical view of collapsed and unstable flooring in portions of the residence.

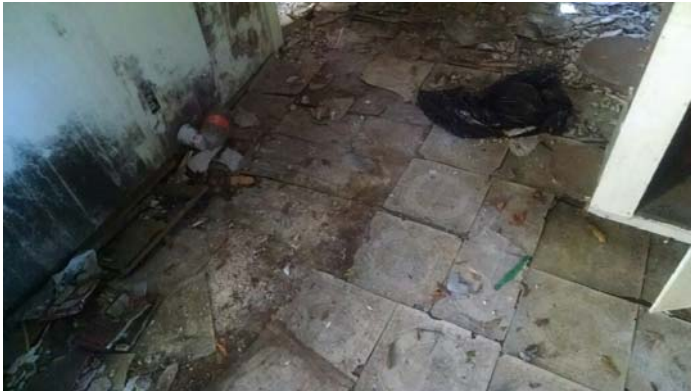
Photo 9 – 12"x12" beige flooring over grey roll vinyl with mastic in the kitchen.

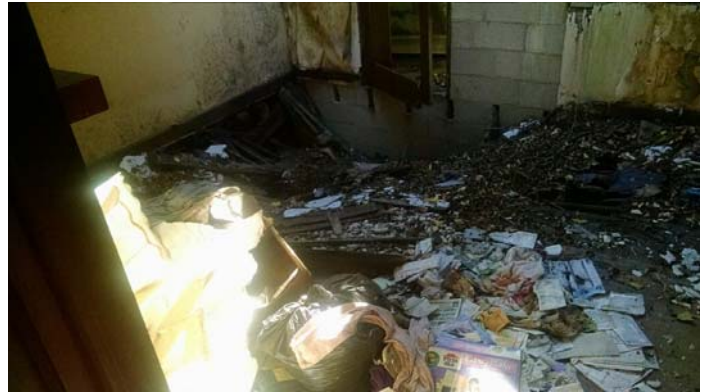
Photo 10 – Typical view of collapsed and unstable flooring in portions of the residence.
