## **Asbestos & Lead Based Paint Assessment**

City of Spartanburg  
255 Caulder Circle  
Spartanburg, South Carolina

Project Number: 0815-163

January 1, 2017

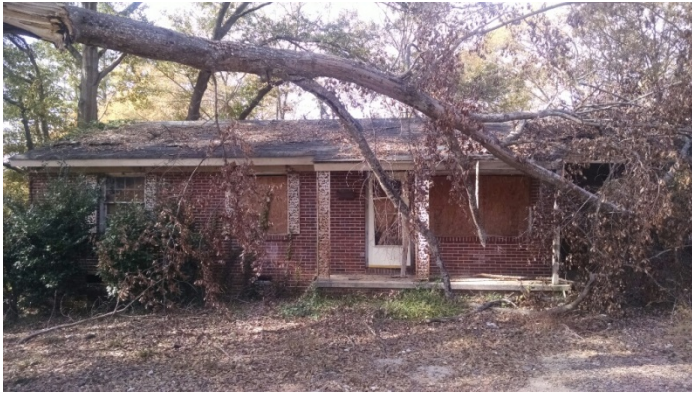
Photo 1 -- 255 Caulder Circle in Spartanburg, SC.

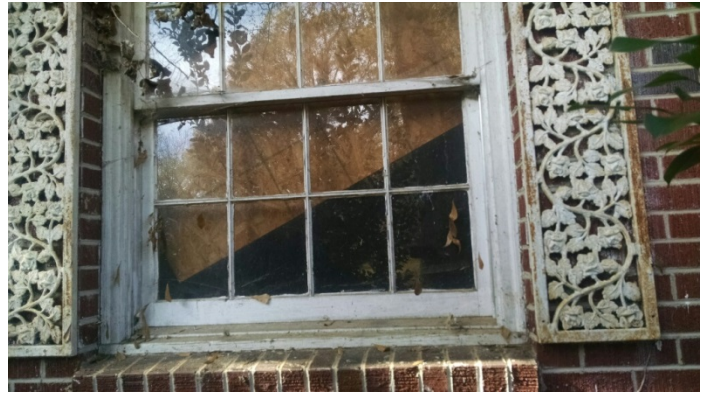
Photo 2 – Windows with glazing.

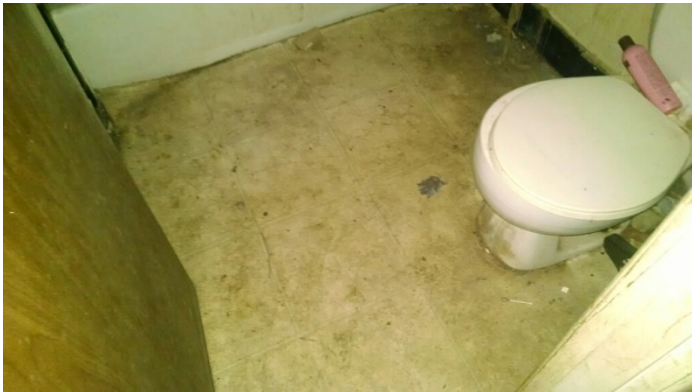
Photo 3 – Yellow vinyl floor in hall bathroom.

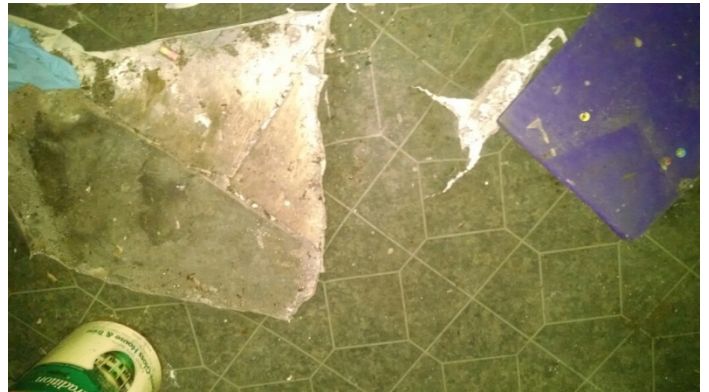
Photo 4 – Roll vinyl and felt in kitchen.

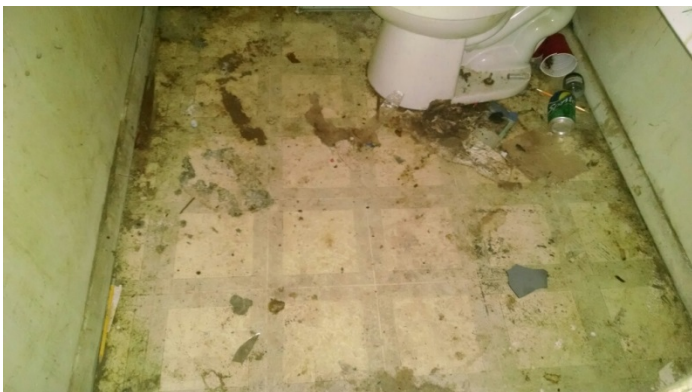
Photo 5 – Tan vinyl floor in master bathroom.

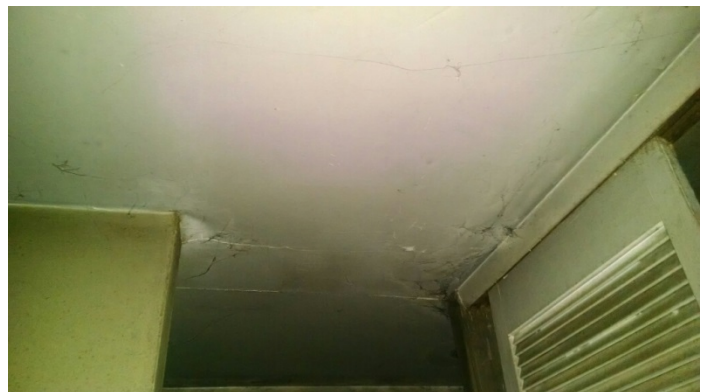
- Approximately 2,650 SF of drywall with joint compound throughout the walls and ceilings.

Photo 5 – Drywall with joint compound.

1. Abate the asbestos containing materials in the structure prior to renovation or demolition.
2. Follow applicable asbestos regulations during renovation or demolition of the structure. You should be aware that stringent requirements are imposed upon anyone renovating or demolishing a structure in which ACM will be disturbed. This work must be performed in accordance with OSHA asbestos regulations, 29 CFR 1910 & 1926, and NESHAP asbestos regulations 40 CFR 61, subpart M. South Carolina regulations require the accreditation of personnel who work in the asbestos field and notification and permitting fees for asbestos removal projects. There is a 10 working day notification period required prior to abatement of asbestos in a facility. Failure to take proper precautions and actions to protect human health and the environment can result in penalties, danger to personnel, and construction delays.
