Asbestos & Lead Based Paint Assessment

City of Spartanburg
1009 Carson Avenue
Spartanburg, South Carolina

Project Number: 0815-163

January 4, 2017

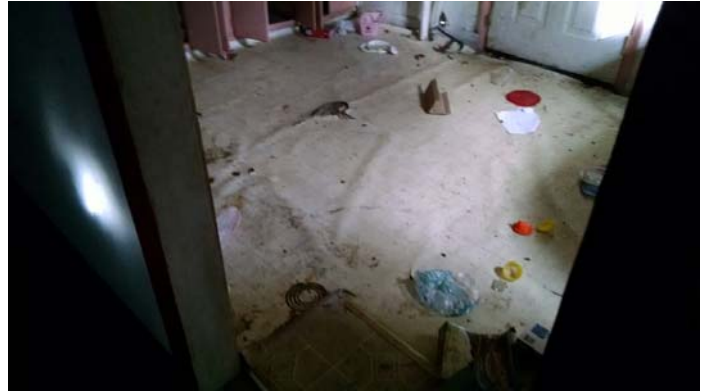
Photo 2 – Yellow roll vinyl, white roll vinyl, bright yellow roll vinyl, and tan roll vinyl in the kitchen.

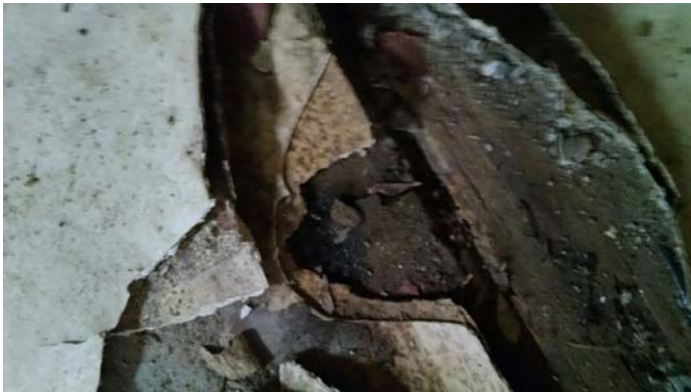
Photo 3 – Yellow roll vinyl, white roll vinyl, bright yellow roll vinyl, and tan roll vinyl in the kitchen.

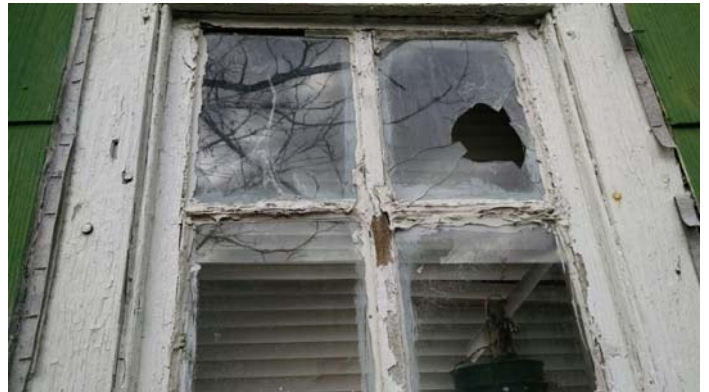
Photo 4 – Window caulk and glazing on exterior windows.

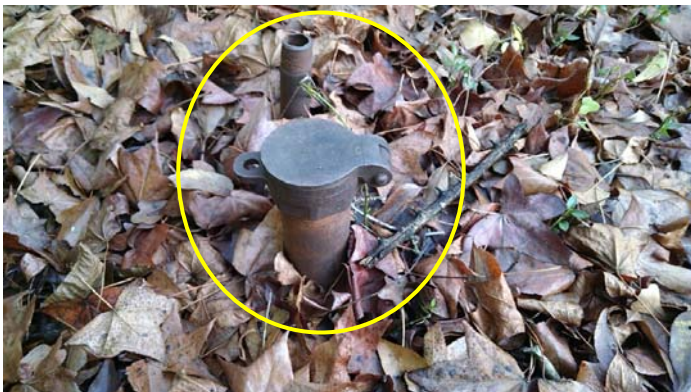
Photo 5 – Underground fuel-tank stub-out in side yard.

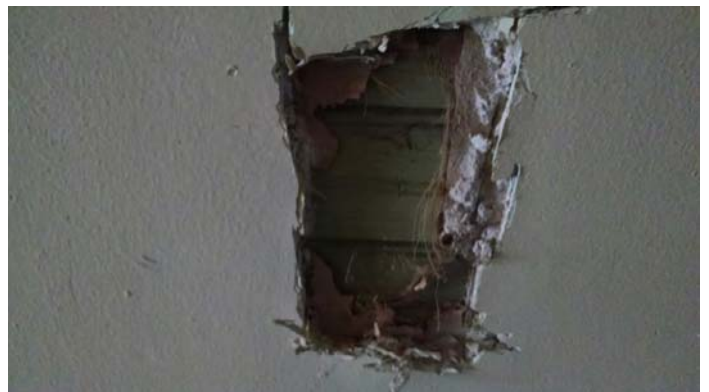
- Approximately 4,200 SF of drywall system throughout.
- Approximately 4,900 SF of exterior cement board siding.

Photo 6 – Drywall walls with joint compound.

1. Abate the asbestos containing materials in the structure prior to renovation or demolition.
2. Follow applicable asbestos regulations during renovation or demolition of the structure. You should be aware that stringent requirements are imposed upon anyone renovating or demolishing a structure in which ACM will be disturbed. This work must be performed in accordance with OSHA asbestos regulations, 29 CFR 1910 & 1926, and NESHAP asbestos regulations 40 CFR 61, subpart M. South Carolina regulations require the accreditation of personnel who work in the asbestos field and notification and permitting fees for asbestos removal projects. There is a 10 working day notification period required prior to abatement of asbestos in a facility. Failure to take proper precautions and actions to protect human health and the environment can result in penalties, danger to personnel, and construction delays.

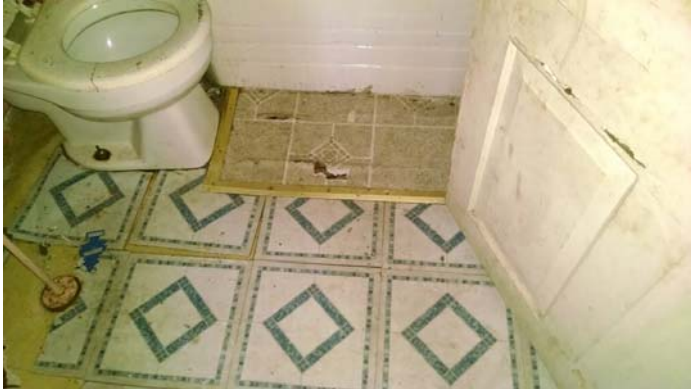
Photo 7 – Bathroom flooring yellow roll vinyl, tan roll vinyl, white 12"x12" self-stick vinyl flooring.

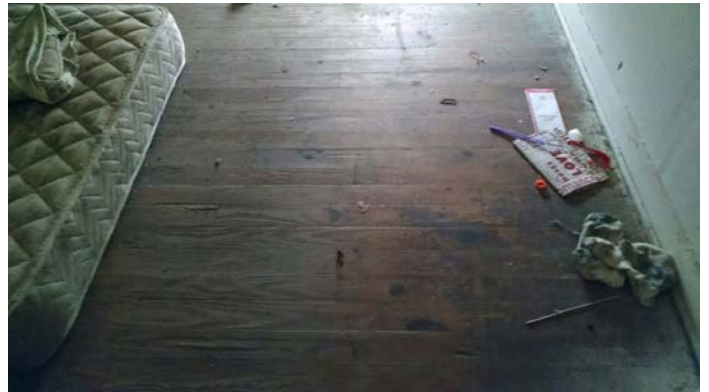
Photo 8 – Hardwood floors.

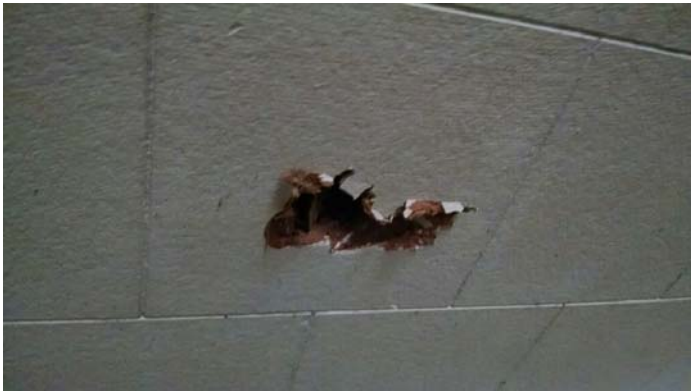
Photo 9 – 1'x1' ceiling tiles.

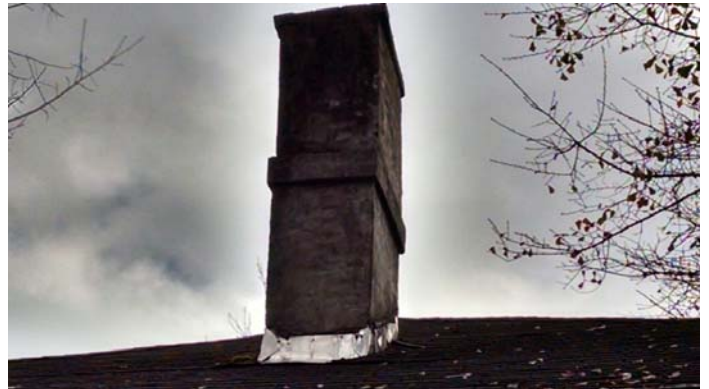
Photo 10 – One chimney with tar assumed.

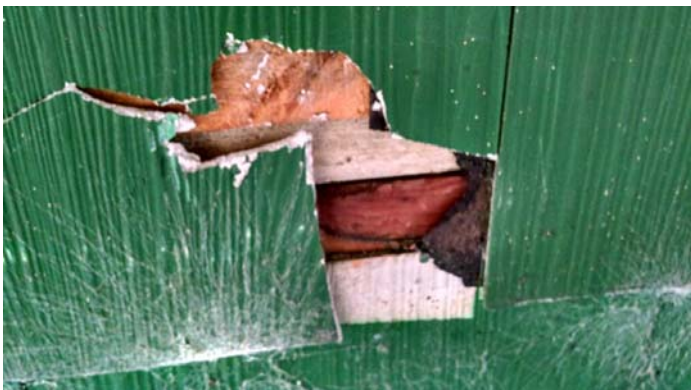
Photo 11 – Cement board siding with felt paper.
