## **Asbestos & Lead Based Paint Assessment**

City of Spartanburg  
702 Saxon Avenue  
Spartanburg, South Carolina

Project Number: 0417-66

May 31, 2017

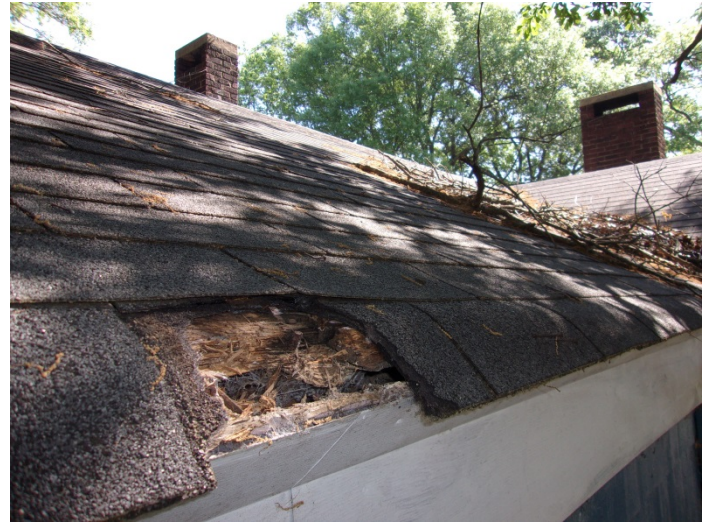
- Approximately 1,700 SF of exterior cement board siding.
- Approximately 12 LF of mastic/tar on 2 chimneys – assumed positive.

Photo 2 – Roof shingles and no felt & 2 chimneys with mastic/tar assumed positive.

1. Abate the asbestos containing materials in the structure prior to renovation or demolition.
2. Follow applicable asbestos regulations during renovation or demolition of the structure. You should be aware that stringent requirements are imposed upon anyone renovating or demolishing a structure in which ACM will be disturbed. This work must be performed in accordance with OSHA asbestos regulations, 29 CFR 1910 & 1926, and NESHAP asbestos regulations 40 CFR 61, subpart M. South Carolina regulations require the accreditation of personnel who work in the asbestos field and notification and permitting fees for asbestos removal projects. There is a 10 working day notification period required prior to abatement of asbestos in a facility. Failure to take proper precautions and actions to protect human health and the environment can result in penalties, danger to personnel, and construction delays.

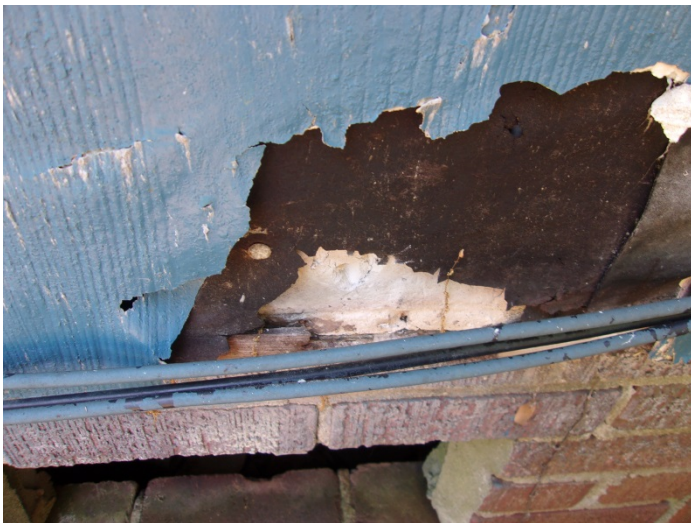
Photo 3 – Cement board siding with felt paper and unfinished drywall beneath.

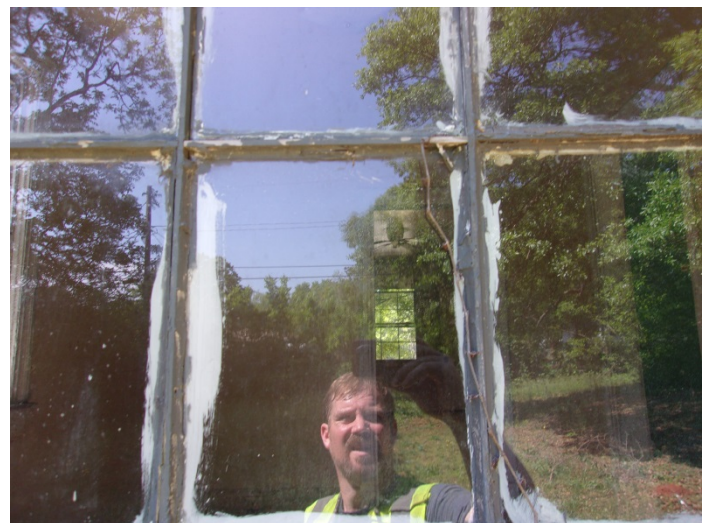
Photo 4 – Wooden window caulk.

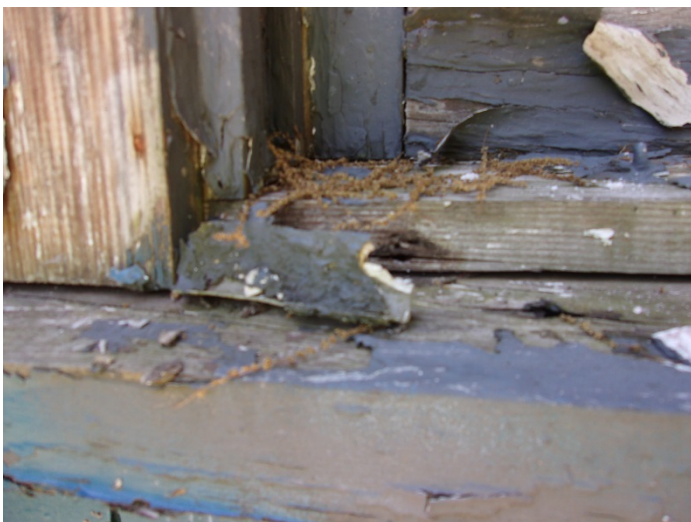
Photo 5 – Wooden window glazing.

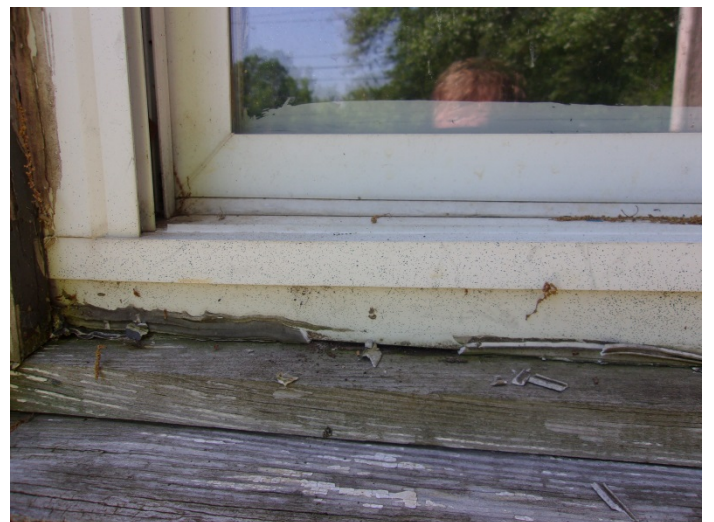
Photo 6 – Vinyl window caulk.

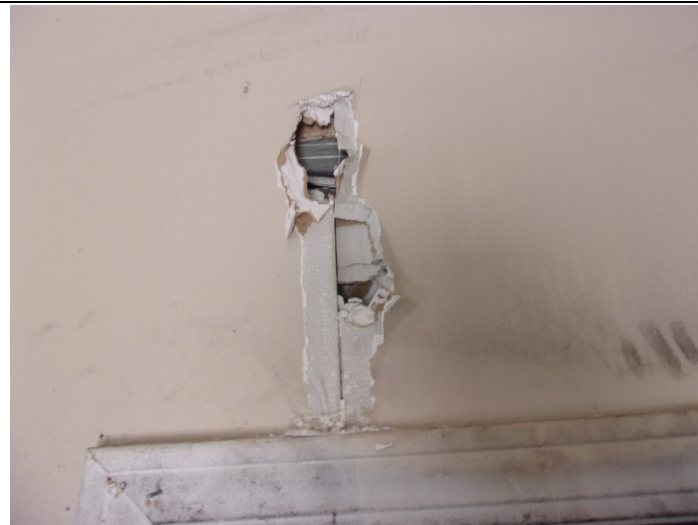
Photo 7 – Top layer of drywall with joint compound & tape in the living room.

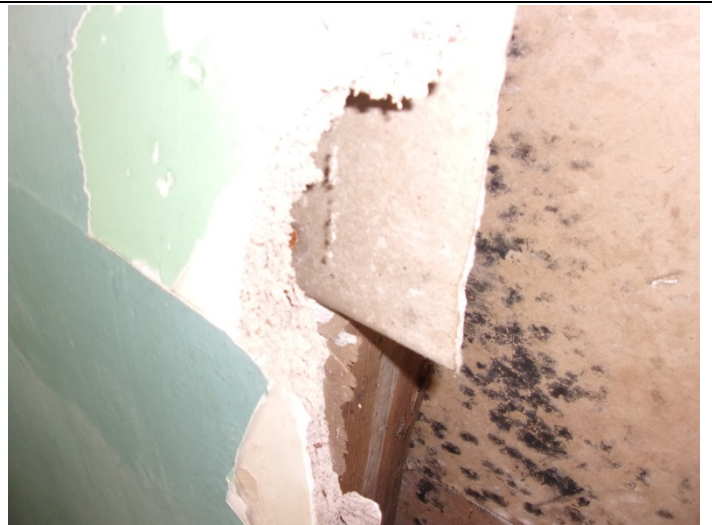
Photo 8 – Plaster with finish over unfinished drywall throughout.

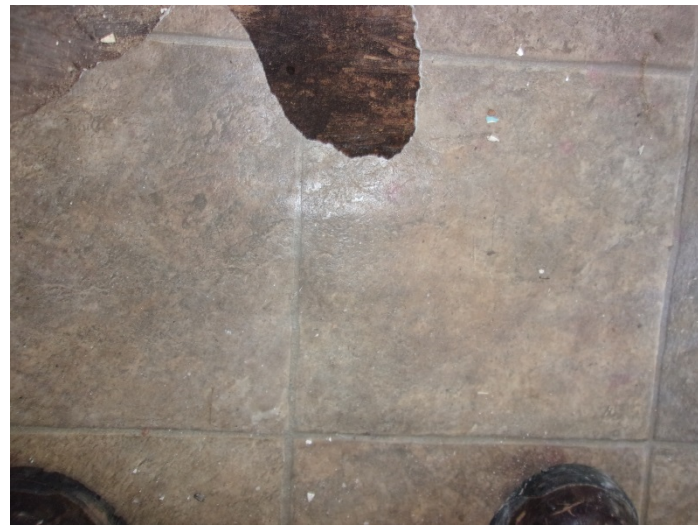
Photo 9 – Brown large square pattern vinyl floor with no mastic in the kitchen.

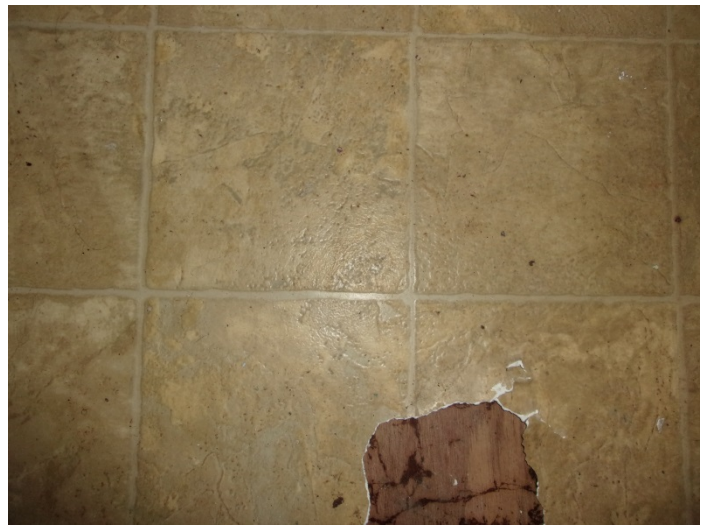
Photo 10 – Beige medium square pattern vinyl floor with no mastic in the bathroom.

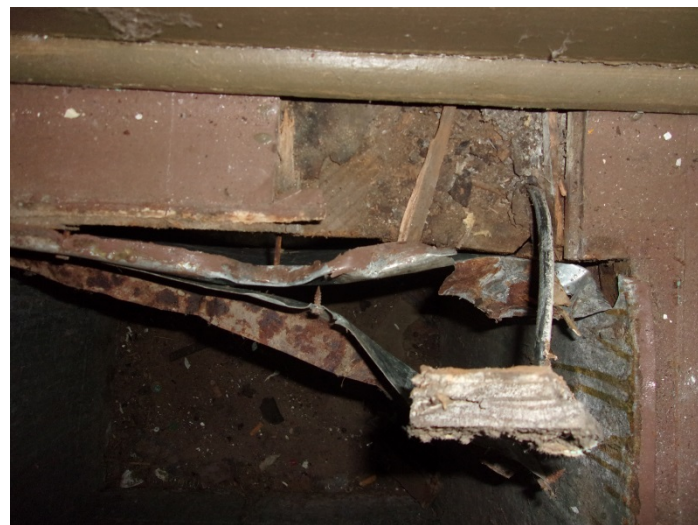
Photo 11 – Tan pattern vinyl floor with mastic under wood in the kitchen.

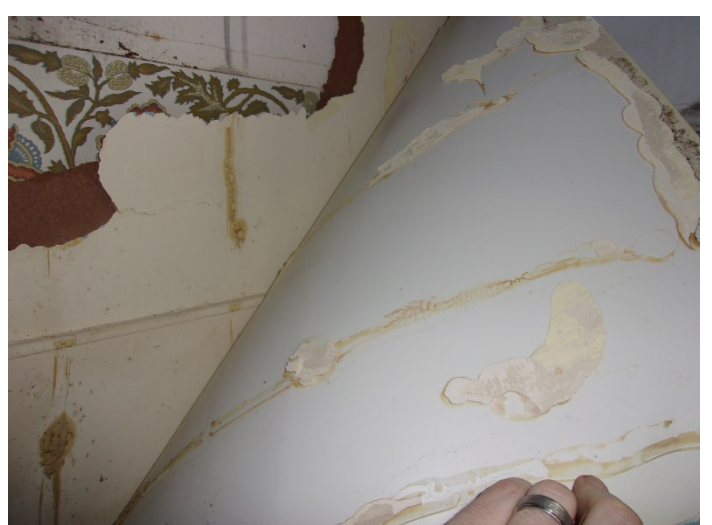
Photo 12 – Mastic beneath shower stall.
