## **Asbestos & Lead Based Paint Assessment**

City of Spartanburg  
152 Palisade Street  
Spartanburg, South Carolina

Project Number: 0815-163

August 11, 2016

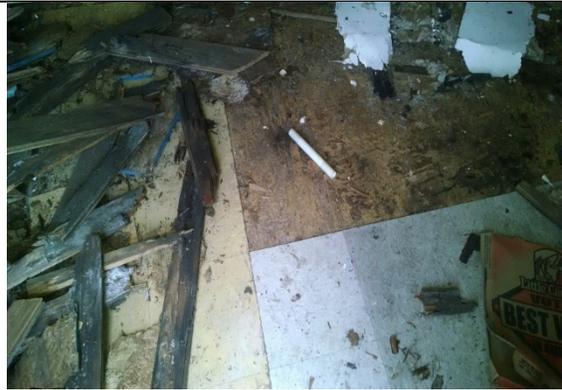
Photo 2 – Front middle entrance room, multiple flooring

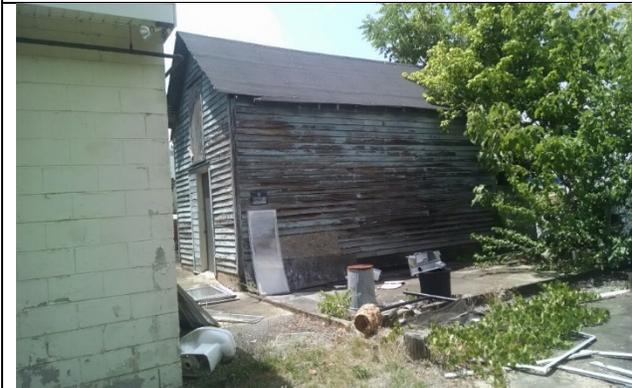
- Approximately 13,500 SF of drywall with joint compound throughout the interior with sample numbers on wall at sample sight.
- Approximately 350 SF of black floor mastic in the shed behind the house.

Photo 3 – Rear Shed

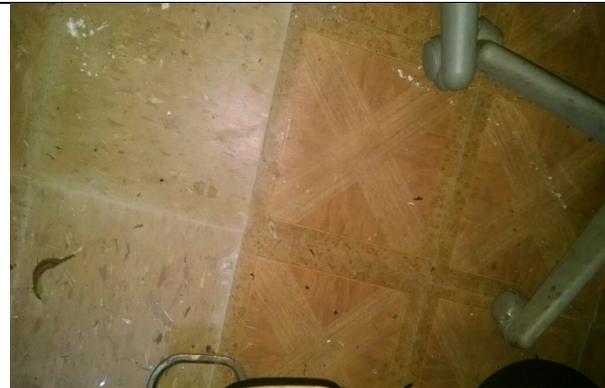
Photo 4 – Front Right bathroom flooring

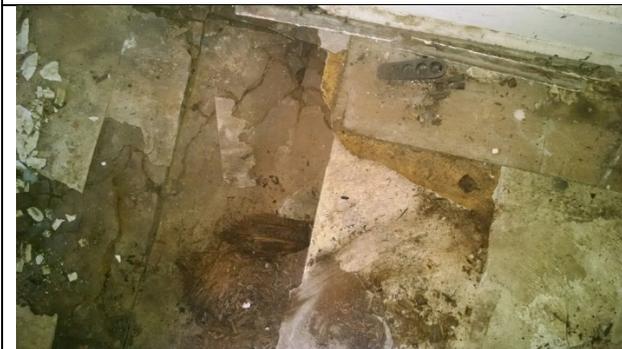
- Approximately 300 SF of tan 12"x12" tile with mastic and yellow roll vinyl with mastic in the hall and two rooms to the right of the middle entrance area.

Photo 5 – Flooring in Hall and 2 rooms right of middle.

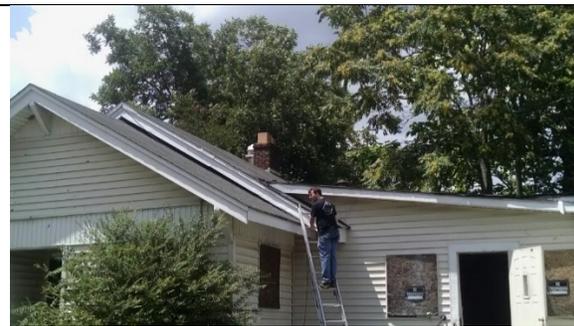
Photo 6 – Front left roof, roof shingles(2) and felt(1)

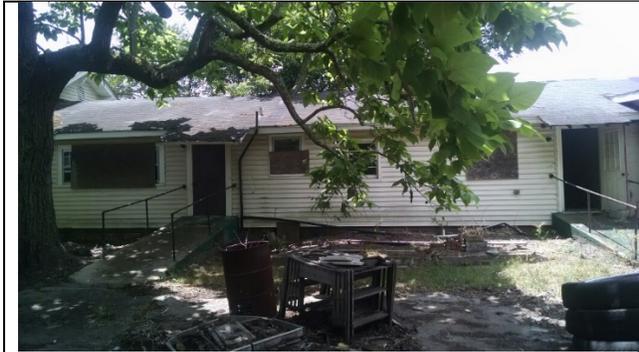
Photo 7 – Middle left roof, roof shingles(2) and felt(1)

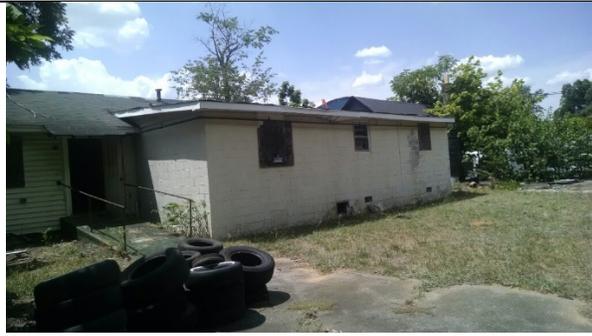
Photo 8 – Rear left roof, green roof shingles(1) and felt(1)

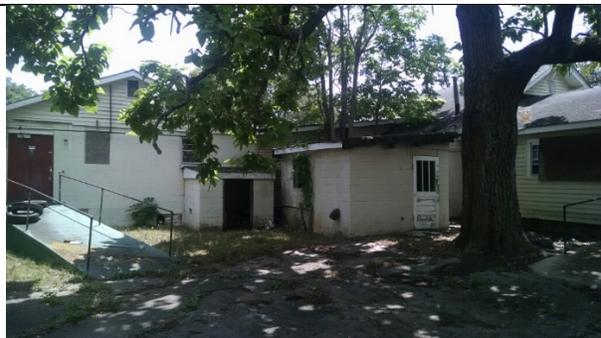
Photo 10 – Rear low roof, roof shingle(3) and felt(1)

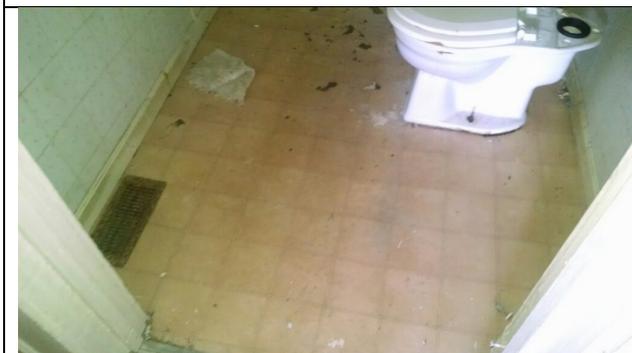
Photo 11 – Front left side bathroom, tan roll vinyl flooring with mastic

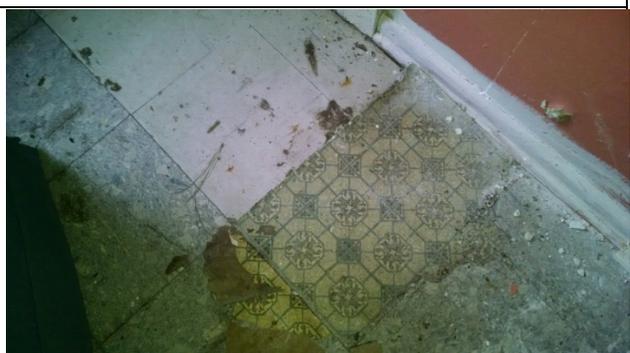
Photo 12 – 3<sup>rd</sup> from rear room multiple types of flooring

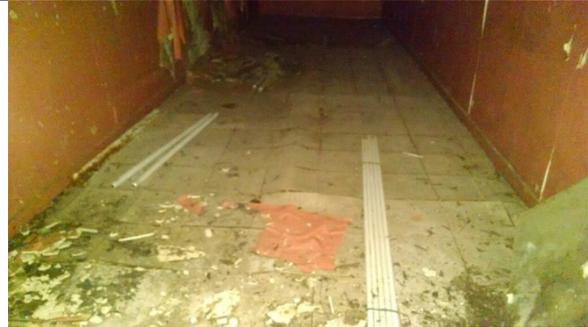
- Approximately 300 SF of vinyl flooring top layer pink 12"x12" vinyl flooring, grey 12"x12" tile with mastic in the big room behind the janitor's closet.

Photo 13 - big room behind janitors closet, top layer pink 12"x12" vinyl flooring, grey 12"x12" tile with mastic

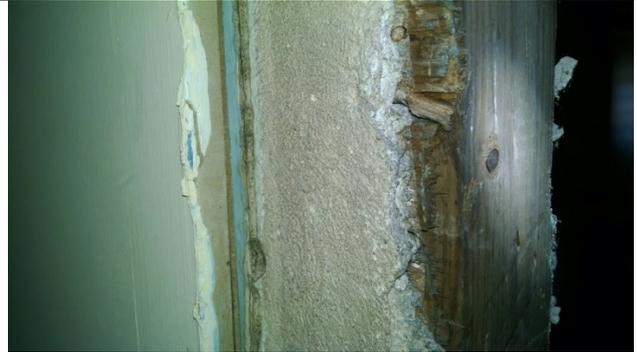
Photo 14 - Drywall over plaster

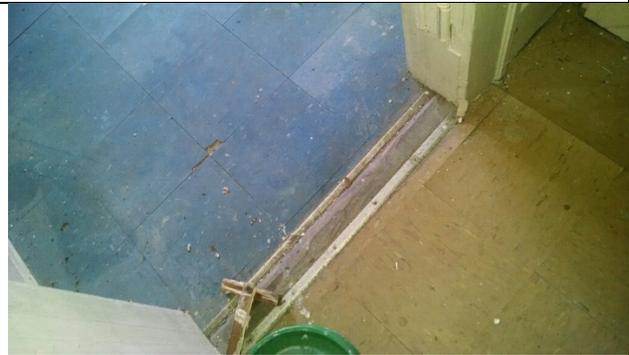
Photo 15 - Multiple flooring types

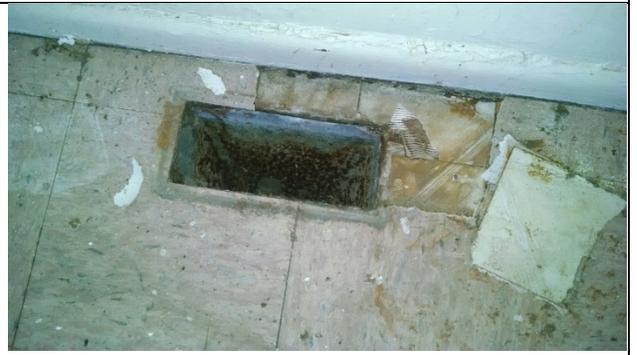
- Approximately 416 SF of grey speckled 12"x12" vinyl flooring with mastic, grey and brown square pattern roll vinyl over two more layers of roll vinyl in the third room from the rear on the left.

Photo 16 - third room from rear on left side, grey speckled 12"x12" vinyl flooring with mastic, three more layers of roll vinyl

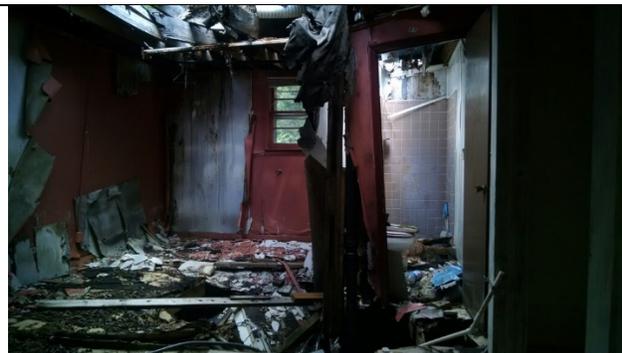
- Approximately 216 SF of purple 12"x12" vinyl flooring with mastic, yellow square pattern 12"x12" vinyl flooring with mastic, grey speckled 12"x12" vinyl flooring with mastic, grey stone pattern roll vinyl with mastic in the far rear left room.

Photo 17 - Far rear left room, purple 12"x12" vinyl flooring with mastic and multiple layers

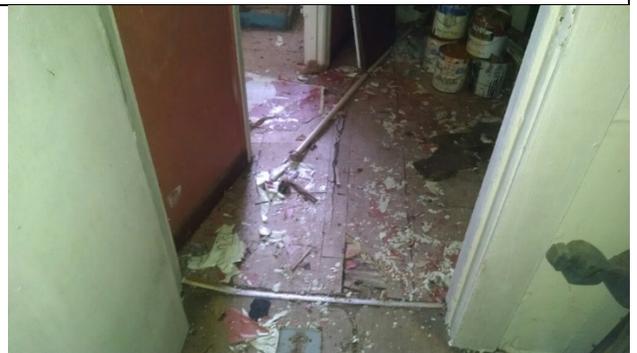
- Approximately 200 SF of 4 layers of flooring, top pink layer already seen, 2nd tan striated pattern vinyl flooring, 3rd layer grey vinyl flooring, 4th thinner layer of vinyl flooring can't tell color in the janitor's closet.

Photo 18 - Janitors closet, 4 layers of flooring
