## **Asbestos & Lead Based Paint Assessment**

City of Spartanburg  
143 George Street  
Spartanburg, South Carolina

Project Number: 0417-66

May 26, 2017

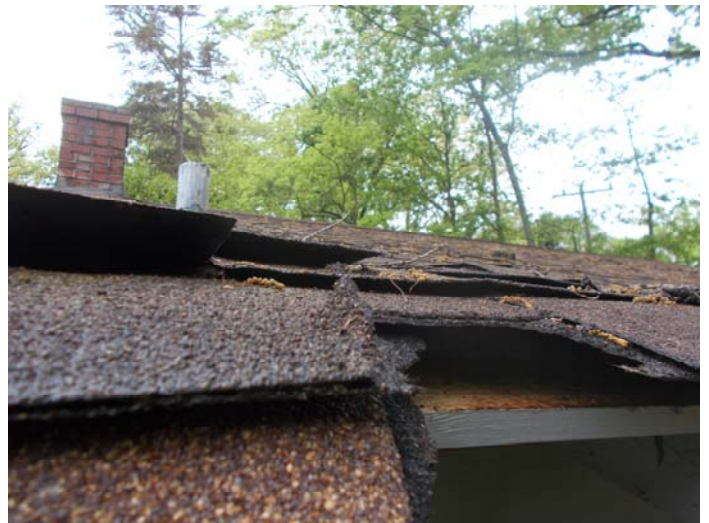
Photo 2 – Roofing material (4 layers) and felt (1 layer).

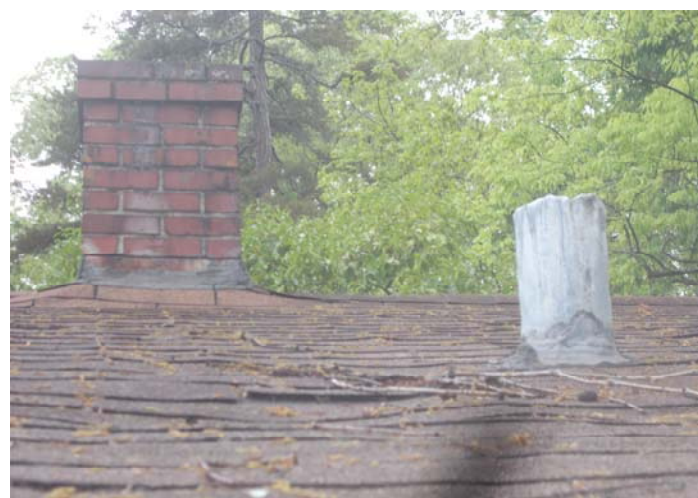
Photo 3 – Chimney and vent penetration with mastic assumed positive.

1. Abate the asbestos containing materials in the structure prior to renovation or demolition.
2. Follow applicable asbestos regulations during renovation or demolition of the structure. You should be aware that stringent requirements are imposed upon anyone renovating or demolishing a structure in which ACM will be disturbed. This work must be performed in accordance with OSHA asbestos regulations, 29 CFR 1910 & 1926, and NESHAP asbestos regulations 40 CFR 61, subpart M. South Carolina regulations require the accreditation of personnel who work in the asbestos field and notification and permitting fees for asbestos removal projects. There is a 10 working day notification period required prior to abatement of asbestos in a facility. Failure to take proper precautions and actions to protect human health and the environment can result in penalties, danger to personnel, and construction delays.

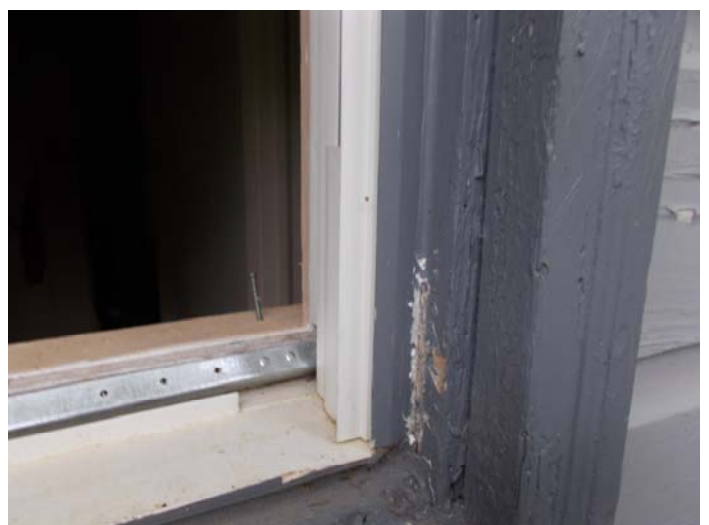
Photo 4 – Caulk on exterior vinyl window.

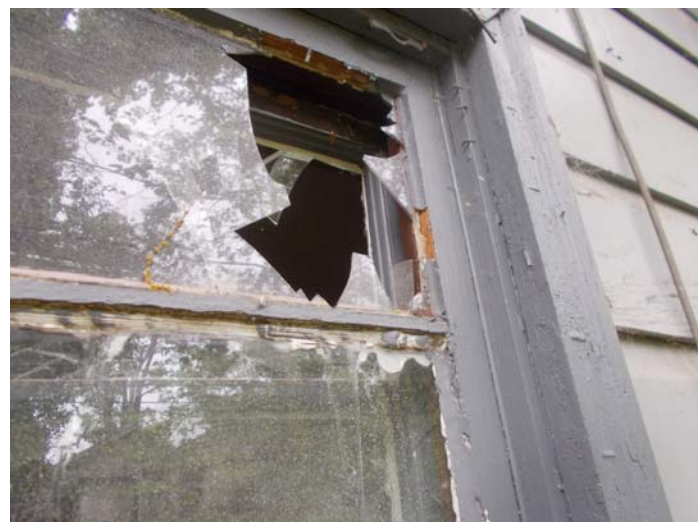
- Exterior purple wooden windows.

Photo 5 – Caulk and glazing on exterior wooden window.

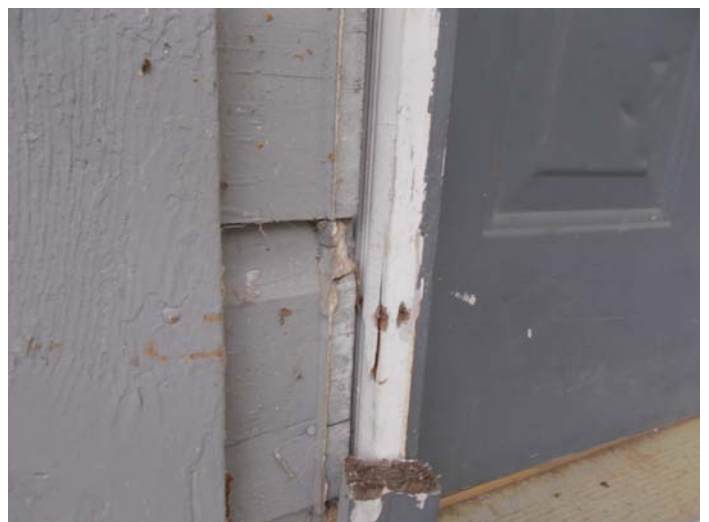
Photo 6 – Caulk on exterior door frame.

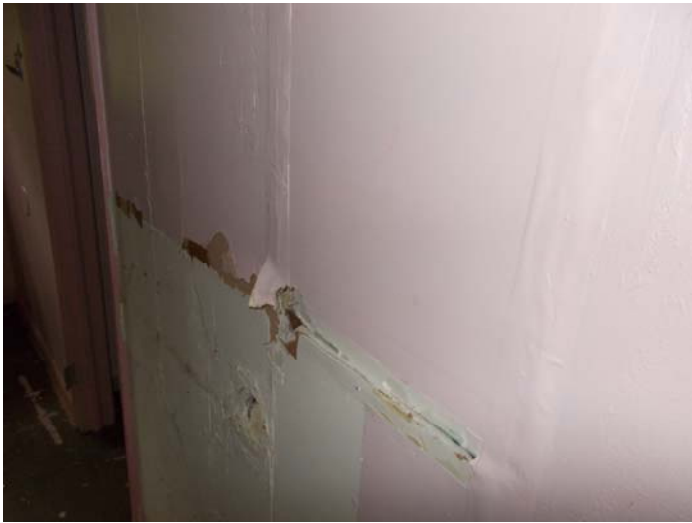
Photo 7 – Drywall with tape and coating throughout interior.

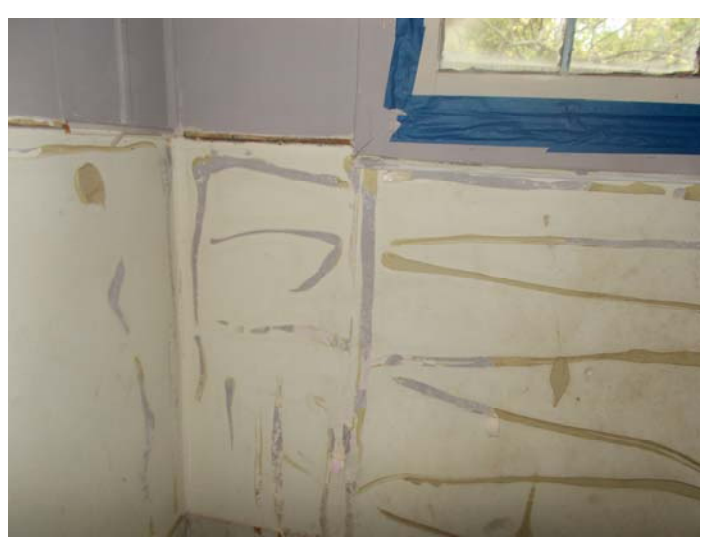
Photo 8 – Wall mastic in shower stall area.

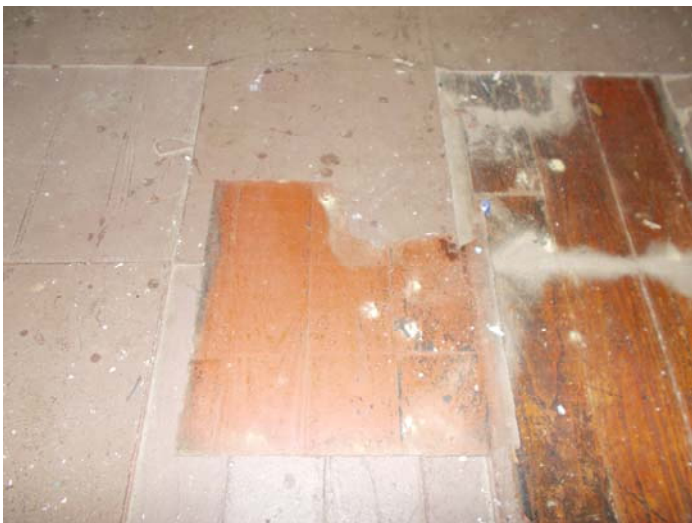
Photo 9 – 12"x12" dark orange floor tile with mastic in the right rear bedroom.

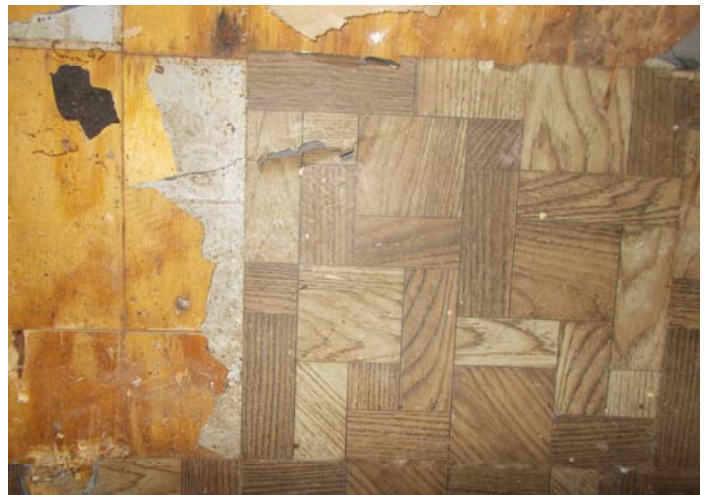
Photo 10 – 12"x12" wood pattern self-stick floor tile and 12"x12" grey self-stick floor tile.
