## **Asbestos & Lead Based Paint Assessment**

City of Spartanburg  
458 Zephyr Street  
Spartanburg, South Carolina

Project Number: 0417-66

May 31, 2017

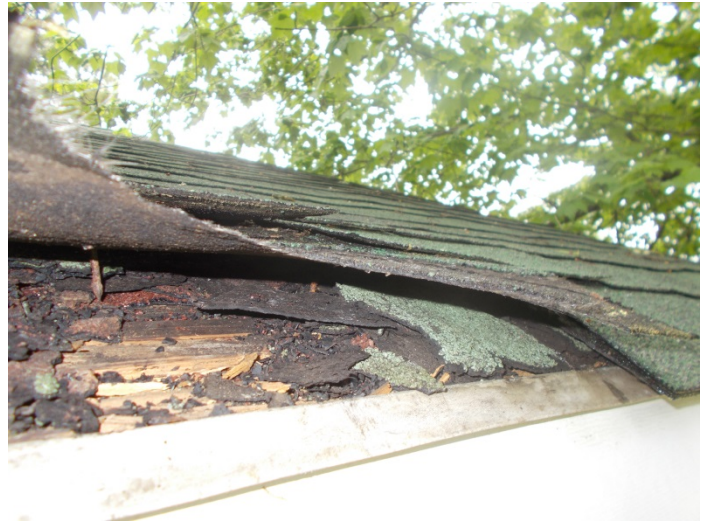
Photo 2 – Roof shingles and no felt.

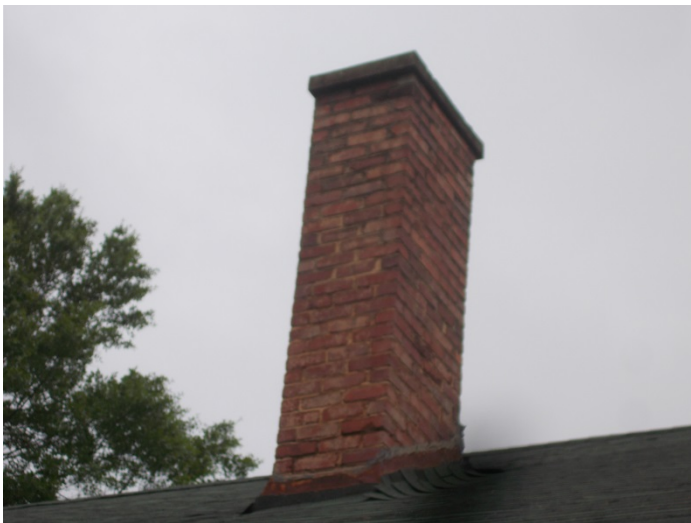
- Approximately 13 exterior windows with outer caulk on the frames.
- Approximately 3,800 SF of texture over plaster with finish walls and ceilings.
- Approximately 18 LF of mastic/tar on 3 chimneys – assumed positive.

Photo 3 – Typical chimney with mastic assumed positive.

1. Abate the asbestos containing materials in the structure prior to renovation or demolition.
2. Follow applicable asbestos regulations during renovation or demolition of the structure. You should be aware that stringent requirements are imposed upon anyone renovating or demolishing a structure in which ACM will be disturbed. This work must be performed in accordance with OSHA asbestos regulations, 29 CFR 1910 & 1926, and NESHAP asbestos regulations 40 CFR 61, subpart M. South Carolina regulations require the accreditation of personnel who work in the asbestos field and notification and permitting fees for asbestos removal projects. There is a 10 working day notification period required prior to abatement of asbestos in a facility. Failure to take proper precautions and actions to protect human health and the environment can result in penalties, danger to personnel, and construction delays.

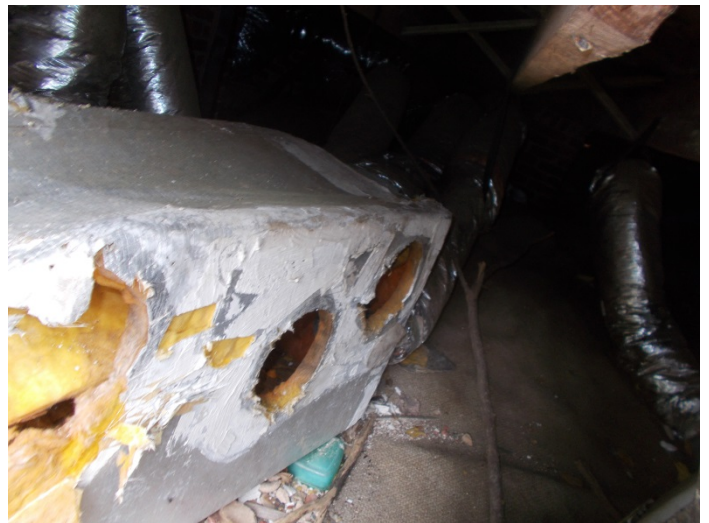
Photo 4 – HVAC mastic in the crawlspace.

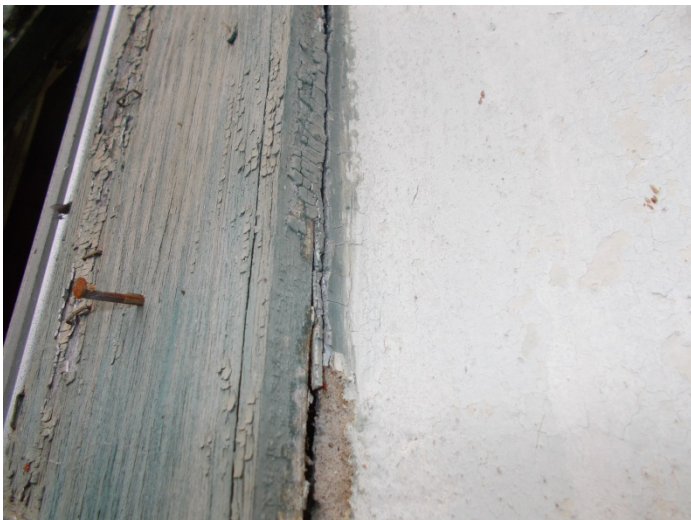
Photo 5 – Outer caulk on exterior windows.

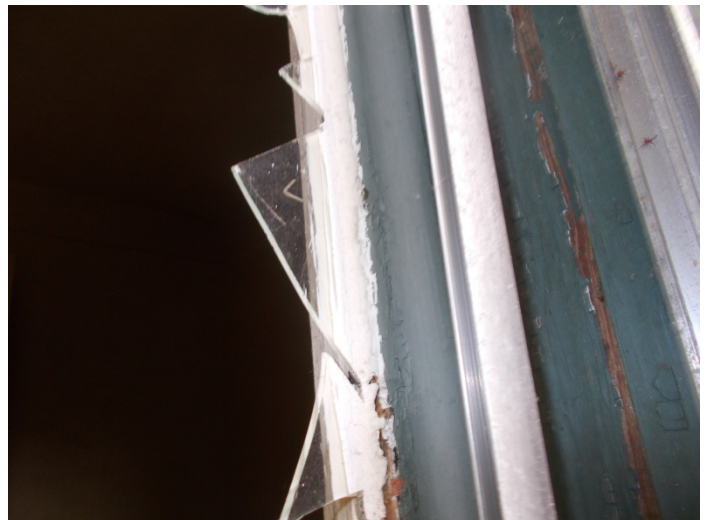
Photo 6 – Inner caulk on window panes.

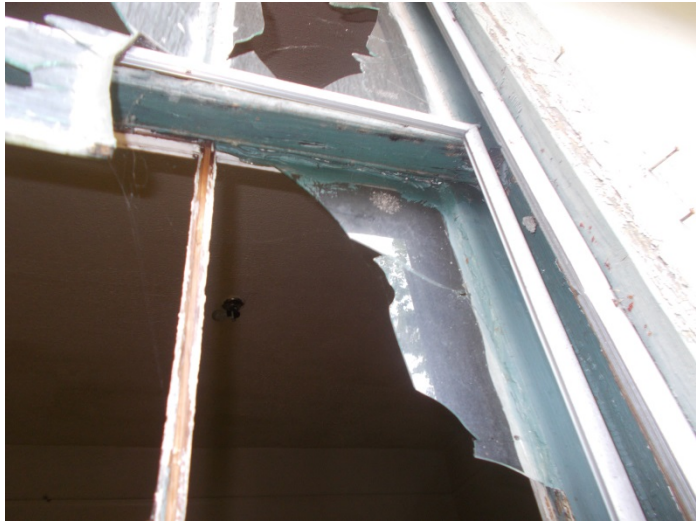
Photo 7 -- Window glazing.

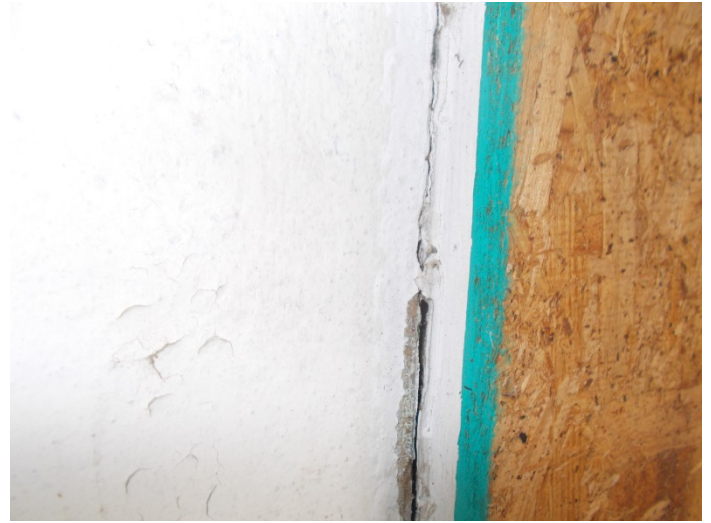
Photo 8 – Door caulk.

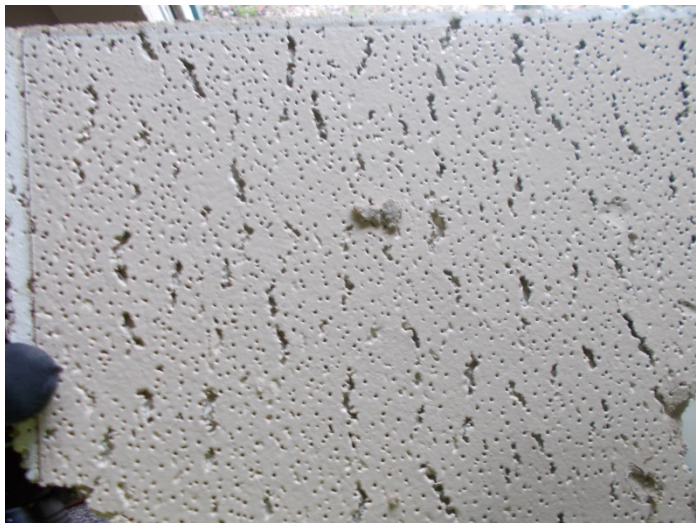
Photo 9 – 2' x 2' fissure ceiling tile in the kitchen.

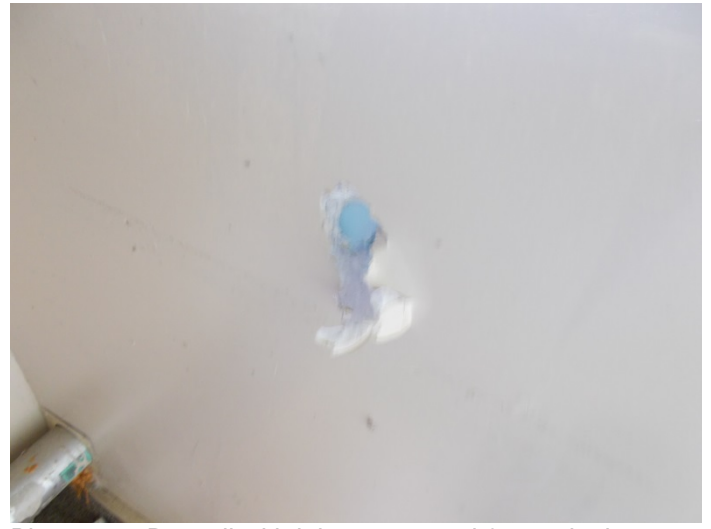
Photo 10 – Drywall with joint compound & tape in the rear entry & bathroom.

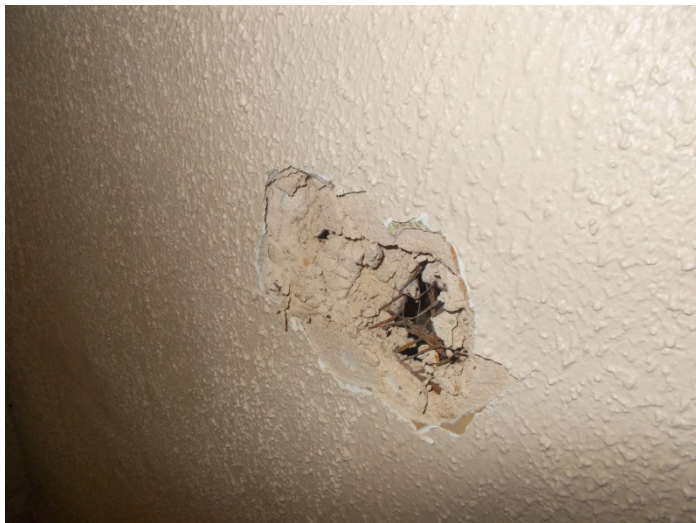
Photo 11 – Texture over plaster with finish throughout the ceilings and walls.

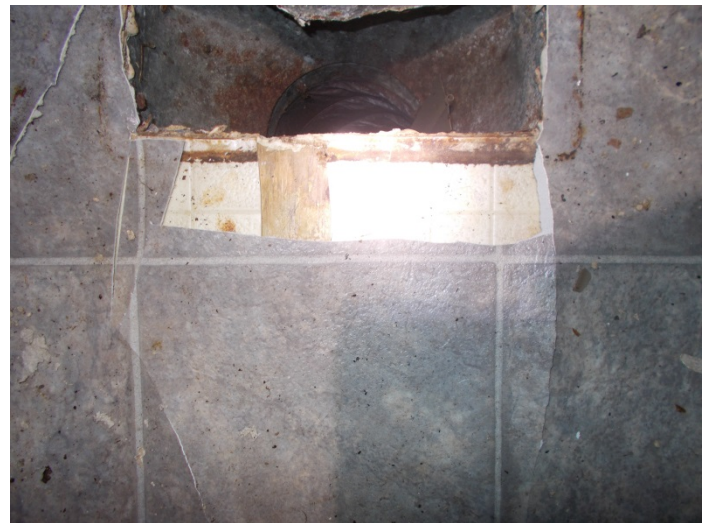
Photo 12 – Stone square pattern vinyl floor with no mastic over cream vinyl floor with mastic.

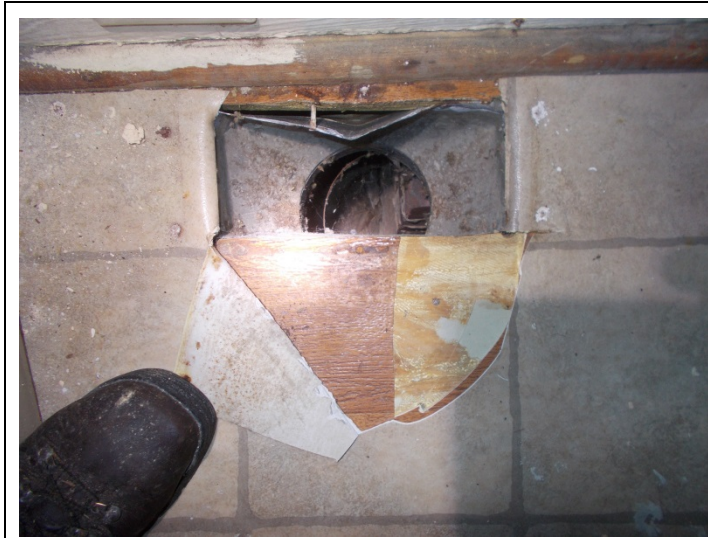
Photo 13 – Beige square pattern vinyl floor with no mastic over wooden pattern vinyl floor with mastic.
