Asbestos & Lead Based Paint Assessment

City of Spartanburg
215 Ardmore Road
Spartanburg, South Carolina

Project Number: 0815-163

January 11, 2017

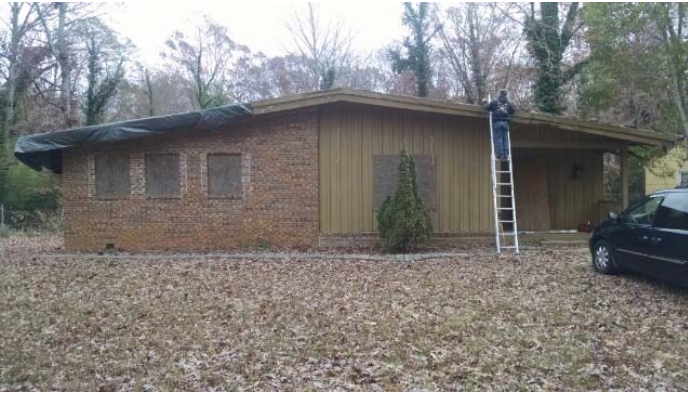
Photo 1 – 215 Ardmore Road.

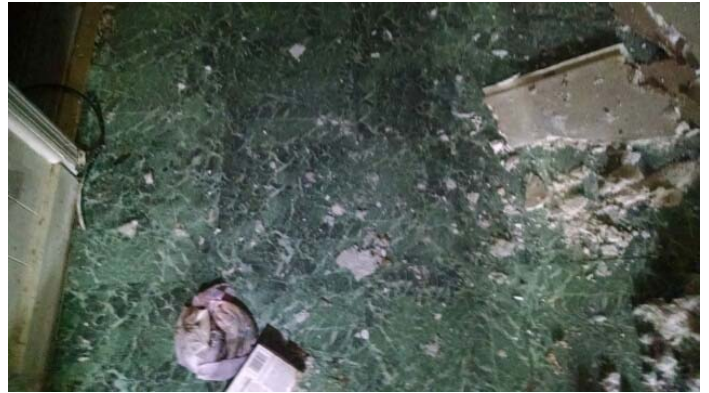
Photo 2 – Kitchen flooring.

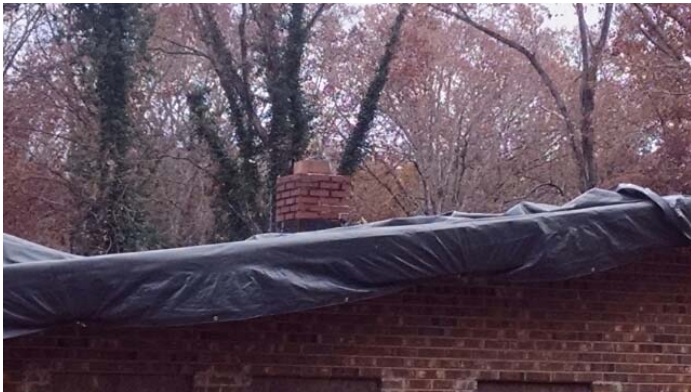
- Approximately 2,200 SF of tar on roof shingles and felt.
- Approximately 6 LF of tar on the chimney is assumed positive.

Photo 3 – Chimney with assumed tar.

1. Abate the asbestos containing materials in the structure prior to renovation or demolition.
2. Follow applicable asbestos regulations during renovation or demolition of the structure. You should be aware that stringent requirements are imposed upon anyone renovating or demolishing a structure in which ACM will be disturbed. This work must be performed in accordance with OSHA asbestos regulations, 29 CFR 1910 & 1926, and NESHAP asbestos regulations 40 CFR 61, subpart M. South Carolina regulations require the accreditation of personnel who work in the asbestos field and notification and permitting fees for asbestos removal projects. There is a 10 working day notification period required prior to abatement of asbestos in a facility. Failure to take proper precautions and actions to protect human health and the environment can result in penalties, danger to personnel, and construction delays.

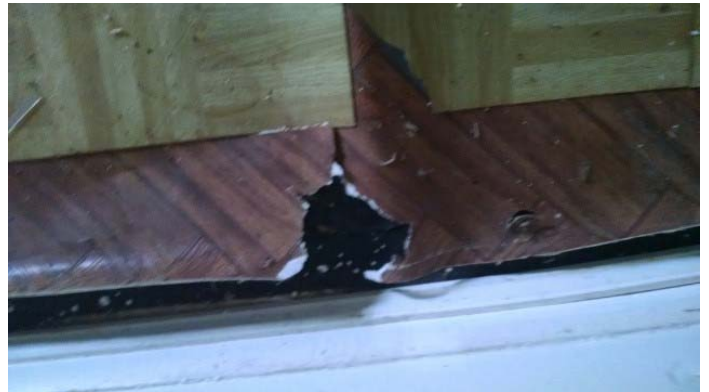
Photo 4 – Front room 2 layers of flooring and black felt.

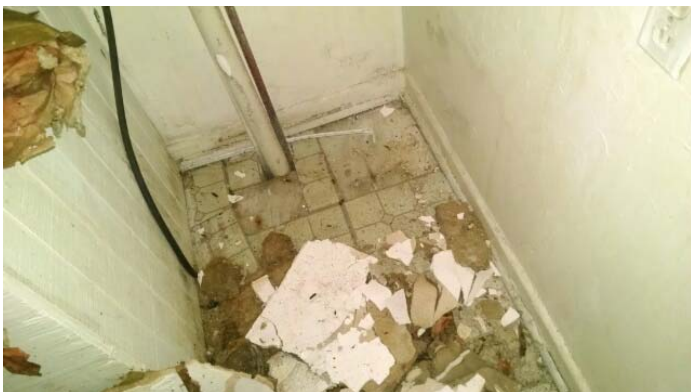
Photo 5 – Utility room flooring.

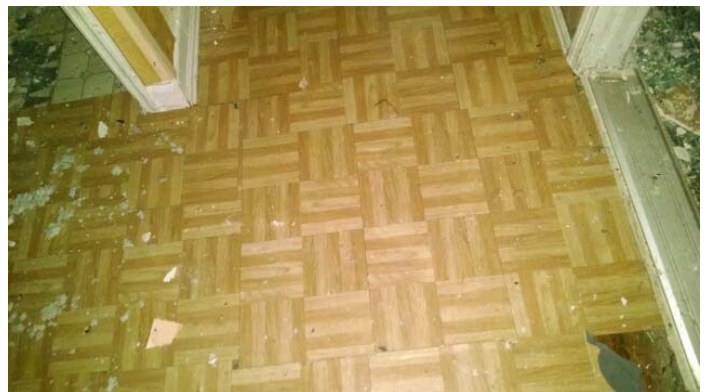
Photo 6 – Hallway flooring.

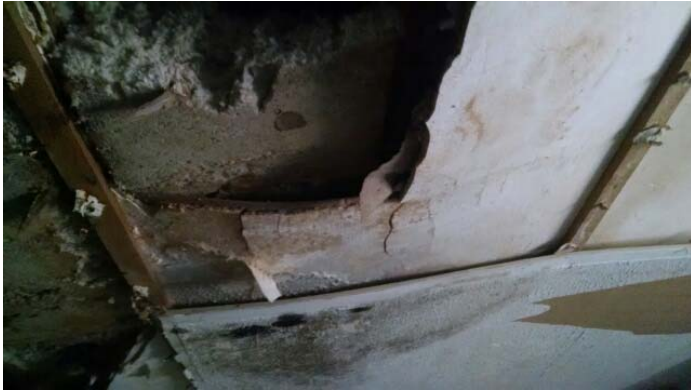
Photo 7 – Ceiling texture, drywall and plaster in kitchen.

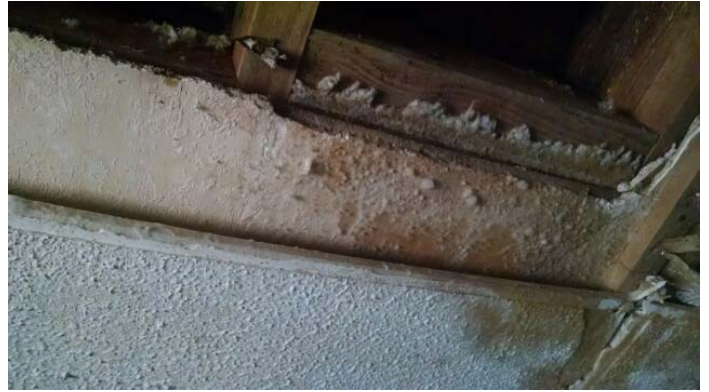
Photo 8 – Ceiling texture, drywall and plaster in kitchen.
